Dismantling Methodology – Part 2b Item 4.6 – Record of elements to be retained for record purposes only. (Issue 03 – 21/01/2026).

The following schedule updates the indicative schedule noted in the Arup Methodology Document Ref: 151667-TSA-30-MVL3-REP-A-AR-012001 (HUDDERSFIELD STATION - Methodology for deconstructing, storing and reconstructing the Tea Rooms.

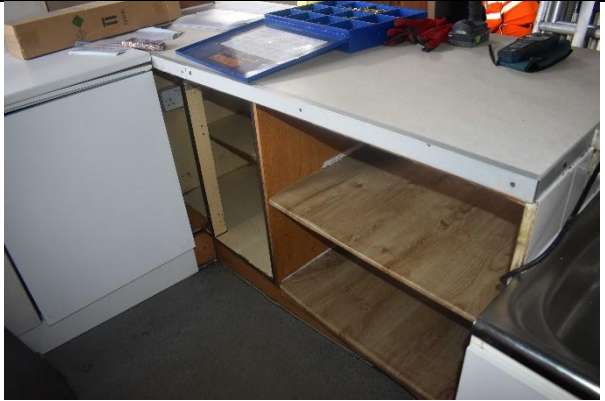
Ref:	Item Description	Photograph
Café – 01	<p>MDF buffet counter.</p> <p>Note: This is a modern chipboard melamine counter top (dated 2005).</p> <p>Dimensions of the countertop are shown on HPC Drawing Ref: HPCSK008.</p>

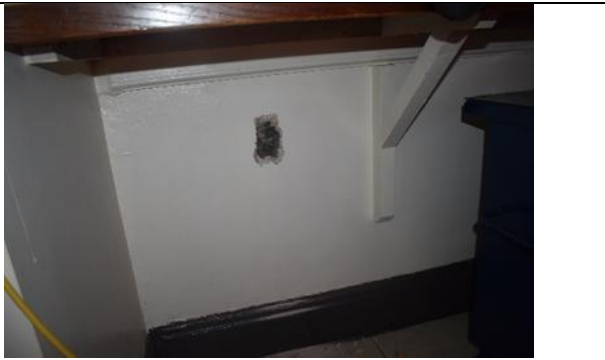
Café – 02	<p>Cladding Type B Plywood sheet.</p> <p>Note: This cladding material is 12.5mm modern gypsum plasterboard. Samples have been retained for record purposes.</p>

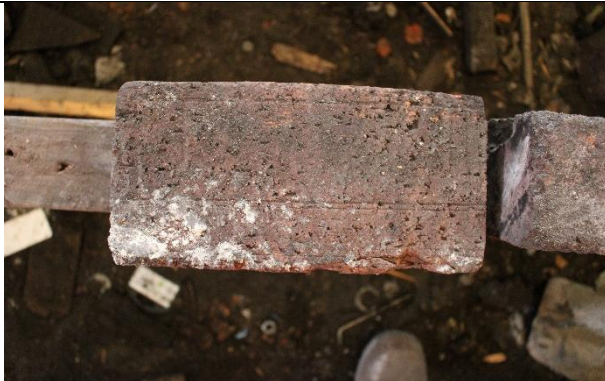
All Areas – 03	<p>Bricks from solid walls.</p> <p>Samples retained from perimeter foundations and sub-walls.</p>

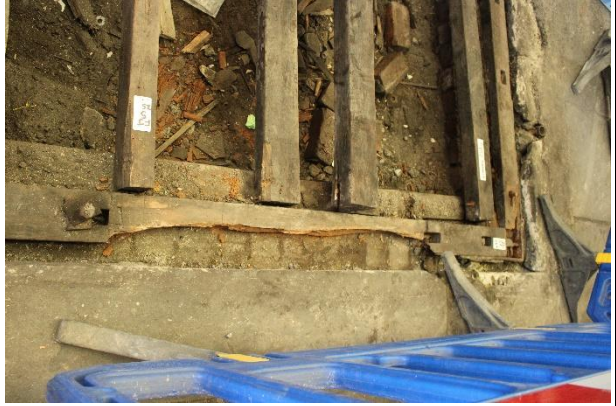
<p>All Areas – 04</p>	<p>Door thresholds.</p> <p>Thresholds discovered to be either concrete infill or part of the timber soleplate. All to be retained for record purposes.</p> <p>Photo shows door threshold into café area – timber severely degraded.</p>

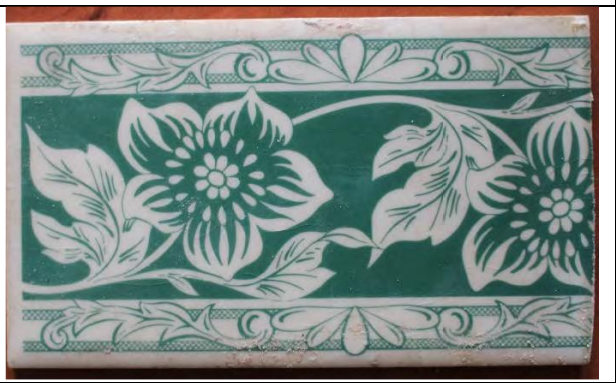
<p>Café – 05</p>	<p>Wall tiles (behind counter).</p> <p>Sample wall tiles taken from site – these are modern ceramic tiles (See Findings report for full details).</p>

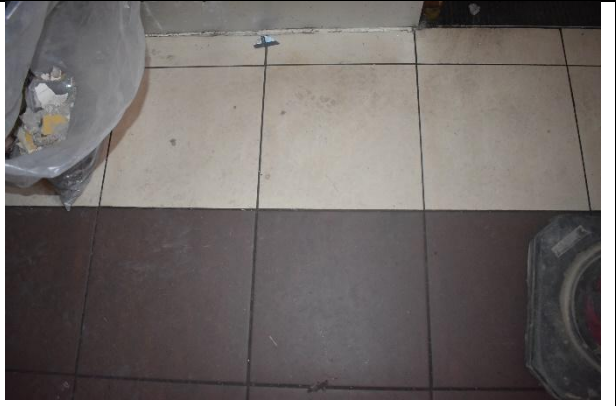
<p>All Areas – 07</p>	<p>Floor Tiles - Zone 5 (Café) Cream and white ceramic floor tiles.</p> <p>Size: 400x400mm</p> <p>Samples of all floor tile have been taken for record purposes.</p>

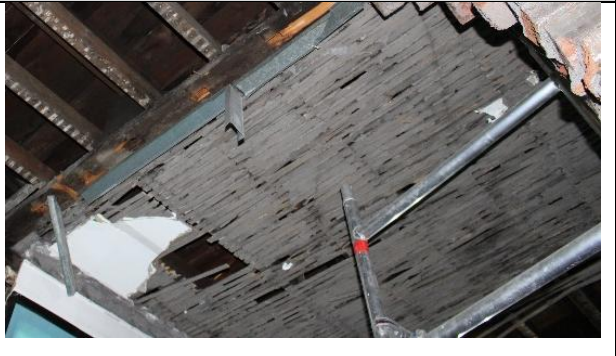
<p>Ref:</p>	<p>Item Description</p>	<p>Photograph</p>
<p>All Areas – 08</p>	<p>Lath and Plaster Ceiling -</p> <p>Samples of the plaster and timber laths have been retained for record purposes.</p> <p>Profiles and a retained section from the plaster coving has also been retained for record purposes.</p>

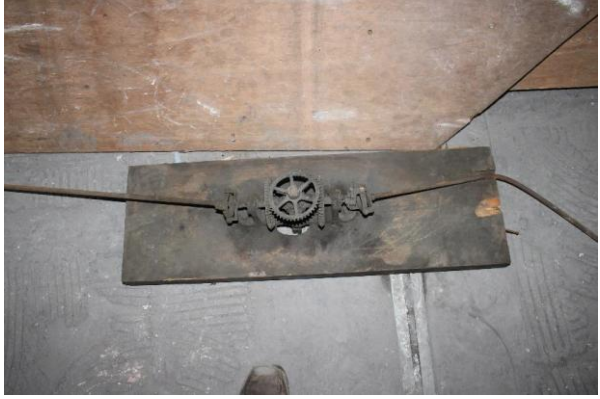
<p>Café - 09</p>	<p>Clock display arms</p> <p>The actuator arms for the clock that was installed in the café area has been retained for record purposes.</p> <p>See HPC Fine Note 25 for full details.</p>

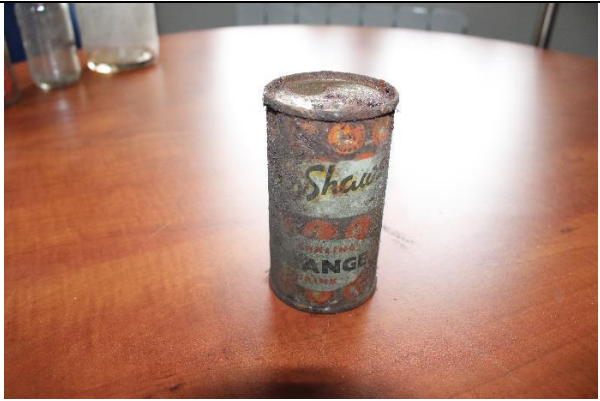
<p>All Areas – 10</p>	<p>Discovered items</p> <p>All of the items including bottles, wrappers and tickets that were discovered during the dismantling of the Tea Rooms has been retained for record purposes.</p> <p>See HPC File Note 19 for full details.</p>

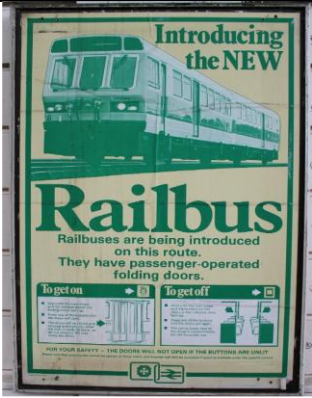
<p>Building External</p>		
<p>Ref:</p>	<p>Item Description</p>	<p>Photograph</p>
<p>External – 11</p>	<p>Heritage Posters</p> <p>Copies of all heritage posters that were discovered under the moder poster frames have been retained for record purposes.</p> <p>See HPC File Note 09 for full details.</p> <p>Options to be reviewed to determine whether these can be displayed within the Tea Rooms.</p>
