Intrusive Coal Mining Risk Assessment (CMRA) and Geotechnical Assessment

St Marys Primary School Gomersal

Reference: 251009.SC.01

Client: Bowmer and Kirkland

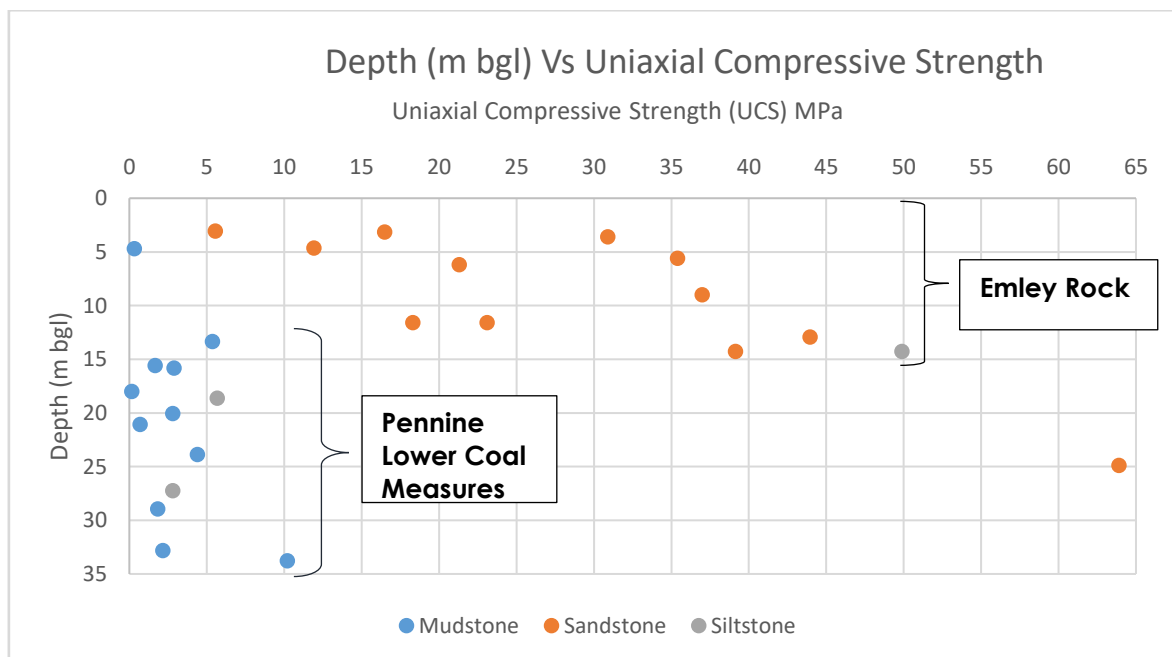
The graph below presents the UCS data obtained for mudstone, sandstone and siltstone and the relationship of this data with increasing depth. The UCS values are either derived directly from a UCS test or via a correlation with Point Load Strength Index ($IS_{(50)}$) and a suitable modulus value (k):

Overall, there is no reliable trend of bedrock strength with increasing depth. There is, however, a more obvious relationship between bedrock strength and lithology (i.e. mudstone, siltstone or sandstone). As the Emley Rock sandstone is situated at shallower depths (up to approximately 10 m bgl), the bedrock sequence is considered more competent, albeit with a significant spread of strength data, throughout this initial sequence. The UCS of sandstone varies between ~5 MPa and ~45 MPa.

At depths beyond 10 m bgl, the geological sequence becomes dominated by mudstone, which correlates with a reduction in strength, varying between ~0.5 MPa and typically, <5MPa. There are frequently values recorded close to or less than 1.0 MPa. These deposits may be associated with zones of fractured, destructured bedrock, which may exhibit negative skin friction when considering deeper foundation design.

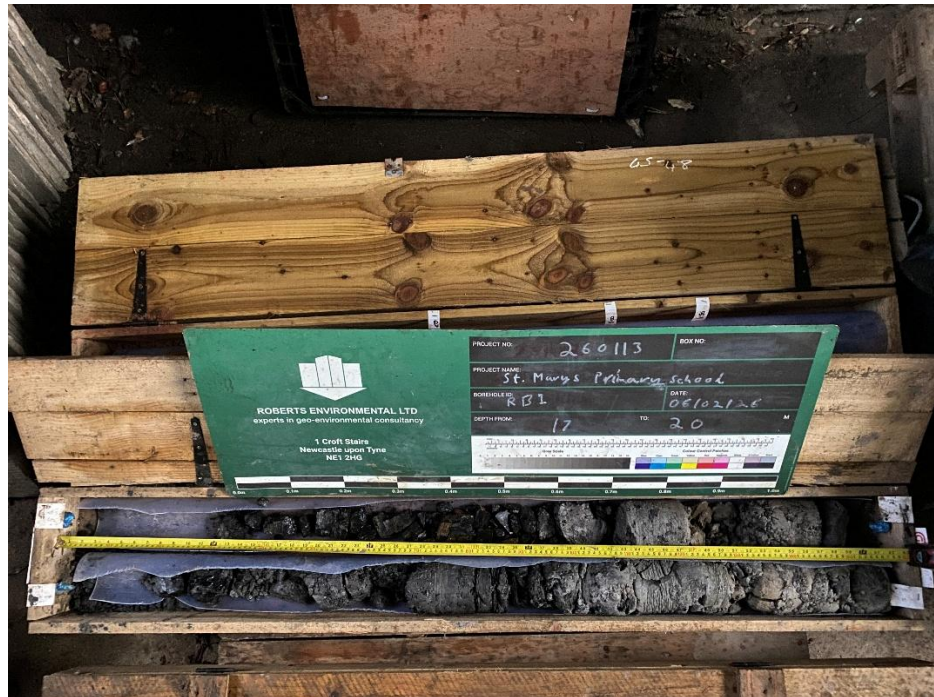
6.
Gomersal St. Mary's Primary School
 RB1 17 – 20m .

Borehole	Void/Broken Ground?	Depth (m bgl)	Intact Rock Cover Required (10:1)	Rock Cover Present?
RB1 (REL)	Void	17.00 – 17.60	6.00	12.90
	Void	29.20 – 32.00	28.00	11.60*
RB2 (REL)	Void	30.15 – 31.20	10.05	28.95
	Void	33.10 – 33.50	4.00	2.90*
RB3 (REL)	Void	31.90 – 33.50	16.00	29.45
RO4 (RSK)	Broken Ground	17.67 – 17.82	1.50	15.97
	Broken Ground	18.46 – 18.50	0.40	16.76
RO5 (RSK)	Void	14.80 – 16.20	14.00	12.40
	Void	27.90 – 29.30	14.00	11.70*

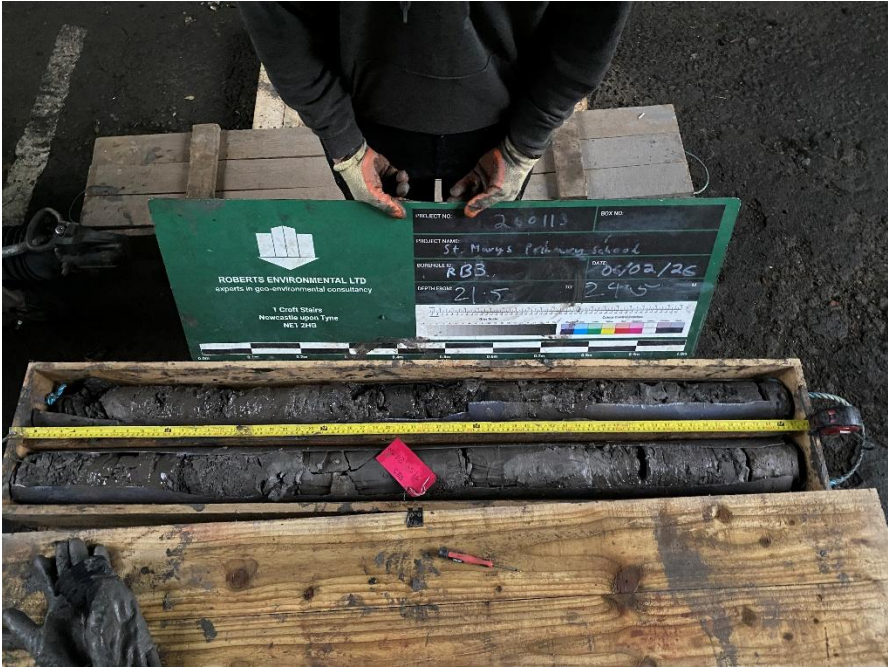
<p>A photograph showing a soil core sample in a wooden box. A yellow measuring tape is placed over the core. A green data sheet is visible, with handwritten information: PROJECT NO. 260113, BOX NO., PROJECT NAME St. Mary's Primary School, BORING NO. RB3, DATE 06/02/26, DEPTH 21.5 TO 24.5 M. The data sheet also includes a color calibration chart and a scale bar. A person's hands are visible at the top of the frame, holding the data sheet.</p>
