Our Ref: 251009.CT.01
04 December 2025

Re: 251109: Coal Tar Assessment – St Marys Primary School, Shirley Avenue, Gomersal BD19 4NA.

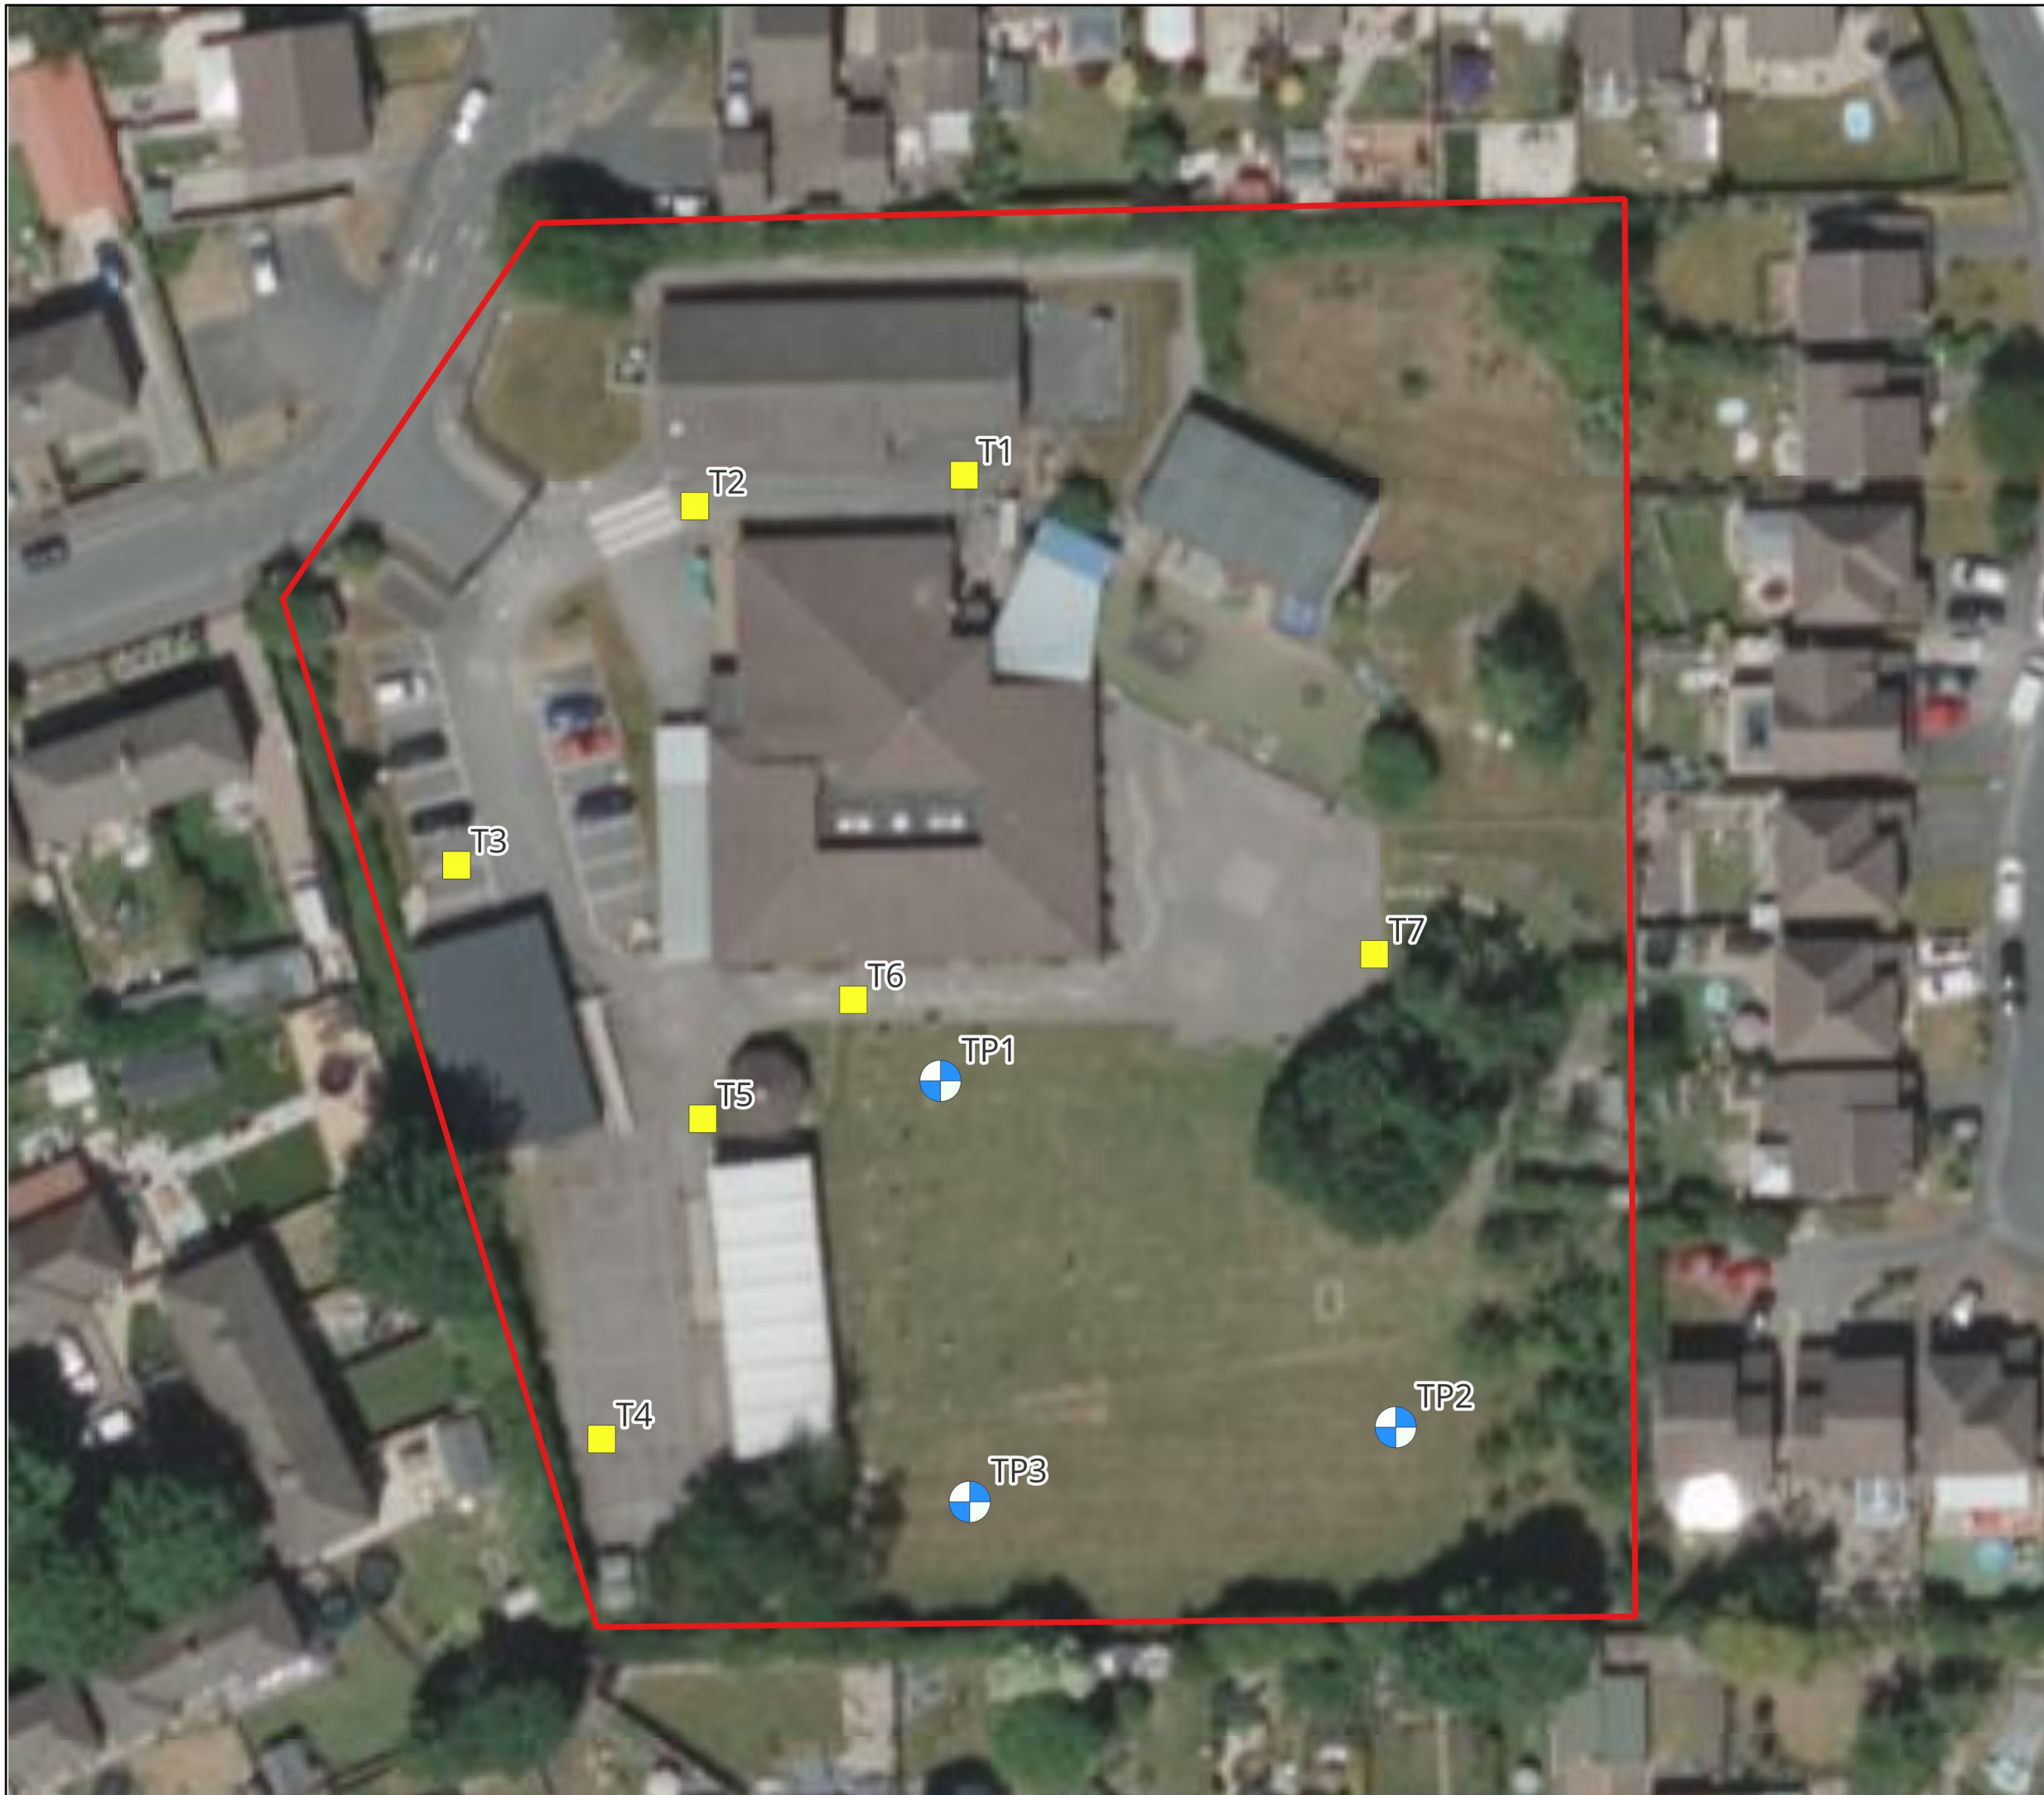
Figure Indicative Coal Tar Sampling and Soakaway Location Plan

Seven samples of asphalt surfacing obtained from the site on the 27th of October 2025, were submitted for Coal Tar Analysis. to Express Mobile Soil Testing, registered at Retford, Nottinghamshire. An indicative plan showing the location the samples were obtained, is attached in **Enclosure 1** with a copy of the results attached in **Enclosure 2**.

The sample obtained from the playground area within the eastern part of the site (Sample T7), was found to contain <0.10% coal tar with ~0.003% Benzo(a)Pyrene within the Coal Tar fraction. As such surfacing from the playground area within the eastern part of the site, may require disposal to a Hazardous landfill.

The remaining six samples obtained from the access roadway in the northern part of the site (Samples T1 and T2) the footpath area of the playground adjacent south of the school (Sample T6), the car park present within the western part of the site (Sample T3) and the playground area in the south-western part of the site (Sample T4 and T5) were found to not contain Coal Tar.

REL would suggest that an additional 4No. samples of coal tar are recovered from around the location of Sample 9 and analysed to determine with greater certainty the presence of coal tar and / or BaP above the threshold as outlined in WM3. This should be undertaken prior to the excavation / disturbance of asphalt surfacing.

During the removal of hazardous waste there is the potential for any such wastes to mix with underlying or adjacent non-hazardous wastes. As such, surfacing and sub-base materials from the car park and play-areas should be handled and stockpiled separately. Validation inspections would be required prior to off-site disposal to confirm the absence of significant cross contamination. The minimum frequency of any additional testing will need to be agreed with individual landfill operators and must meet the requirements of current UK legislation and guidance.

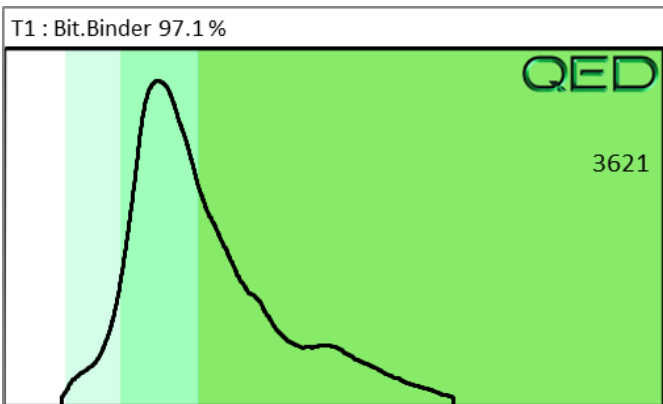
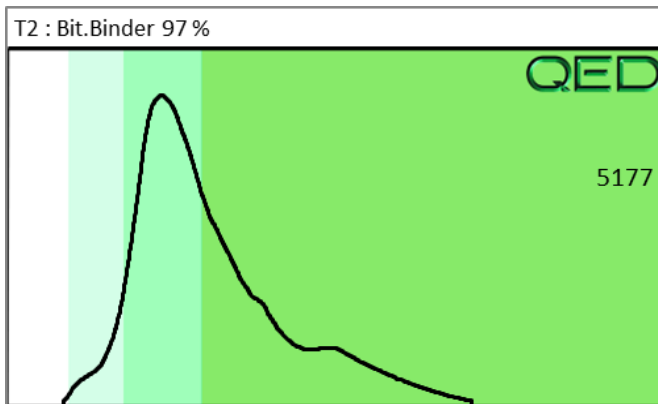
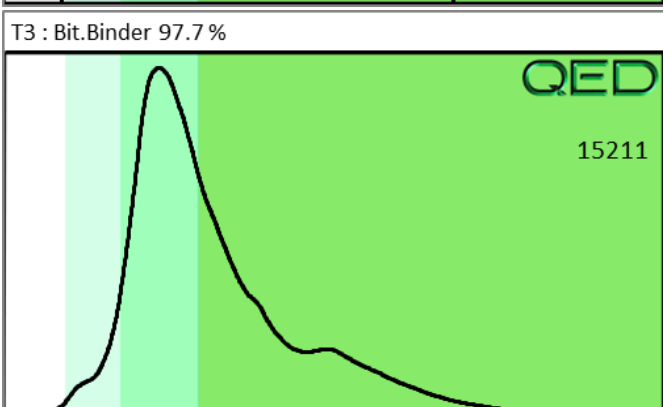
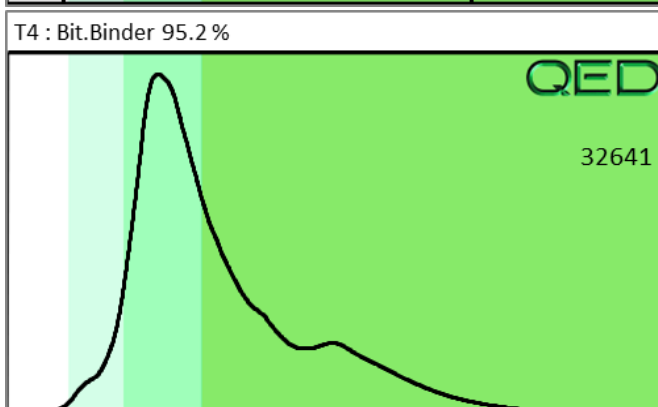
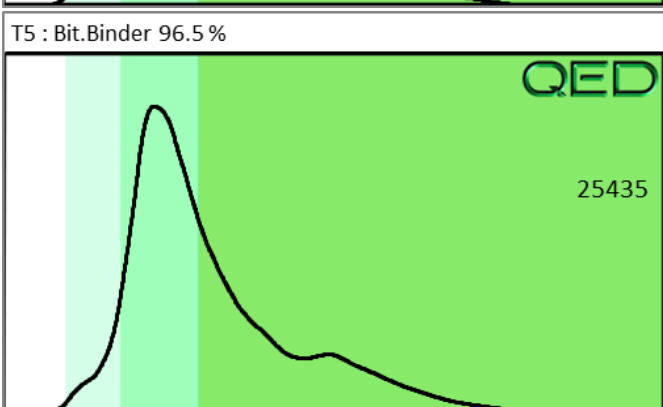
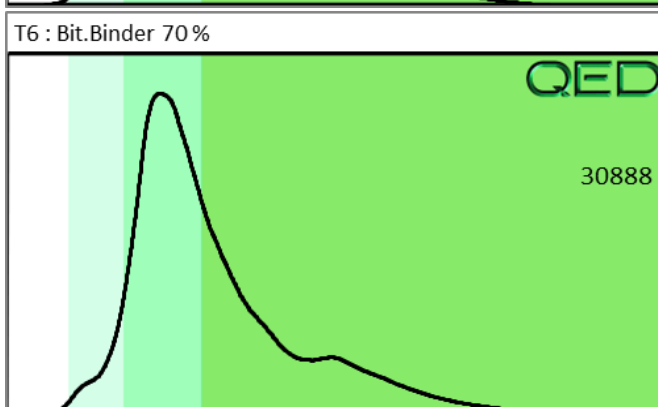
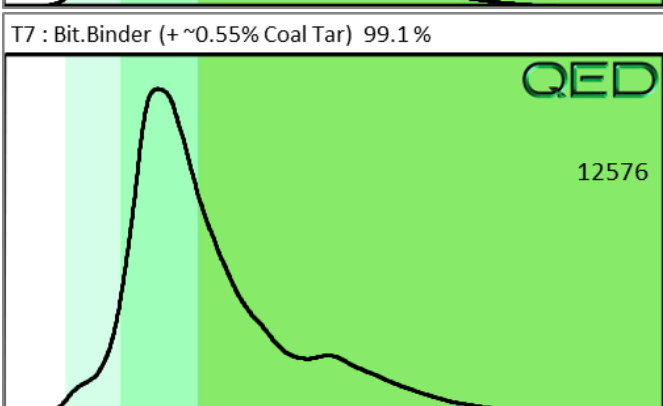
Binder Identification = %match confidence, ND indicates <0.1% coal tar detected, NA = Not Applicable
 Concentration range for % Coal Tar and total BaP in as received sample based on a binder content of between 3% and 7%
 (% Coal Tar) = Approximate % of Coal Tar in Bitumen Binder (% BaP) = Approximate % of Benzo Pyrene in Coal Tar fraction
 Phenol Indicator : NA = not applicable, coal tar not present, ND = not detected, + = detected, ++ detected at high concentration
 Bitumen Degradation Factor (BDF) <100 Undegraded, 100 - 500 Degraded, >500 V.Degraded
 Red highlight = Hazardous : Yellow highlight = Potentially Hazardous
