# BS 5837

# Arboricultural Report

Impact Assessment & Planting Scheme

at  
Parkton Grove  
Huddersfield  
HD4 7QU

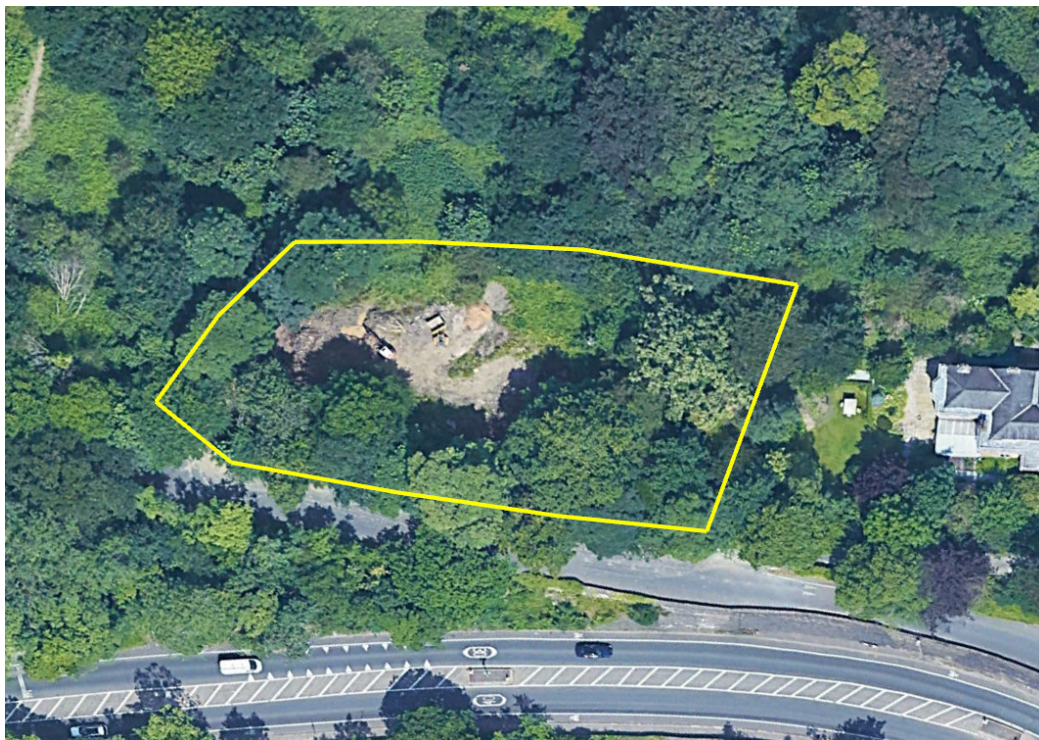
2.3.1. The area indicated below<sup>1</sup> shows the approximate extent of the survey.
