Phase 2 Intrusive Site Investigation Report

LOCATION	Lumb Lane, Huddersfield, HD4 6SZ
ISSUE DATE	April 2026
FOR	Marsden Contracting c/o North Park (Birchencliffe) Ltd.
CLIENT REF.	
OUR REF.	G25097

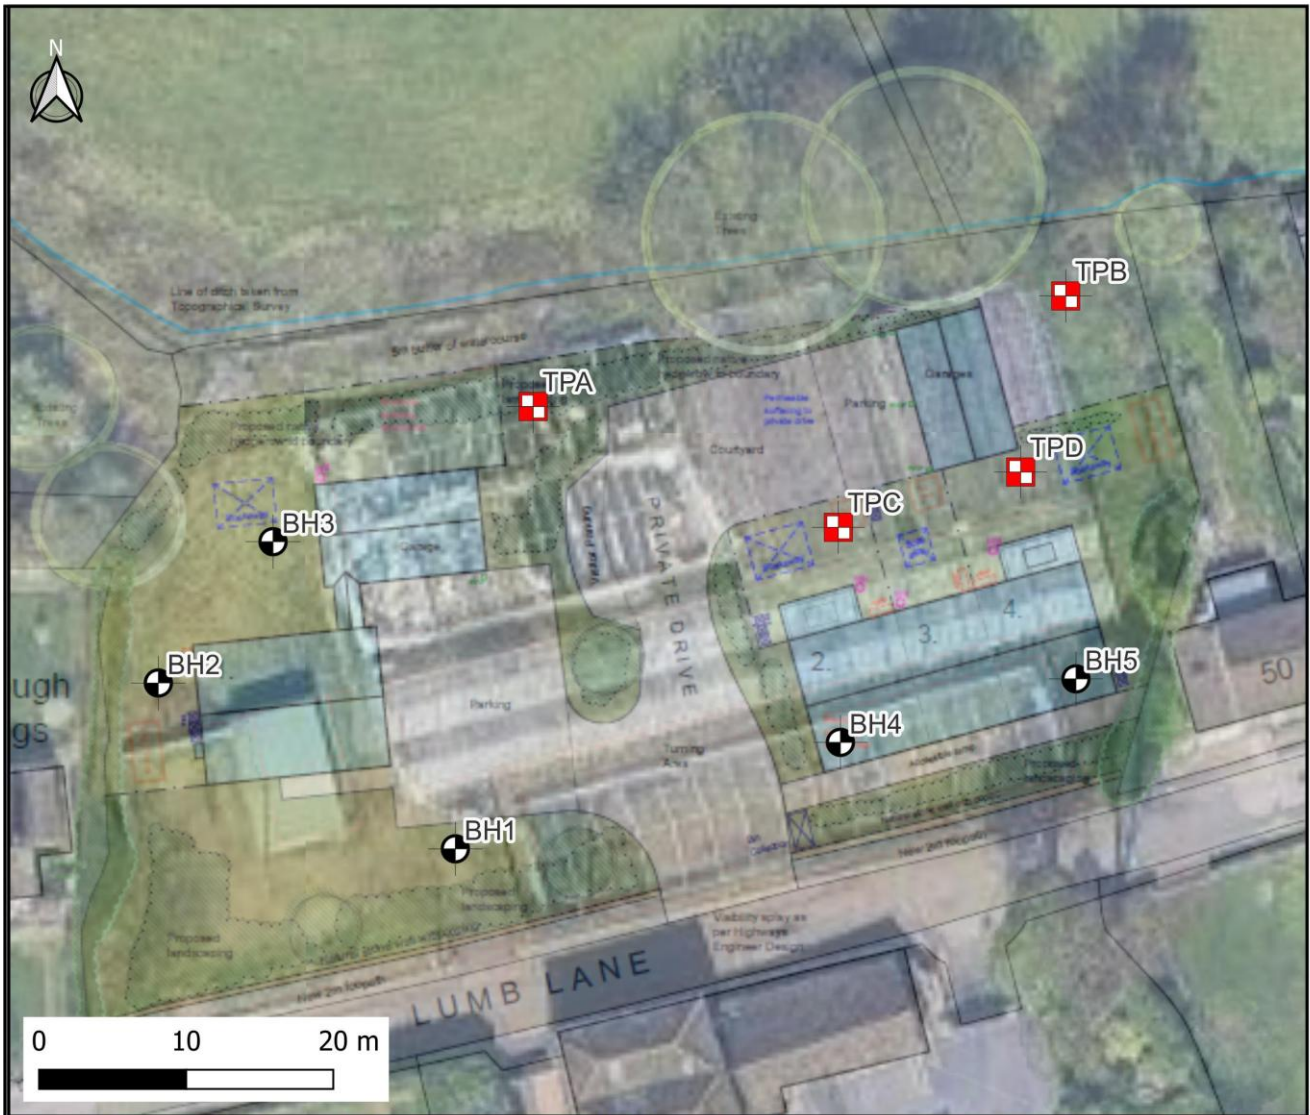
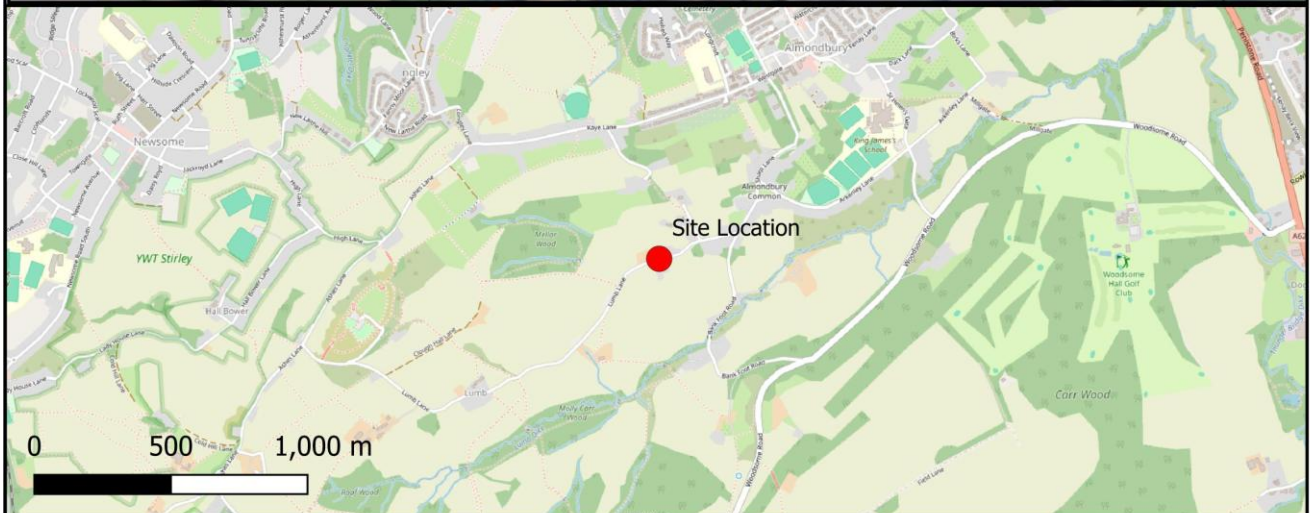
CLIENT North Park (Birchencliffe)		TITLE Site Plan		Legend □ Site Boundary ■ Hand Dug Trial Pit ● Window Samples	
PROJECT Lumb Lane, Huddersfield, HD4 6SZ		Notes:			
PROJECT NUMBER G26097		SCALE: NTS	DRAWN: JB DATE: 26/03/26		CHECK: LR DATE: 26/03/26

The trial pit and borehole positions are shown on the plan provided in Appendix 1.
