Contaminated Land Phase Two
Intrusive Investigation for proposed
residential development at
Land Adjacent
52 Ingham Road,
Thornhill Lees,
Dewsbury,
Kirklees,
WF12 0AQ.

MP Town Planning
111 Ravensthorpe Road
Thornhill Lees
Dewsbury
WF12 9EG.

June 2025

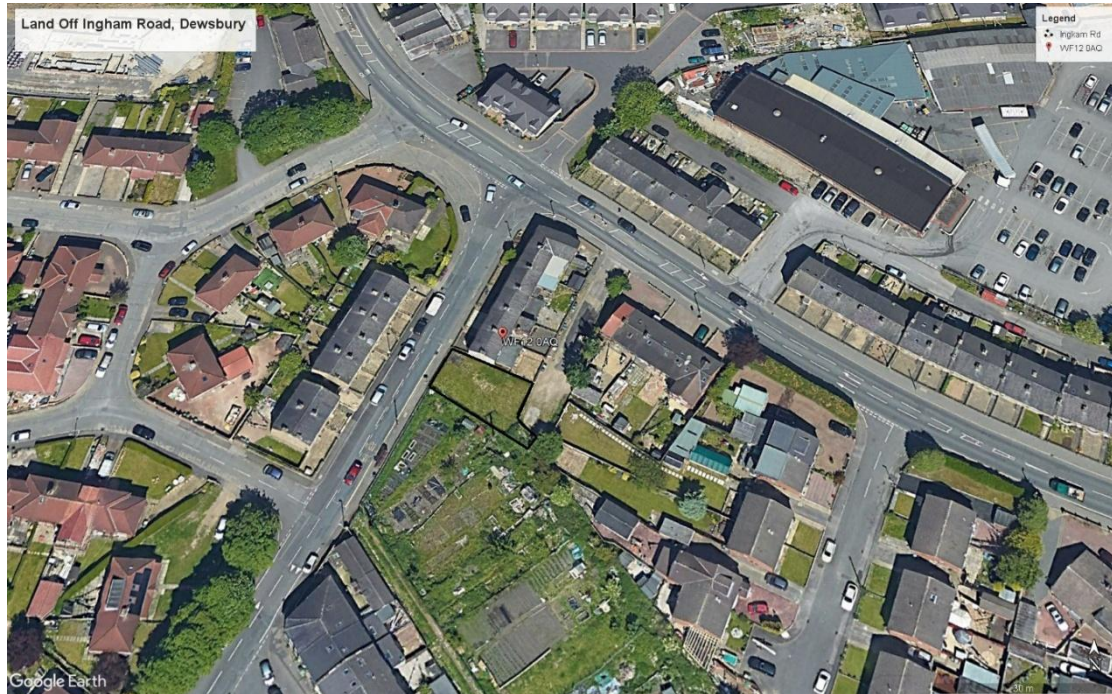
Figure 1 – Aerial Photograph

The site currently consists of a grassed garden attached to the adjacent residential property. To the south a large field slopes up to the east. This has recently been converted in allotments. Existing housing lies to the north, to the east and on the opposite side of the road to the west.

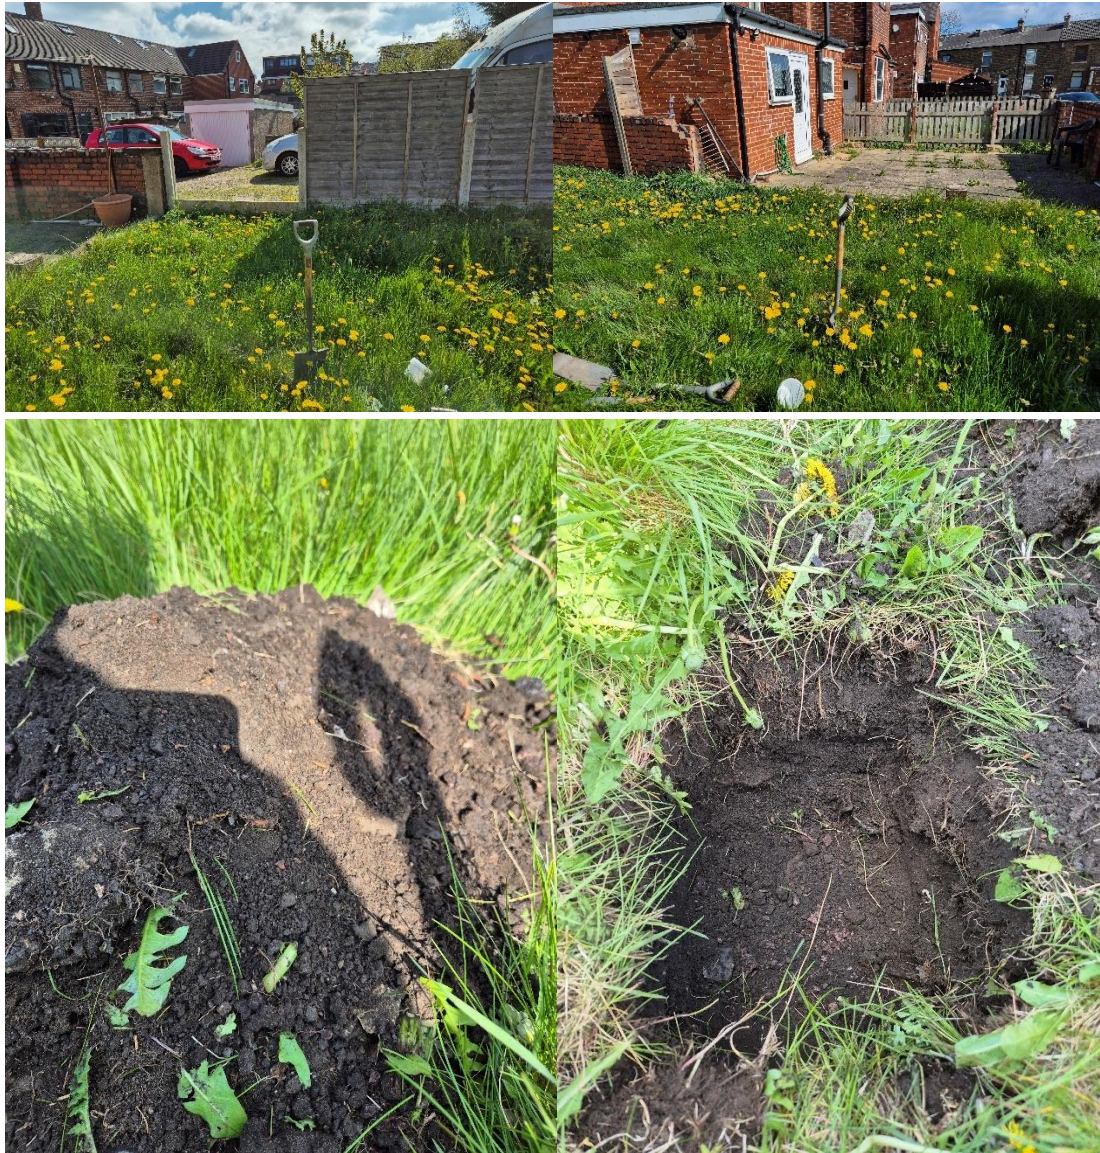
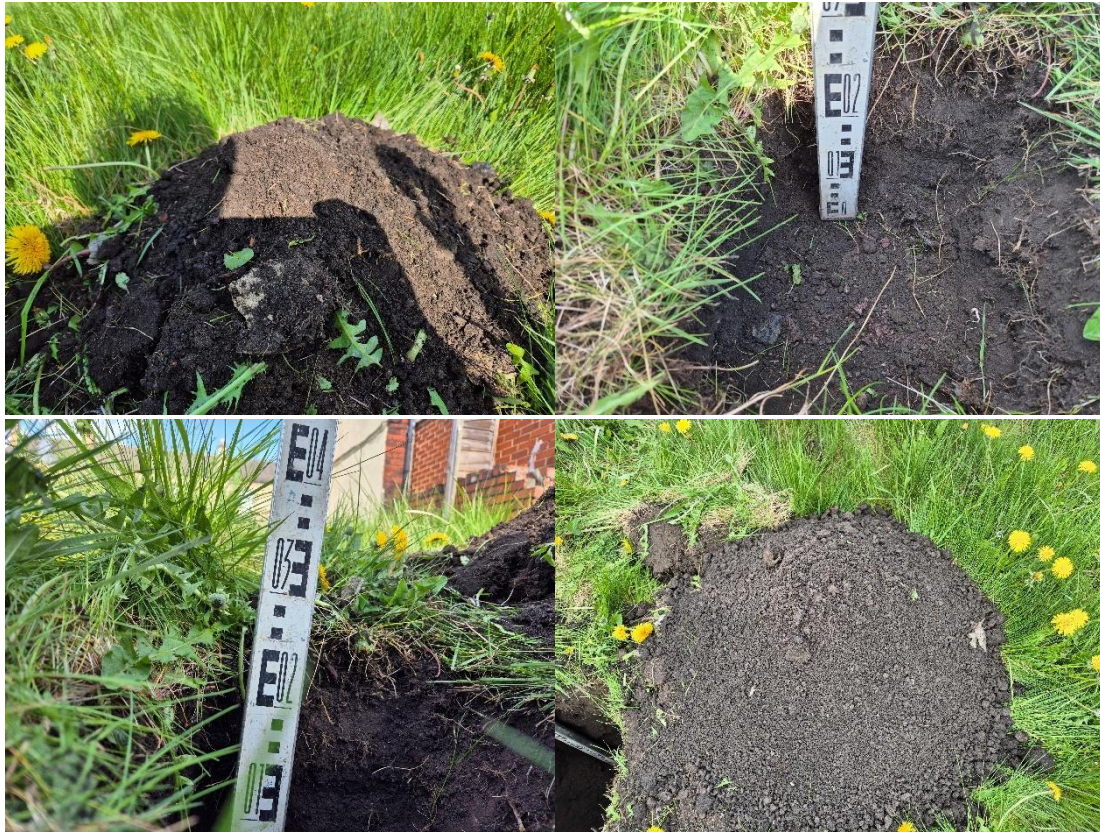
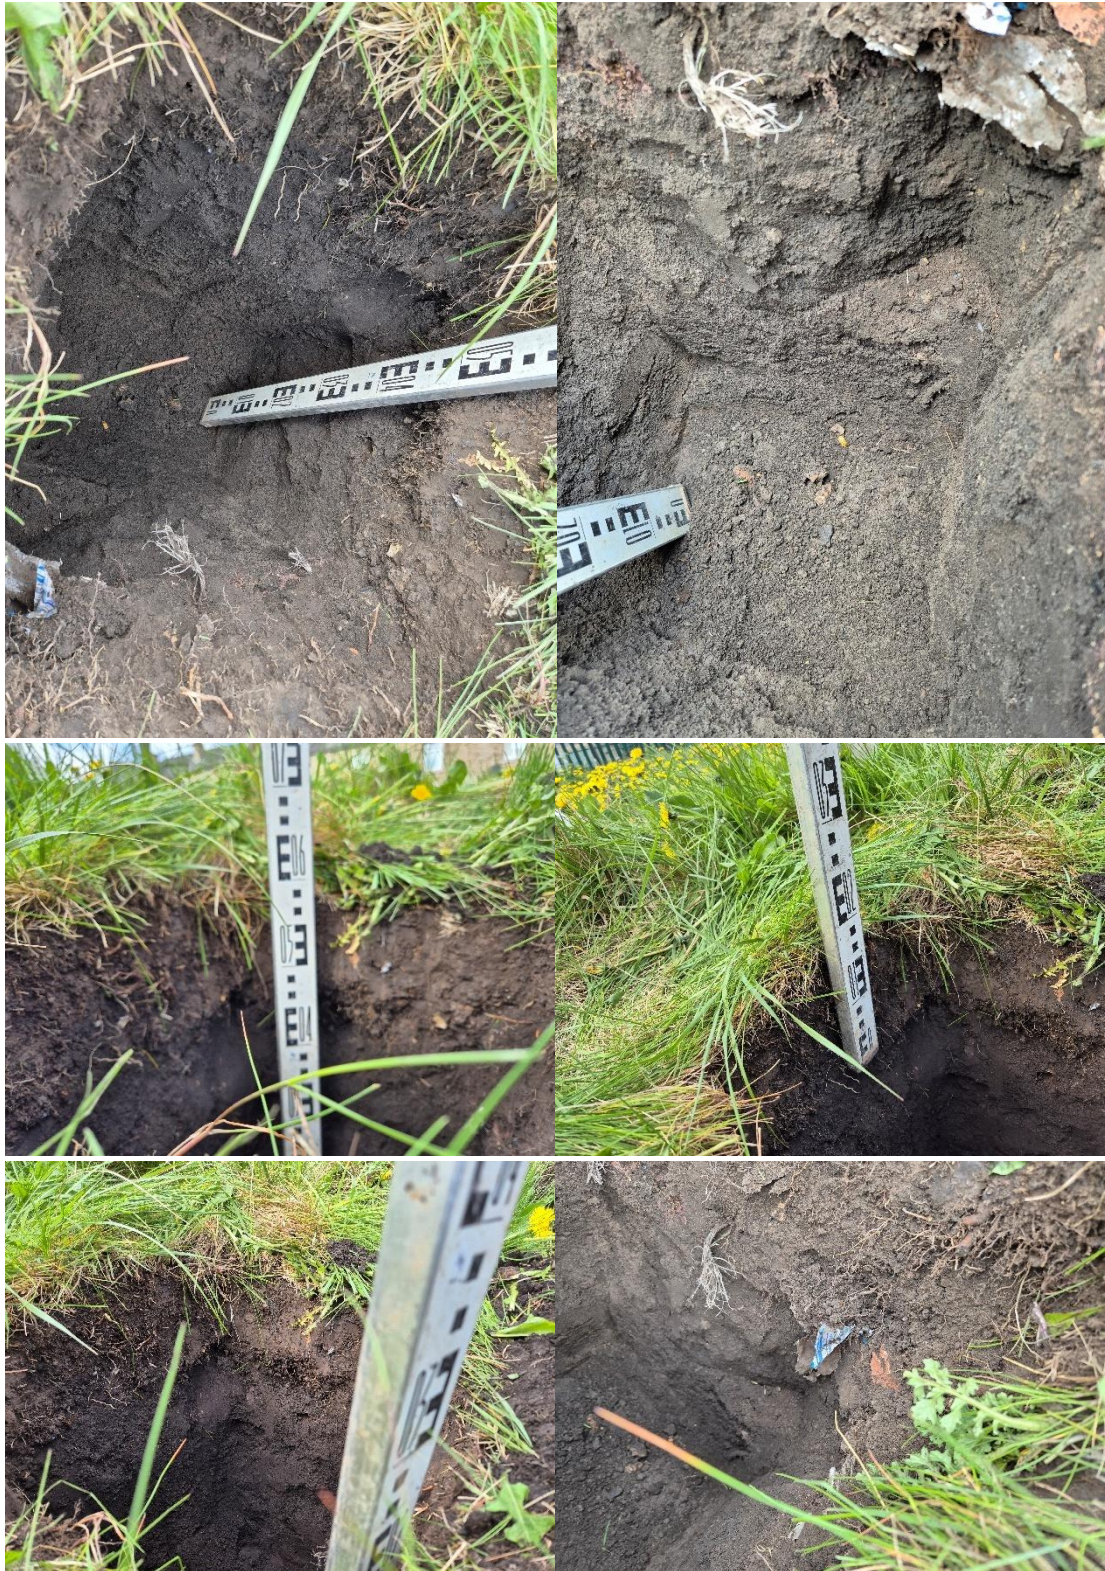
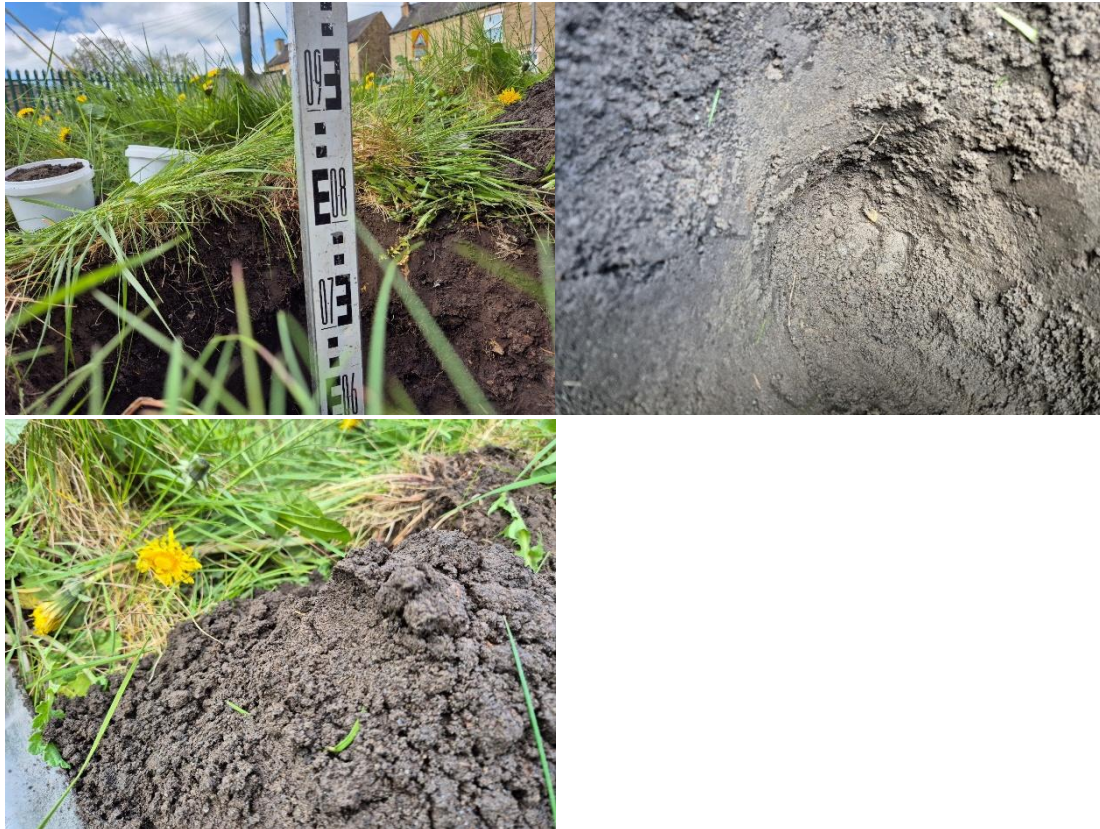
TP1 -northeast corner

Trail Pit 1 – northeast corner

0.00-0.15m grass, roots

0.15-0.3m sandy loam soil , some grit and small stones

0.3-0.6m sandy loam soil, more grit and stone, less organic matter

0.6-0.8 sandy loam soil, more grit and stone, less organic matter

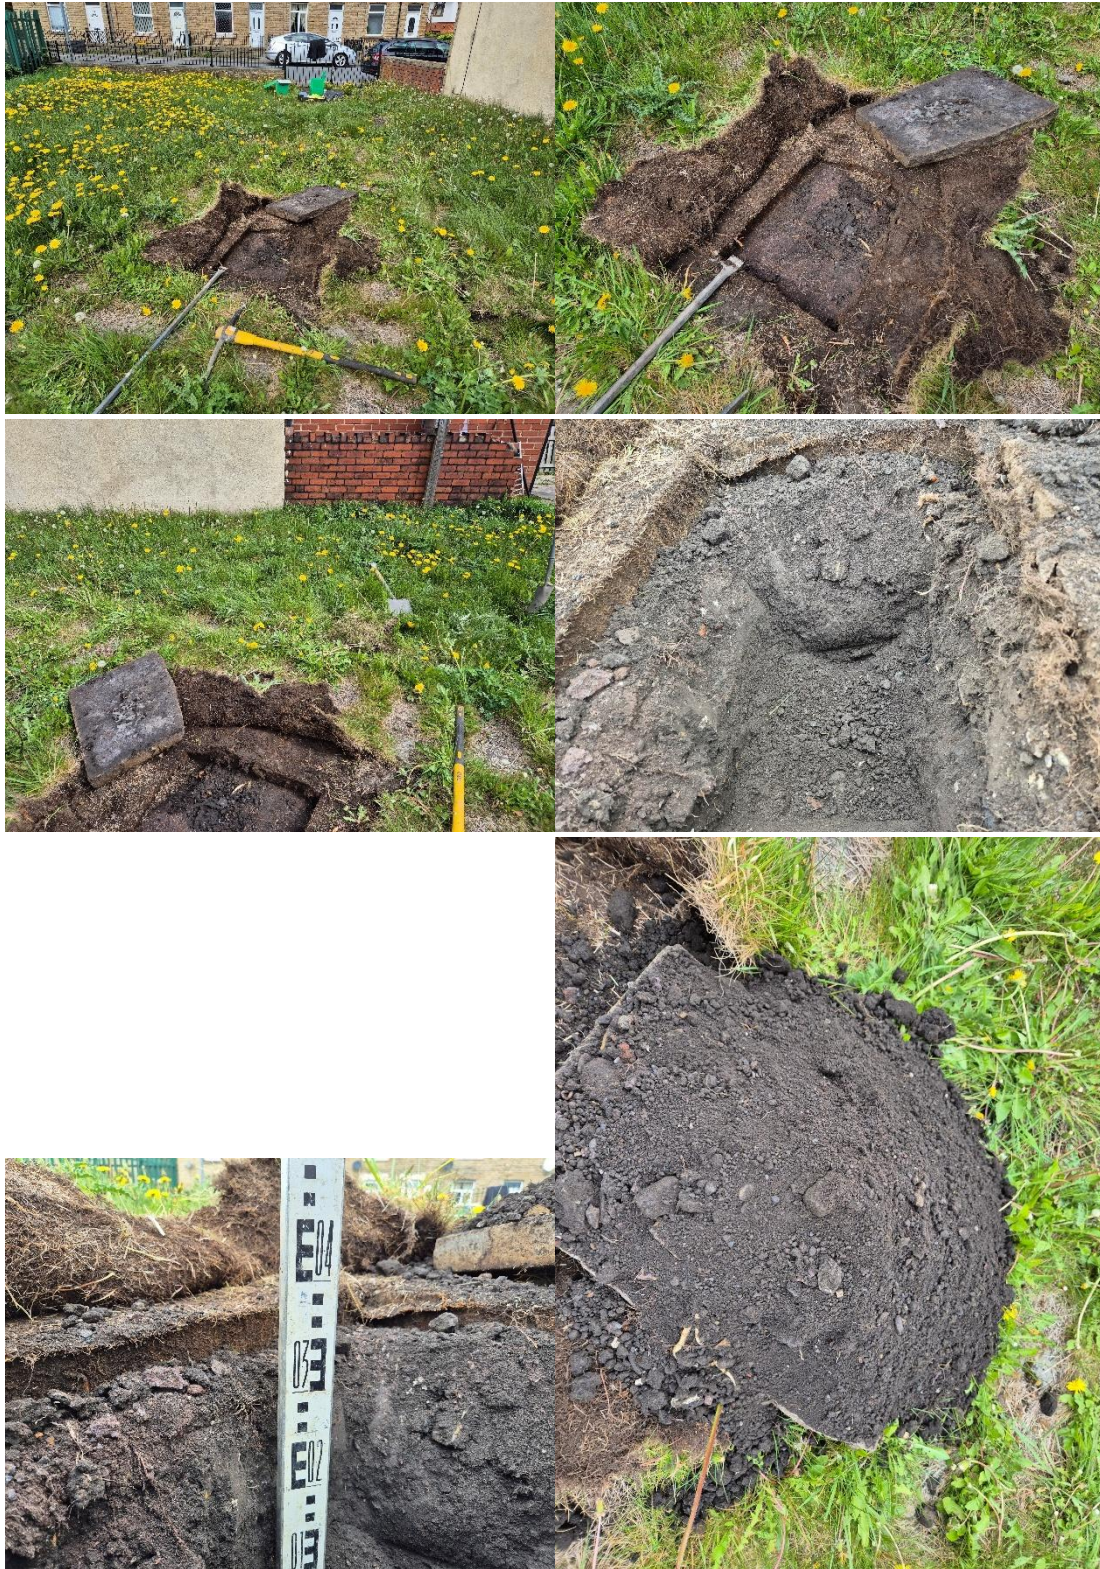
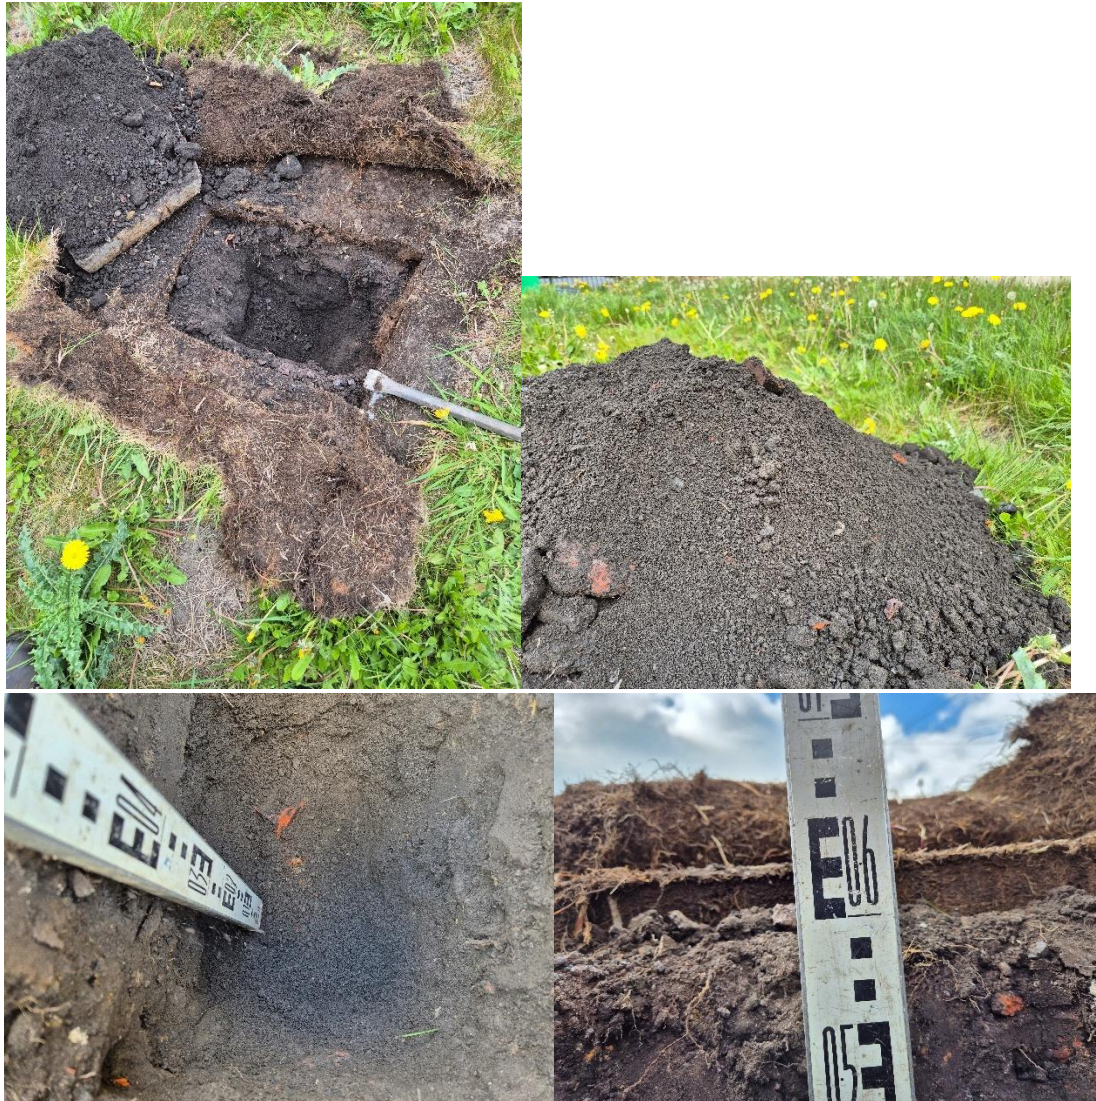
TP2 – Centre of Site under former garage

Trail Pit 2 –eastern boundary under former garage structure – no concrete

0.00-0.05m concrete paving slab

0.05-0.4m sandy loam soil , some grit and small stones

0.4-0.6m sandy loam soil, more grit and stone, less organic matter

0.6-0.9 turning to clay, with grit

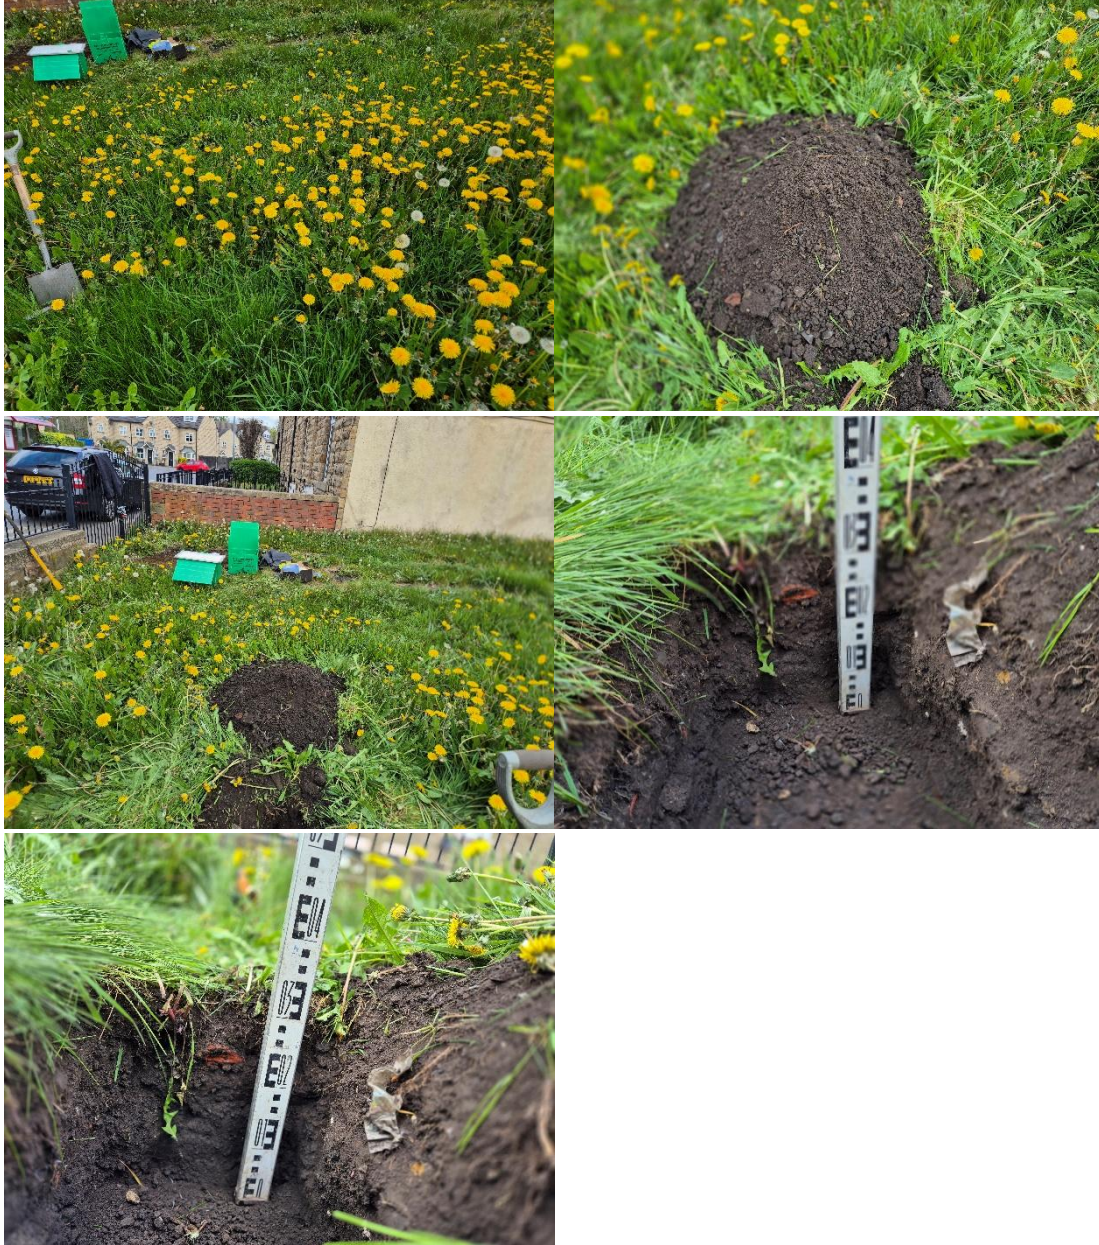
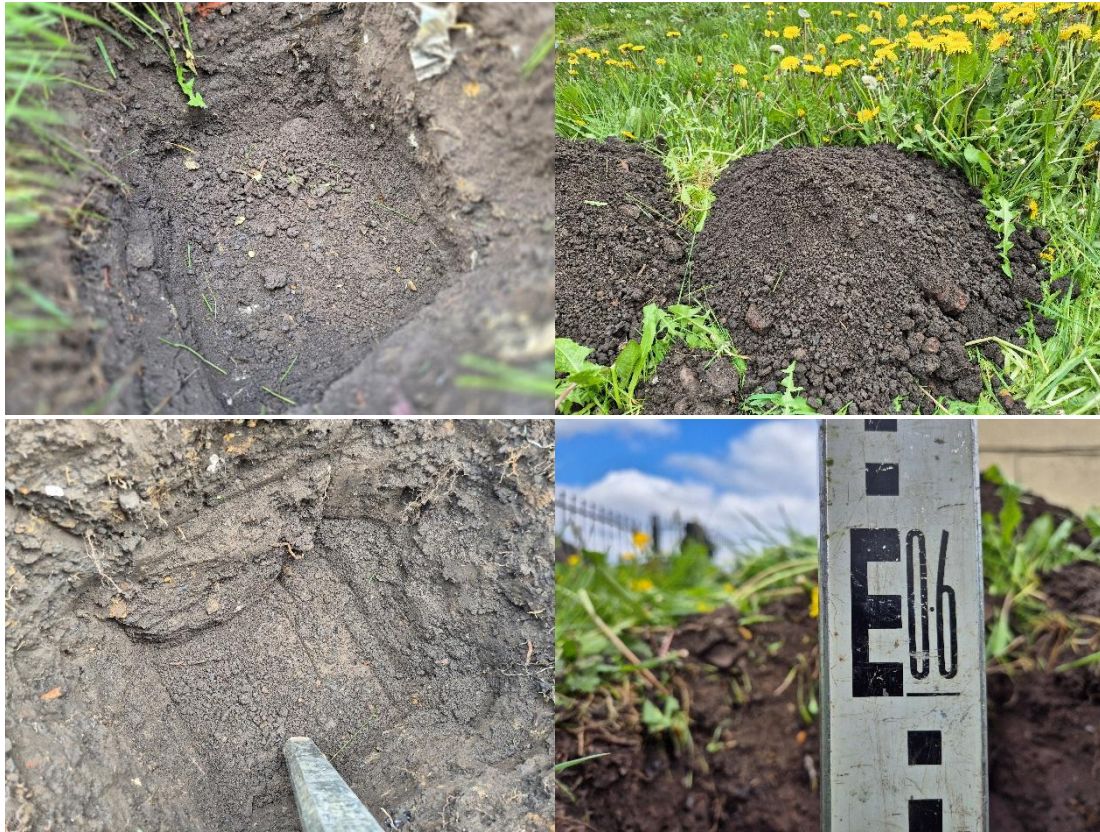
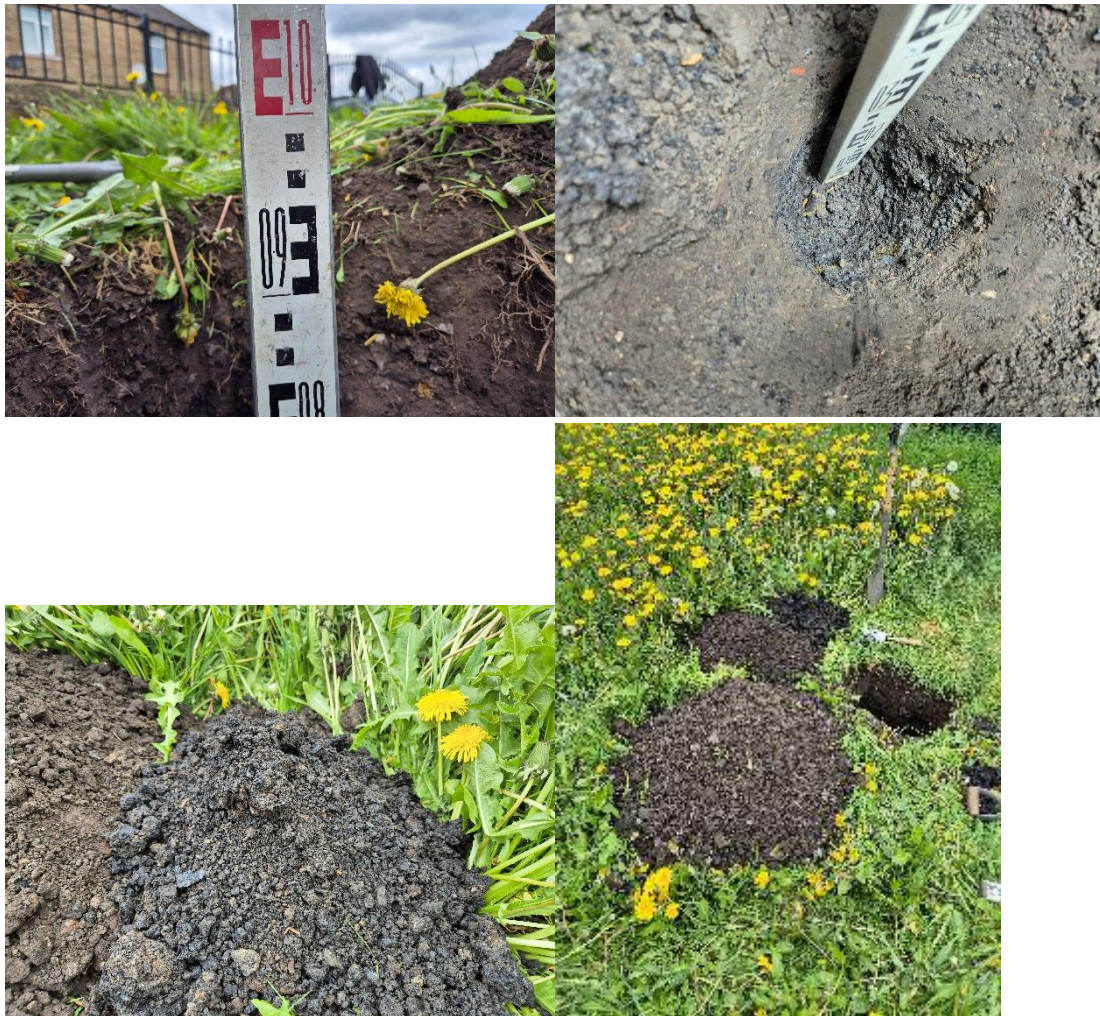
TP3 - (South) Western Corner - adjacent to road and neighbouring field

Trail Pit 3 – southeast boundary

0.00-0.05m	grass, roots
0.05-0.4m	Sandy loamy soil, grit, stone, glass and plastic fragments
0.4-0.6m	Sandy loamy soil, some grit
0.6-0.8m	sandy loamy soil, some coal fragments
