Ref: 657/01(02)
May 2026
Rev: #

Kirkby Grange Farm, Flockton, Wakefield, WF4 4AQ

Heritage, Design & Access Statement

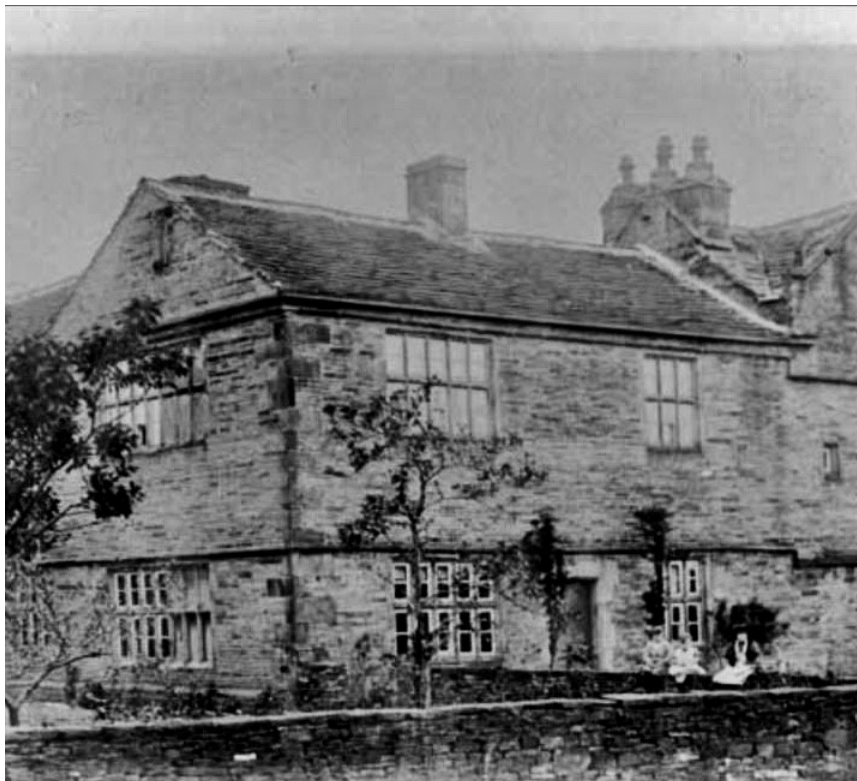
circa 19c (view from east) – Looking directly at what is now referred to as Kirkby Grange Hall.
Note the original position of the front door, between the windows.

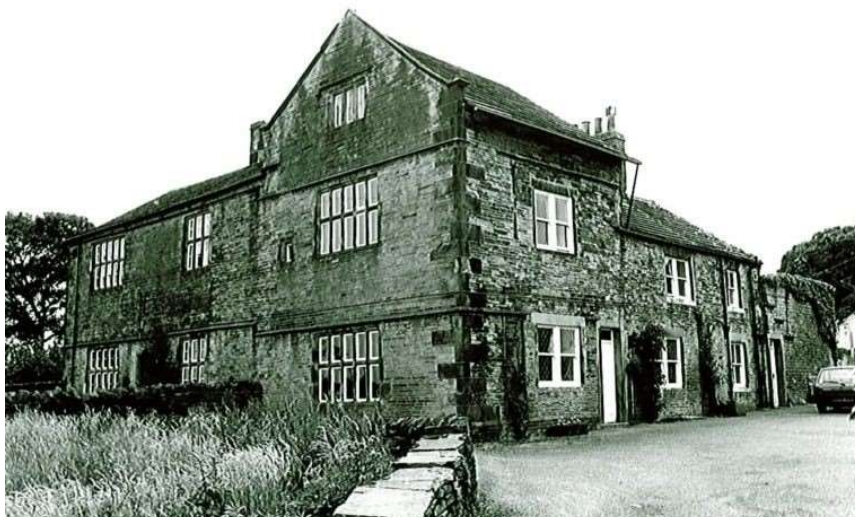
54/31

circa 1980s (view from north) – Looking at now-neighbouring dwelling to Kirkby Grange Hall.

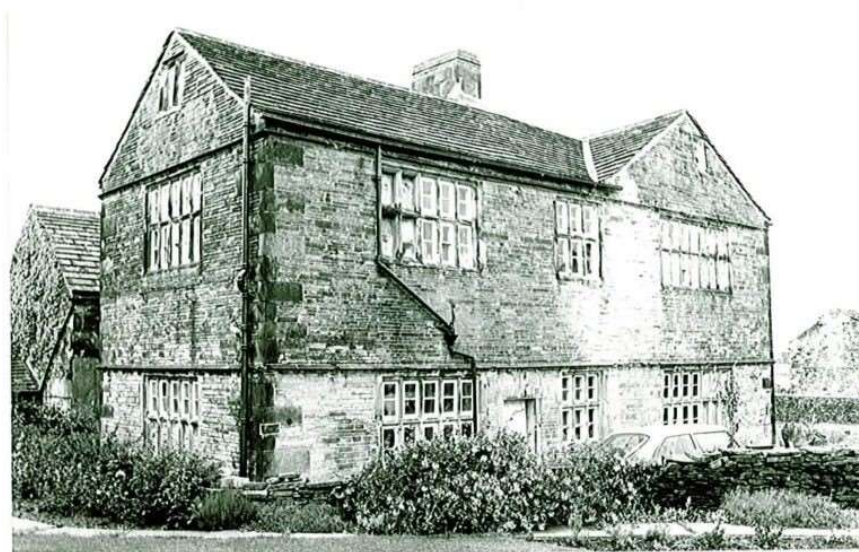
54/30

circa 1980s (view from south) – Looking at now-neighbouring dwelling to the left, with Kirkby Grange Hall to the right hand side.

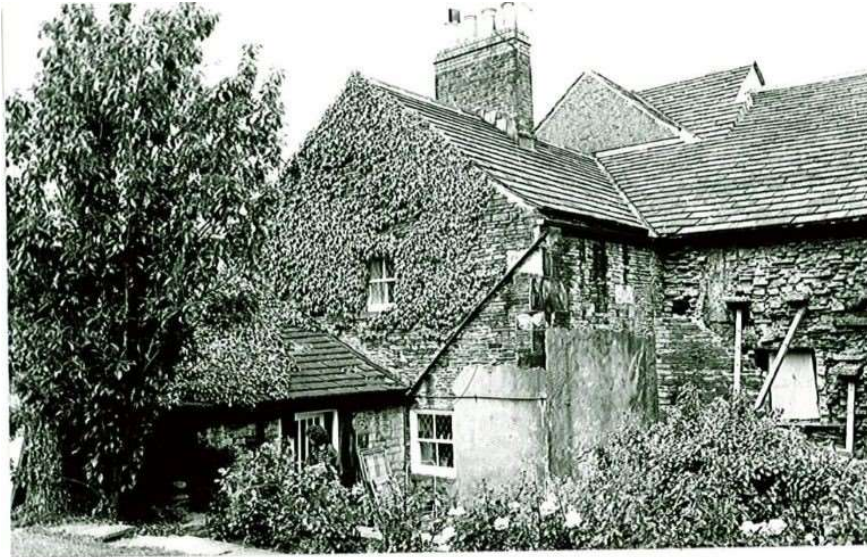
54/29

circa 1980s (view from west) – Looking at now-neighbouring dwelling to the left, with Kirkby Grange Hall to the right hand side (now the external wall to the dining room).

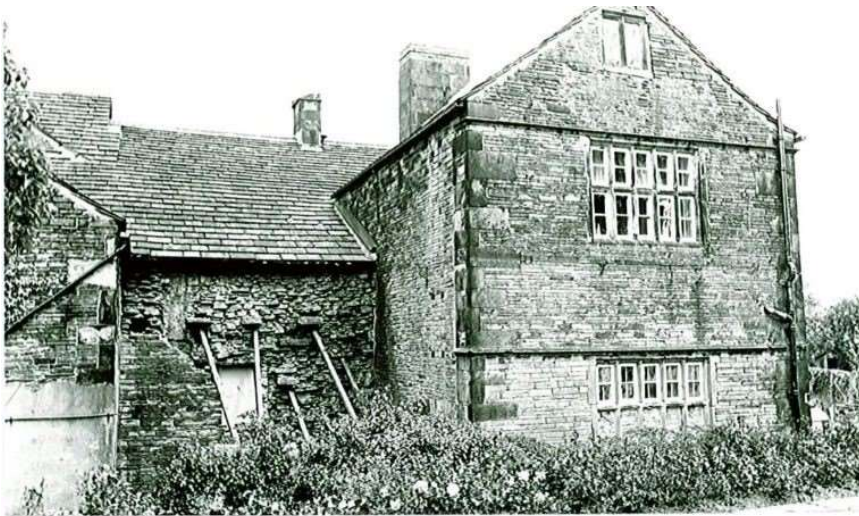
54/2 8

circa 1980s (view from west) – Looking at now-neighbouring dwelling to the right, with Kirkby Grange Hall set back to the left (now the external wall to the dining room).

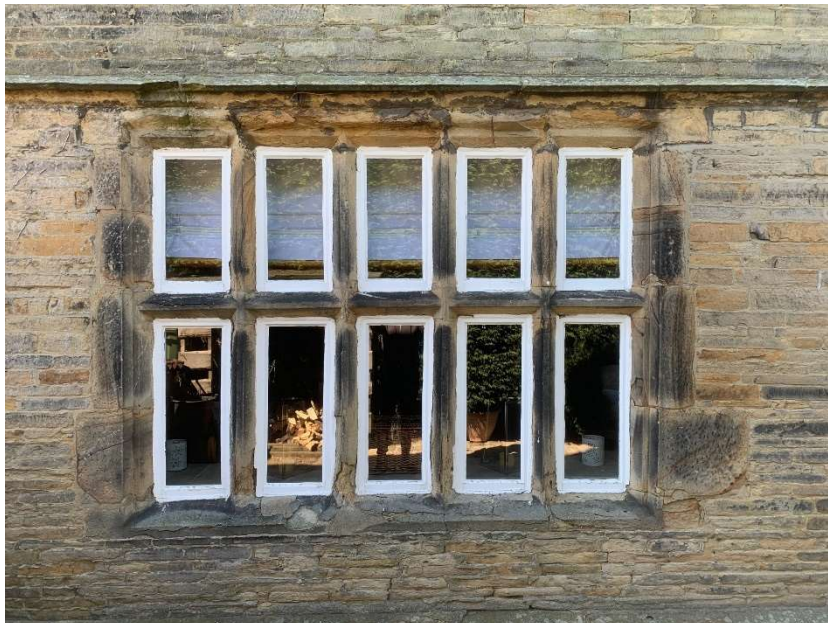
The building remains largely intact and is legible in its original form as a large Yorkshire countryside house. Some evidential use of cementitious mortar and delamination to much of the cut-faced ashlar stone to the window surrounds and elevational detailing such as the string course sadly detract from the aesthetic appearance of the building.

As detailed in '657-01 Kirkby Grange Farm - External Opening Schedule', condition issues with Kirkby Grange Farm include:

- There are open joints to the window openings manifesting from severe stone delamination
- Severe internal condensation problem to existing windows
- Lack of drip detail to the cills

Above: Photograph of GF.01 – see supporting document '657-01 Kirkby Grange Farm - External Opening Schedule'

Existing windows consist of single glazed painted timber windows that are in a mixed state of repair regardless of good upkeep practices. New glazing and painted timber Accoya slimline double-glazed units (Histoglass HD10 thin double-glazing system, or similar approved) to match existing style, carefully installed to replace existing timber units. This will provide a positive impact and enhance the historic building aesthetically and via thermal efficiency.

Method statement for replacing/repairing like-for-like stone window surrounds;

- Structural engineer to be consulted prior to any intervention.
- All works to be completed by hand.
- Defrass stonework
- Carefully remove existing glazing units.
- Apply biocide where necessary.
- Carefully remove stonework.
- Reuse suitable removed stonework where possible.
- Suitably qualified stonemason to install replacement cut-faced stone, where necessary – style and colour to match existing.
- Repoint stonework where necessary with a lime mortar mix
- new glazing and timber Accoya slimline double-glazed units (painted) carefully installed as per the necessary consents/conditions
