# Unexploded Ordnance Risk Mitigation

**Explosive Ordnance Desk Top Study for:**  
**LAND SURROUNDING – FRONTIER BUSINESS PARK, BRADFORD**  
**ROAD, BATLEY, WF17 6JD**  
**PROJECT 26080**  
On behalf of – **REDBRICK YORKSHIRE**

# EXPLOSIVE ORDNANCE DESKTOP STUDY

## LAND SURROUNDING – FRONTIER BUSINESS PARK, BRADFORD ROAD, BATLEY, WF17 6JD

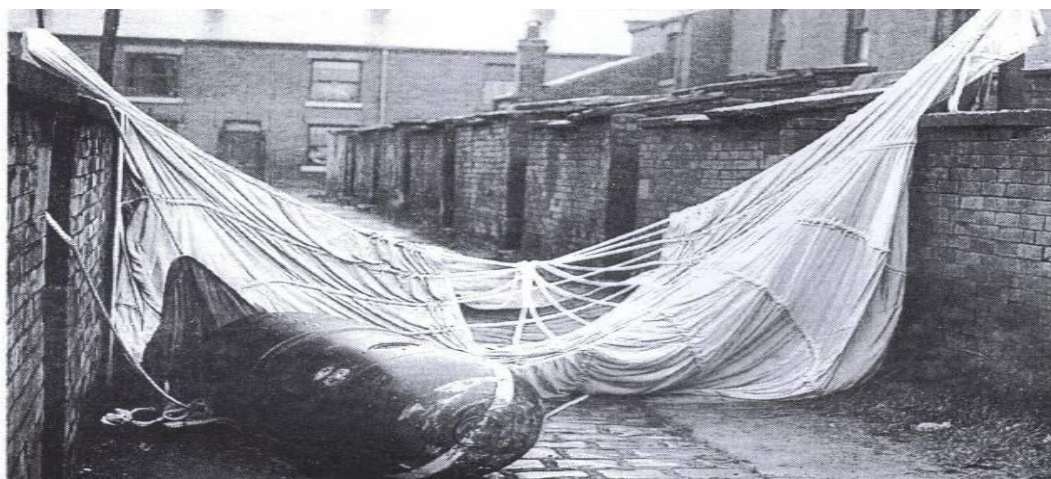
Figure 6: Common Airdropped Mines.

**Blast Bomb / Parachute Mine.** The parachute mine was extensively used on land and at sea and was fitted with specialist fuzes designed to trigger the weapon at a predetermined altitude, water depth or to switch on other magnetic influence mechanisms to trigger the weapon when a ship approached (Magnetic or Acoustic influence). While early versions were based on the standard 1000kg SD Bomb case others were specially designed and manufactured with an aluminium body, making them extremely difficult to detect using magnetometers. The thin cased versions would normally disintegrate on impact on land and are normally considered to pose little threat to work on land-based projects, but the risk increases significantly on projects over water or in marshland. Thicker cased versions however will survive impact and pose a significant risk regardless of the local ground conditions. (See Figure 6)

Note; all mine fuzes were designed to arm after deployment from the ship, submarine or aircraft, some fuze designs incorporated anti-removal booby traps. Unexploded mines found today are the result of a failure within the arming mechanism or procedure whereby the mine never fully armed. Sudden shock or jarring of a weapon in this state has the potential to complete the arming sequence and could result in the mine detonating with lethal consequences.

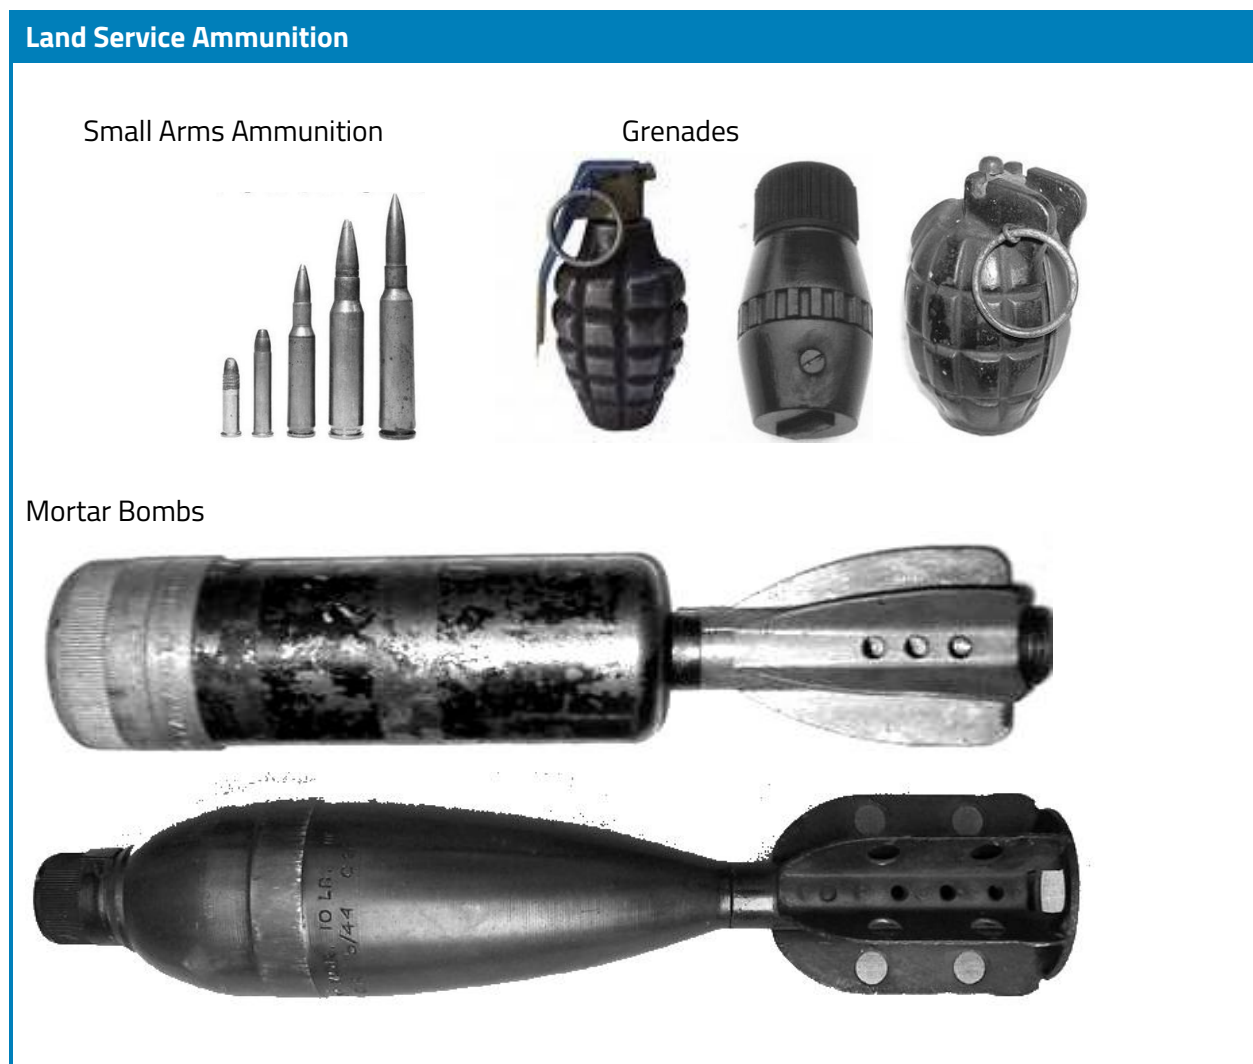
Figure 8: Common Categories of Land Service Ammunition

**Land Service Ammunition (LSA).** While as the name implies this type of ammunition was designed for use on land, it was also issued to naval personnel for close protection of vessels and their crew and to provide a limited offensive capability even to relatively small craft. This type of ammunition includes some shells and projectiles such as those covered previously. Other natures of LSA range from Small Arms Ammunition (SAA), having little or no high explosive content to Grenades, Mortars and Rockets which may pose a risk of detonation due to their explosive content and the design of their fuzes (impact) which; if subjected to sufficient shock or friction may result in the weapon functioning. (See Figure 8).

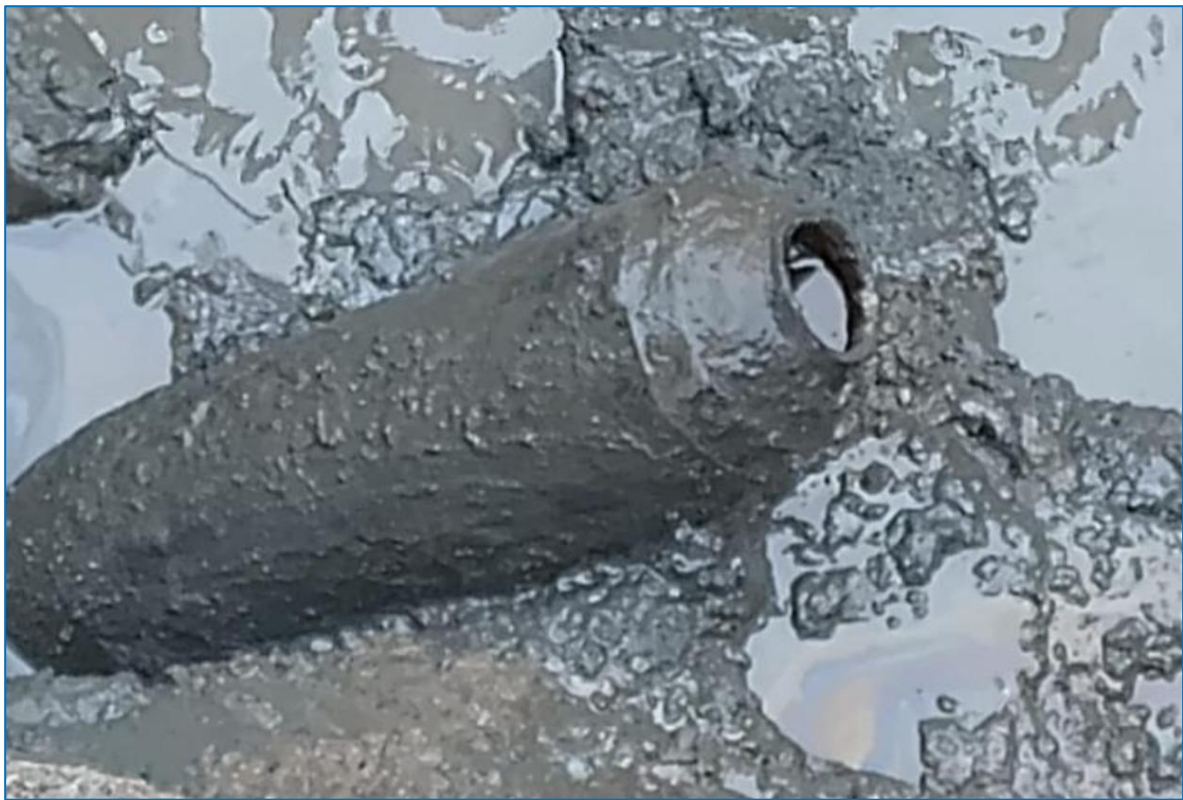
| Description: | <p>A major emergency response has been launched following the discovery of the ordnance at a construction site on Martin Street in the Millbay area of the city. Officers quickly put a 100m cordon in place, which has since been extended to 400 metres, along with associated road closures. Residents within the cordon have been evacuated.</p> <p>The bomb is believed to be a WW2 SC50, a type of German aerial bomb dating back to the Second World War.</p> <p>It was uncovered during survey work carried out by S.I UXO, a company specialising in site investigation and ordnance risk management.</p> <p>The Devon based specialist firm brought in CPT Percy, their Cone Penetration Testing machine, to survey the area for suspected unexploded ordnance. The testing discovered an anomaly 4.3m beneath the ground, and further target investigation confirmed it to be a wartime bomb.</p> <p>Royal Navy bomb disposal experts have now arrived at the scene and are assessing the device. The bomb is expected to be carefully removed from the site and is likely to be taken out to sea for a controlled detonation.</p> |

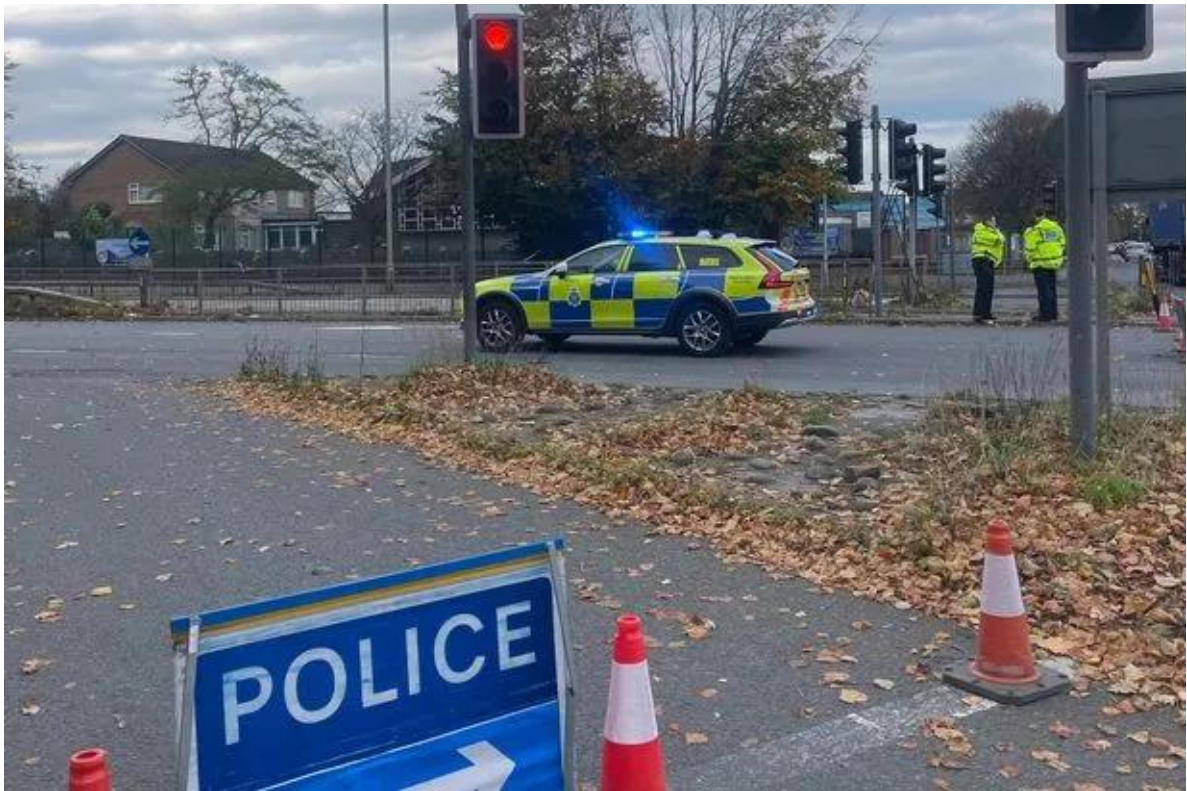
| Description: | Construction workers have described how they discovered two unexploded bombs while digging at a site in Bootle this week. Merseyside Police were called to North Atlantic Avenue, near Dunnings Bridge Road, in Bootle, at around 11.45am today, Thursday, October 24, following the discovery. It followed a report of an unexploded ordnance being found for the second time this week. Police were called to the same area on Tuesday after another device was found, leading to a road block being put in place on Dunnings Bridge Road between Park Lane and Boundary Road, with the junction of Netherton Way. |

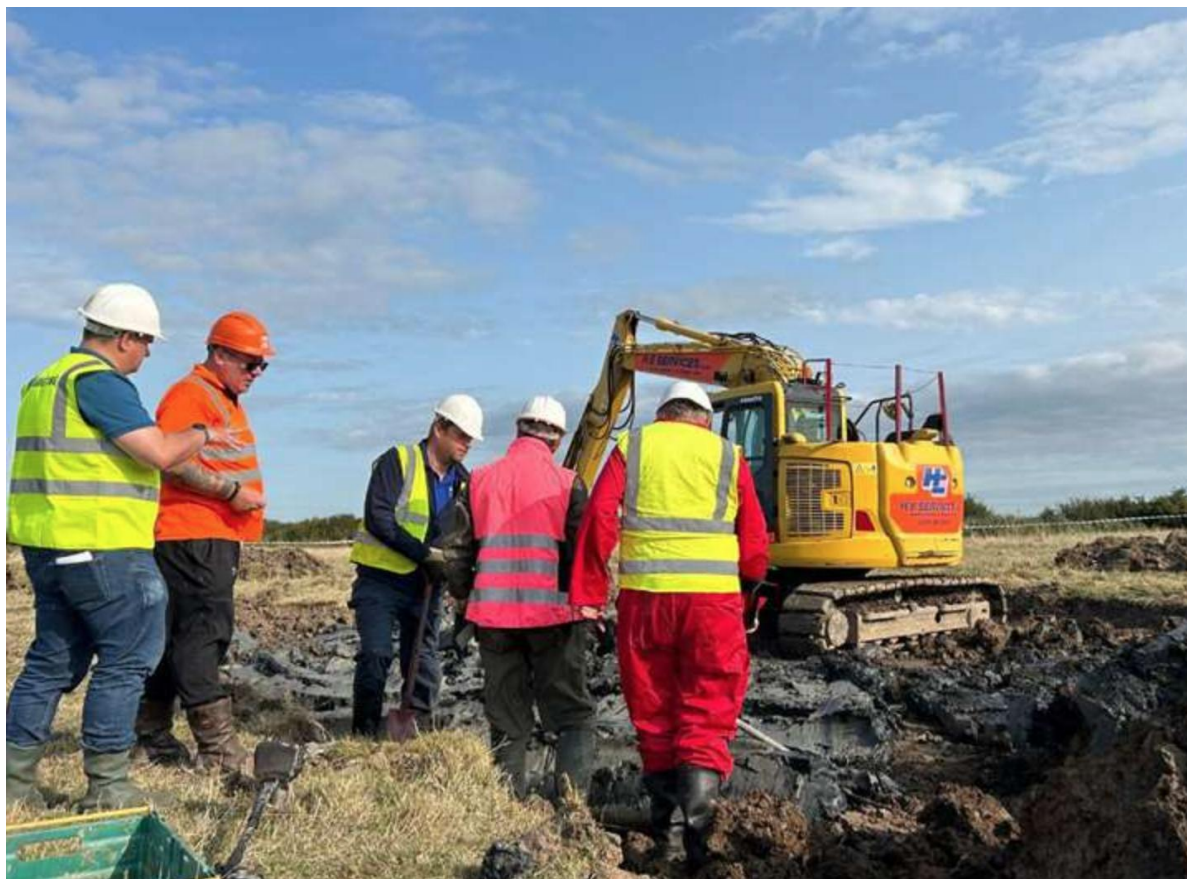
| Description: | <p><b>Dig uncovers V2 Nazi rocket in Halstow Marshes, Hoo – 78 years after it was fired at London from German occupied Holland.</b></p> <p>Remains of a Nazi V2 rocket fired at Britain during the Second World War have been unearthed in a Kent field. The 12.5-tonne German missile was launched towards London from The Hague in occupied Holland 78 years ago but fell short of its target instead landing in the Halstow Marshes on Medway's Hoo Peninsula. The force also noted: "The Warwickshire Police goalkeeper won't be happy. it was blown up in the six-yard box of the pitch."</p> <p>Researchers have pinpointed the exact date and time of its explosion as February 17, 1945, at 2pm. Hitler used the missiles – the world's first ballistic missiles – as part of his terror weapons programme in an effort to force Britain into surrender. Around 100 of these "Vengeance Weapons" were fired towards Britain each week between 1944 and 1945, in the hopes of causing maximum destruction of the V2's weight, 8.5 tonnes was made up of fuel, three tonnes comprised the missile's body, and one tonne made up the weapon's warhead. The find is the second V2 rocket found in Kent in the past few years, with the team at Research Resource Archaeology previously digging up a missile at St Mary's Platt near Sevenoaks back in 2021.</p> |

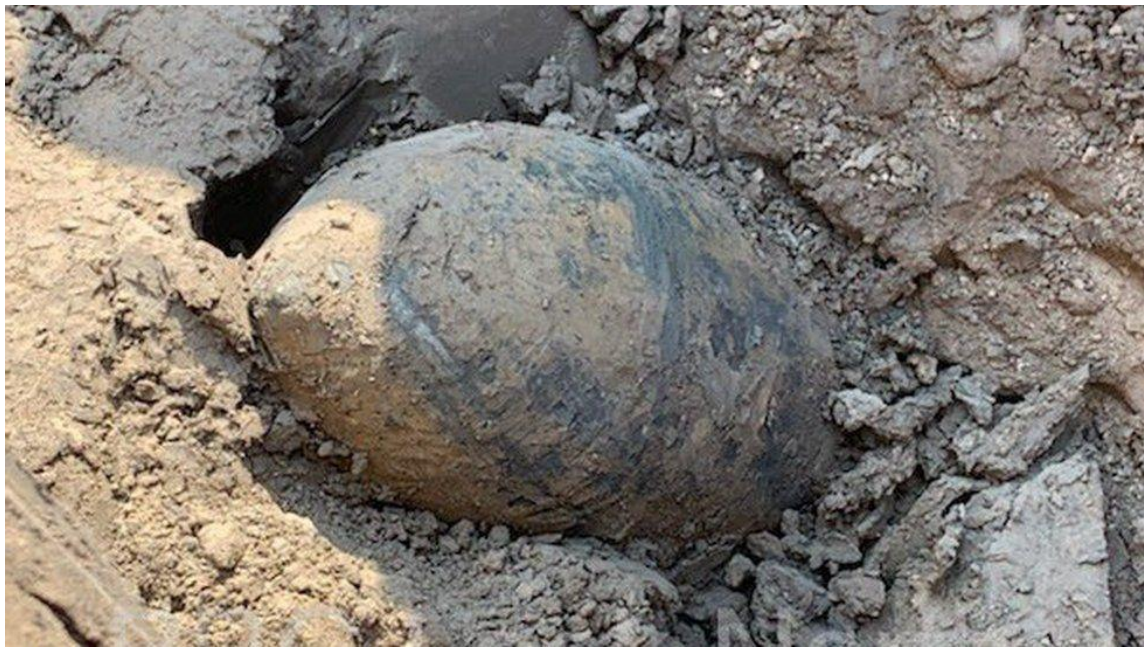
| Description: | <p>A live World War Two bomb unearthed by builders on a housing development has been destroyed in a controlled explosion. The 500lb (227kg) device was found on the new-build estate in Goole, East Yorkshire, on Thursday. Eight homes were evacuated and the M62 was shut between junctions 35 and 37 as a safety precaution.</p> <p>Humberside Police said the device was successfully detonated at 16:22 BST on Saturday. All residents have been able to return to their homes and local business are no longer being asked to remain closed. The force also said a no-fly zone and the closures of the M62 and other roads nearby had since been lifted.</p> <p>John Sharpe, site manager of the Beal Homes development, said he received a call from workers just after midday on Thursday.</p> <p>"They didn't know what they'd dug up at first and a guy went down into the hole because we thought it was a metal pipe.</p> <p>"As he uncovered it he realised it was a bomb and got out pretty quickly," he said.</p> |

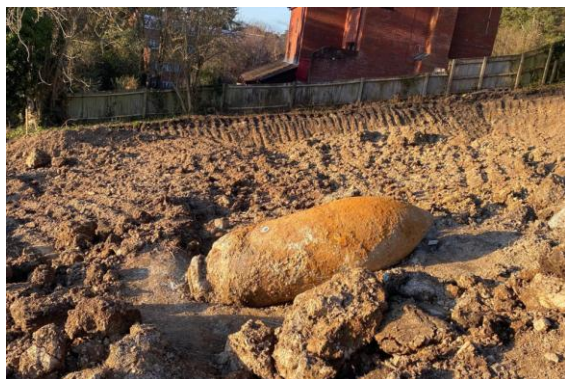
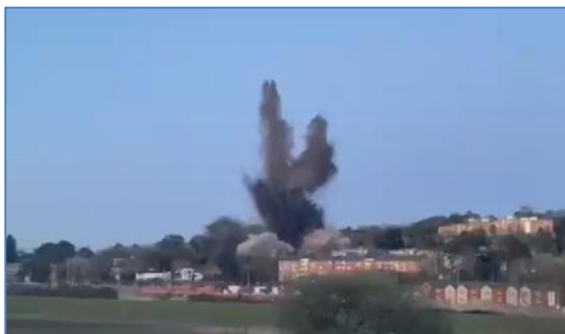
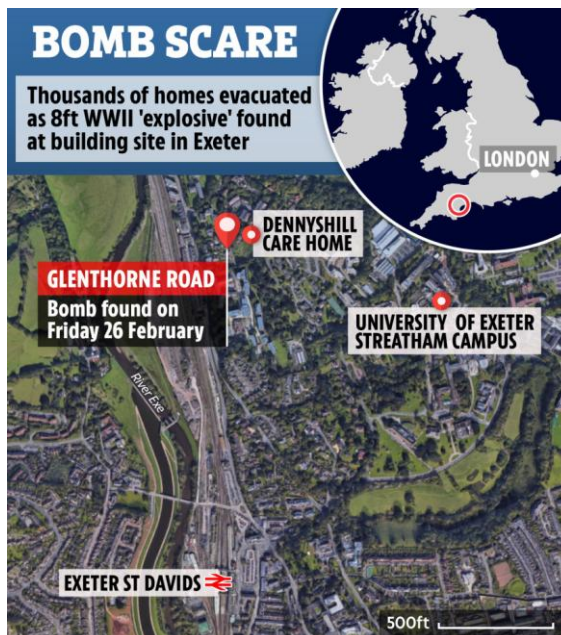
**Source:** The Sun

"Trenches were also dug to prevent ground shock. Despite these mitigation measures, the impact of the blast has been significant and debris has been thrown at least 250-metres away.

"The crater is around the size of a double decker bus.
