**BROWNFIELD  
SOLUTIONS LTD**

**JOE BATTYE**

Bradford Road, Batley

Phase I Geo-Environmental Assessment Report

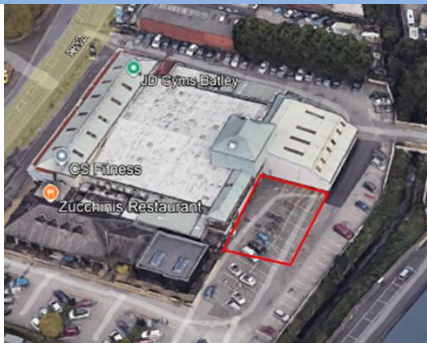
| Feature | Description |
|---|---|
| Current Land Use and Site Features | <p>The site comprises an existing vehicle parking area to the rear of an active gym. Overhead or buried services were not identified during the walkover survey. However, possible scarring on the hardstanding may be related to resurfacing where services are present.</p> <p>The site area was surfaced with bound macadam at the time of the walkover. The macadam was in general was cracked and in a moderate condition with some patchwork repairs noted.</p> <p>No access constraints were identified.</p> |
| Site Boundaries | The north and west boundaries were marked by a gym building. The east and south boundaries were not clearly defined, with the area an open continuation of the larger car parking area. |
