**HARDINGLEY FARM, SHELLEY.**

**BAT SURVEY REPORT.**

**Ref No: 250839/1.**

**Date: 14<sup>th</sup> September 2025.**

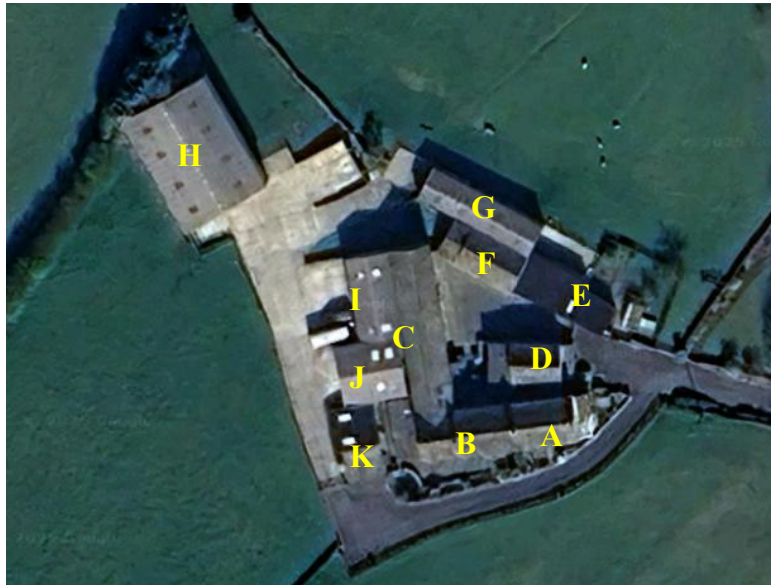
3.1.4. The site presently contains a farmhouse, cottage, chapel and a series of stone and modern barns. Each is described below against the reference letter on the plan below.

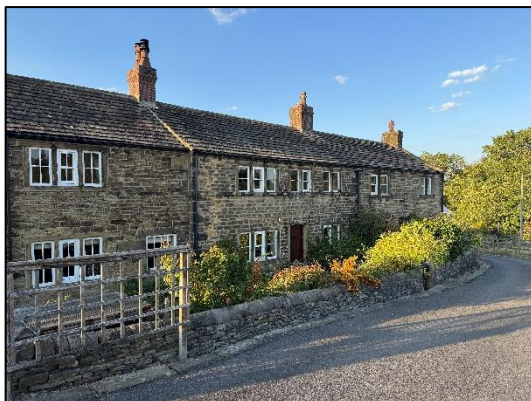
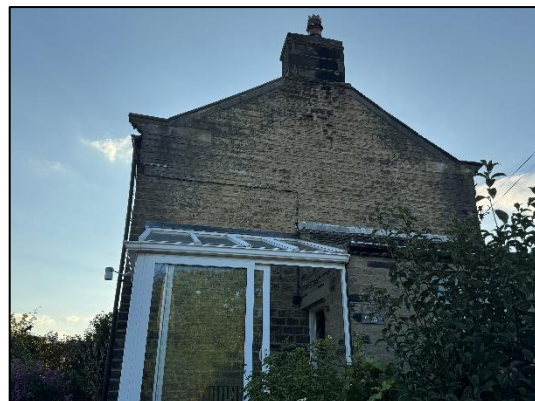
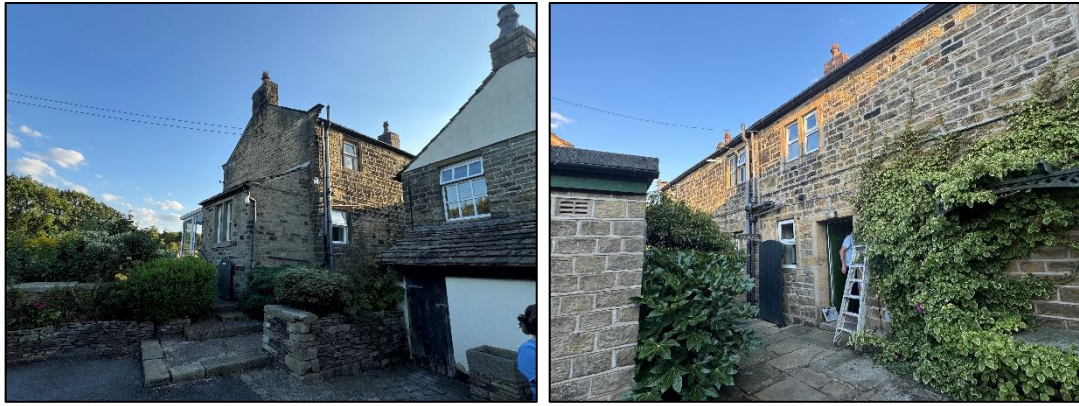
3.1.5.3. The roof is pitched and is generally in good condition with no missing or slipped slates although there were some gaps between the natural stone slates.

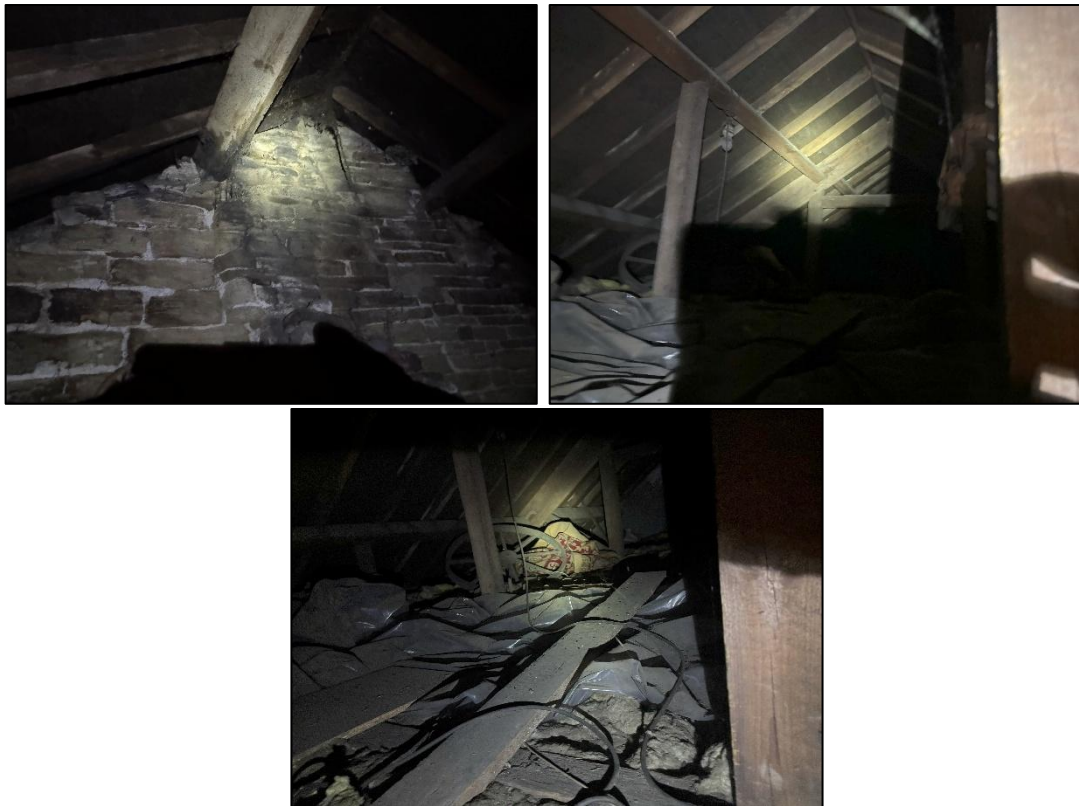
3.1.5.4. Internally there are two floors with a loft above. The roof is supported on a timber purling frame and the roof is lined with felt. The floor of the roof space was covered with a generous layer of dust but no bats or bat field signs were evident and there were abundant cobwebs.

3.1.5.5. This building was assessed in accordance with the Bat Conservation Trust Good Practice Guidelines to have a low potential for roosting bats.

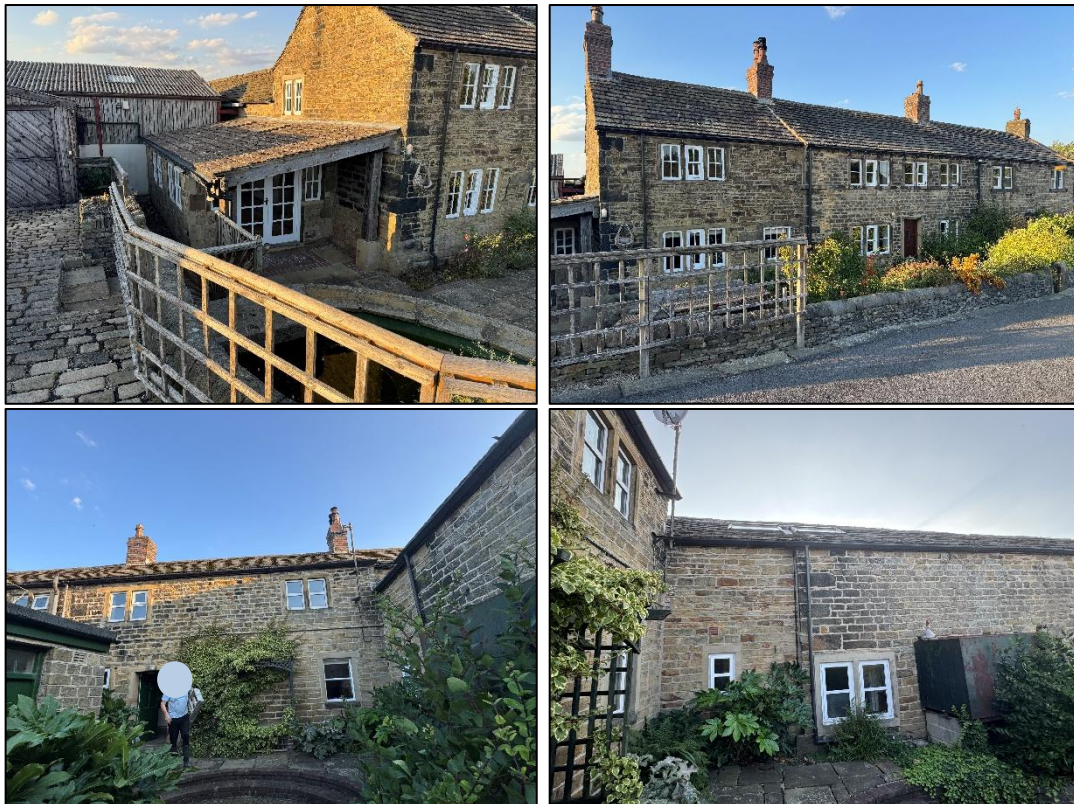
3.1.6.3. The roof is pitched and is generally in good condition with no missing or slipped slates although there were some gaps between the natural stone slates, particularly in the corner where it meets the barn roof.

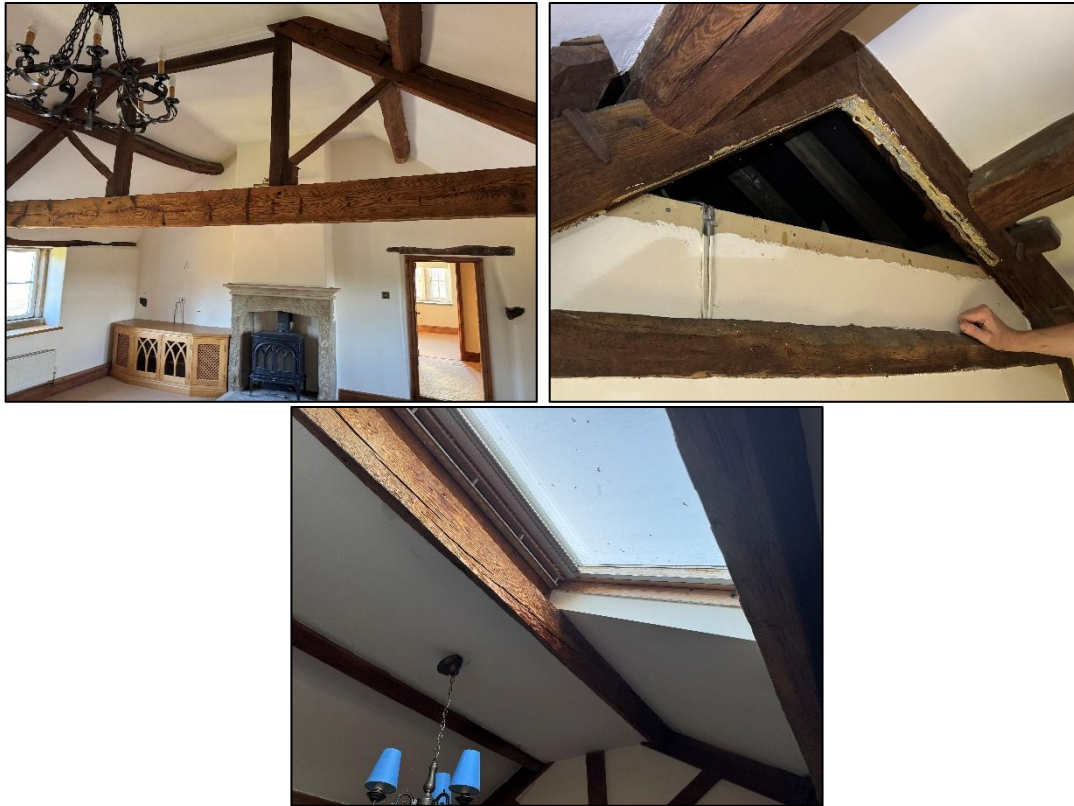
3.1.6.5. The roof is supported on a timber queen post frame that is internal to the bedrooms and the roof is lined with felt.

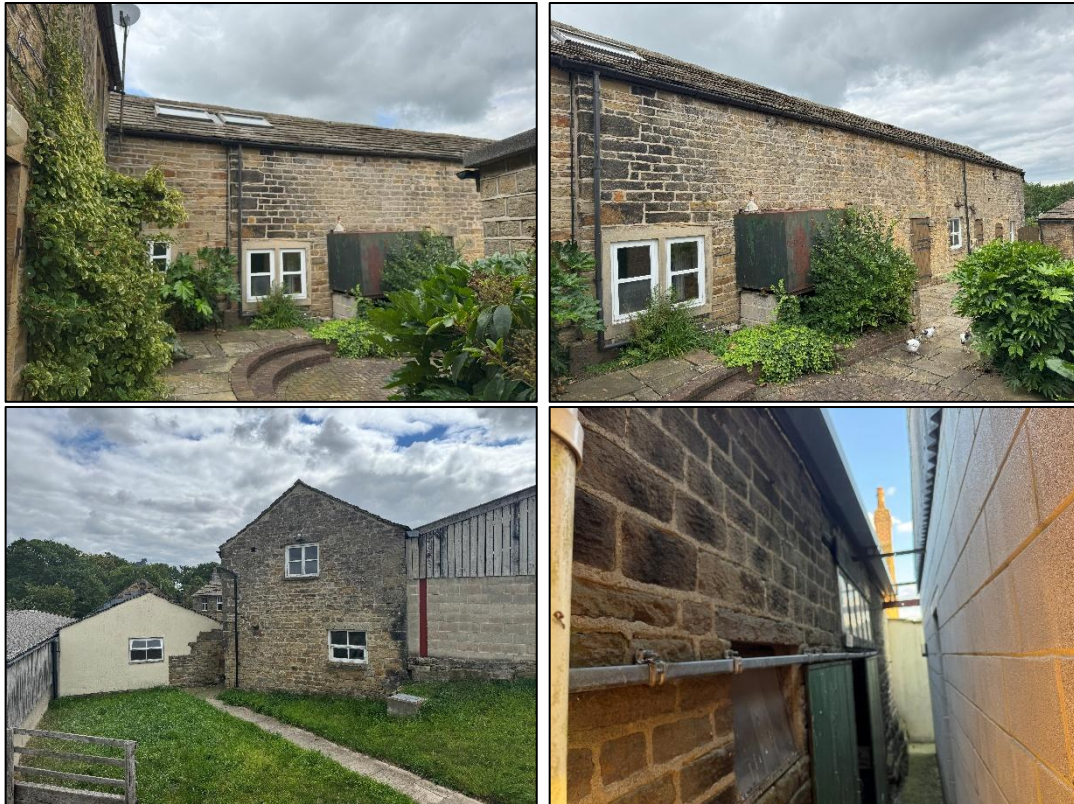
3.1.7.1. This is an old stone building with a pitched roof supported on a king post timber frame and covered with natural stone slates. The southern end of this has been incorporated into the farmhouse and is dealt with accordingly.

3.1.7.2. The stone walls are well pointed and contain no open cracks or crevices.

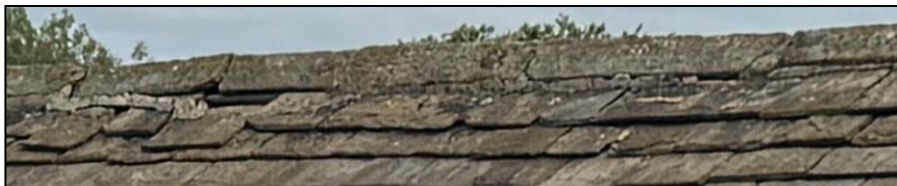
3.1.7.3. The roof is generally in good condition although there are a few displaced stone slates on the western side of the roof, as shown below.

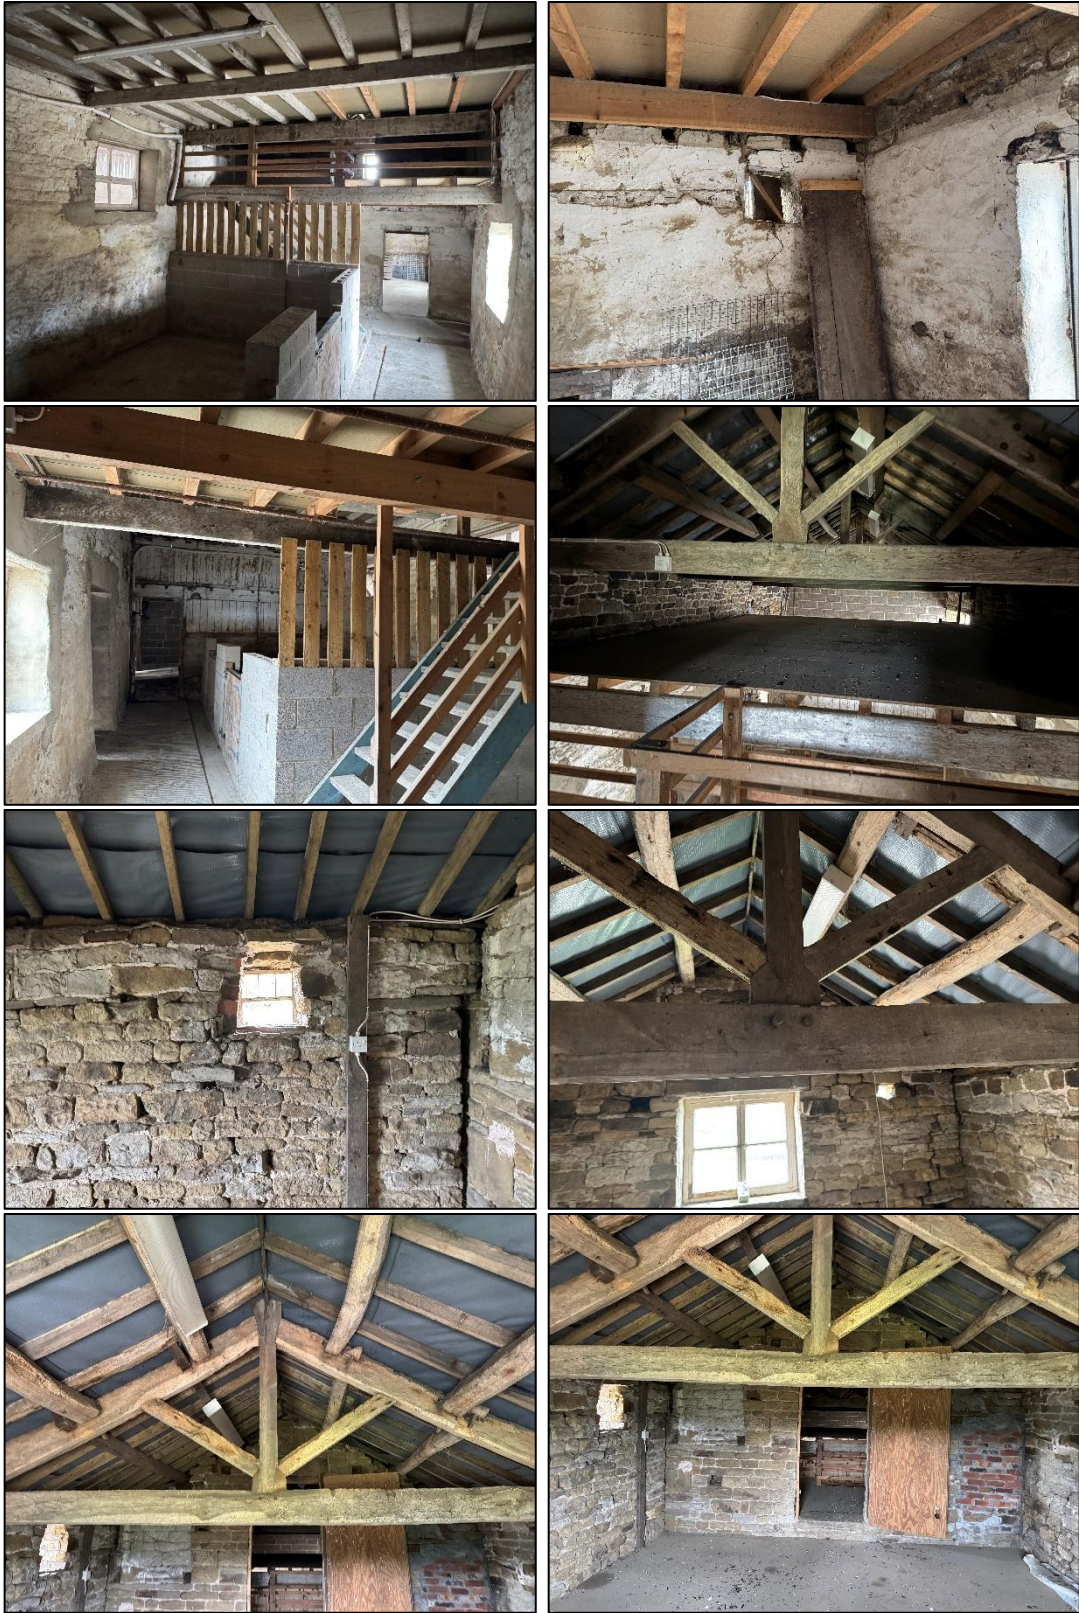
3.1.7.5. The walls are painted white and are generally well sealed with gaps at the top of the walls at the eaves. There are openings in the walls and during this survey swallows were entering these to nest on the top floor.

3.1.7.6. Much of the timberwork seems to have been replaced at some point in time and the roof has been recovered with a plastic membrane beneath the stone slates.

3.1.7.7. This building was assessed in accordance with the Bat Conservation Trust Good Practice Guidelines to have a moderate potential for roosting bats.

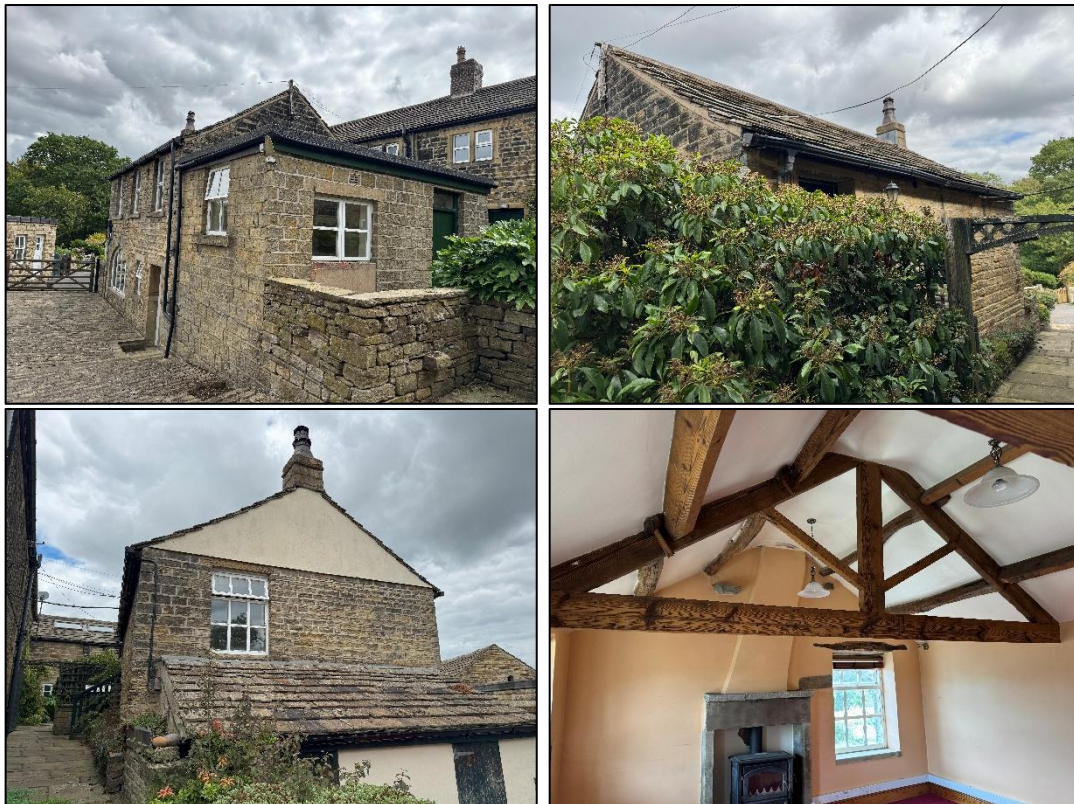
3.1.8.1. There is a detached stone building in the courtyard behind the cottage which has apparently been used as a chapel. The building has stone walls and a pitched roof covered with natural stone slates. There is a single storey flat roofed extension on the western end and a lean to extension on the eastern end.

3.1.8.2. The stone walls are well pointed and contain no open cracks or crevices.

3.1.8.3. The roof is generally in good condition with no signs of slipped or missing roof tiles.

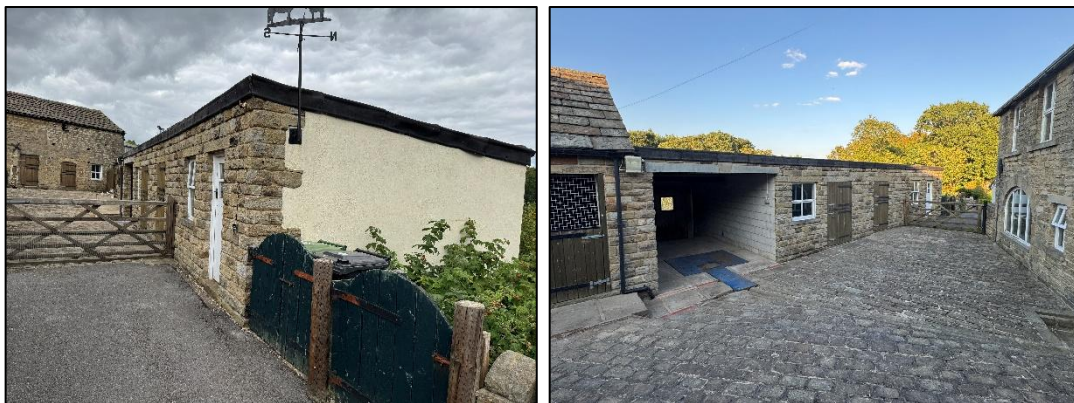
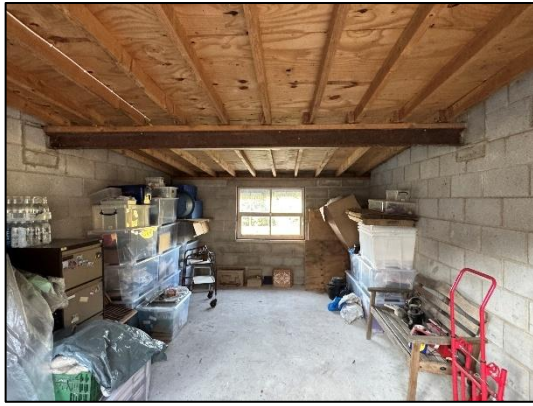
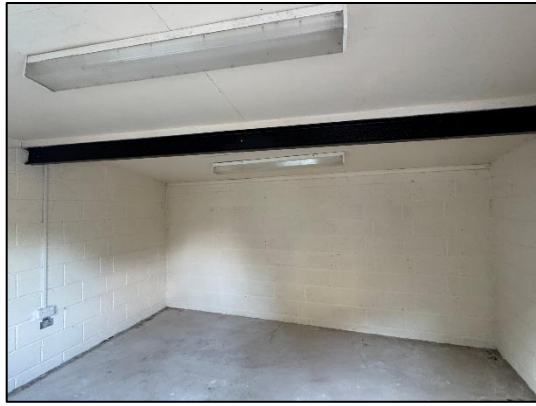
3.1.9.5. There were swallow nests on the strip light unit in the open garage section of this building.

5.2. Abundant swallows were found to be nesting in the buildings on site, including the stone barn, the stables and the garage block and therefore swallow nesting opportunities must be provided in any converted buildings.

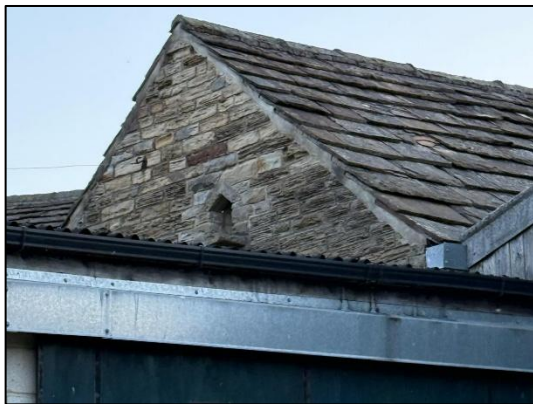
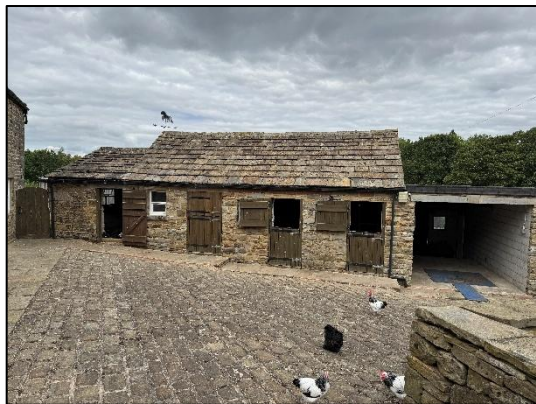
3.1.10.2. The stone walls of the building are in good condition and there is a small open window in the eastern gable end wall.

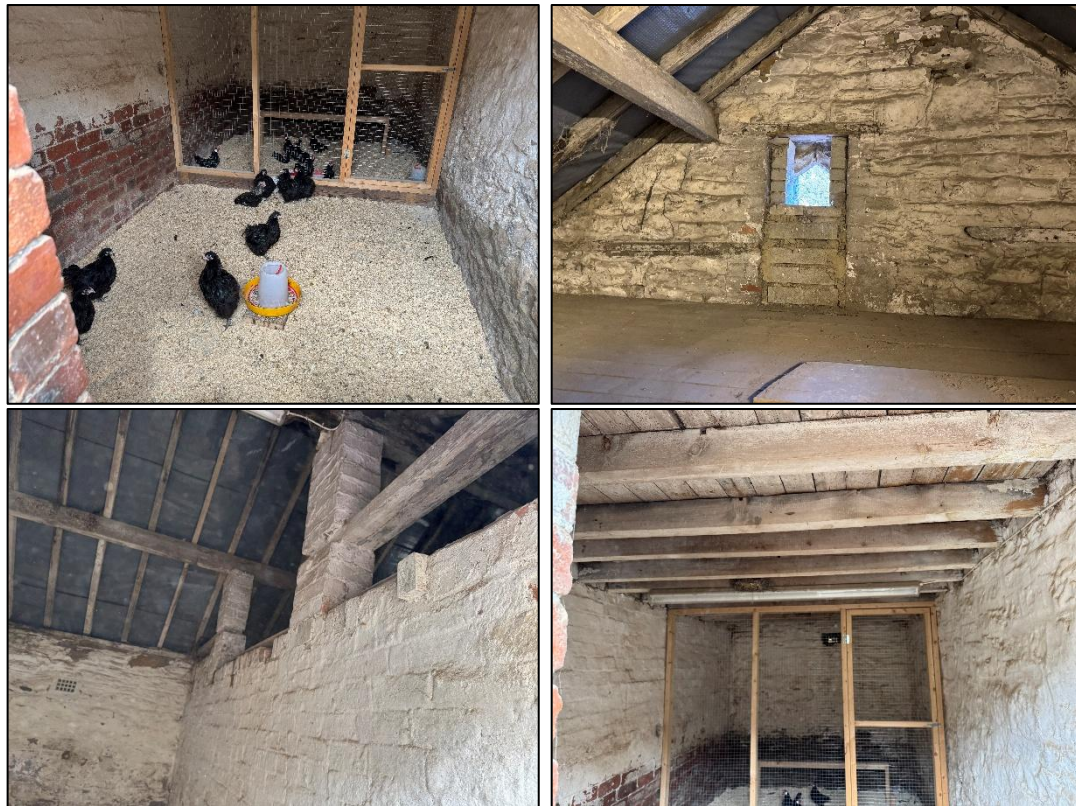
3.1.10.4. Internally the building is split into four stables. One of these has a second floor above it suitable for hay or straw storage while the remaining stables are open to the underside of the roof.

3.1.10.5. The roof is lined with a plastic membrane that is generally sound but does have an occasional tear.

3.1.10.6. Internally there are no bat field signs on the mezzanine floor and no bats present in the roof.

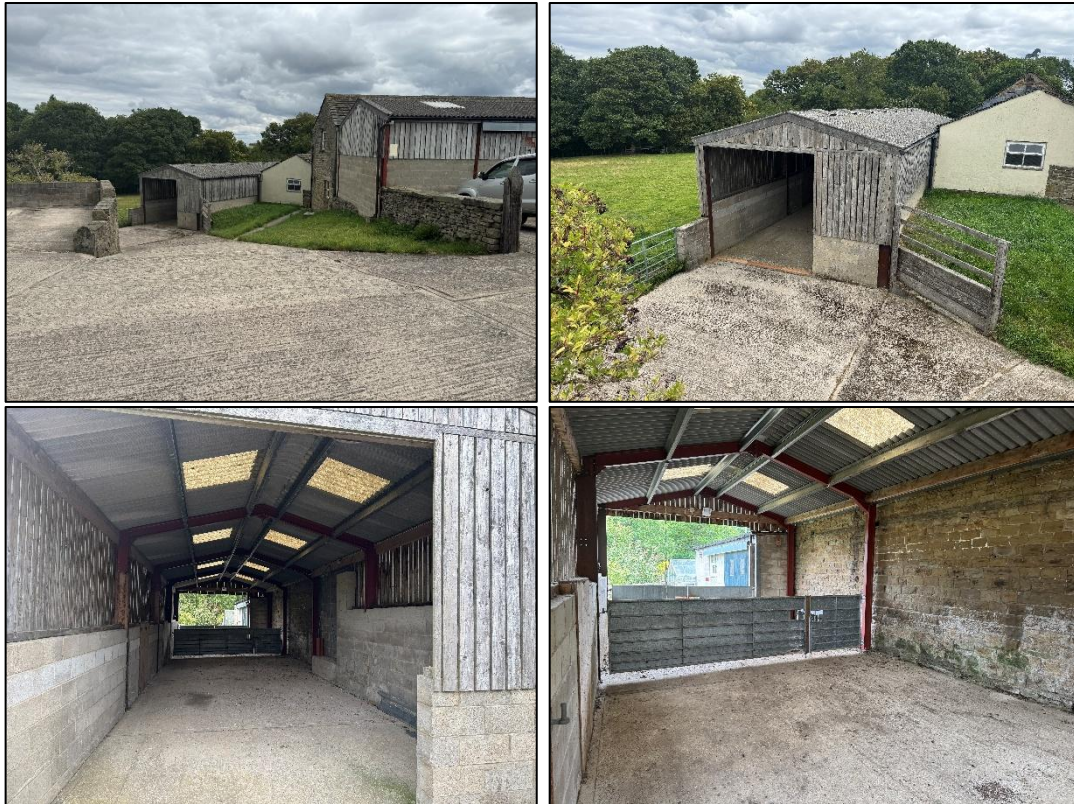
3.1.11.1. Behind the stables there is a modern building which is a lean-to that incorporates the rear wall of the stables. The remaining side walls are low blockwork walls with slatted timbers above topped by a pitched roof supported on a timber and steel frame and covered with corrugated cement sheets. The ends are open for vehicular access.

3.1.11.2. This building was assessed in accordance with the Bat Conservation Trust Good Practice Guidelines to have a negligible potential for roosting bats.

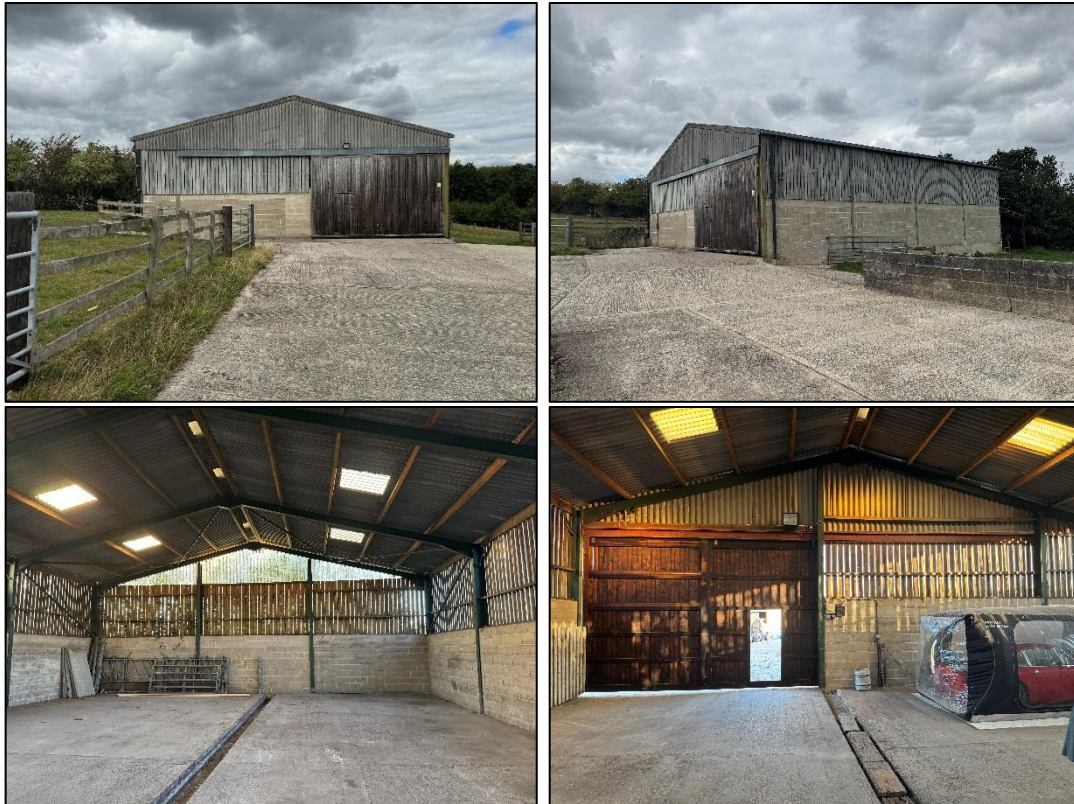
3.1.12.1. Standing at the back of the farm there is a large modern farm building with low blockwork walls with slatted timber above with a pitched roof, supported on a timber and steel frame and covered with corrugated cement sheets.

3.1.12.2. The building is in good condition and is well sealed. Inside there are various stored vehicles.

3.1.12.3. This building was assessed in accordance with the Bat Conservation Trust Good Practice Guidelines to have a negligible potential for roosting bats.

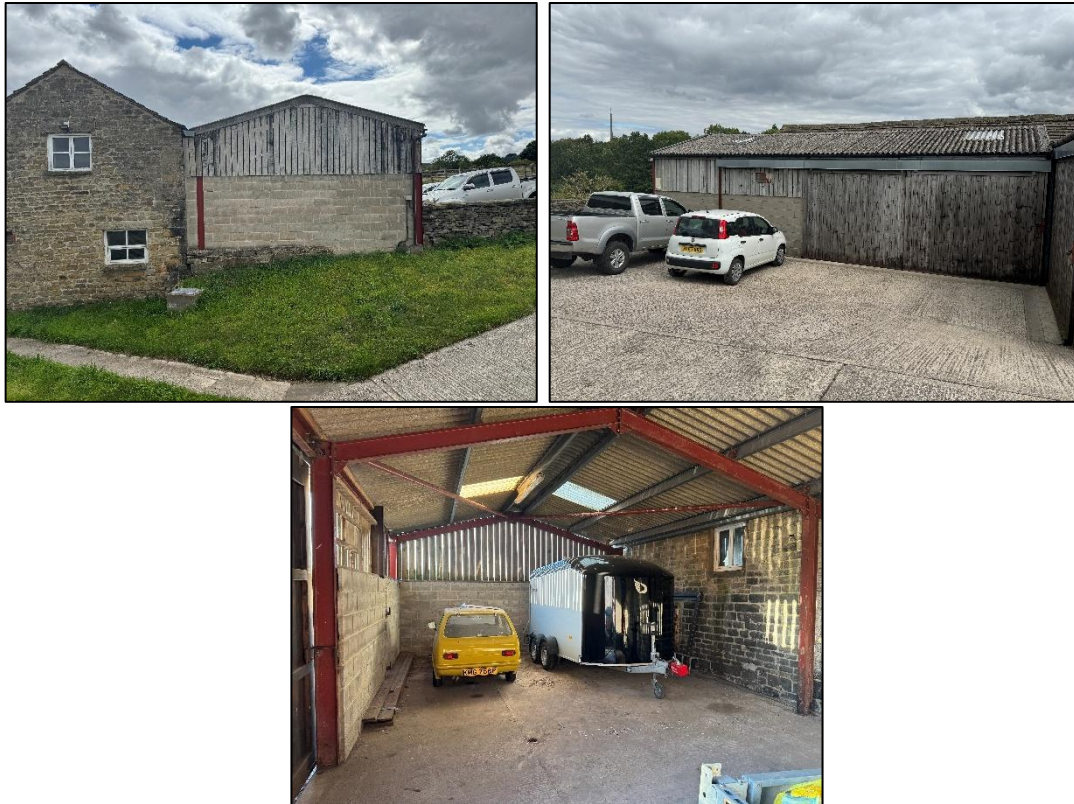
3.1.13.1. At the northwest corner of the stone barn there is a modern farm building that abuts the stone barn wall. This is a modern farm building with low blockwork walls with slatted timber above with a pitched roof, supported on a timber and steel frame and covered with corrugated cement sheets.

3.1.13.2. Internally the barn is used for vehicle storage and at the time of the survey contained a car and a horsebox plus a rubbish skip.

3.1.13.3. This building was assessed in accordance with the Bat Conservation Trust Good Practice Guidelines to have a negligible potential for roosting bats.

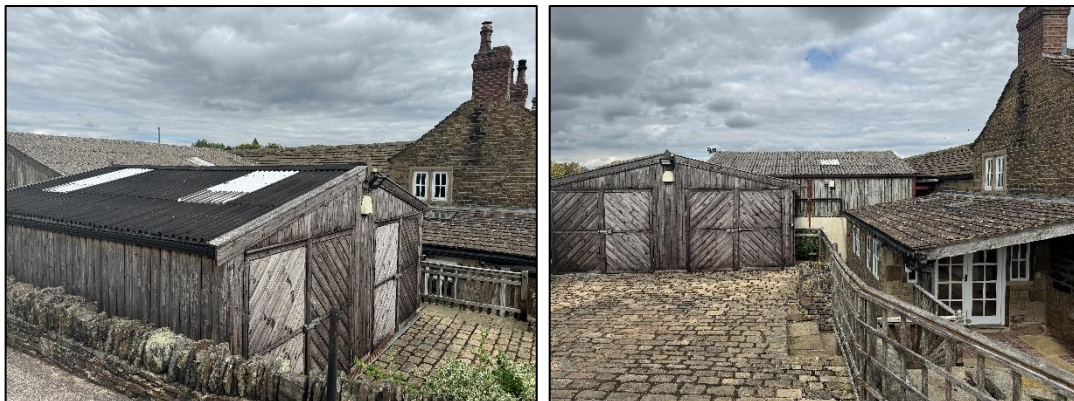
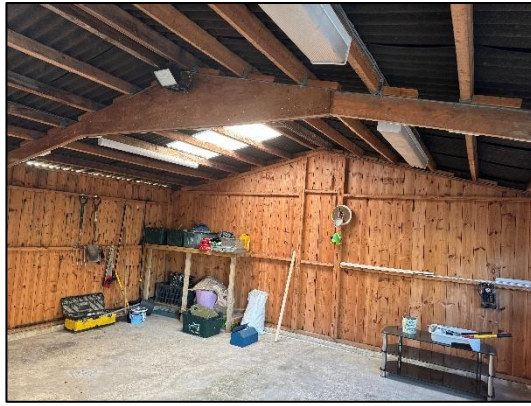
3.1.15.1. Located at the southwest corner of the site, this is a timber building with a pitched roof covered with corrugated bitumen roof sheets.

3.1.15.2. This building was assessed in accordance with the Bat Conservation Trust Good Practice Guidelines to have a negligible potential for roosting bats.

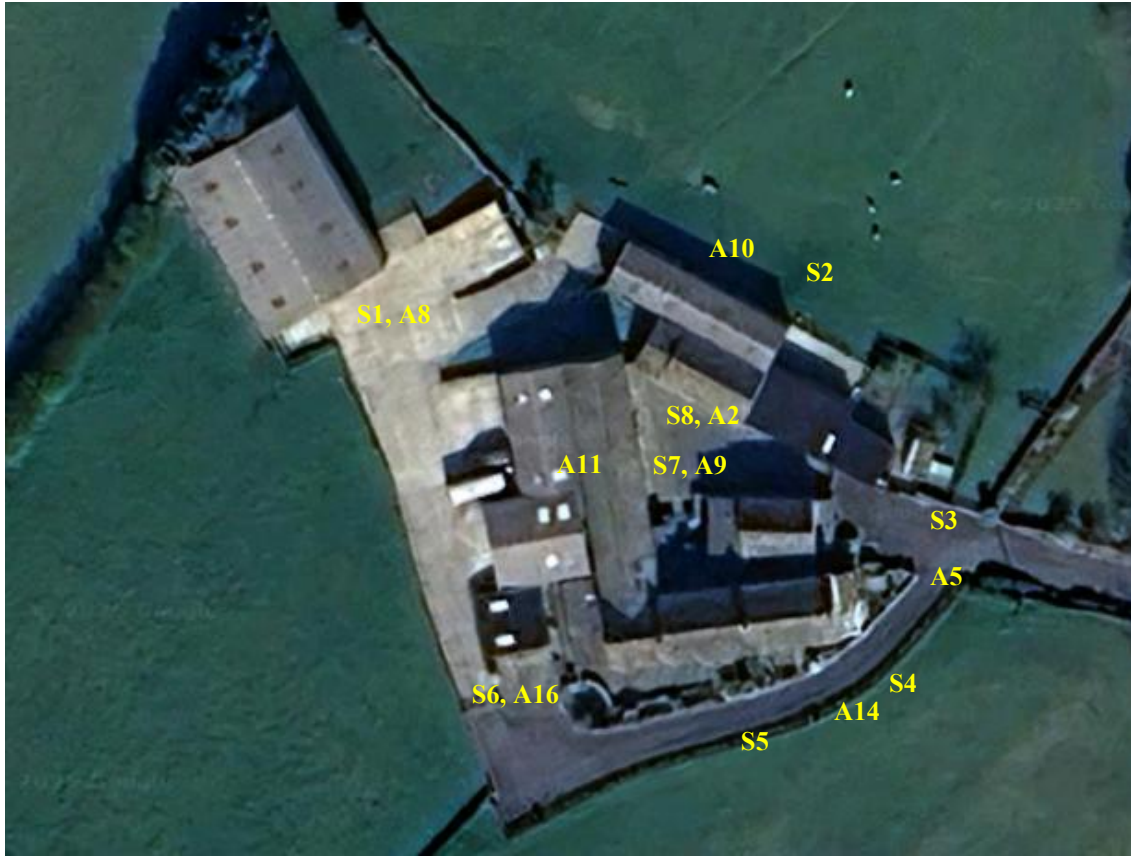
3.2.3. The position of the surveyors and the static Anabats are shown on the aerial photograph below where S is a surveyor and A is an Anabat. Anabat 11 was placed upstairs in the stone barn.

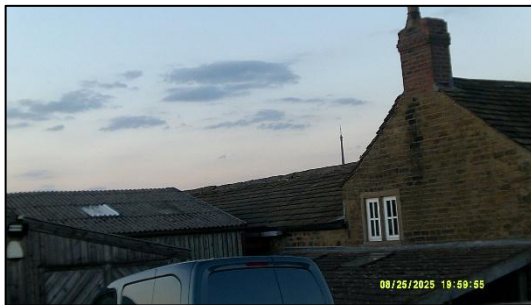
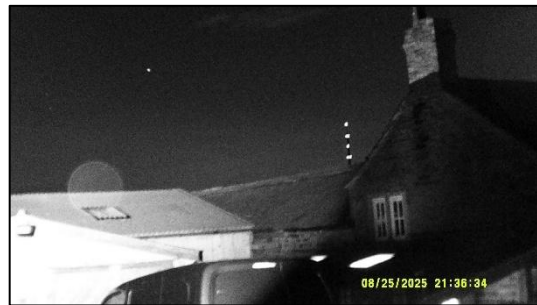
C1.

3.2.4. Sixteen infrared cameras and infrared torches were also set up around the buildings, ensuring that all suitable features were covered. The photographs below show the view of each camera at both the start and towards the end of the survey when it was darkest.

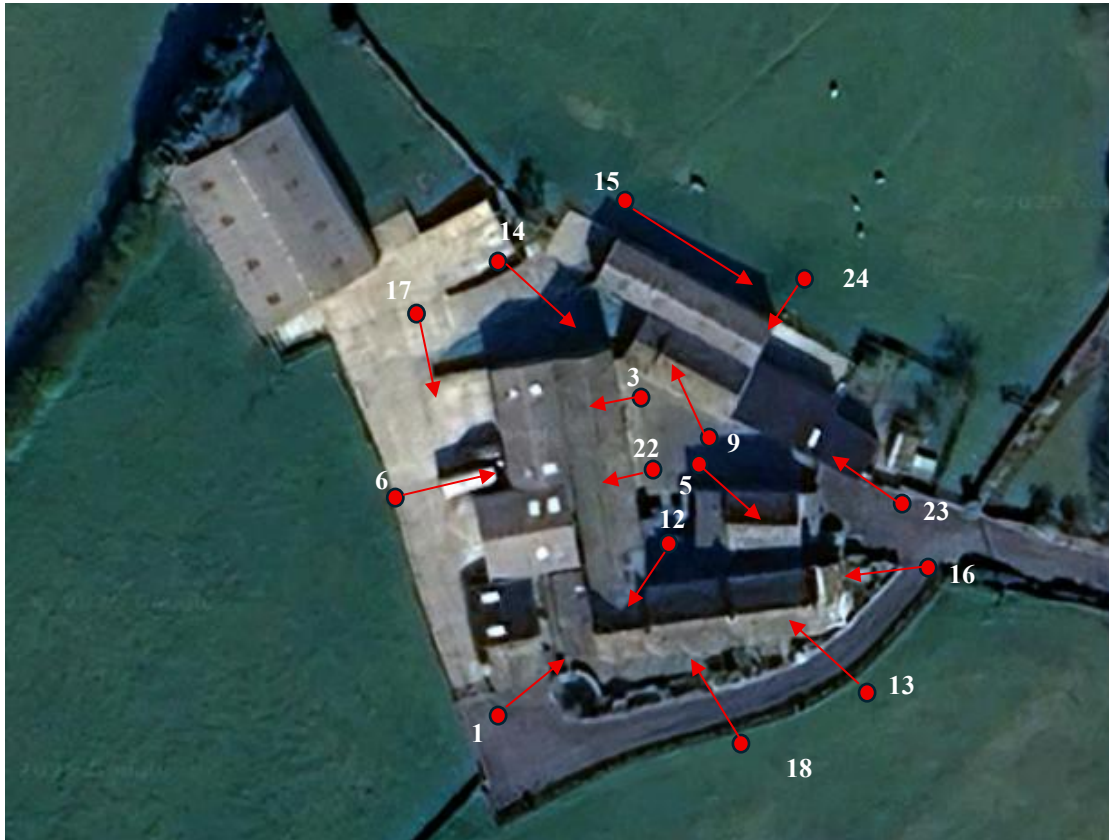
3.2.5. The aerial photograph below shows where the cameras were positioned along with their approximate field of view.

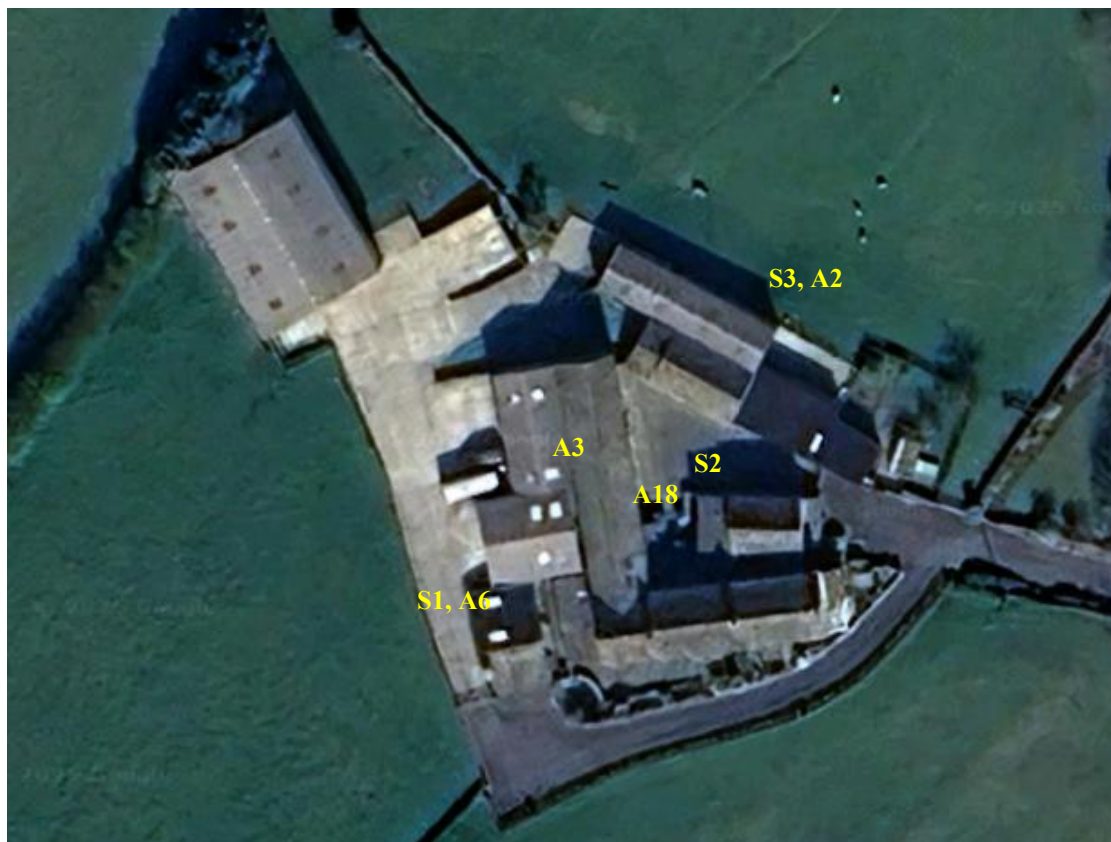
3.3.3. This survey was designed to cover predominantly the stone barn but also the farmhouse and the stable block, F. The position of the surveyors and the static Anabats are shown on the aerial photograph below where S is a surveyor and A is an Anabat.

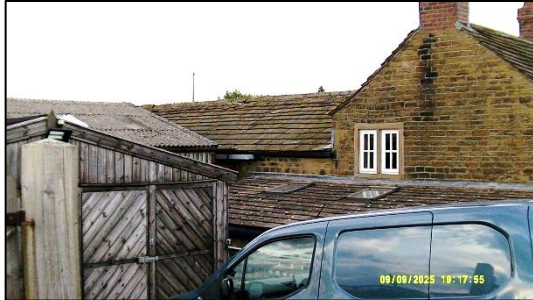
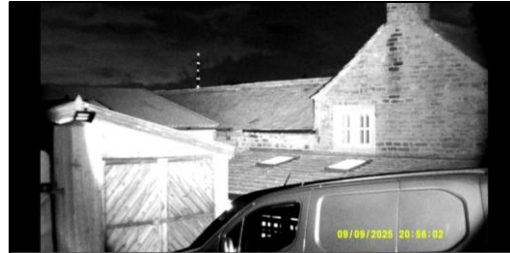
C9.

3.3.4. Three infrared cameras and infrared torches were also set up around the buildings, ensuring that all suitable features were covered. The photographs below show the view of each camera at both the start and towards the end of the survey when it was darkest.

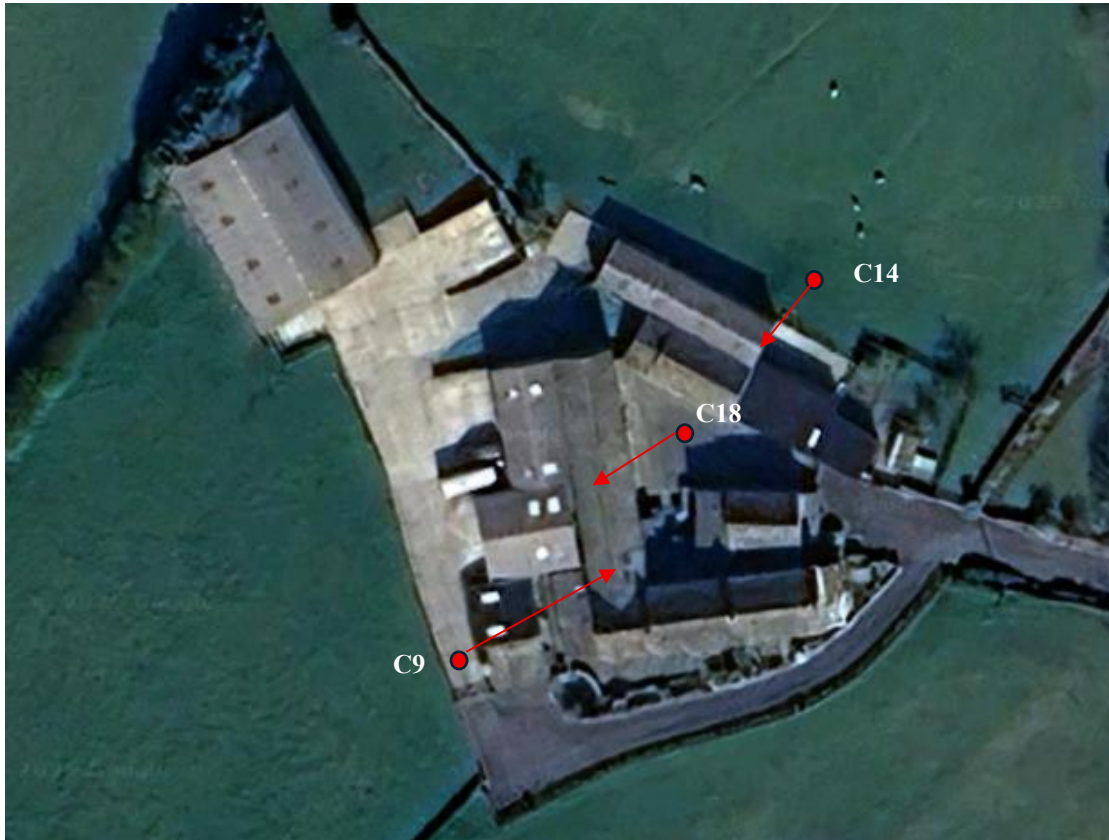
3.3.5. The aerial photograph below shows where the cameras were positioned along with their approximate field of view.
