## Road Safety Audit: Stage 1

**Formation of temporary construction access track  
A629 Penistone Road, Birds Edge**

**Plough Barn, Birds Edge Lane, Huddersfield**

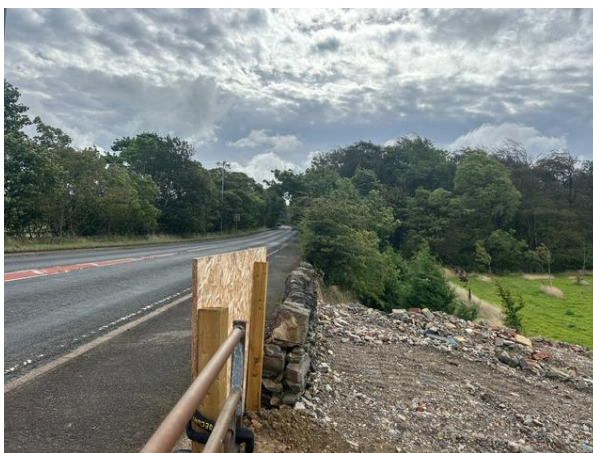
**Photo 1 - southeast of access**

Visibility to the southeast of the proposed temporary access junction appears to be restricted due to sight-line obstruction caused by the existing hedge and trees, as illustrated in Photo 1. Such reduced visibility may increase the risk of drivers emerging from the construction access failing to adequately observe approaching north-westbound traffic, and vice versa, potentially resulting in give-way-type conflicts. Photo 2 shows the existing visibility splay to the northwest of the site entrance.

Furthermore, the visibility splay shown on the submitted plan has been measured from within the footway, which is incorrect, as the correct 2.4 metre x-distance would place the driver's eye position inside the site access. The width of the footway varies on either side of the entrance—approximately 2.0 metres on the north-western side and 1.7 metres on the south-eastern side—meaning that measuring the splay from within the footway does not represent the appropriate driver position.

The visibility splay should instead be taken from an x-distance of 2.4 metres set back from the front of the kerb line to the inside of the entrance, in accordance with standard practice, as this represents a reasonable maximum distance between the front of a vehicle and the driver's eye position.

Vegetation within the visibility splay should be cut back and maintained to ensure adequate sight lines are provided at the junction. The visibility splay should be re-drawn and assessed from a set-back position of 2.4 metres from the back of the kerb line, to avoid any encroachment into the running carriageway

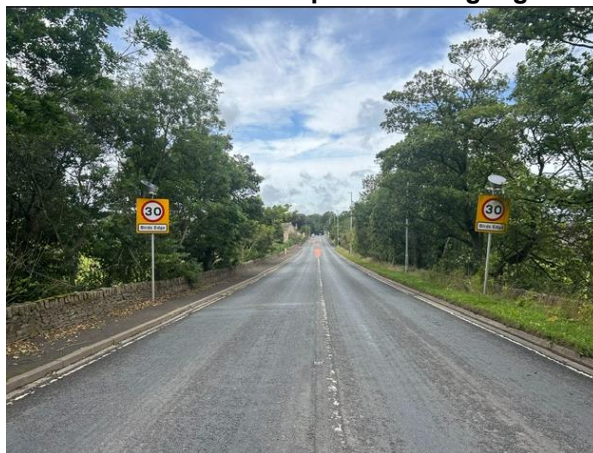
**Photo 3 – Current speed limit signage**

The submitted plans do not indicate the provision of any warning signage to alert drivers to the presence of a new access at this location. The absence of such signage may increase the potential for vehicle conflict, including shunt-type collisions.

The access lies within a 30mph speed limit, shown in photo 3 approximately 74 metres from the terminal signs.

Observations made on site suggested that vehicle speeds remained higher until further towards the junction with Birds Edge Lane, which may further elevate the risk of conflict at the new access.

Appropriate temporary warning signage should be provided to highlight the presence of the new access and reduce the likelihood of vehicle conflict.

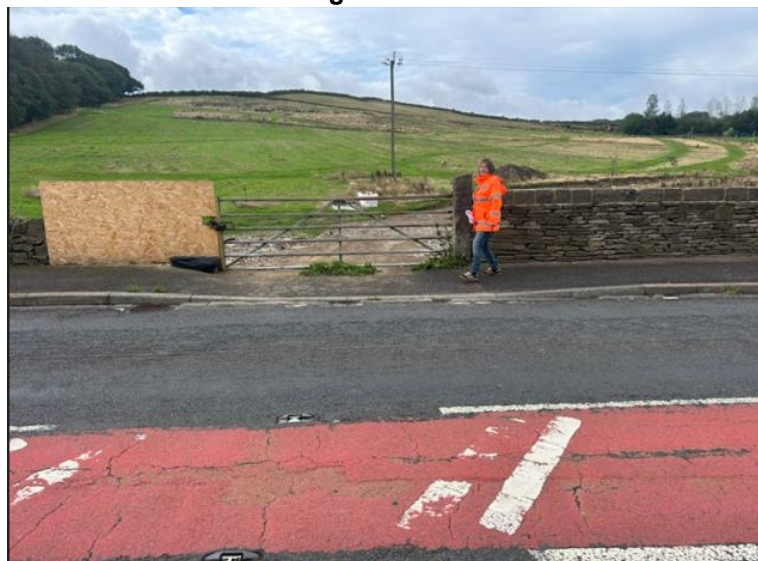
**Photo 4 showing evidence of land levels**

A difference in gradient between the existing footway and the land on which the access track is proposed to be formed appears to create visibility issues, as illustrated in Photo 4.

The fall in land levels on the approach to the entrance, combined with wall heights of approximately 1.1metres to the southeast and 0.74 metres to the northwest, with pillars either side at around 1.3 metres, may restrict drivers' ability to adequately observe approaching traffic. This may increase the potential for emerging vehicle conflicts.

A review of the proposed internal track levels should be undertaken and reprofiled if necessary to ensure that suitable visibility splays can be achieved. It may also be beneficial to increase the gradient level to provide improved stability for HGVs accessing and egressing the site.

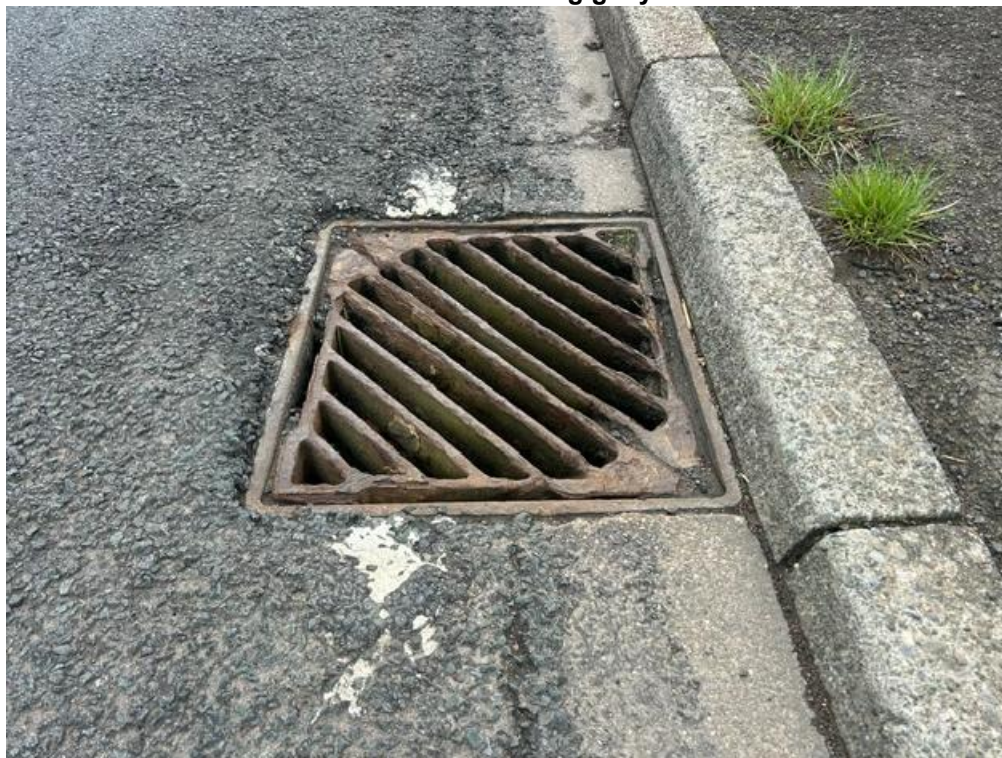
**Photo 5 - Existing gully**

A cast iron gully is present on the highway as shown in photo 5 below. Due to the proposed widening of the access the gully will be within the mouth of the junction and is likely to be overrun by construction site traffic. This may increase the risk of structural failure of the gully if not suitably constructed to withstand the loading associated with heavy vehicle overrun.

The gully should be repositioned outside the mouth of the junction as part of the works or reinstalled using a construction and cover that provides skid-resistance performance complementary to the adjacent carriageway surface.
