PHASE 2 GEO-ENVIRONMENTAL REPORT

Report on a Phase 2 Geo-environmental Investigation

Location:	274 Cumberworth Lane Denby Dale, Huddersfield, West Yorkshire, HD8 8QS	
For:	FHH Developments	
Consultants:	Hinchcliffe Architecture & Design	
Report No:	C5759/26/E/8948	Report date: April 2026

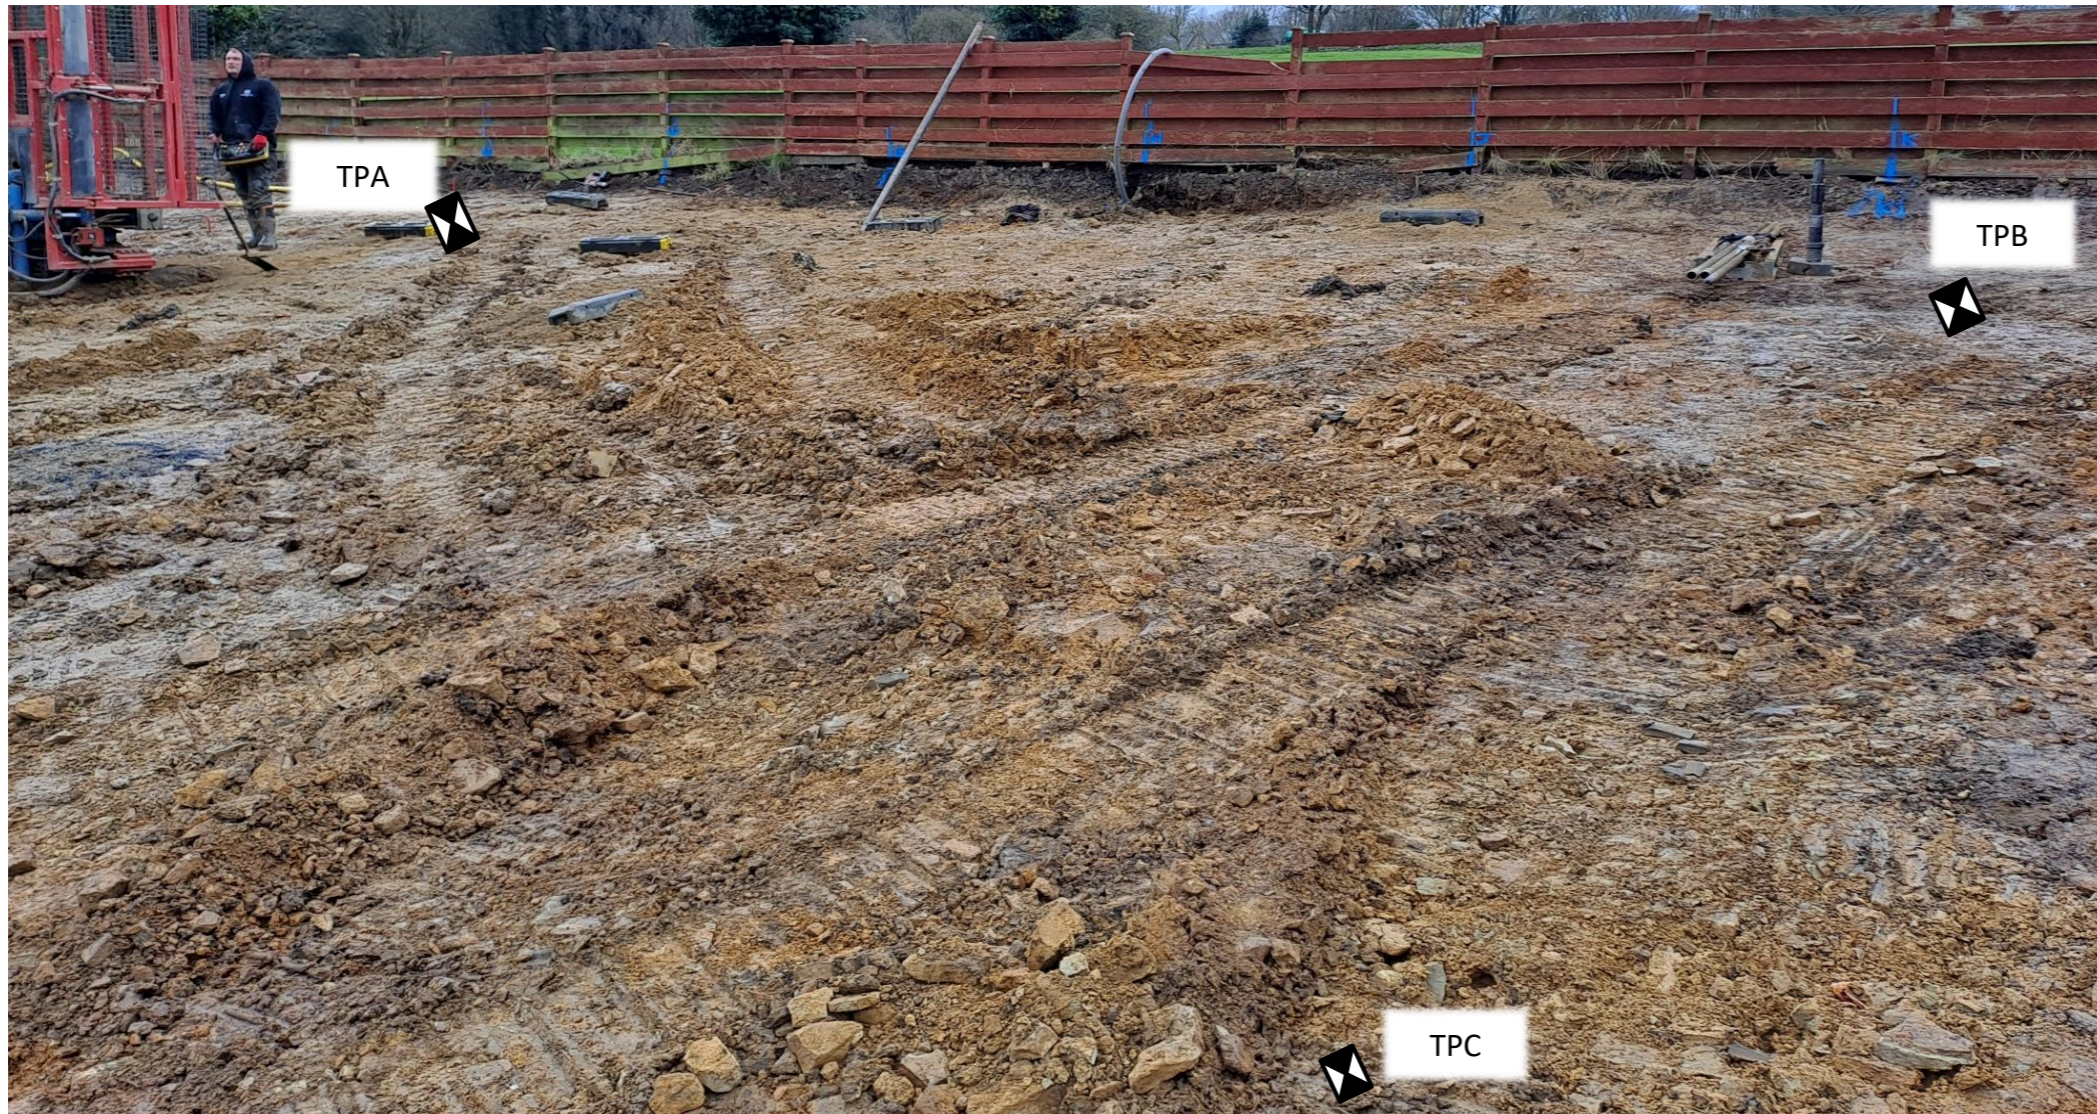
Site Plan

Investigation positions approximated from site operative's notes.

The investigatory locations are shown on the site plan which is presented in Appendix 1 to this report. It is of note that the property shown on the site plan was demolished prior to the fieldworks taking place and enabling works had been undertaken to make the site safe for the mobilisation of drilling rigs.

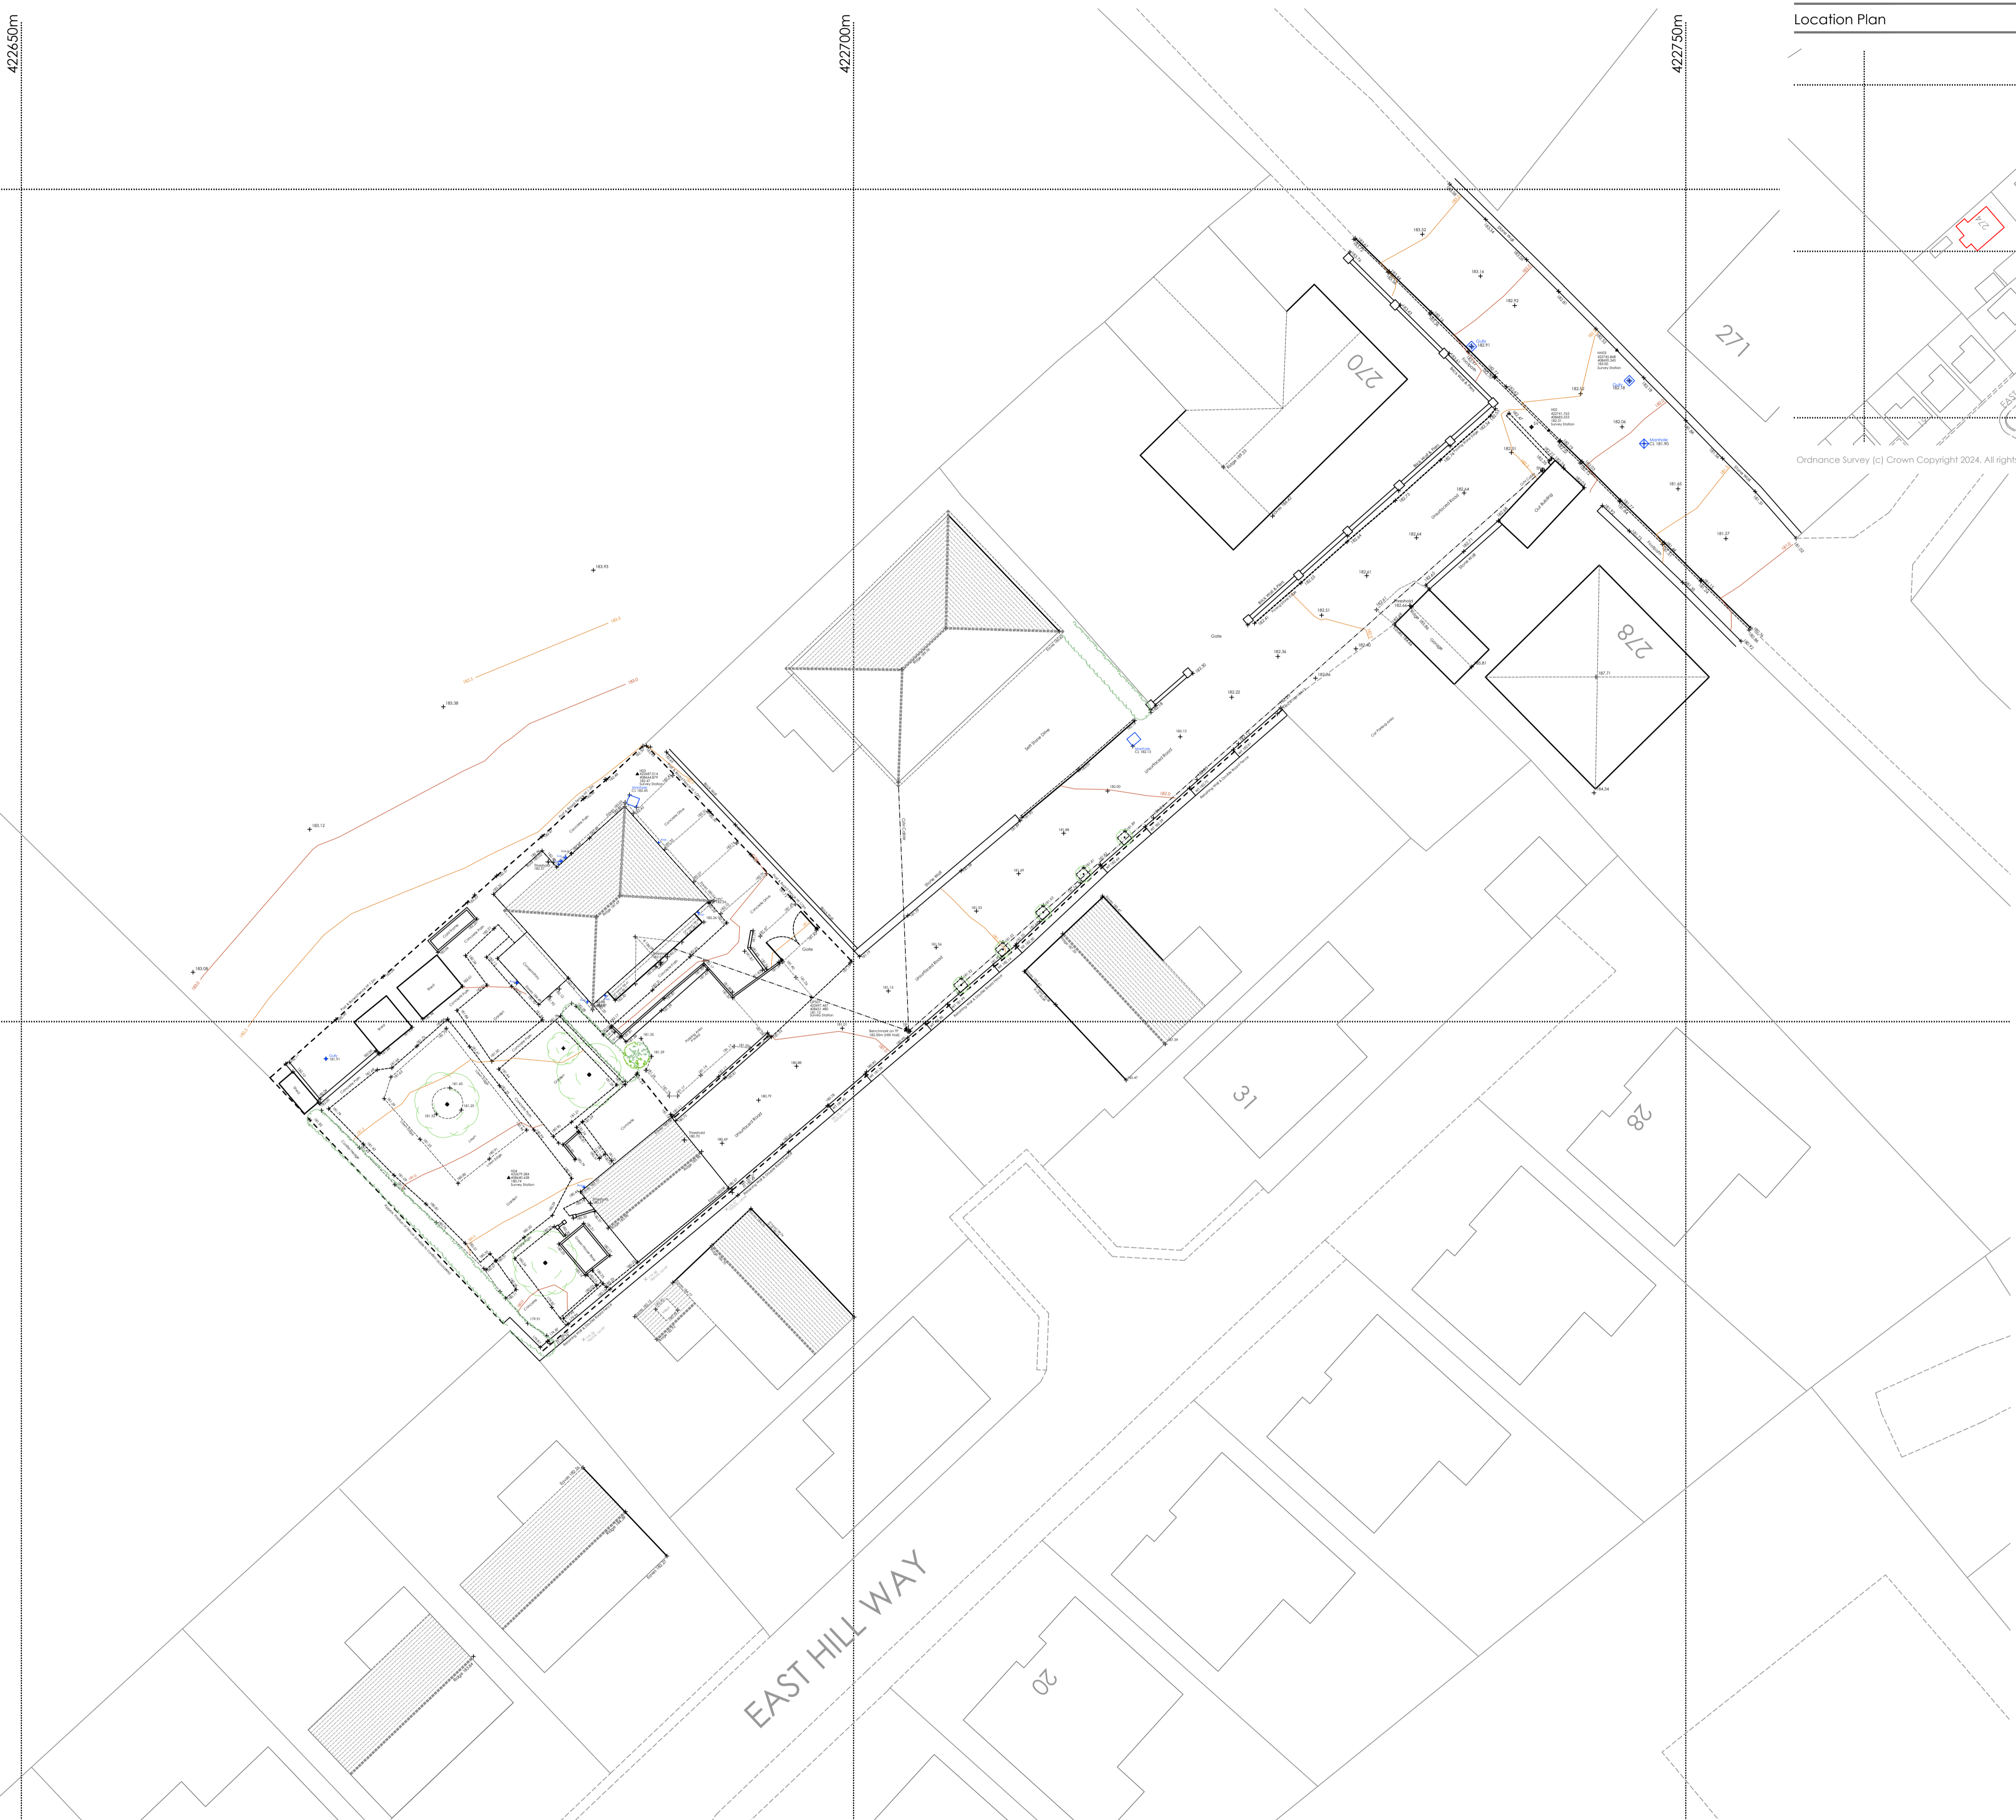
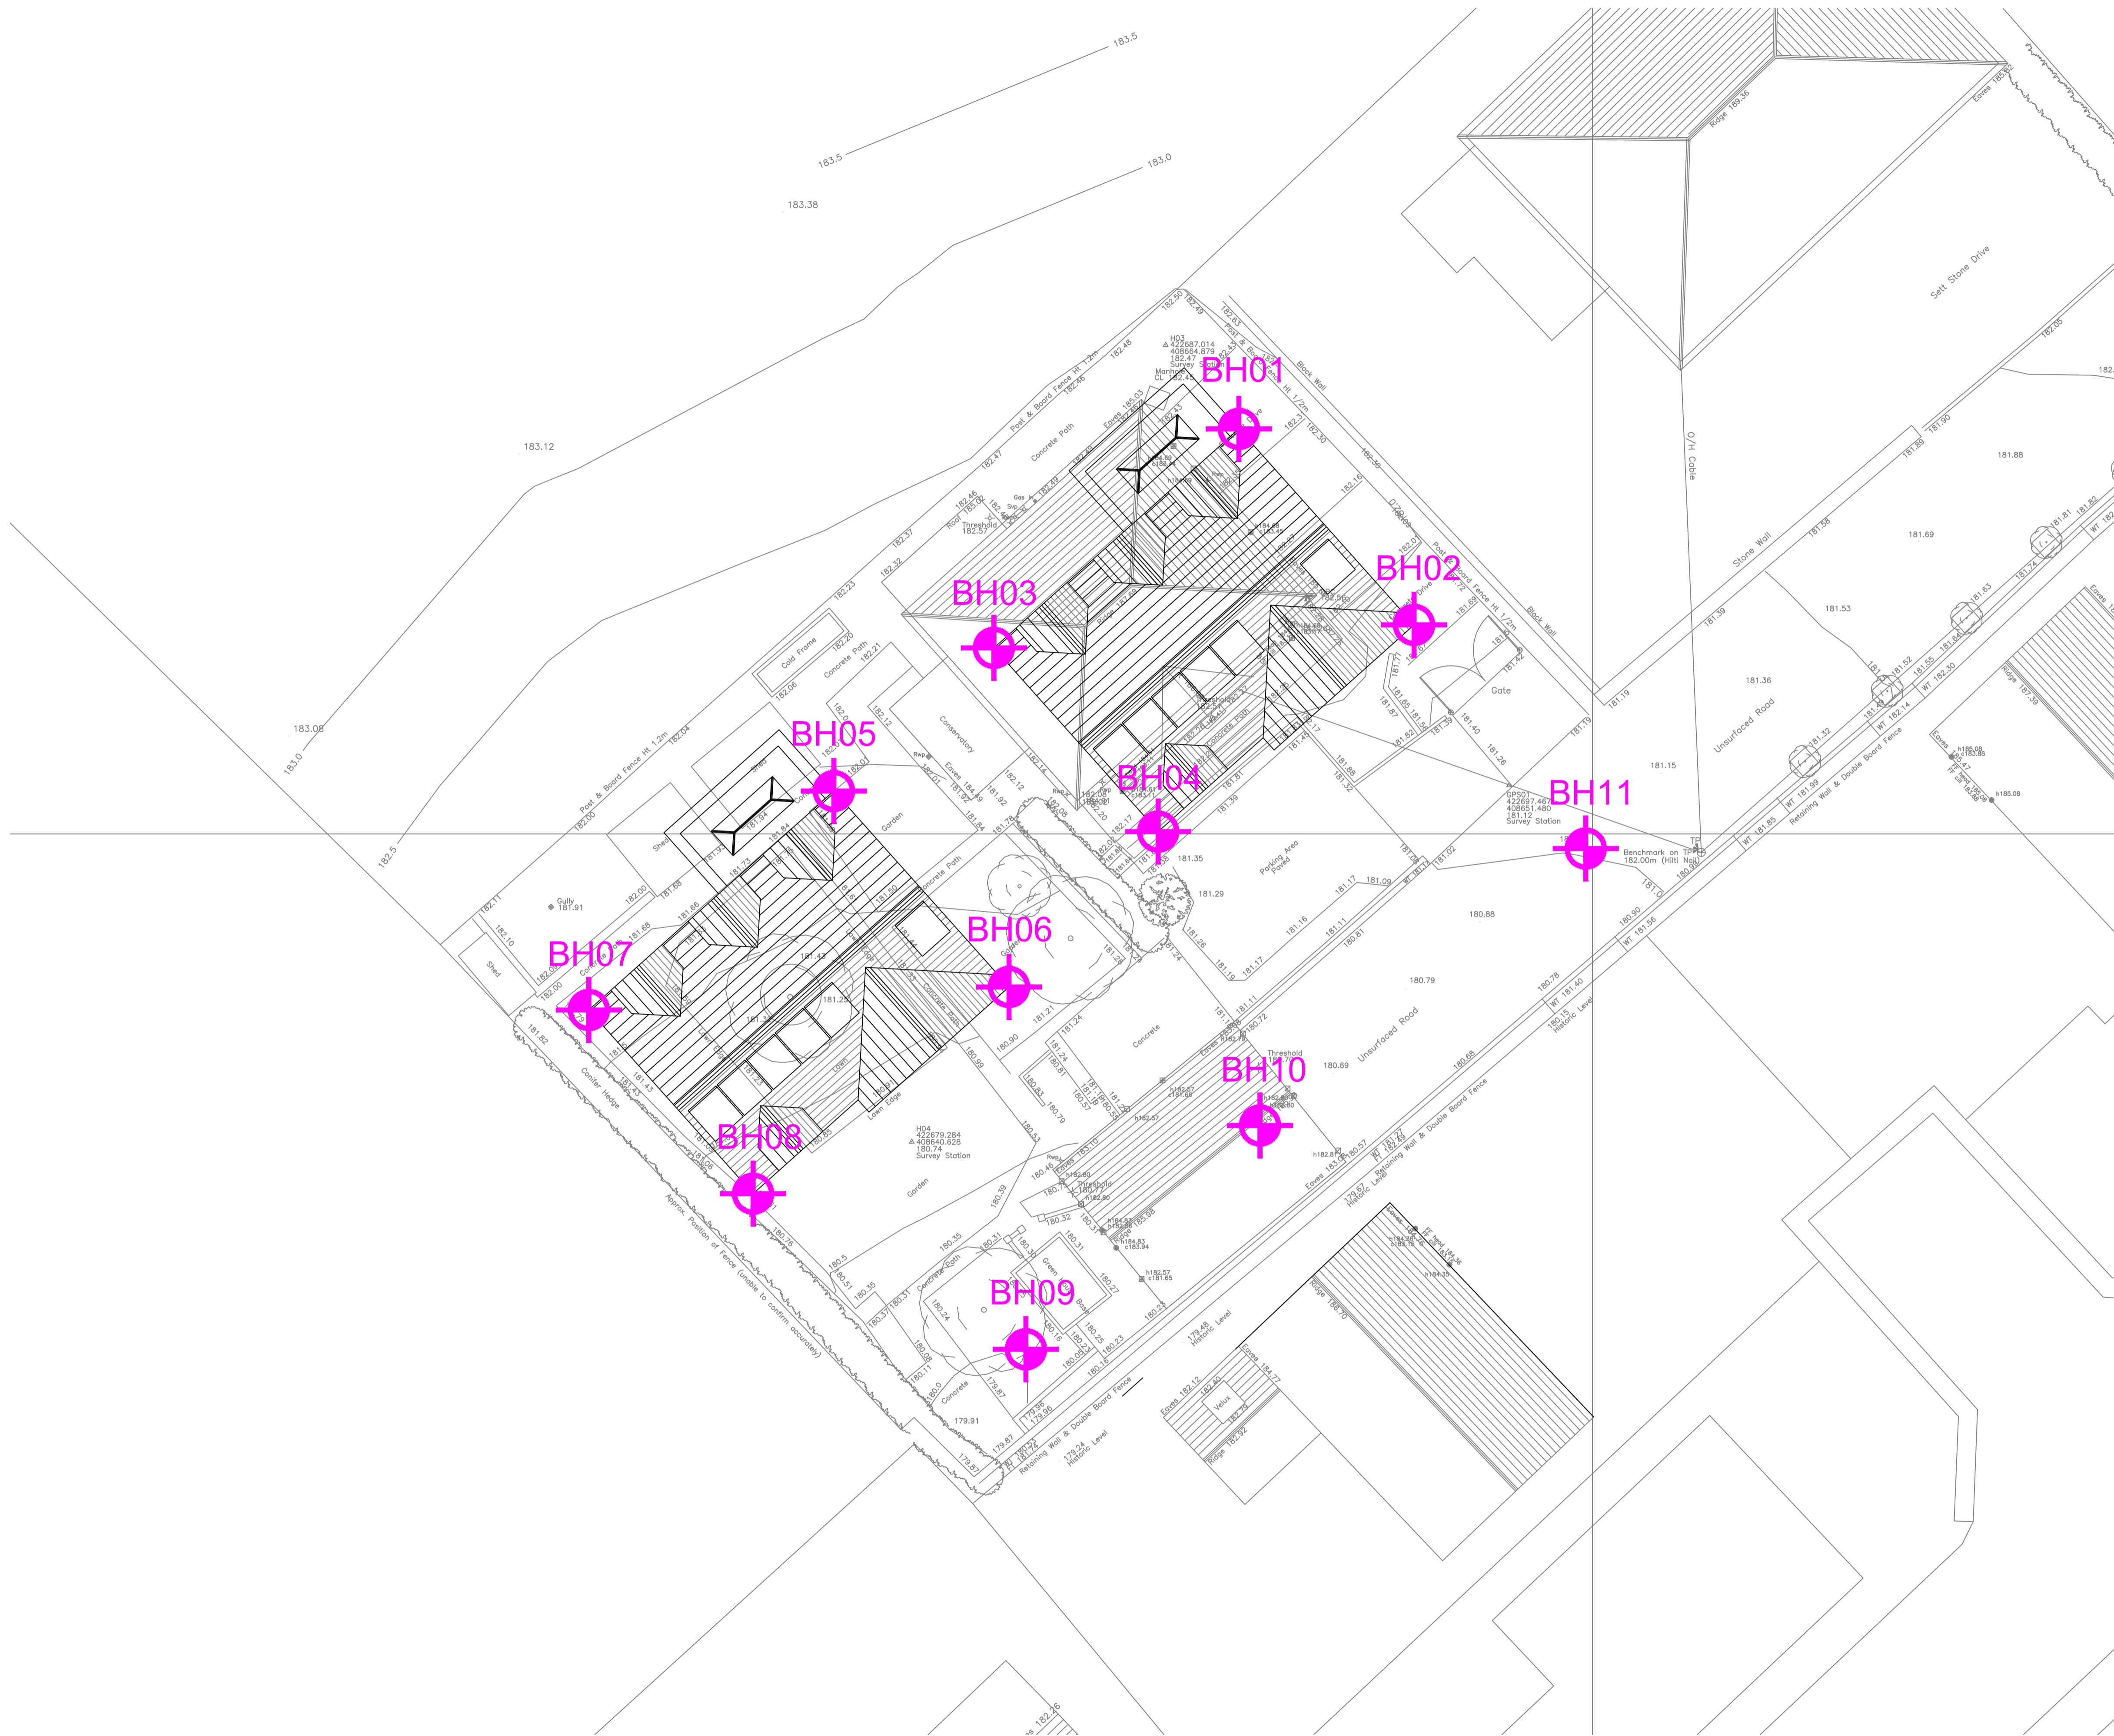
BORE HOLE LOCATION

SITE STRIP TO NATURAL STRATA TO CONFIRM SHAFTS ARE OUTSIDE OF SITE BOUNDARY

BOREHOLES TO BE ADJUSTED LOCALLY TO SUIT SITE BOUNDARY.
