TECHNICAL NOTE

DATE:	20 November 2025	CONFIDENTIALITY:	Public
SUBJECT:	70097732 - Heckmondwike Bus Hub – Materials Management.		
PROJECT:	70097732 - Heckmondwike BS	AUTHOR:	L McFadden
CHECKED:	C Smith	APPROVED:	I Hall

RE: MATERIALS MANAGEMENT – ACCEPTABILITY OF IBAA AS BACKFILL IN DRAINAGE TRENCHES

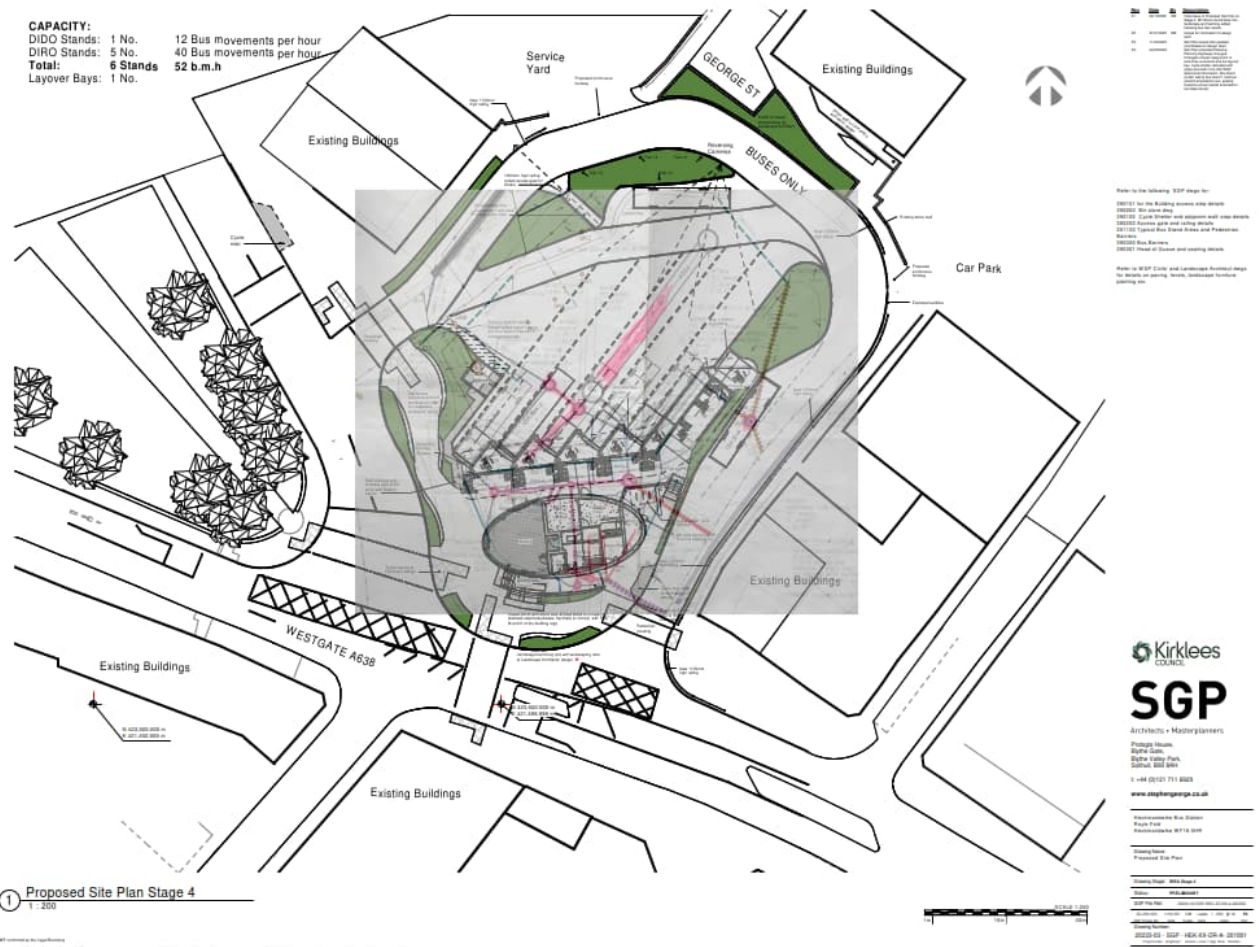
Figure 2 – Proposed Site Plan showing where IBAA Material Remains In-Situ (highlighted areas)

Approximately 350m³ of material was imported to the Heckmondwike Bus Hub site to be used as fill beneath the hub building as well as backfill to drainage trenches across the site. The imported material is understood to be a recycled product comprising Incinerator Bottom Ash Aggregate (IBAA) sourced from Ferrybridge. The material underwent both geotechnical and chemical testing, as a result of the geotechnical testing the material was deemed geotechnically unsuitable for use as fill beneath the hub building and was subsequently removed from the hub building area of the site. A small volume of the imported material does remain on site as backfill to drainage trenches, RG Carter have confirmed that the volume of the material remaining in-situ at the site is approximately 28.5 m³ (approximately 48.5 tonnes). **Figure 1** shows the areas where the material remains on site, it has predominantly been placed as fill within drainage runs. The IBAA material remaining on site is beneath areas of proposed hardstanding and has not been placed in areas of soft landscaping or as part of soakaway drainage solutions. **Figure 2** shows the proposed site layout, with an overlay showing the areas where the material remains on site. The Proposed Site Plan (without overlay) is provided as **Appendix 1**.

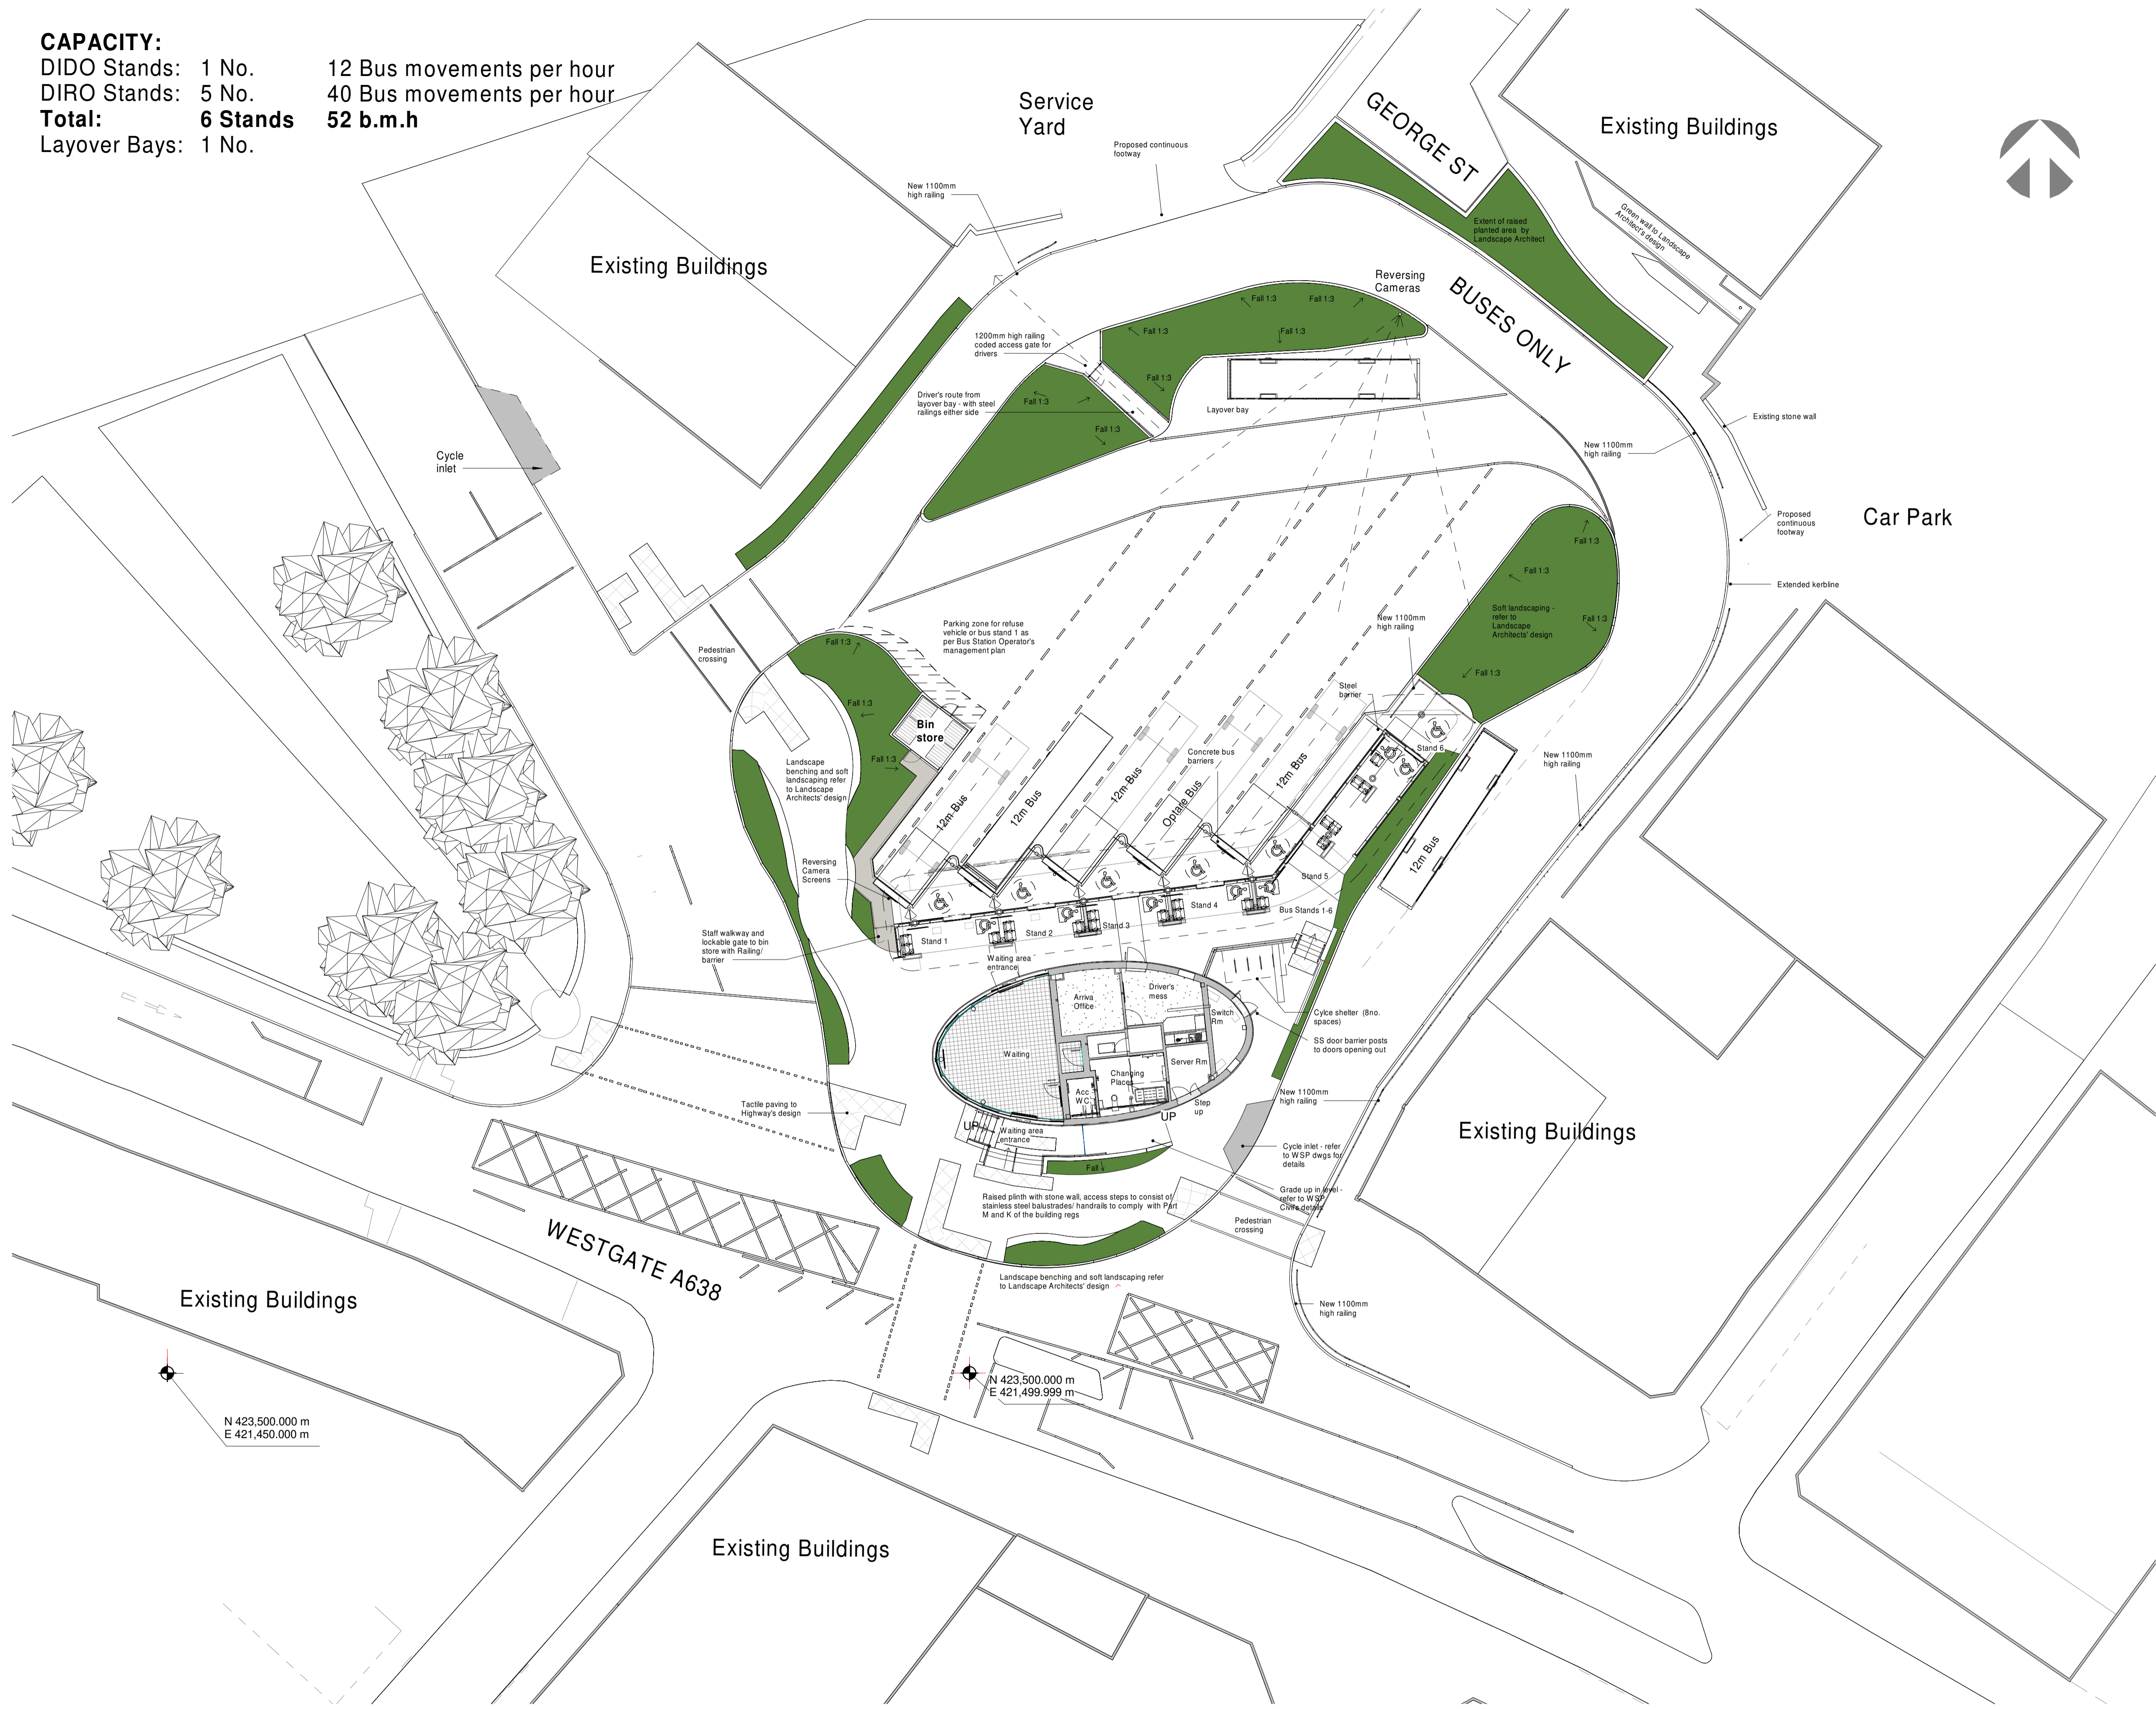
CAPACITY:
 DIDO Stands: 1 No. 12 Bus movements per hour
 DIRO Stands: 5 No. 40 Bus movements per hour
Total: 6 Stands 52 b.m.h
 Layover Bays: 1 No.

Refer to the following SGP dwgs for:
 390101 for the Building access step details
 390000 Bin store dwg
 390100 Cycle Shelter and adjacent wall/step details
 390200 Access gate and railing details
 201120 Typical Bus Stand Areas and Pedestrian Barriers
 390300 Bus Barriers
 390301 Head of Queue and seating details

Refer to WSP Civils' and Landscape Architect dwgs for details on paving, levels, landscape furniture, planting etc
