Phase 1: Desk Study

Cote Royd, Halifax Road, Huddersfield

Spofforth Properties Ltd

NE-26-149

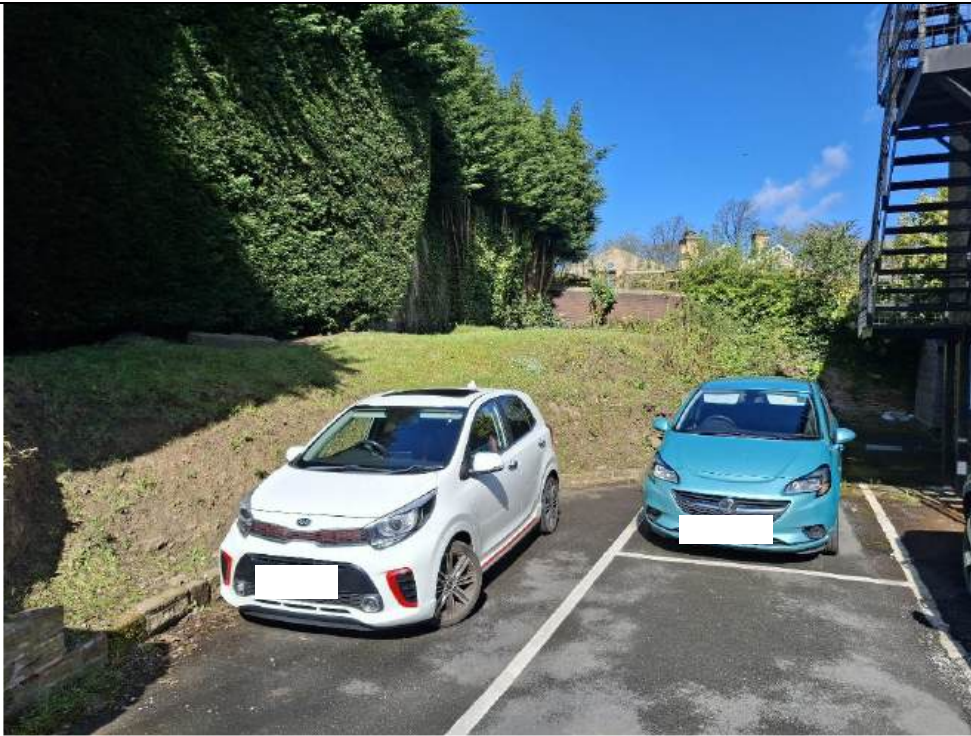
Photo 5: Raised ground at rear of building. Taken at west portion of site looking northwest.
