Phase 2: Site Investigation

George Hotel, Huddersfield

GMI Construction Group PLC

S250101

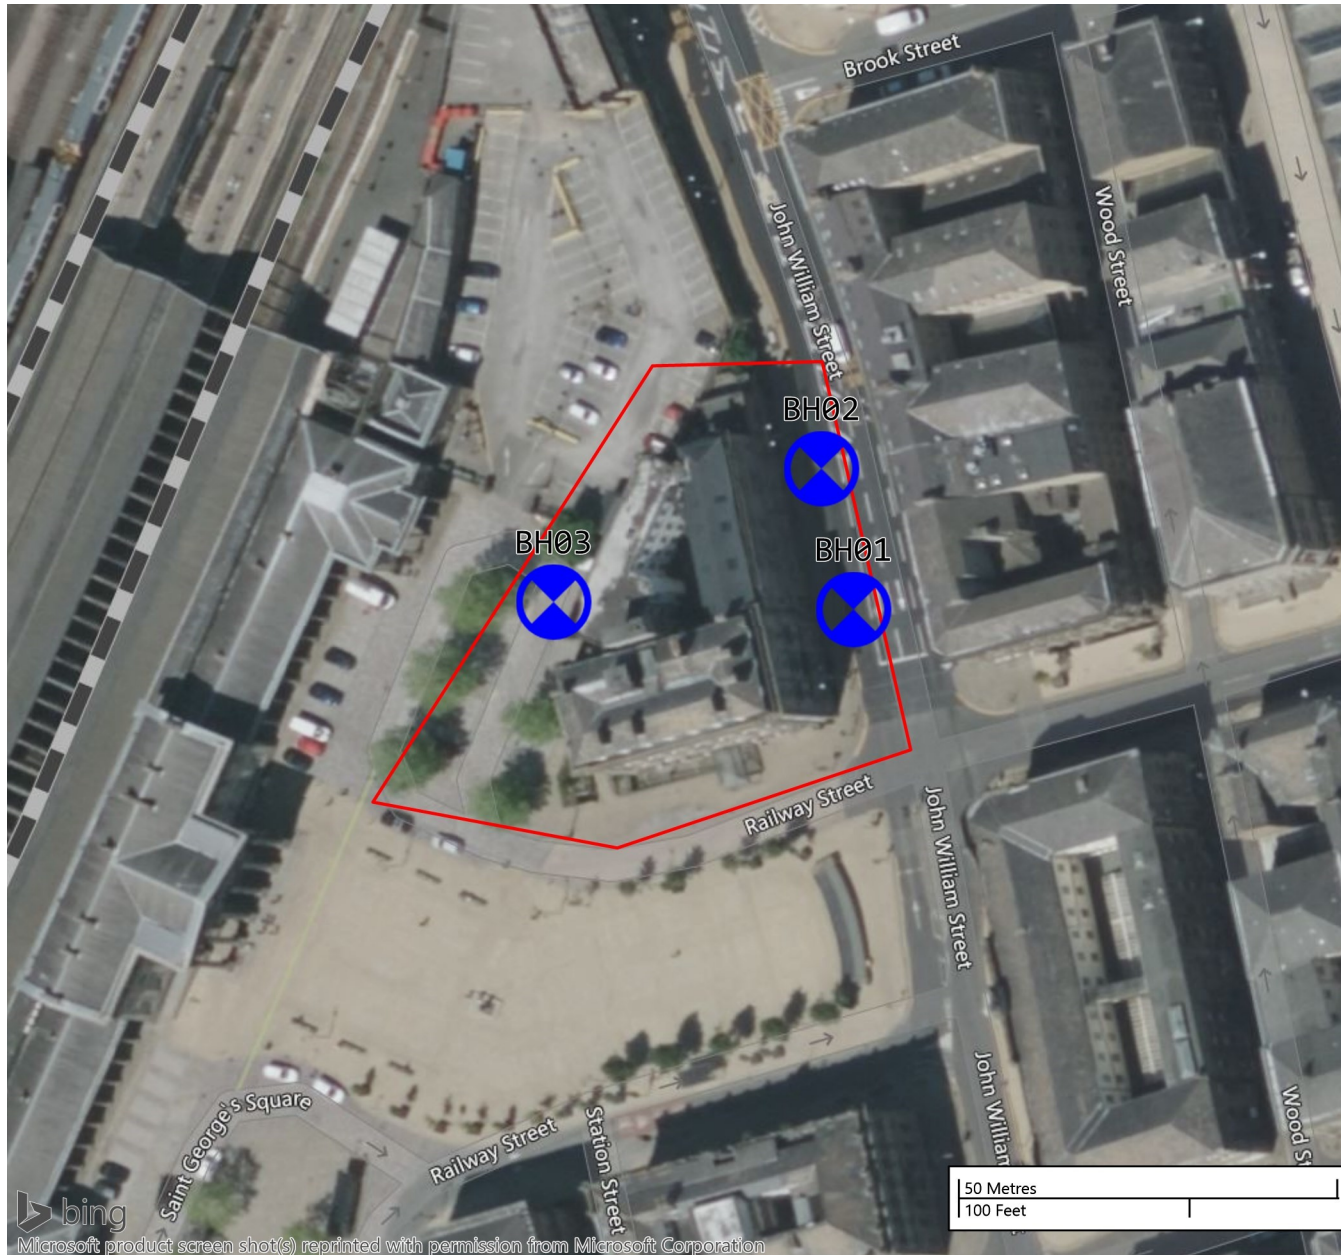
Figure Title
Exploratory Hole Location Plan
Project Number
S250101
Project Name
George Hotel, Huddersfield
Client
GMI Construction Group PLC
Date
September 2025
DRG Number
Figure 2
Scale
1:1000 @ A4 [DO NOT SCALE]

Descriptions of the strata encountered in the boreholes together with details of sampling and groundwater are presented in Appendix B of this report. A plan showing the location of the boreholes can be found in Appendix A (Figure 2).

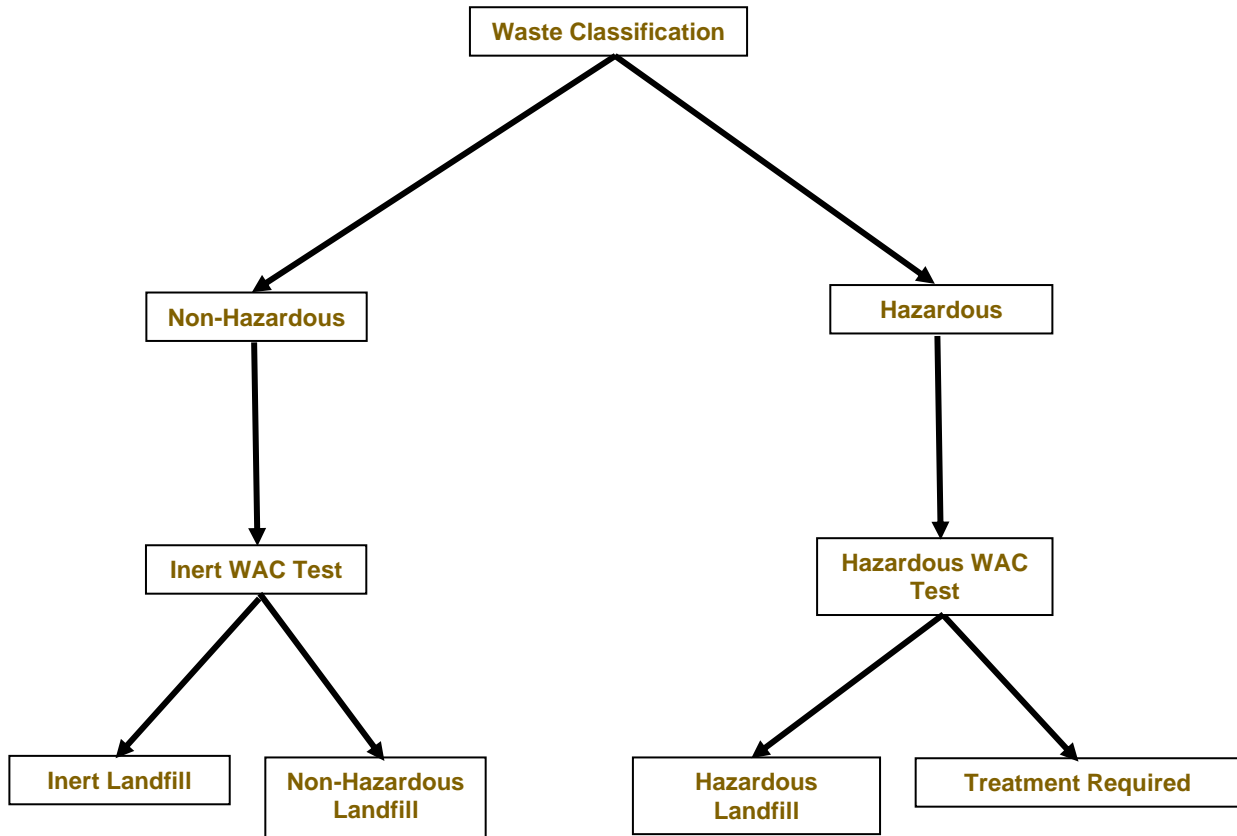
The below flow chart provides further information on the waste classification process.

If waste classification and/or WAC testing are not undertaken, material taken off site may be subject to WAC testing by the appropriate waste disposal company. The decision on whether or not to accept waste, or whether further testing is required, is at the discretion of the waste disposal company.
