South Crosland Barns

Drainage Strategy

October 2025

AMA Project Number: 23484

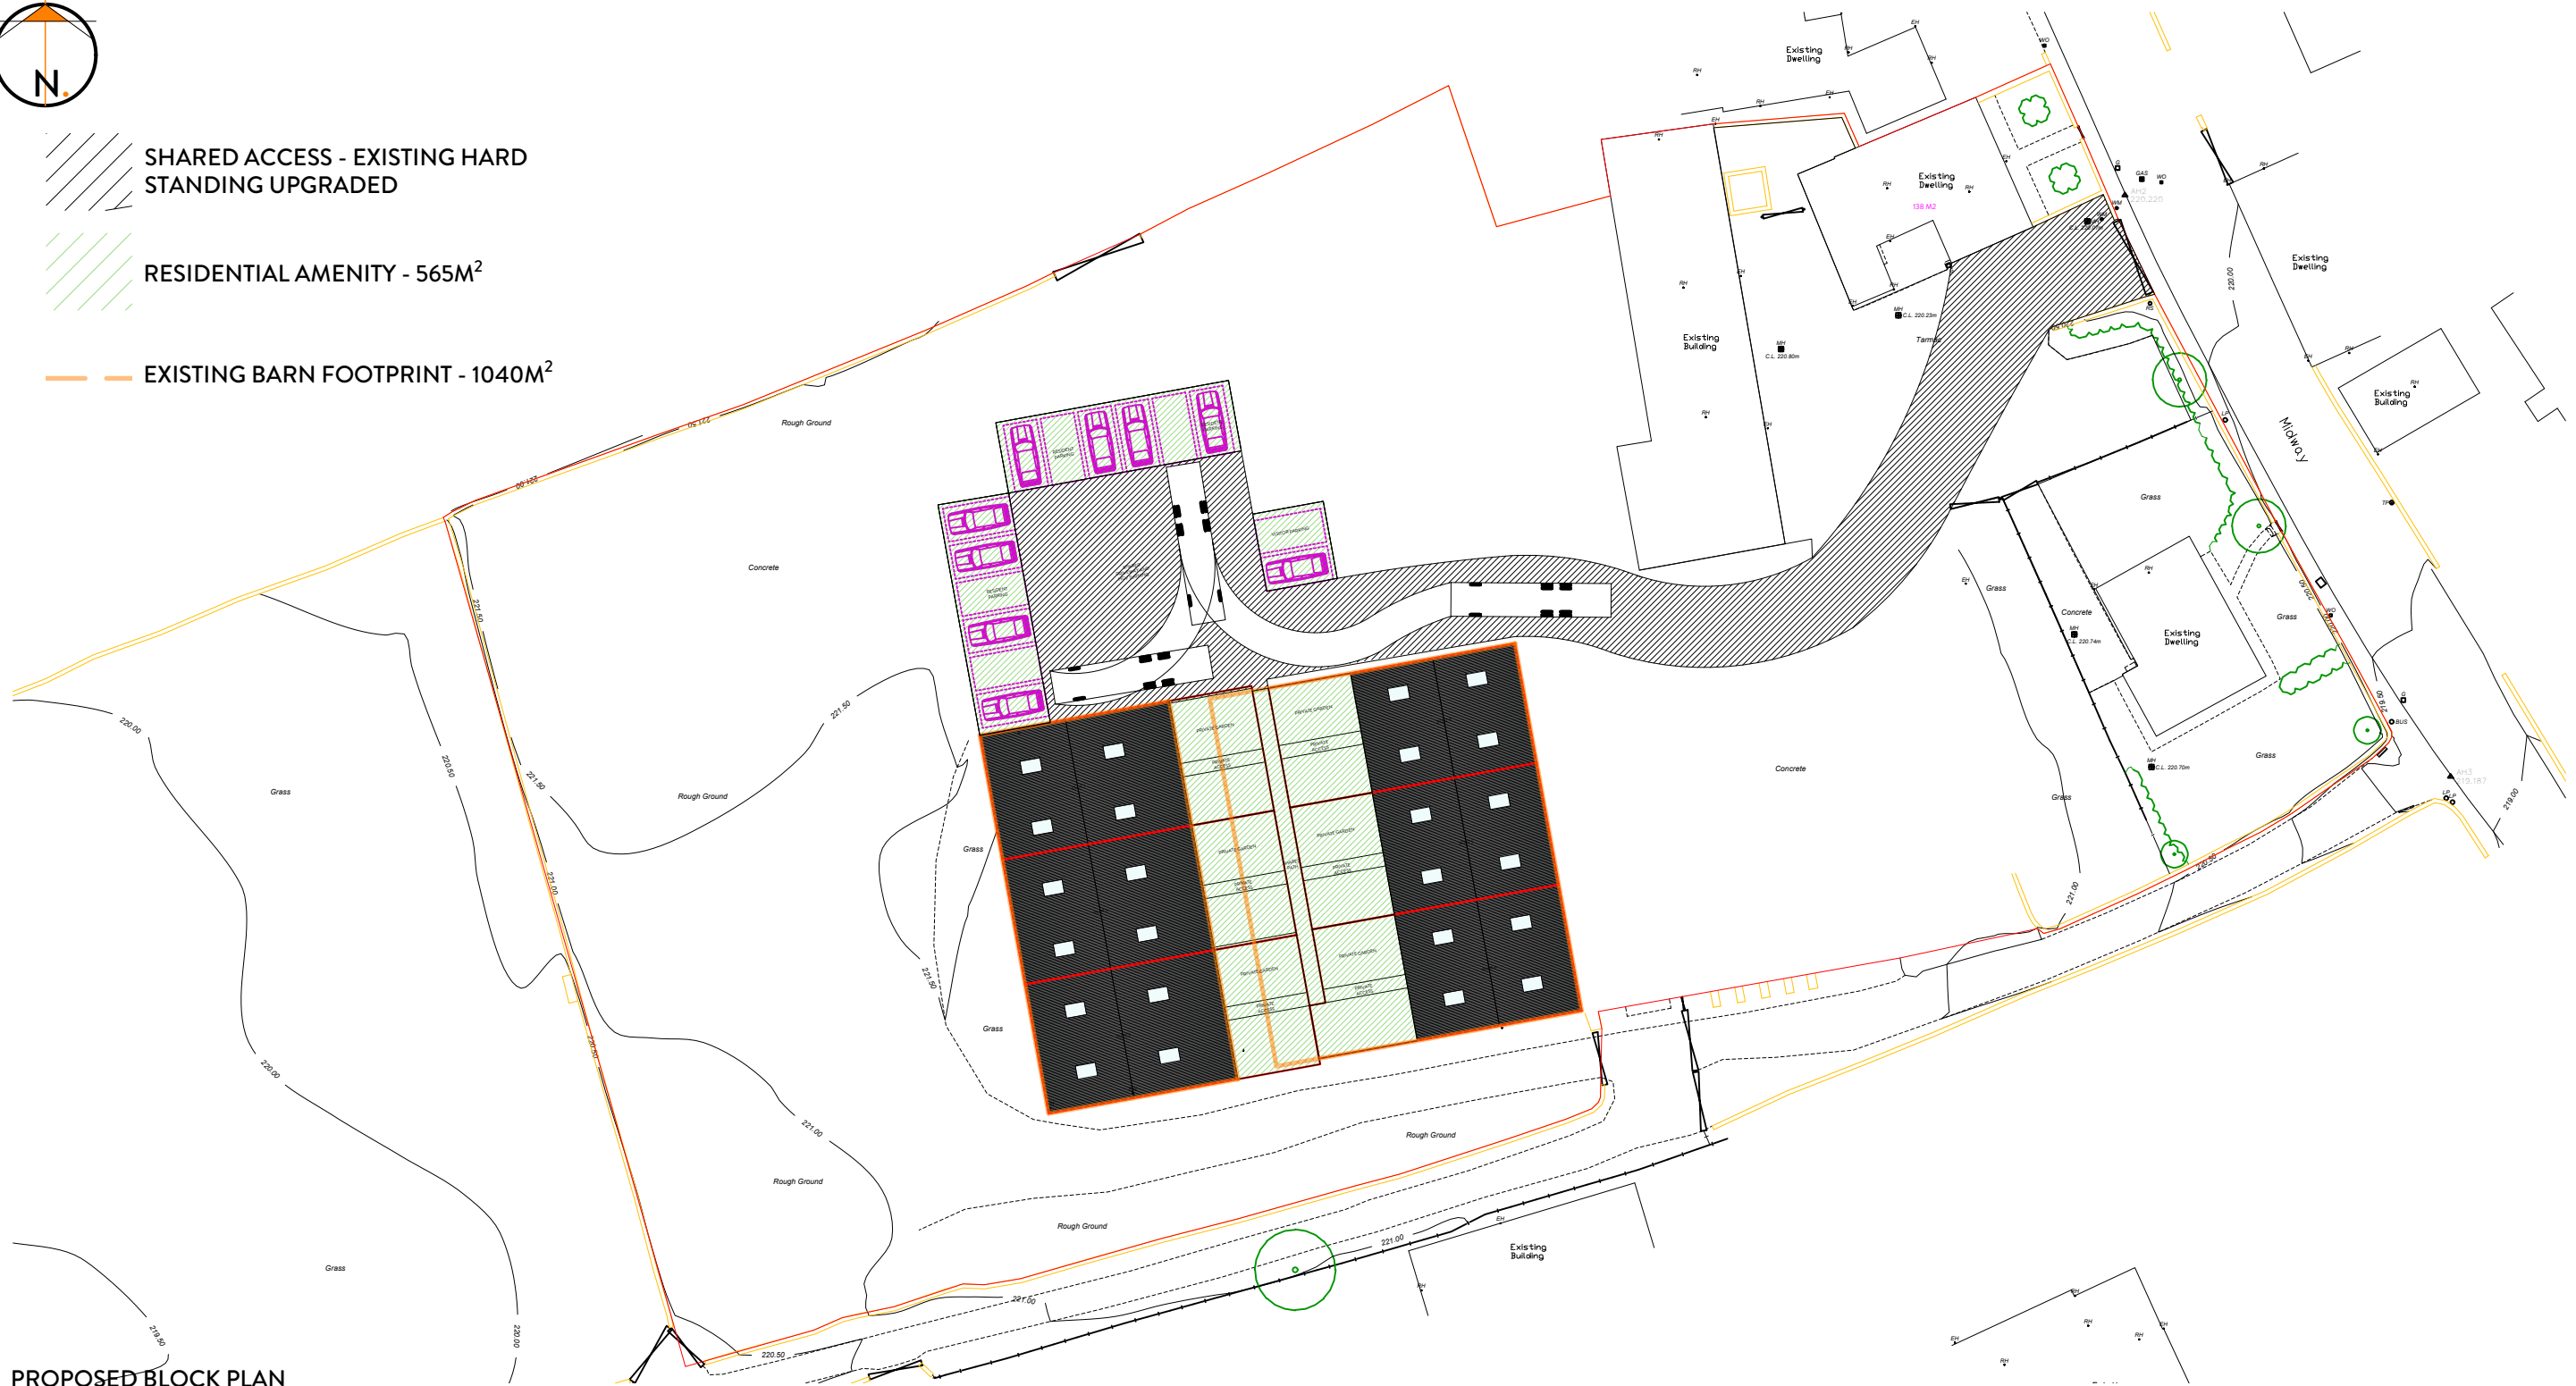
PROPOSED BLOCK PLAN
1:500

- SHARED ACCESS - EXISTING HARD STANDING UPGRADED
- RESIDENTIAL AMENITY - 565M²
- EXISTING BARN FOOTPRINT - 1040M²

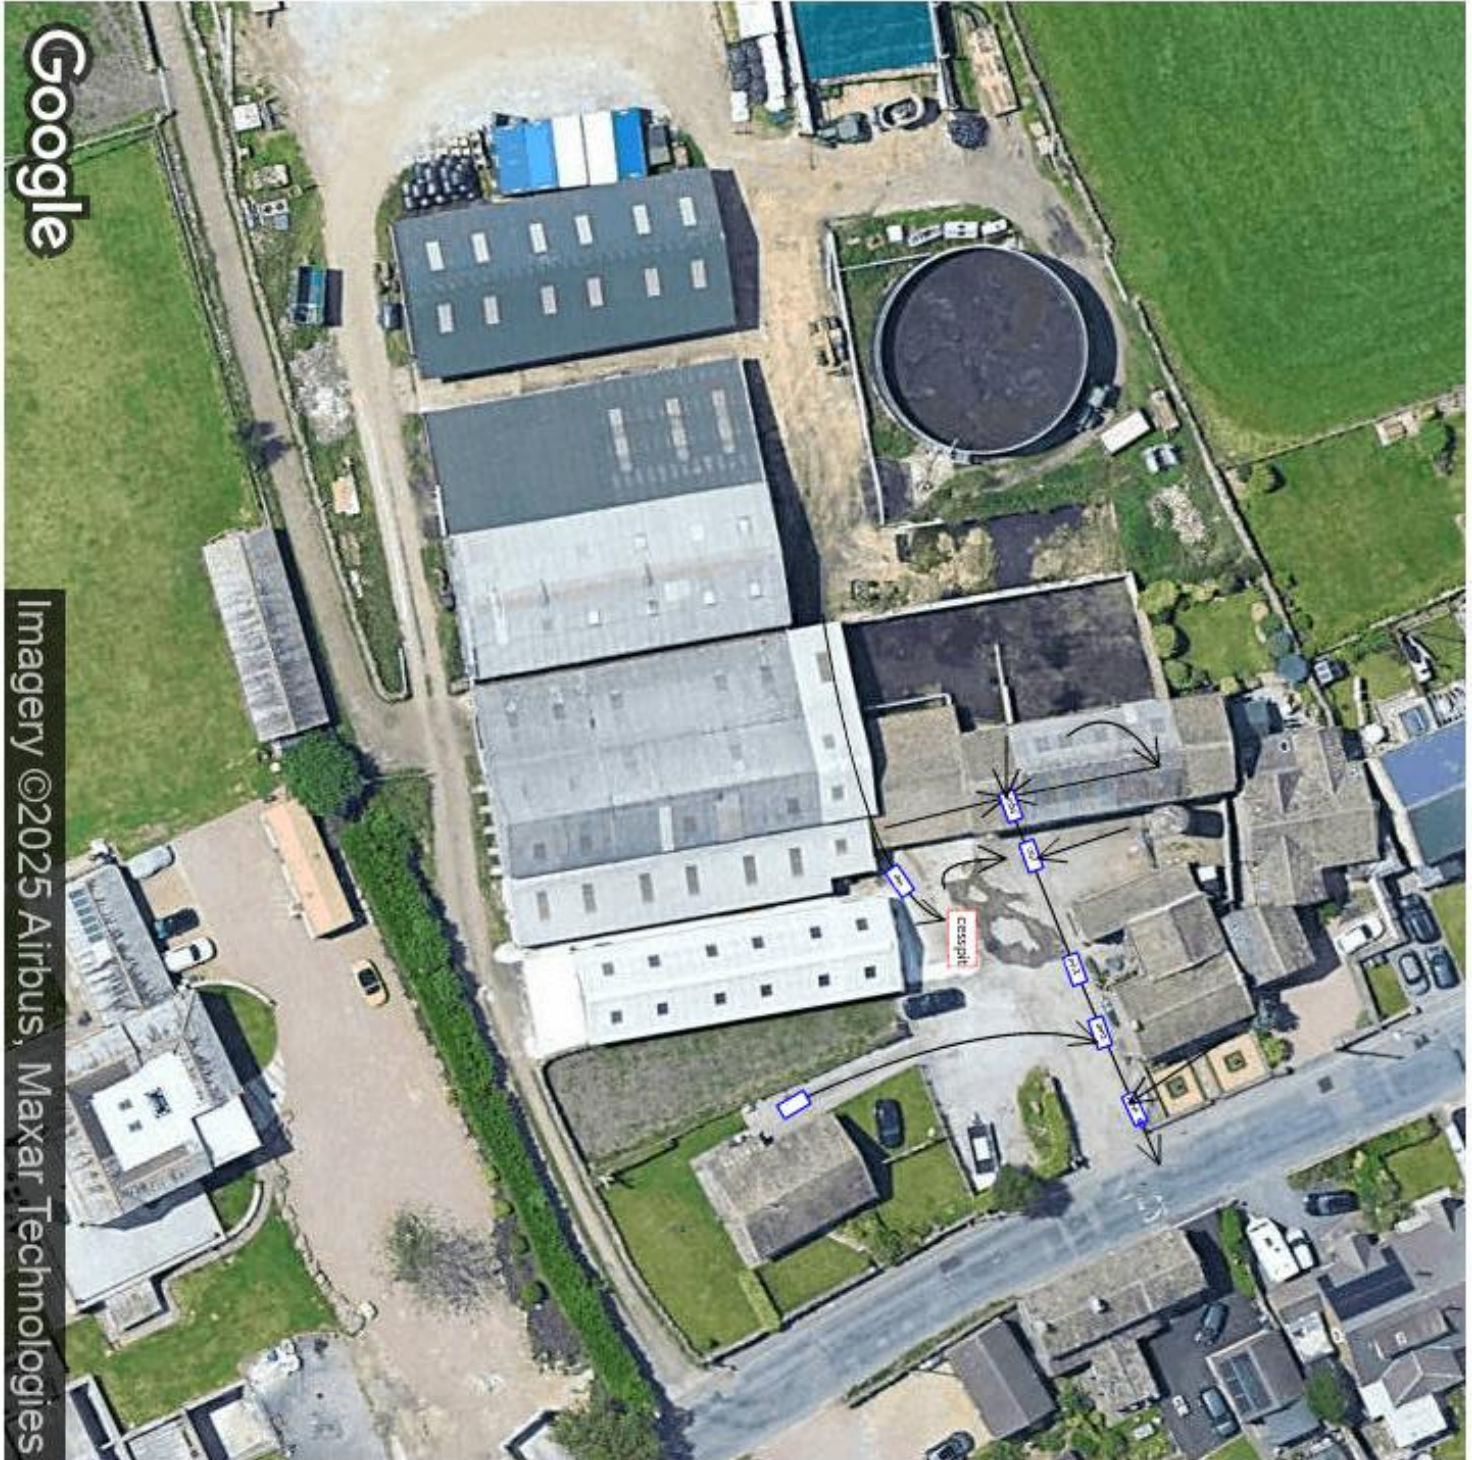
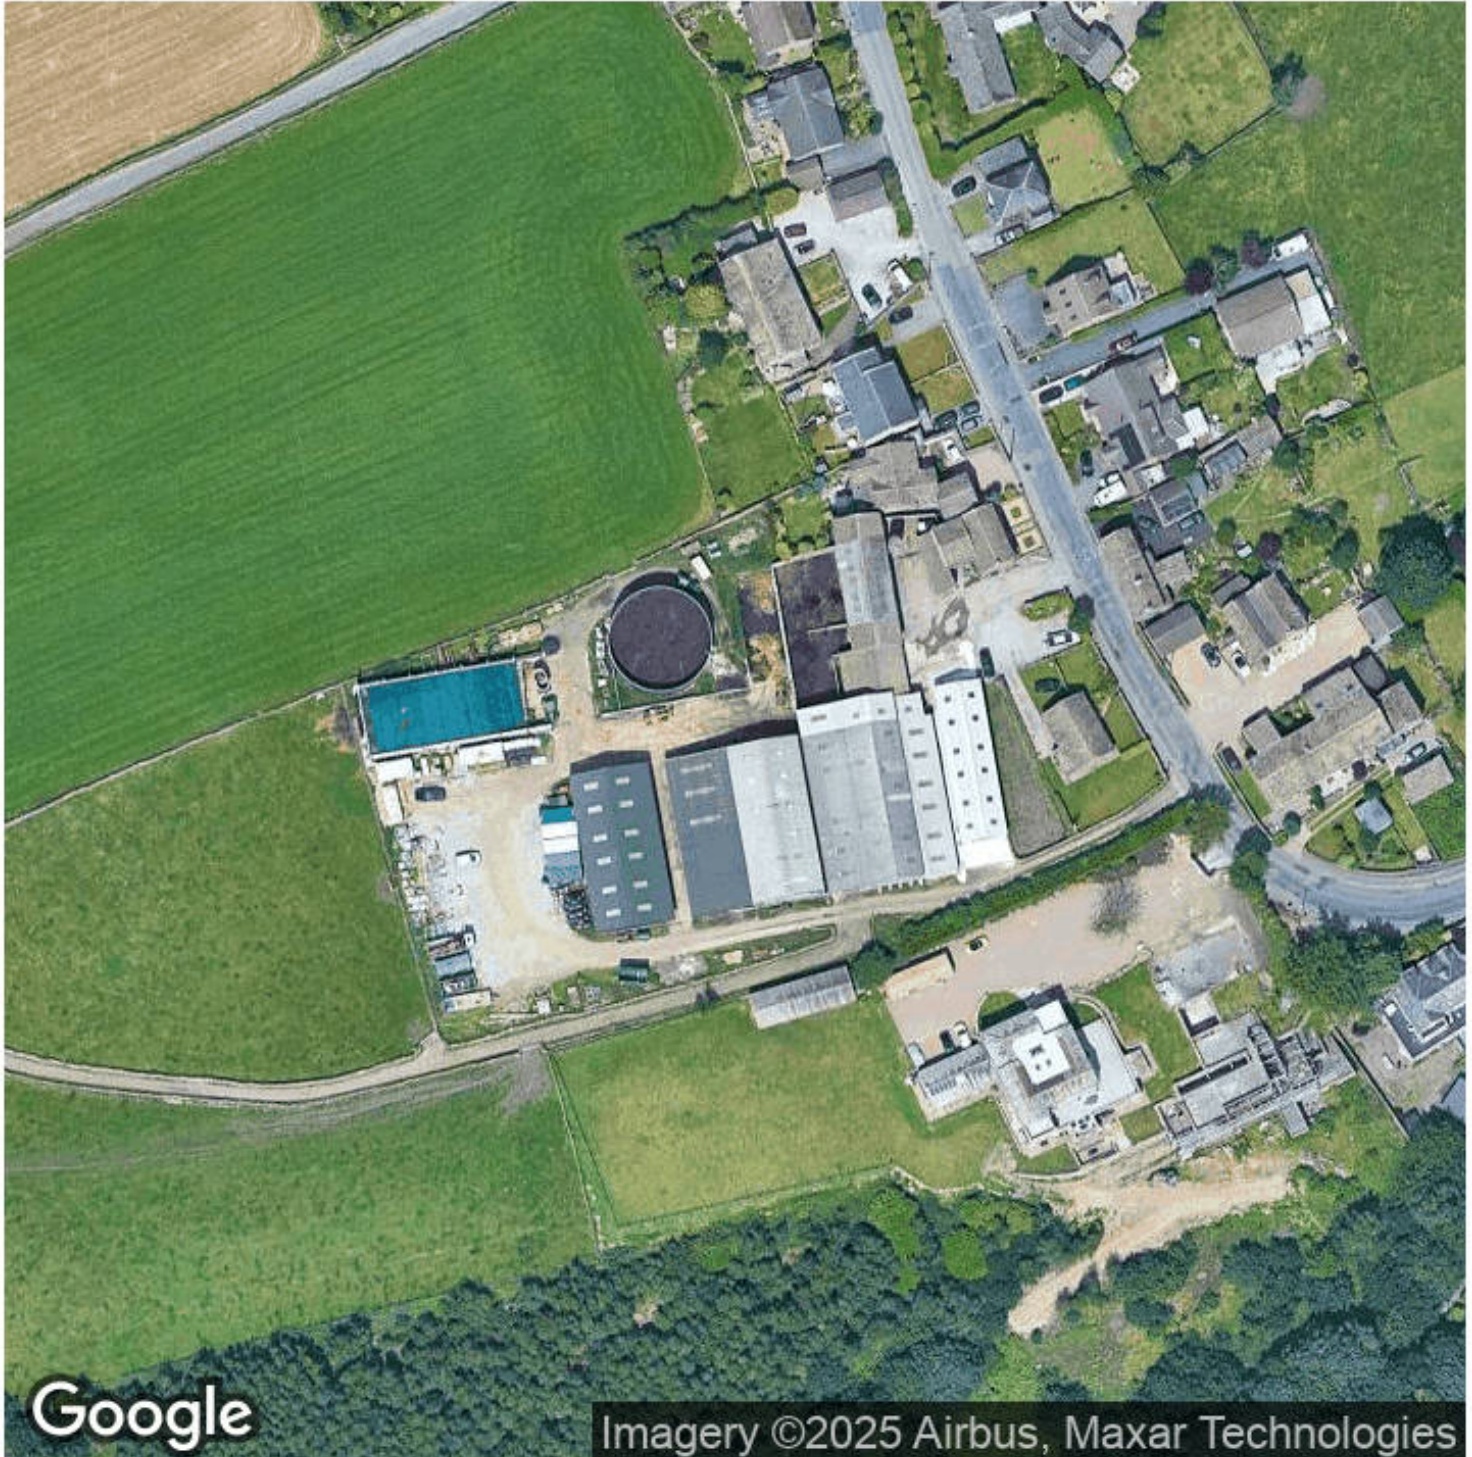
This sketch is not to scale and does not represent the exact routing of the drainage system

WHILST CARRYING OUT THE CCTV OF THE SITE WE FOUND THAT ALL MANHOLES FROM 1 TO 5 ARE FOR THE FOUL SYSTEM, THE DRAINS FROM THE COW SHED GO TO A CESSPIT WHICH IS THEN PUMPED TO A SLURRY TANK.

LINES WHICH ENTER MANHOLE 5 ARE FROM GULLYS WHICH ARE LOCATED IN THE OUT BUILDINGS, WE ALSO NOTED LINE THERE APPEARS TO BE A DISUED DRAIN GOING TO MANHOLE 1.

THE SURVEY HIGHLIGHTED MULTIPLE CRACKS AND DEFECTS WITHIN THE DRAINAGE SYTEM, WE WOULD RECOMEND THAT ALL THE DRAINS ARE REPLACED WITH NEW 150MM PVC PIPE UPSTREAM FROM MANHOLE 4.

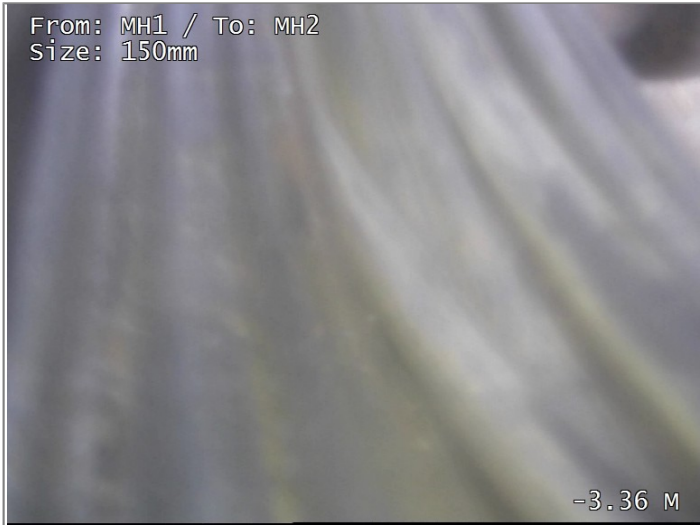
Survey abandoned - Remark: SILT

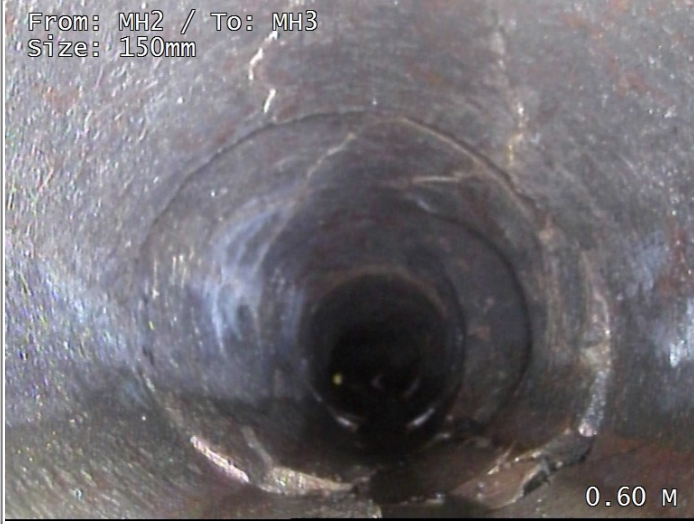
<p>0.60 M</p> <p>Cracks multiple from 12 to 12 o'clock</p>	<p>From: MH2 / To: MH3 Size: 150mm</p>

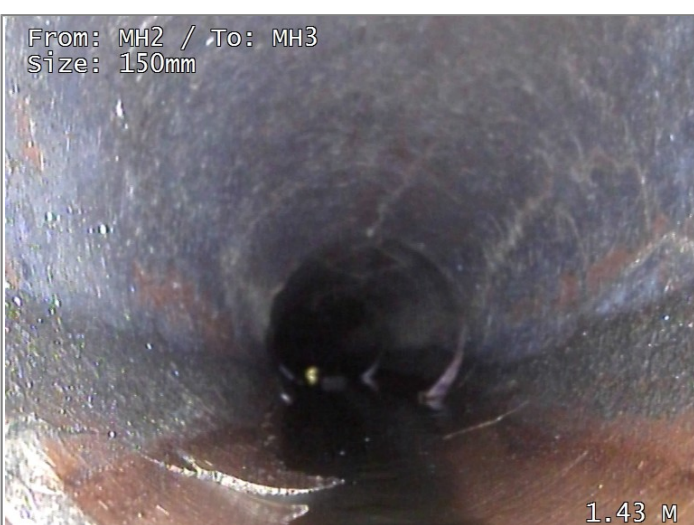
<p>1.43 M</p> <p>Cracks multiple from 12 to 12 o'clock</p>	<p>From: MH2 / To: MH3 Size: 150mm</p>

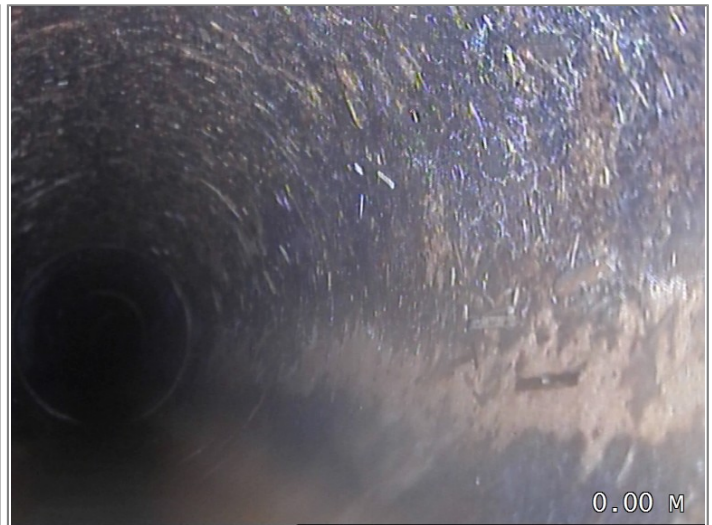
Joint displaced medium

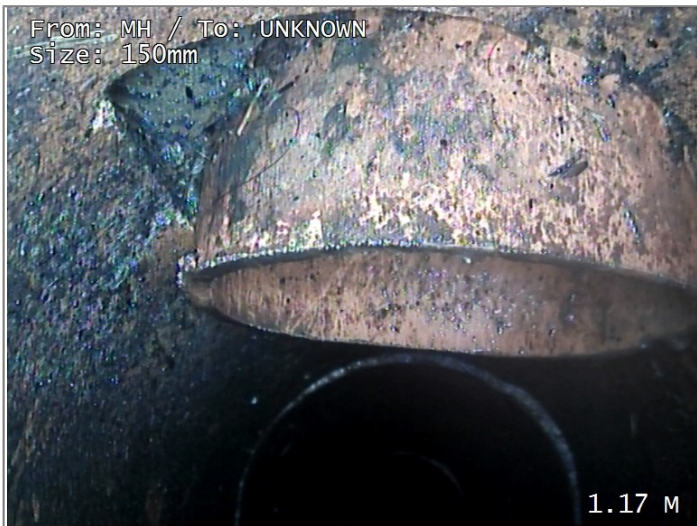
Junction at 12 o'clock, diameter 100mm - Remark: PERTUDING

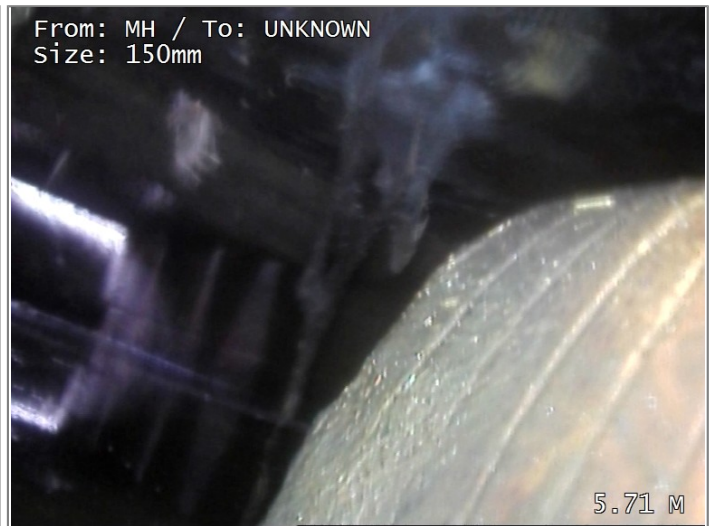
Finish node type, other special chamber, reference CESSPIT WHICH PUMPS TO SLURRY TANK

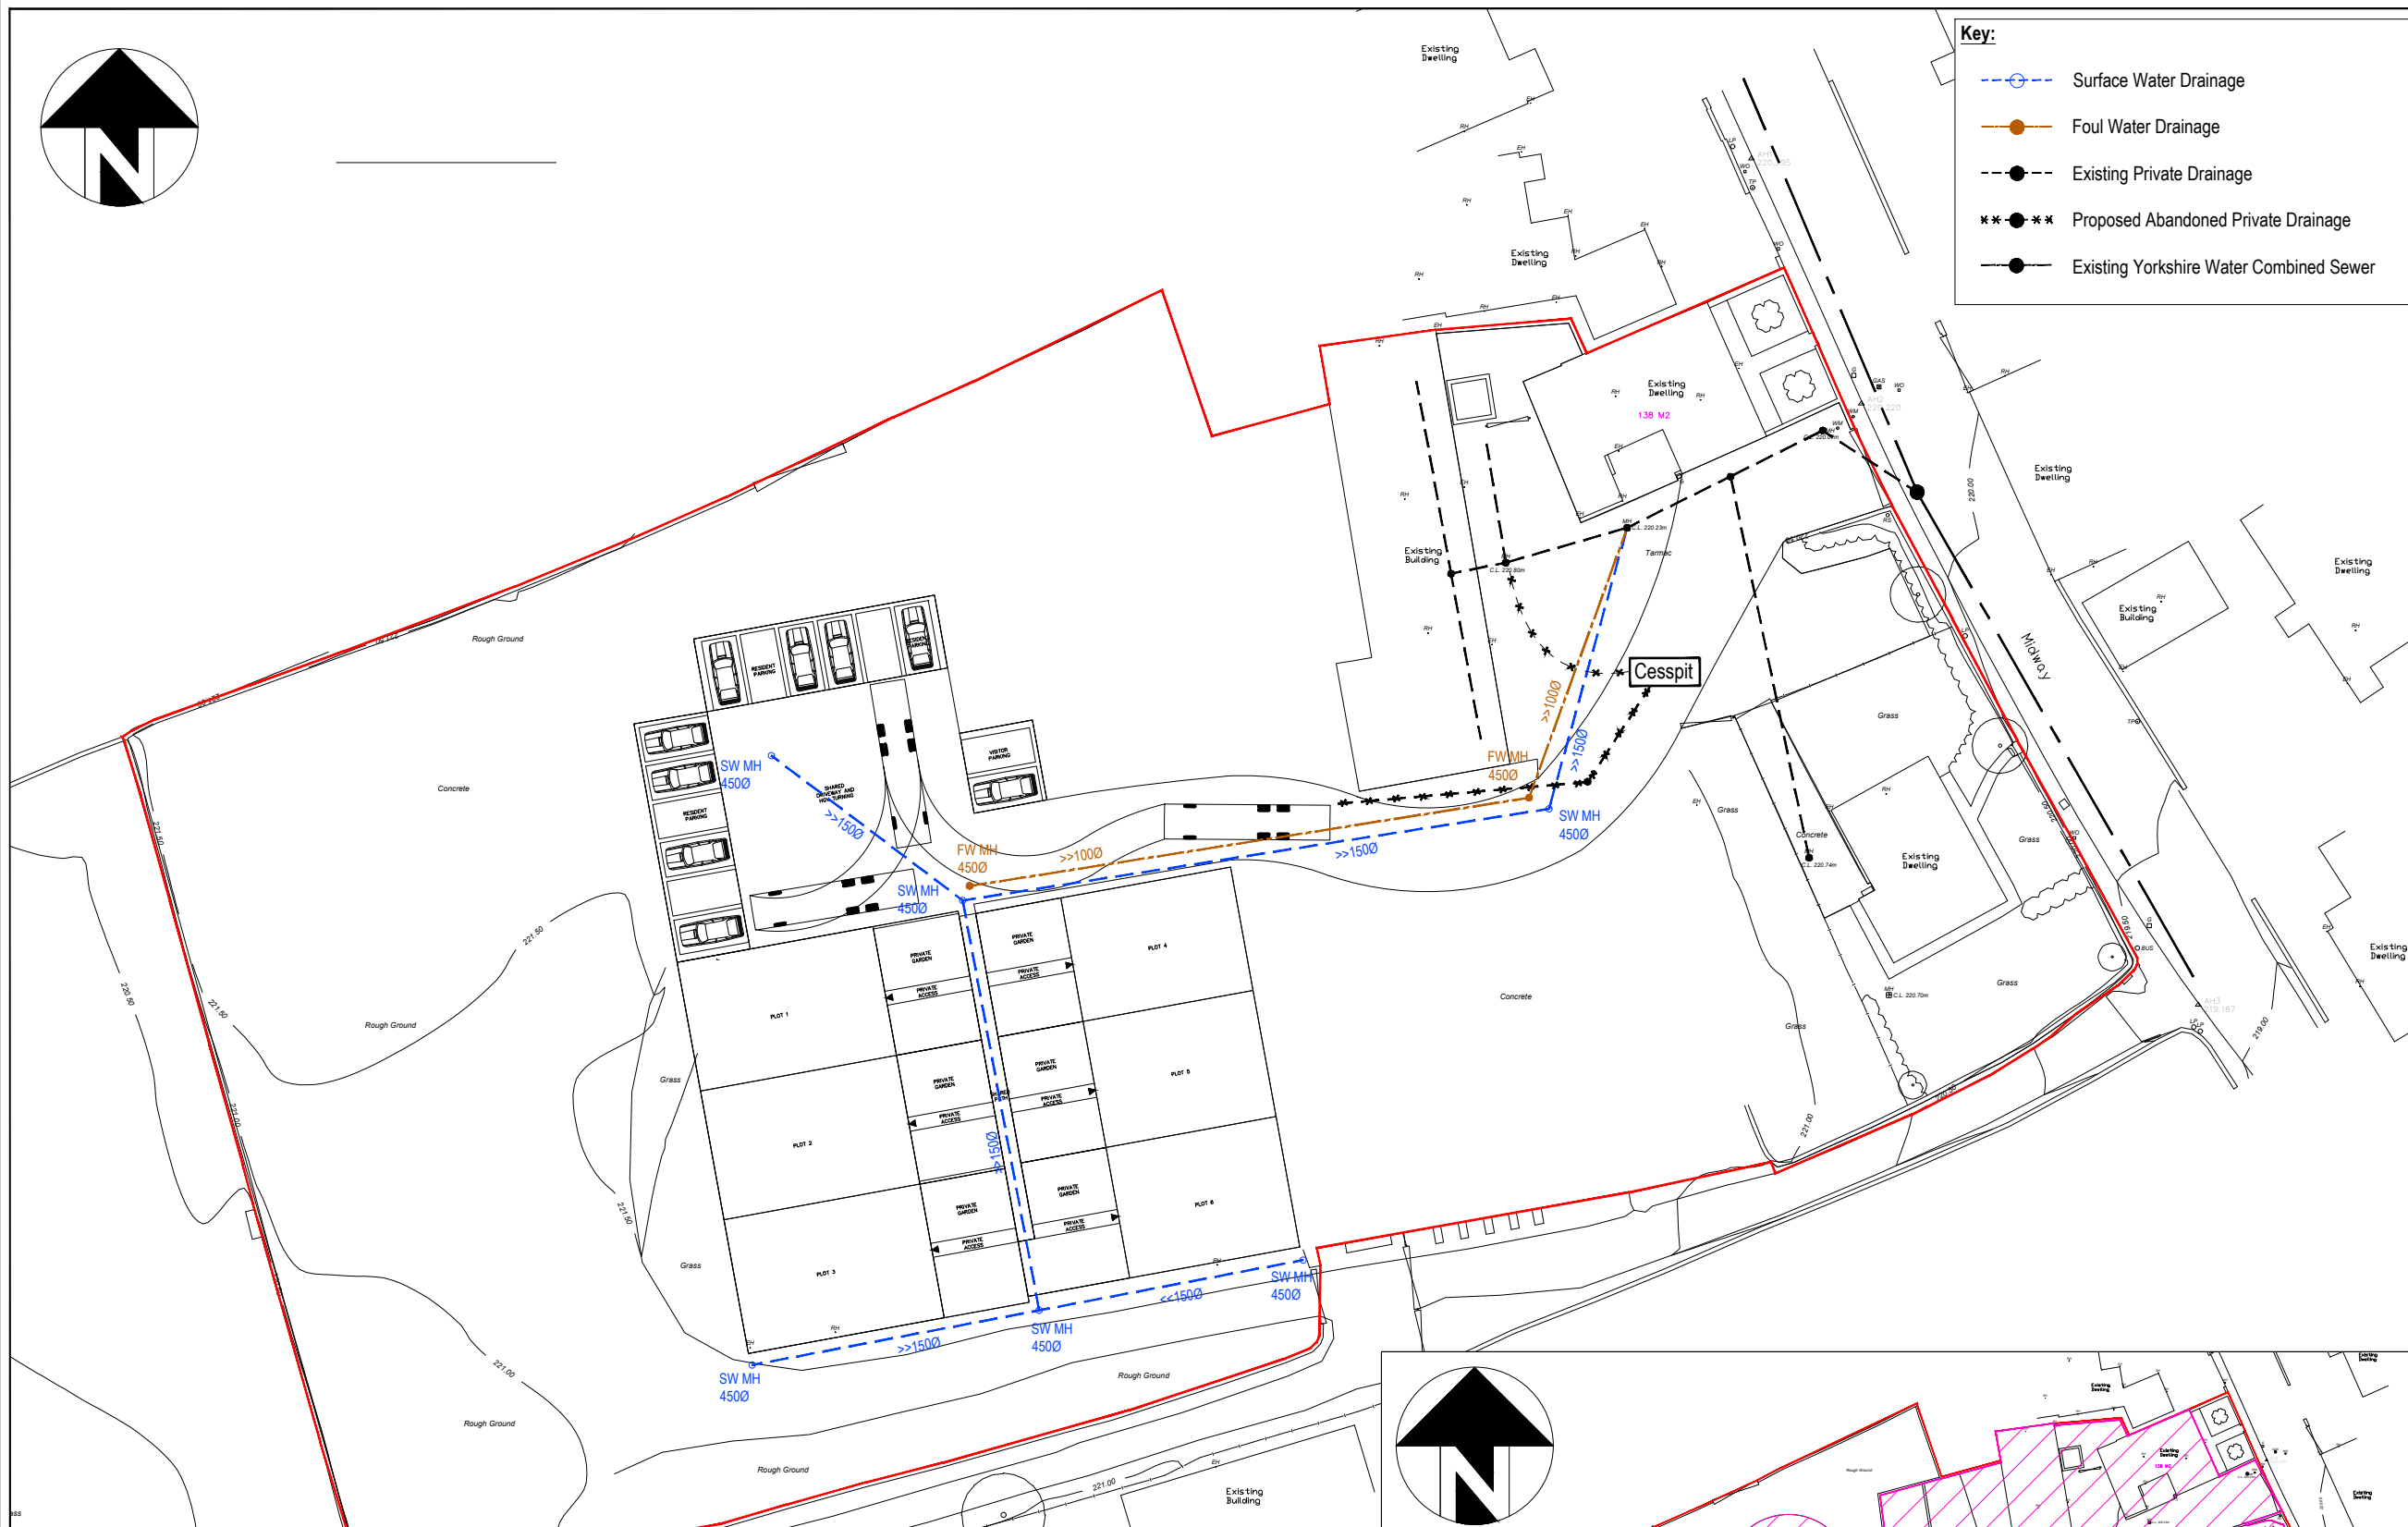
Key:	
	Surface Water Drainage
	Foul Water Drainage
	Existing Private Drainage
	Proposed Abandoned Private Drainage
	Existing Yorkshire Water Combined Sewer

Drainage Strategy:
 The surface water and foul water is to discharge to the Yorkshire Water combined sewer located in Midway via the existing drainage network within the site.

As the impermeable area is not changing, there is no requirement for attenuation within the site.

Notes:
 The pipe sizes and manholes are indicative.
 The cesspit and drainage leading to cesspit is proposed to be removed.

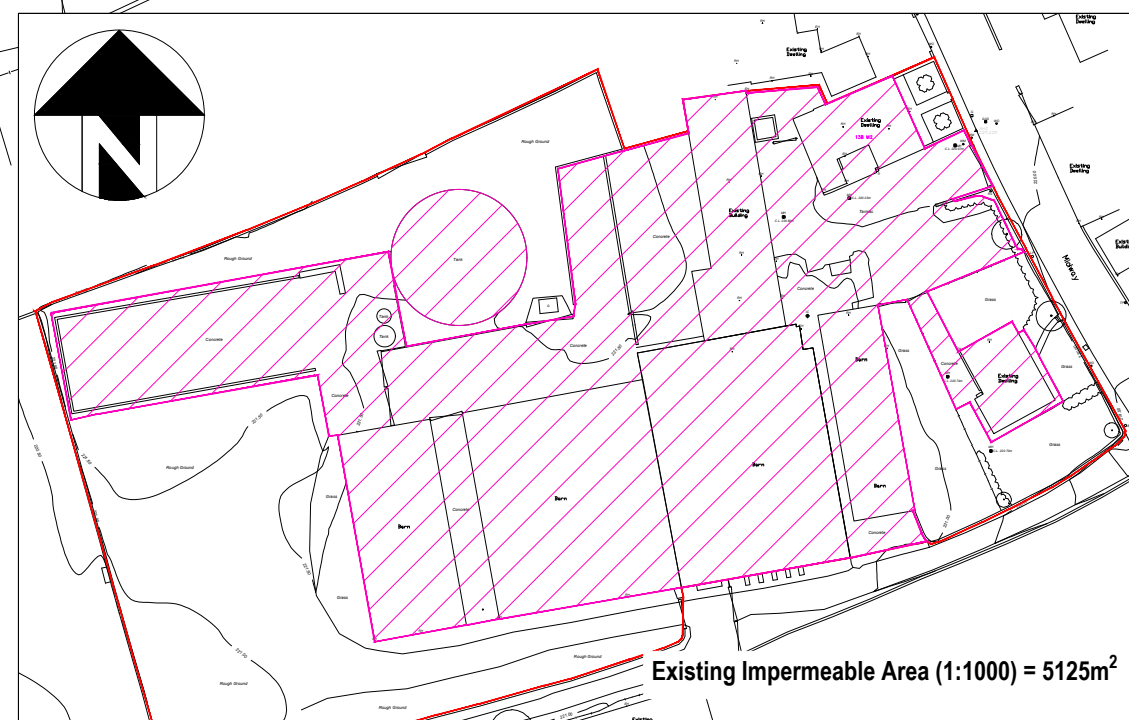
Existing Impermeable Area (1:1000) = 5125m²
