Bat Survey to  
Marsh Lane Farm  
Marsh Lane  
Shepley  
HD8 8BT

15<sup>th</sup> July 2026

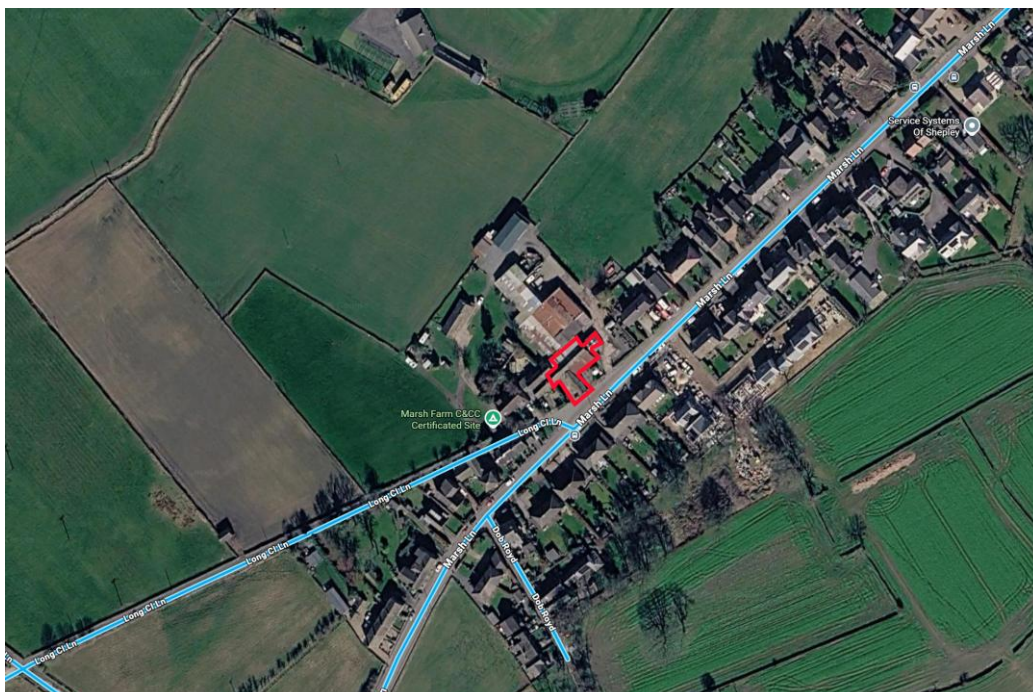
Figure 2 Aerial view of the site, surrounds and buildings surveyed

5.1 The site consists of a large, two-storey barn forming the east end of a row of stone cottages with double pitched roof forming a T-shape. The site is located on Marsh Lane and is close to other residential dwellings but there is very little foraging habitat close to the site and this will significantly affect the number of bats present.

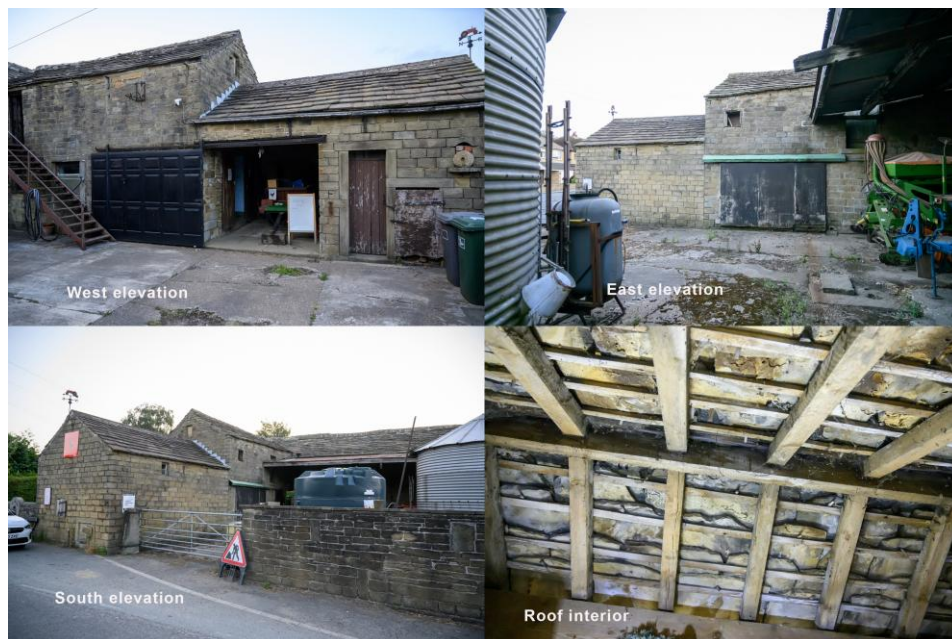
Photo 1: General view of the section of barn running south

There is a large barn running south from the main barn and this is constructed from stone and has a stone roof covering. Generally, the walls are sound and without structural gaps or cavities and there are no external decorative wooden features. The internal roof is unlined, and the roof tiles are easily inspected from the inside. The timbers are modern indicating a reroofing in the past, but this is not recent as the ridges have a build-up of cobwebs and dust. There is no roof lining and there is no light ingress along the ridge. There were no droppings or discarded prey remains on the floor or on any of the stored goods. Although bats could use the ridge sections, they would not be present under tiles except as singletons. There is a single storey extension off the south end of this barn which also has an unlined stone roof but is subjected to consonant light ingress as the doors are left open for the sale of farm produce and closed only at dusk.

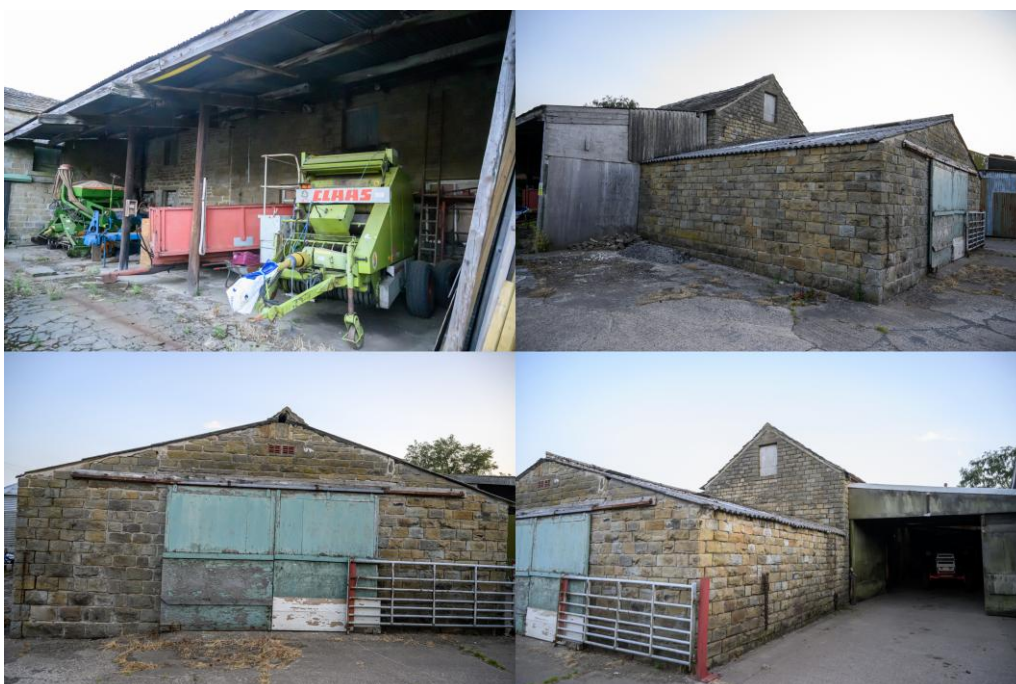
Photo 2. Main barn general views

The main section of barn runs east and extends from the cottage and is built of stone and has an unlined stone roof. This roof is original and has been renewed only on the extreme east end but remains unlined. The ridge section is very heavy with cobwebs, and the floor shows no evidence of use by bats. Any droppings or discarded prey remains would be evident on the floor or stored goods but there appears to be no use by ridge dwelling species. The walls are sound and have only minor bits of missing mortar externally and at dusk, torchlight reveals them to be shallow and simply the result of frost damage to mortar. On both the north and south elevations of this barn, there are lean-to extensions built on pole timbers and having a metal corrugated roof. The east gable has a solid dry verge that offers no gaps. Again, the unlined roof limits use by bats to small numbers or individual bats beneath tiles rather than a nursery roost. There is no evidence of a feeding perch or any other accumulations of droppings. A single storey extension is tagged onto the southern elevation, but this has a single thickness corrugated sheet roof with translucent panels and is of negligible interest to bats.

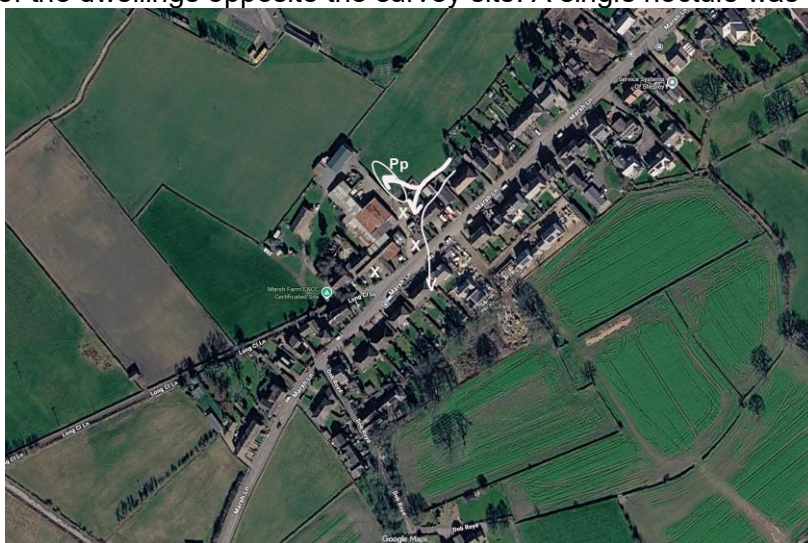
Figure 3: Location surveyors and areas of bat activity and flight direction.

An emergence survey was carried out on the same evening as the scoping survey and conditions were favourable with temperatures of 20°C and no wind and high humidity. Sunset was recorded at 21:29. The first bat detected was a common pipistrelle at 21:47 and this was clearly seen flying into the survey site from the east and the time confirms that it would have emerged from residential dwellings to the east of the site. At 22:05, a second bat came into the site from the same direction, and this continued for the next 40 minutes or so with low numbers of bats feeding around the east and north side of the survey site. No bats were recorded along the west edge of the barn. Only small numbers of bats were noted with two being the maximum at any one time. An hour after sunset, bats were almost absent from the site with some heading east and only two flying south over Marsh Lane towards trees to rear of the dwellings opposite the survey site. A single noctule was recorded over the site.
