## Phase 2 Intrusive Site Investigation Report

<b>LOCATION</b>	Oxford Road, Gomersal, BD19 4JS
<b>ISSUE DATE</b>	May 2026
<b>FOR</b>	Angela Swift (Gomersal) Ltd
<b>CLIENT REF.</b>	
<b>OUR REF.</b>	G26117

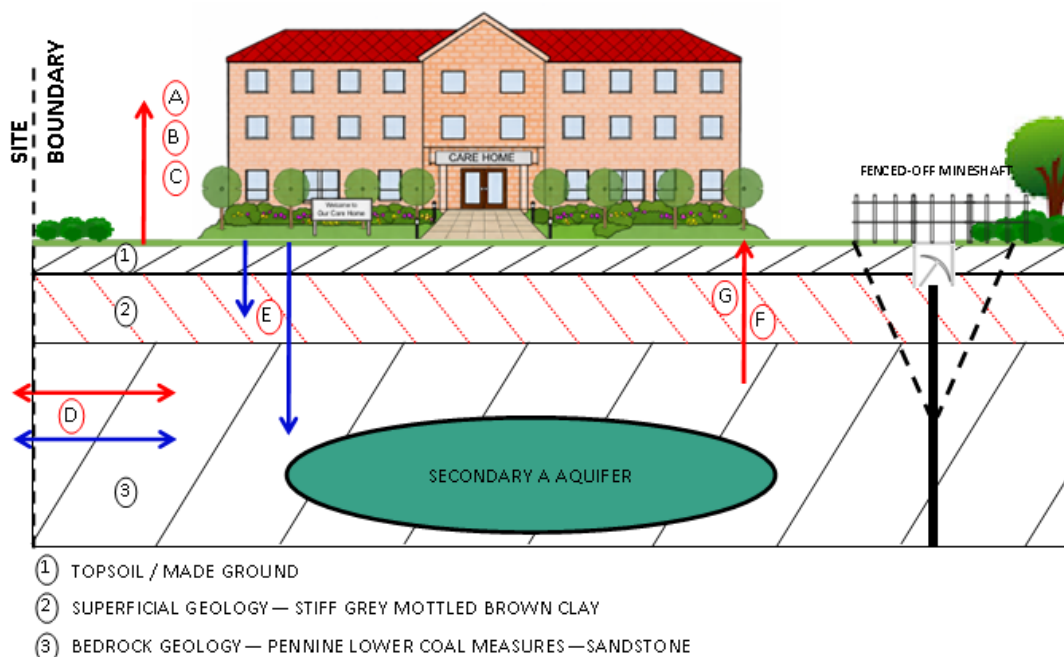
Figure 1: CGHM – Conceptual cross section of site including a Source, Pathway and Receptor Model

The conceptual ground hazard model (CGHM) presented on the following page shows the potential hazards and pollutant linkages which have been considered at the site and those which may still be complete, or would be complete, if the site were to be developed as a residential unit in its current condition.

**IDENTIFIED HAZARDS Including Potential CONTAMINATION SOURCES**

- Potential contamination of shallow soils by past land use both within and near to the site.
- Possible presence of limited made ground.
- Stability concerns relating to the onsite mineshaft. **Mitigated by fencing and site management**
- Potential mine gas risk due to onsite mineshaft.

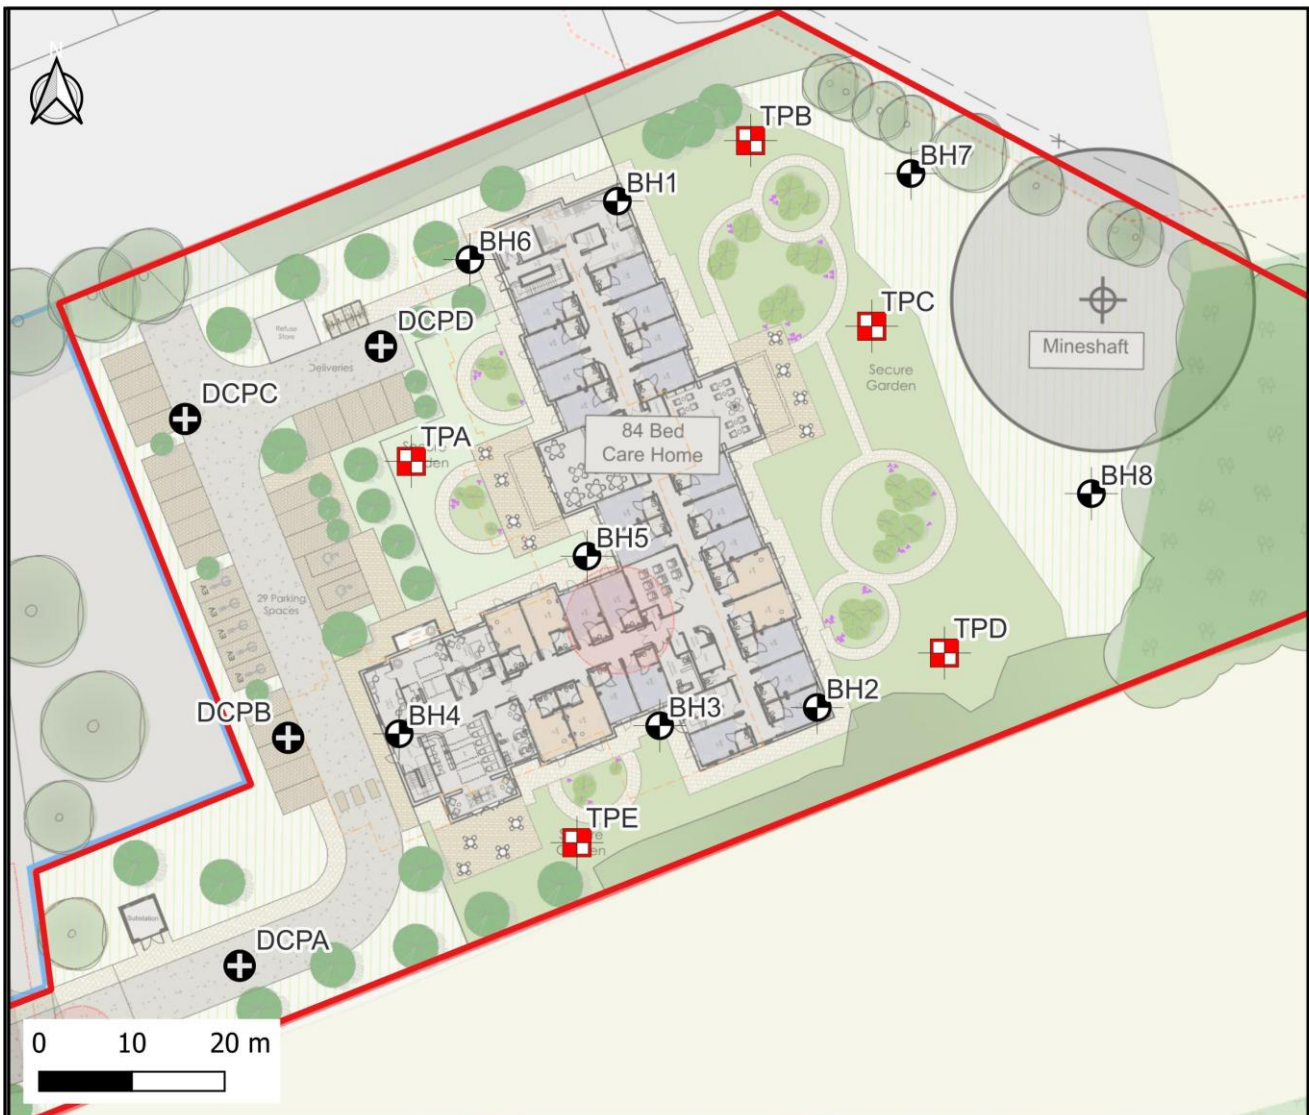
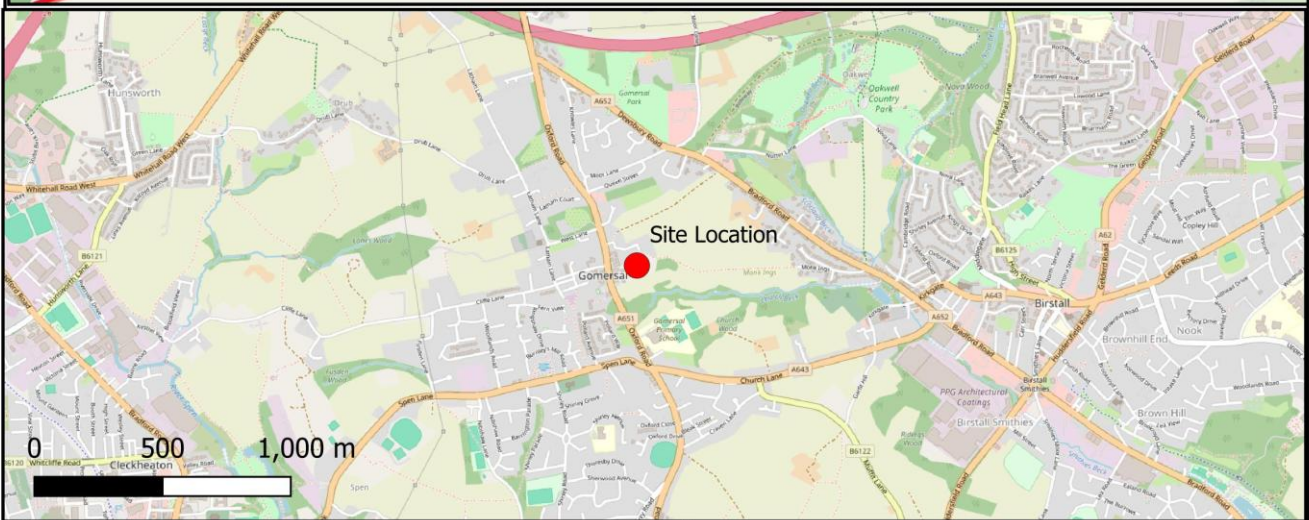
<b>CLIENT</b> A Swift c/o Walter Thompson		<b>TITLE</b> Site Plan		<b>Legend</b> □ Site Boundary ■ Hand Dug Trial Pit ⊕ Window Samples ⊕ DCP Location
<b>PROJECT</b> Oxford Road, Gomersal, BD19 4JS		Notes:		
<b>PROJECT NUMBER</b> G26117		SCALE: NTS	DRAWN: JB DATE: 20/02/26	CHECK: LR DATE: 20/02/26
		REV: 0 DATE: 20/02/26	GeoInvestigate Ltd Terry Dicken Industrial Estate Ellerbeck Way Stokesley TS9 7AE

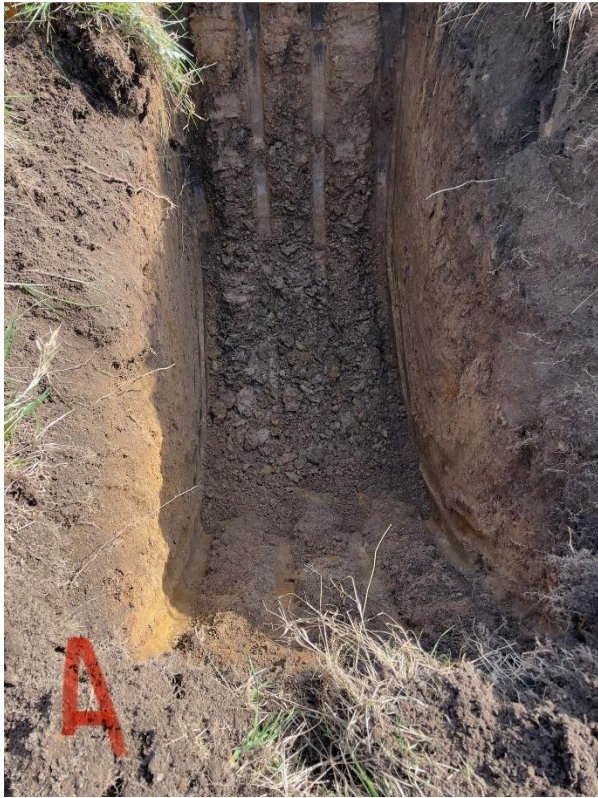
TPA

<b>Client Ref:</b> <b>Our Ref:</b> G26117 <b>Date:</b> 08/04/2026 <b>Location:</b> Oxford Road, Gomersal, BD19 4JS <b>Comments:</b>				<b>TP-A</b> <b>Sheet No 1 of 1</b> <b>Drilled by:</b> AM <b>Logged by:</b> JJ	
Depth (m)	Description of Strata	Thick-ness	Legend	Sample	Test Type Result	Depth to Water	Depth (m)
0.30	TURF and TOPSOIL. Loose dark brown slightly clayey gravelly sand. Gravel is fine to coarse of sandstone.			O	Cv kN/m <sup>2</sup>		0.10 0.20 0.30
1.10	Medium dense light brown sandy slightly clayey GRAVEL. Gravel is fine to coarse of sandstone and mudstone. Occasional cobbles noted.			O  O			0.40 0.50 0.60 0.70 0.80 0.90 1.00 1.10
	Trial Pit terminated at 1.10m.						
<b>Remarks:</b> Trial Pit excavated to a maximum depth of 1.10 mbgl Trial Pit remained dry on completion				<b>Key:</b> O Disturbed sample Cv Shear vane W Water sample			<b>TP-A</b>

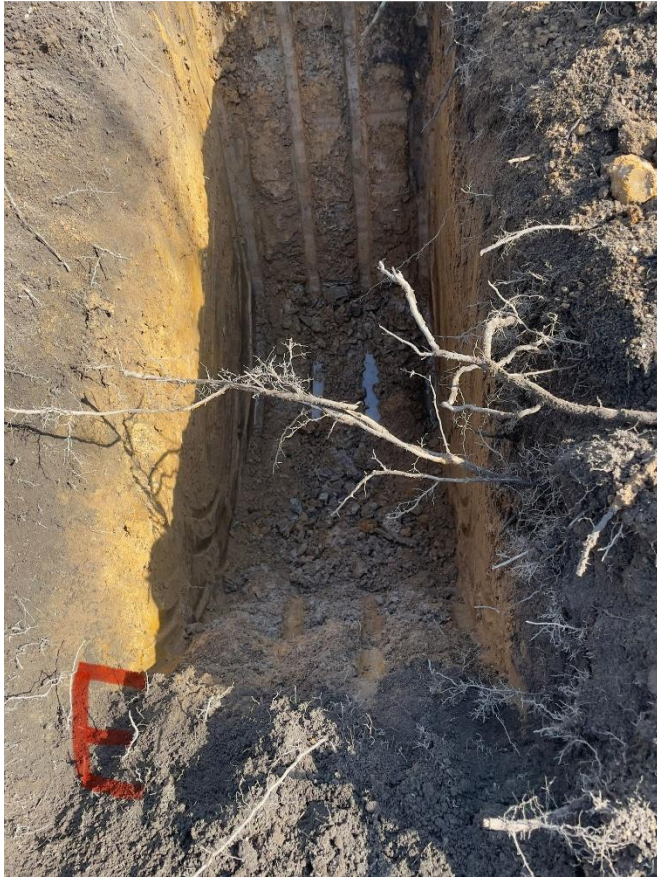
TPE

0.20	TURF and TOPSOIL. Loose dark brown slightly clayey gravelly sand. Gravel is fine to coarse of sandstone.	200		O	Cv kN/m <sup>2</sup>		0.10 0.20
0.80	Medium dense light brown sandy slightly clayey GRAVEL. Gravel is fine to coarse of sandstone and mudstone. Occasional cobbles noted.	600		O			0.30 0.40 0.50 0.60 0.70 0.80

1.20	Weak grey SANDSTONE.	400		O			0.90 1.00 1.10 1.20
	Trial Pit terminated at 1.20m due to refusal.						
<b>Remarks:</b> Trial Pit excavated to a maximum depth of 1.20 mbgl Trial Pit remained dry on completion		<b>Key:</b> O Disturbed sample Cv Shear vane W Water sample		<b>TP - E</b>

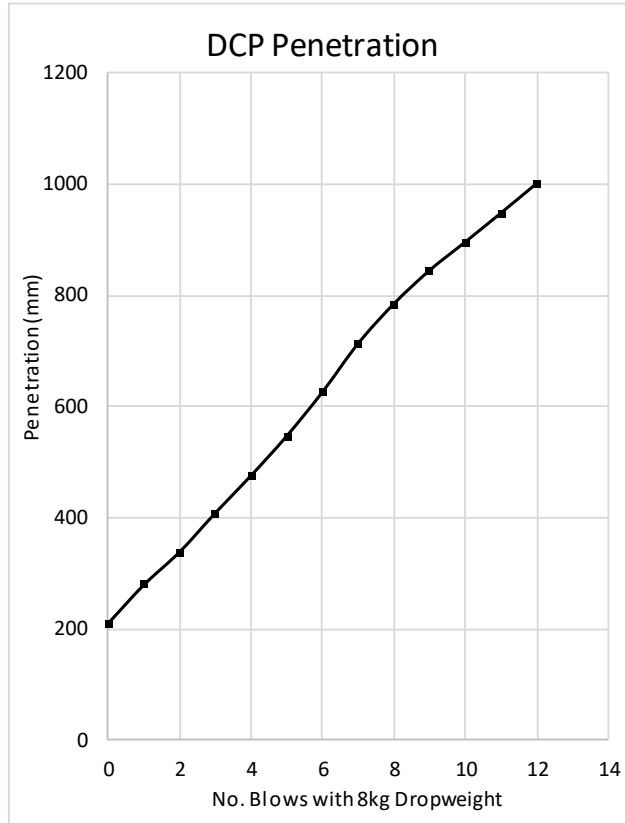
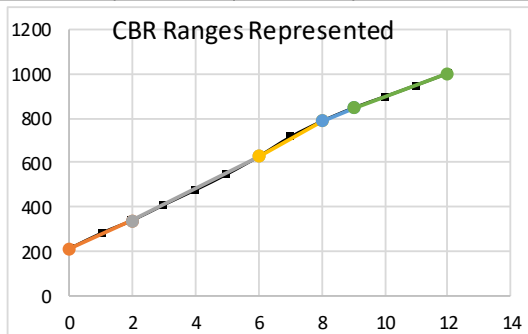
## DCP Test Result

<b>Site</b>	Oxford Road, Gomersal, BD19 4JS	
<b>Job no.</b>	G26117	
<b>Test no.</b>	DCP A	
<b>Date</b>	08/04/2026

Raw DCP Data		
No. blows (8kg Weight)	Cumulative Blows	Penetration (mm)
0	0	211
1	1	280
1	2	339
1	3	409
1	4	476
1	5	547
1	6	626
1	7	713
1	8	784
1	9	844
1	10	895
1	11	947
1	12	1000

Start Point: 211 mm Below Ground Level

Range (blows)	Start (blows)	End (blows)
0-2	0	2
2-6	2	6
6-8	6	8
8-9	8	9
9-12	9	12

Start (depth)	End (depth)	mm per blow	Log <sub>10</sub> (CBR)
211	339	64.0	0.57087
339	626	71.8	0.51840
626	784	79.0	0.47421
784	844	60.0	0.60049
844	1000	52.0	0.66618

Depth (mm)	CBR Value (%)
211-339	3.7
339-626	3.3
626-784	3.0
784-844	4.0
844-1000	4.6

Therefore, a CBR value of 2.5% for natural material would be a reasonable, conservative value to use for design purposes, but it should be noted that wet or winter weather and site trafficking may detrimentally affect the CBR rating of the soil once works are commenced, and CBR values may vary seasonally and with moisture content.

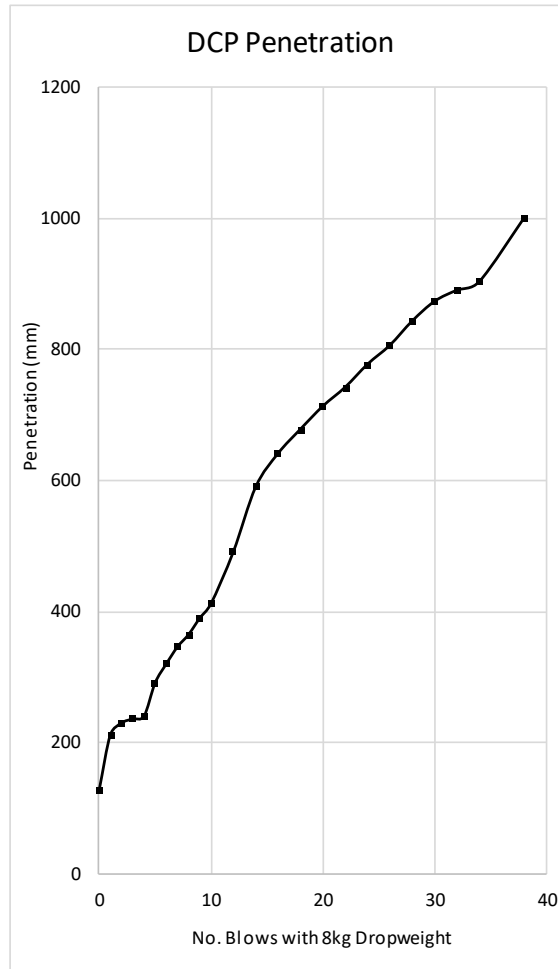
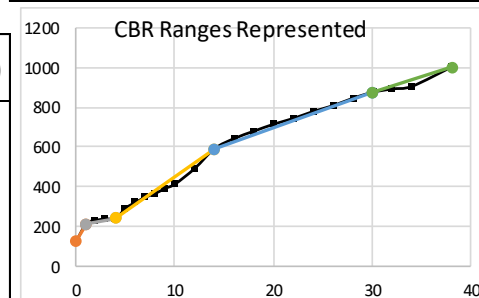
## DCP Test Result

Raw DCP Data		
No. blows (8kg Weight)	Cumulative Blows	Penetration (mm)
0	0	128
1	1	212
1	2	230
1	3	236
1	4	240
1	5	291
1	6	320
1	7	346
1	8	365
1	9	390
1	10	412
2	12	491
2	14	590
2	16	641
2	18	678
2	20	713
2	22	742
2	24	777
2	26	806
2	28	843
2	30	873
2	32	890
2	34	903
4	38	1000

Range (blows)	Start (blows)	End (blows)
0-1	0	1
1-4	1	4
4-14	4	14
14-30	14	30
30-38	30	38

Start (depth)	End (depth)	mm per blow	Log <sub>10</sub> (CBR)
128	212	84.0	0.44604
212	240	9.3	1.45467
240	590	35.0	0.84792
590	873	17.7	1.16122
873	1000	15.9	1.21085

Depth (mm)	CBR Value (%)
<b>128-212</b>	<b>2.8</b>
<b>212-240</b>	<b>28.5</b>
<b>240-590</b>	<b>7.0</b>
<b>590-873</b>	<b>14.5</b>
<b>873-1000</b>	<b>16.2</b>

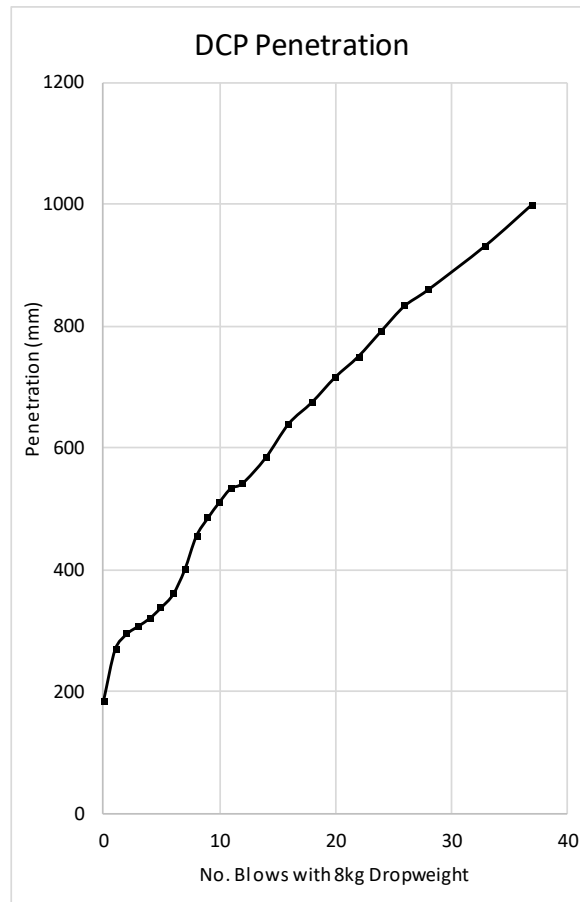
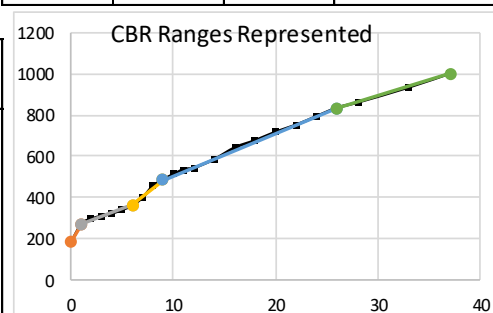
## DCP Test Result

Raw DCP Data		
No. blows (8kg Weight)	Cumulative Blows	Penetration (mm)
0	0	187
1	1	271
1	2	296
1	3	309
1	4	322
1	5	340
1	6	361
1	7	401
1	8	456
1	9	486
1	10	512
1	11	535
1	12	543
2	14	585
2	16	641
2	18	676
2	20	717
2	22	751
2	24	793
2	26	834
2	28	860
5	33	933
4	37	1000

Range (blows)	Start (blows)	End (blows)
0-2	0	1
2-10	1	6
10-16	6	9
15-30	9	26
0-30	26	37

Start (depth)	End (depth)	mm per blow	Log <sub>10</sub> (CBR)
187	271	84.0	0.44604
271	361	18.0	1.15318
361	486	41.7	0.76788
486	834	20.5	1.09414
834	1000	15.1	1.23410

Depth (mm)	CBR Value (%)
<b>187-271</b>	<b>2.8</b>
<b>271-361</b>	<b>14.2</b>
<b>361-486</b>	<b>5.9</b>
<b>486-834</b>	<b>12.4</b>
<b>834-1000</b>	<b>17.1</b>

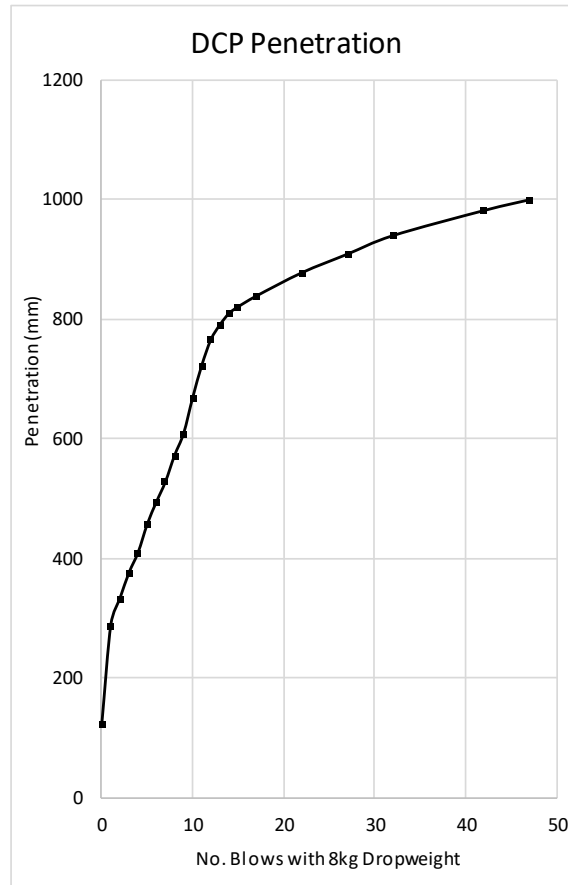
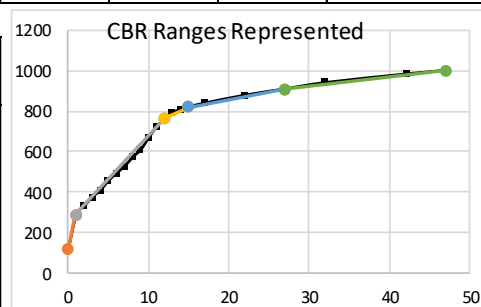
## DCP Test Result

Raw DCP Data		
No. blows (8kg Weight)	Cumulative Blows	Penetration (mm)
0	0	122
1	1	289
1	2	333
1	3	376
1	4	410
1	5	457
1	6	494
1	7	528
1	8	572
1	9	609
1	10	669
1	11	723
1	12	766
1	13	791
1	14	810
1	15	821
2	17	839
5	22	878
5	27	909
5	32	940
10	42	982
5	47	1000

Range (blows)	Start (blows)	End (blows)
0-2	0	1
2-10	1	12
10-16	12	15
15-30	15	27
0-30	27	47

Start (depth)	End (depth)	mm per blow	Log <sub>10</sub> (CBR)
122	289	167.0	0.13059
289	766	43.4	0.74956
766	821	18.3	1.14475
821	909	7.3	1.56538
909	1000	4.6	1.78448

Depth (mm)	CBR Value (%)
122-289	1.4
289-766	5.6
766-821	14.0
821-909	36.8
909-1000	60.9

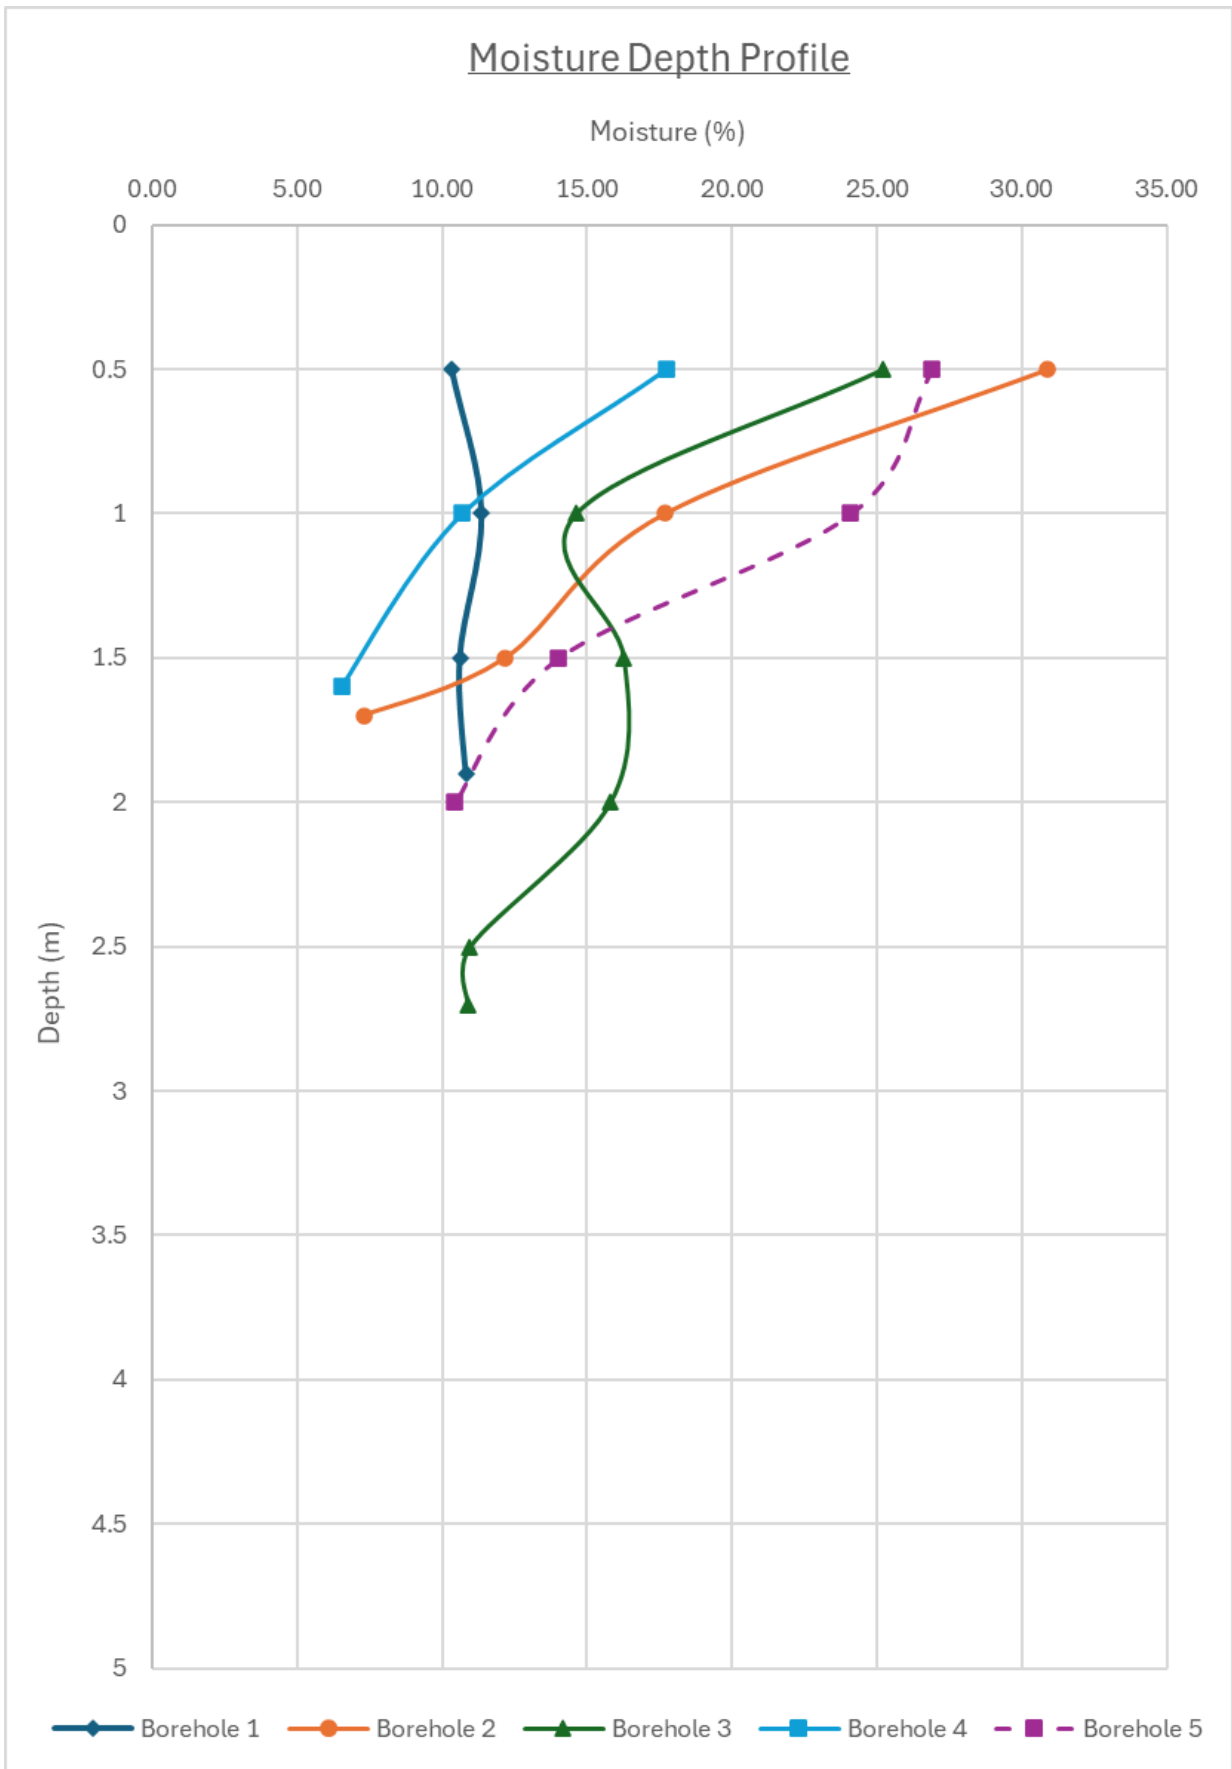
TP / BH No.	Sample Depth (m)	Insitu Moisture Content (%)	% Passing BS 425 Micron Sieve	Corrected Moisture Content (%)	Plastic Limit (%)	Liquid Limit (%)	Plasticity Index (%)	Soil Classification BS5930 [1999]
4	0.50	17.7	87.1	20.3	*	*	*	*
	1.00	10.7						
	1.60	6.5						
5	0.50	26.9	78.4	30.7	*	*	*	*
	1.00	24.1						
	1.50	14.0						
	2.00	10.4

\* Note - Essentially Non Plastic Material

Borehole moisture profiles are presented in Appendix 2. Moisture contents between 3.95% and 24.1% were reported.

Testing returned Plasticity Indices of between 10.1% (BH2) and 10.8% (BH3) which classifies the soils as Clay of Low (CL) and Intermediate (CI) Plasticity, according to BS 5930. According to NHBC Section 4.2 Building Near Trees, the clay soils are noted to be Low to Medium Shrinkage Soils (volume change potential). However, in BH4, BH5, BH6, BH7 and BH8 were deemed too sandy to carry out plasticity testing following initial sieve preparation.

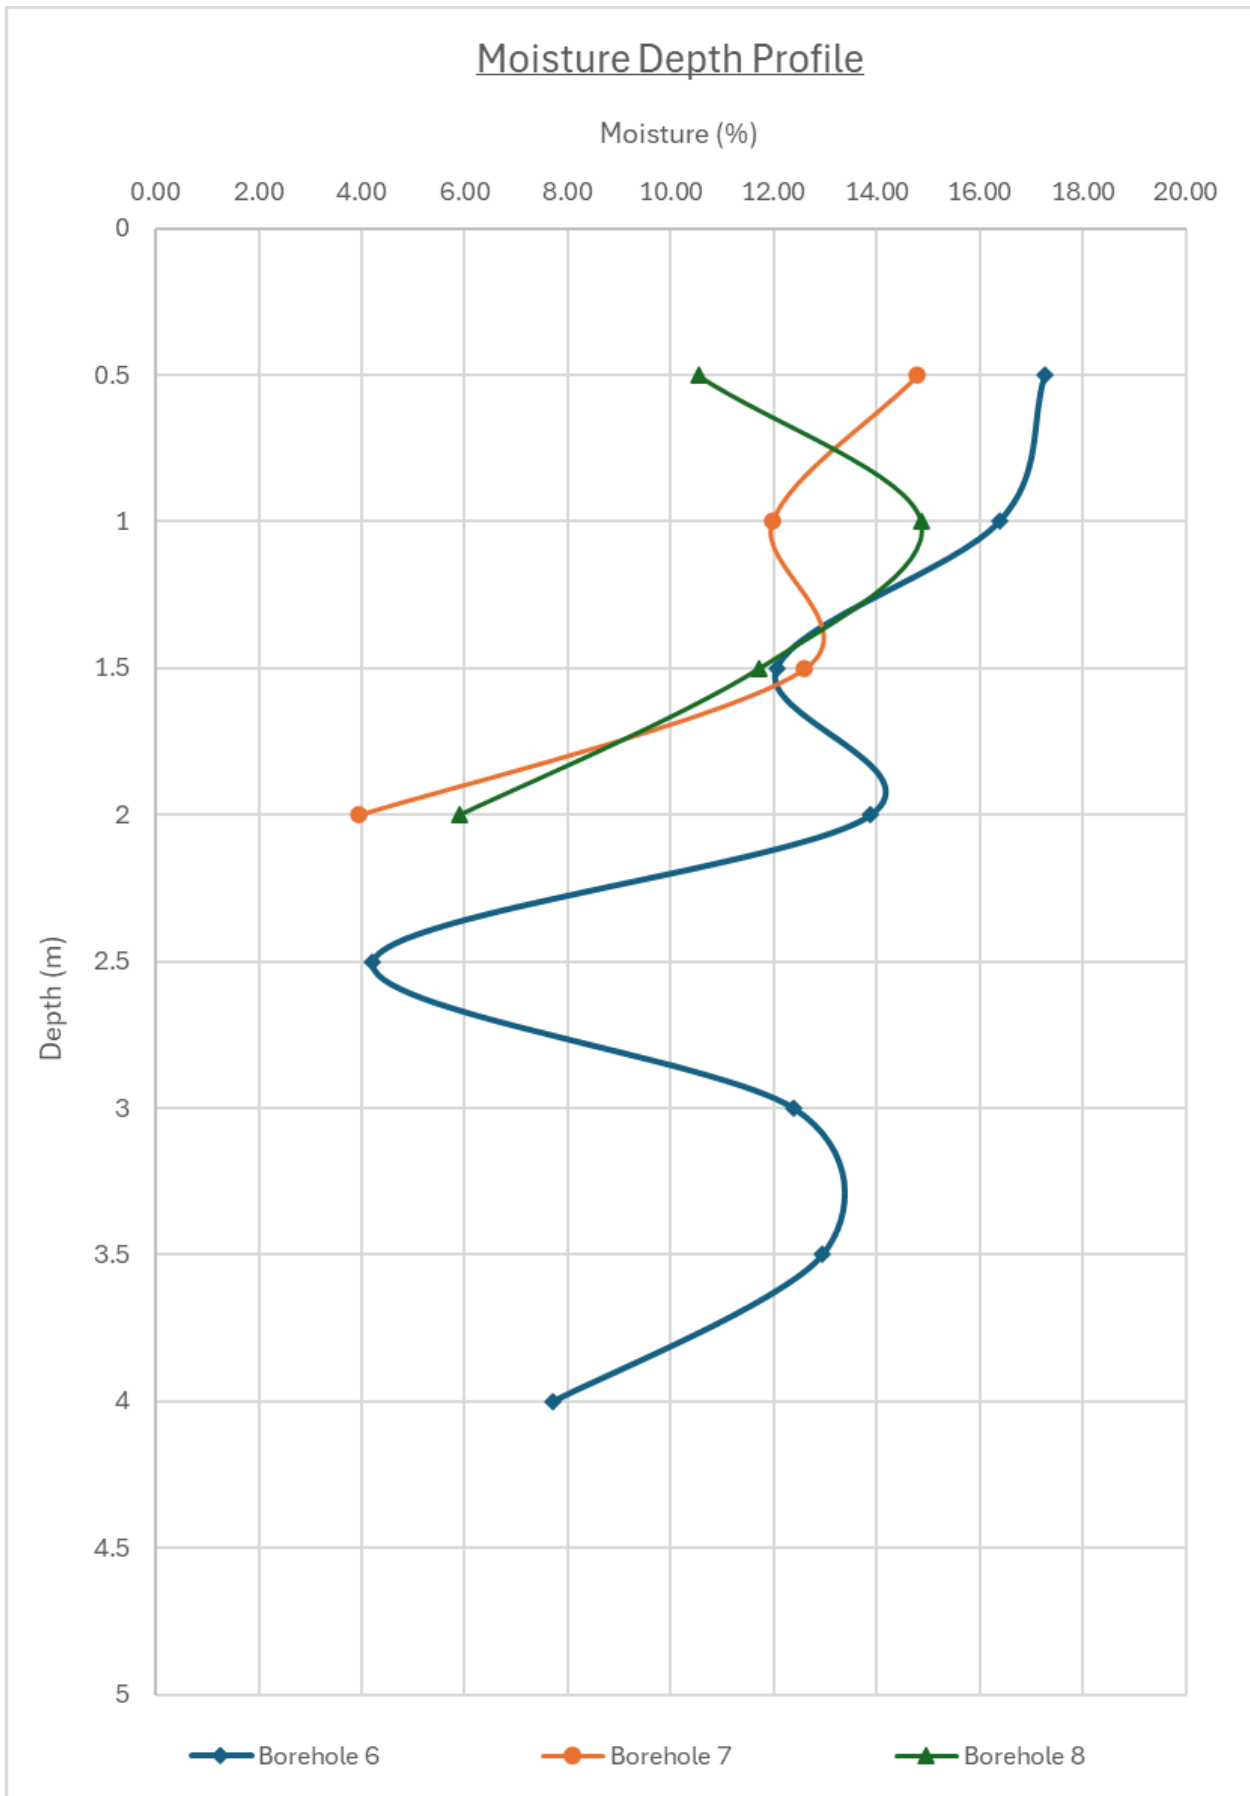
## Geotechnical Test Results

TP / BH No.	Sample Depth (m)	Insitu Moisture Content (%)	% Passing BS 425 Micron Sieve	Corrected Moisture Content (%)	Plastic Limit (%)	Liquid Limit (%)	Plasticity Index (%)	Soil Classification BS5930 [1999]
6	0.50	17.3	51.4	*	*	*	*	*
	1.00	16.4						
	1.50	12.1						
	2.00	13.9						
	2.50	4.2						
	3.00	12.4						
	3.50	12.9						
	4.00	7.7						
7	0.50	14.8	64.9	*	*	*	*	*
	1.00	12.0						
	1.50	12.6						
	2.00	4.0						
8	0.50	10.5	45.8	*	*	*	*	*
	1.00	14.9						
	1.50	11.7						
	2.00	5.9

\* Note - Essentially Non Plastic Material
