## Phase 2: Site Investigation

Mill Lane, Batley

Mandale Construction North Ltd

S240106/SI

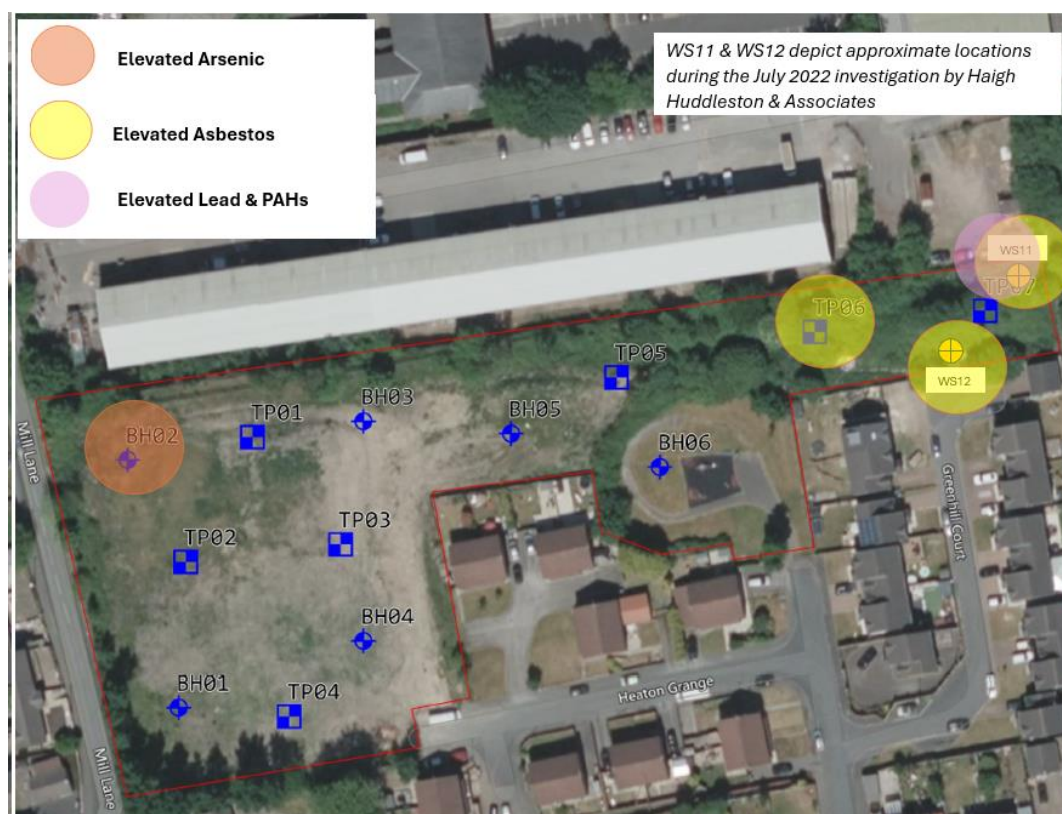
**FIGURE A: ELEVATED CONTAMINATION LOCATIONS**

- WS11, 1.20m – Lead (310mg/kg), Benzo(b)fluoranthene (3.3mg/kg), Benzo(a)pyrene (4.0mg/kg), Dibenzo (a,h)anthracene (0.4mg/kg) and PAH Total (57mg/kg).

The location of the samples which recorded elevated contamination are shown below on Figure A, based on the 6no samples tested to date along with the approximate location of the historic contamination.

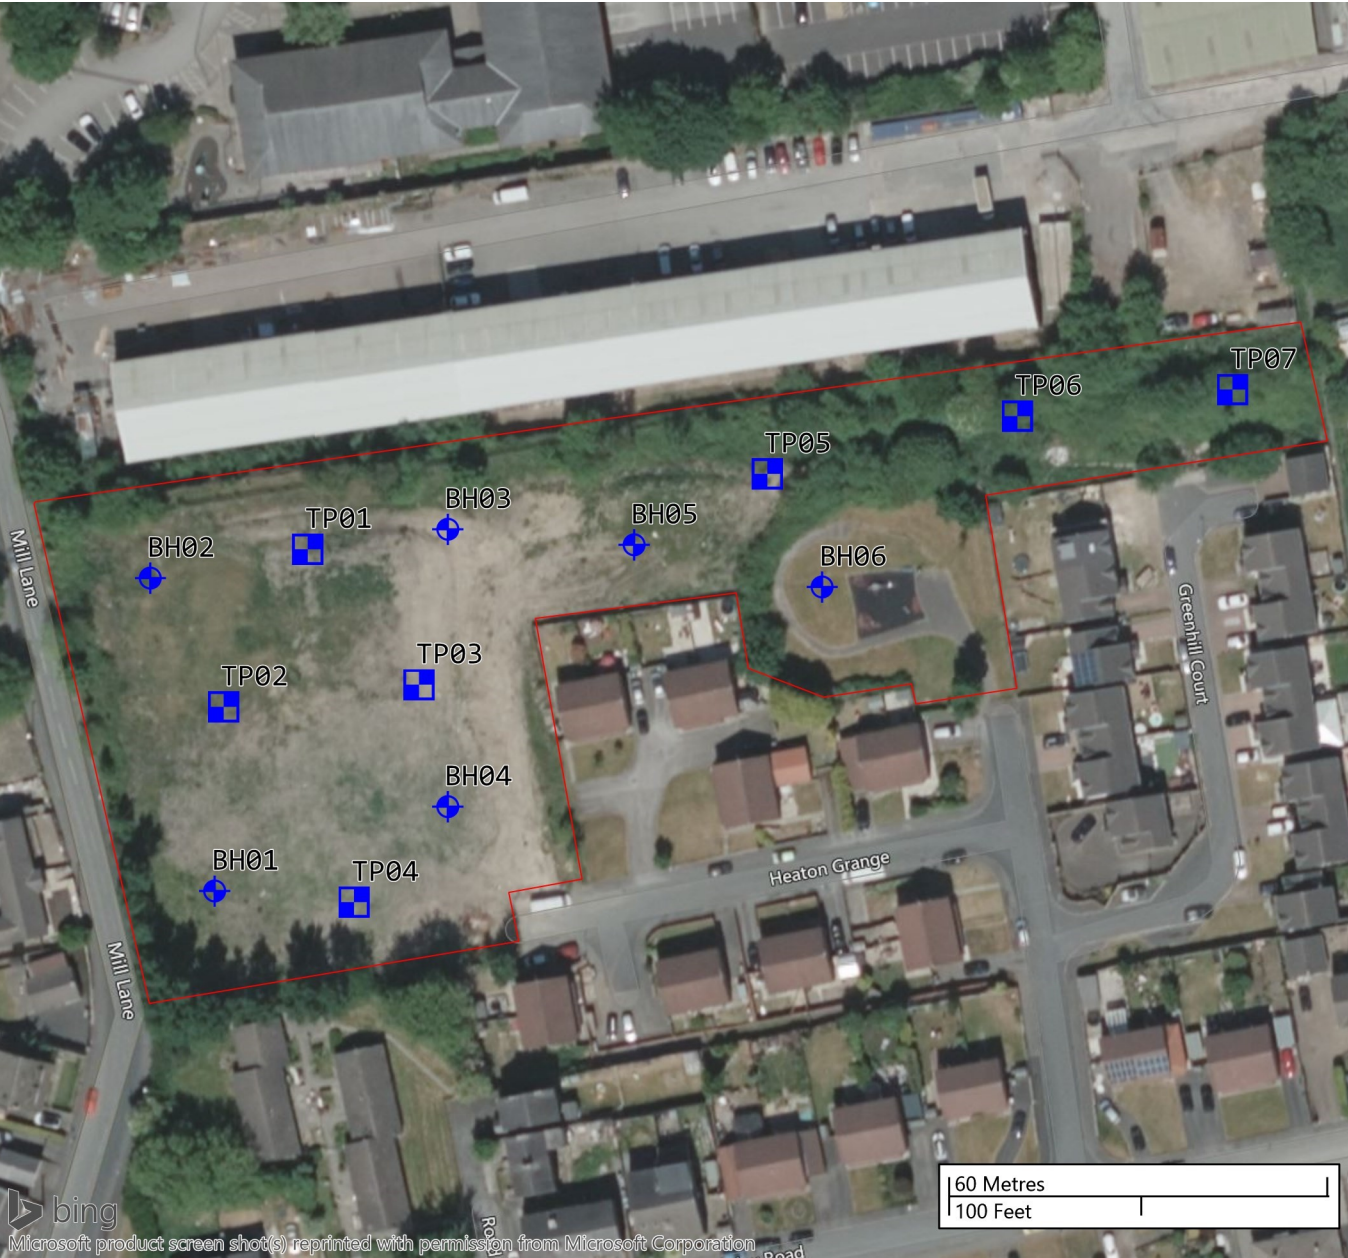
- 6no. small percussive boreholes (BH01 to BH06 inclusive) drilled to a maximum depth of 2.00m below ground level (bgl).
  - The boreholes were targeted to provide coverage in the area of the proposed footprint of the development to allow foundation design to take place and to provide samples for geotechnical and shallow contamination testing and analysis.

- 7no. machine excavated trial pits (TP01 to TP07 inclusive) to a maximum depth of 2.00mbgl.
  - The trial pits were targeted to appraise the shallow ground conditions and retrieve, bulk and environmental samples for laboratory testing.

A plan showing the location of the boreholes and trial pits can be found in Appendix A (Figure 2).
