# Preliminary Roost Assessment

32 Wentworth Street, Huddersfield HD15PX

This report is prepared to inform a planning application with Kirklees Council. The proposal can be described as the 'demolition of existing garage and outbuilding and erection of replacement garage and outbuilding'

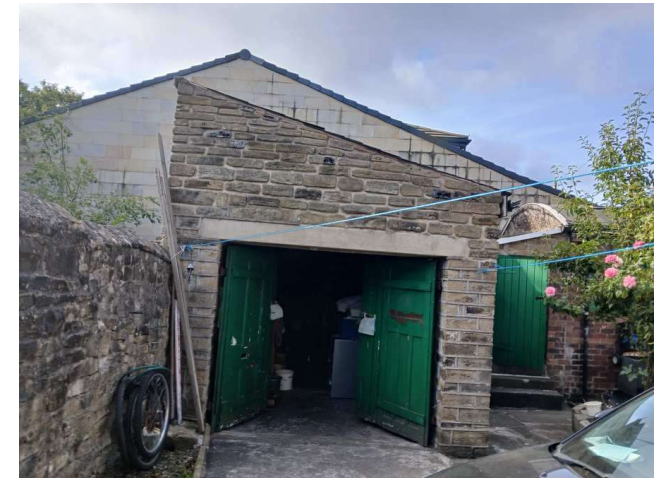
*Building B1 – southern elevation*

B1 is a single-storey, brick-built structure located in the south-east portion of the site and that is used for item storage and as such is disturbed on a daily basis according to client communications. The roof is lean-to structure and is clad with slate tiles. It is in generally good condition with tight fitting tiles, although there are a small number of lifted tiles around the edges. The roof on the western elevation is surrounded by a fascia gap with a number of areas of damage, as well as gaps which crevice dwelling species might utilise. B1 is connected to B2 by a wall. The inside of the garage hosts a number of gaps and crevices.

B1 is assigned a roosting value of LOW. There are low numbers of minor external and internal features which may provide roosting habitat value to crevice dwelling bat species, although it is unlikely to provide habitat for void dwelling species.

One bat emergence survey is required during the active bat season (May – September) to establish presence or likely-absence of a bat roost in the building. The survey should be completed during the optimal survey period of mid-May to August inclusive.

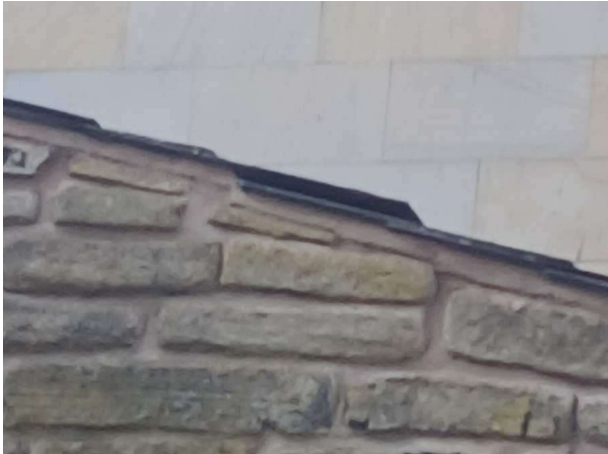
| Feature | Materials/Details | Condition / description / suitability | Photograph |
|---|---|---|---|
| Roof | Tiles | <p><b>Condition/description</b><br/>The garage roof was in overall good condition, however there were a few points of damage such as lifted tiles.</p> <p><b>Suitability/access/evidence of bats</b><br/>The slipped tiles may provide shallow resting places in their own right, but may also lead to deeper cavities between the roof tiles and lining.</p> | <p><i>B1 roof – southern elevation</i></p> |

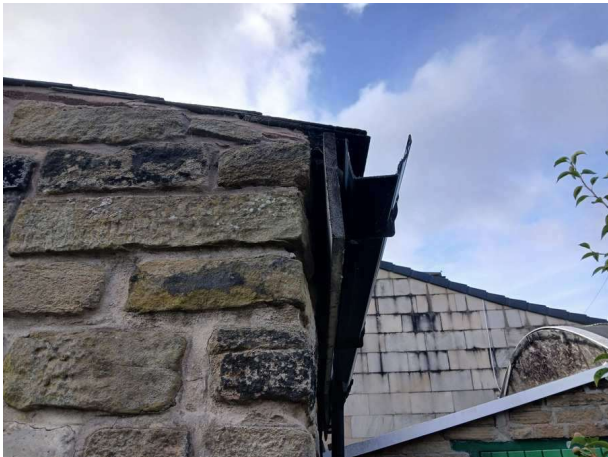
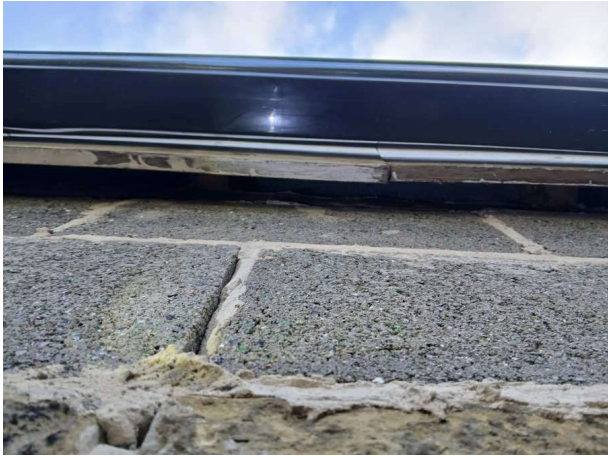
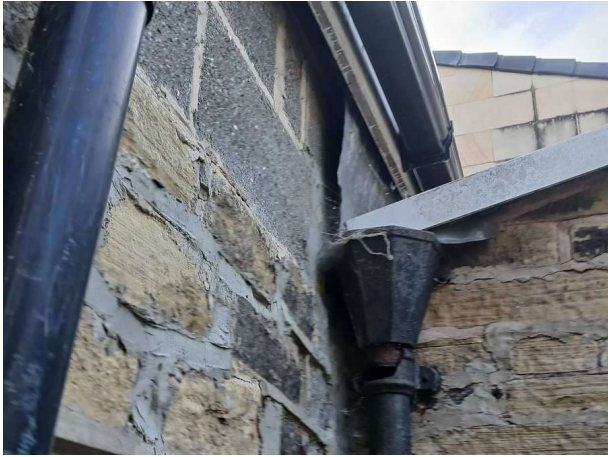
| Feature | Materials/Details | Condition / description / suitability | Photograph |
|---|---|---|---|
| Eaves | Timber board | <p><b>Condition/description</b><br/>The eaves are generally in good condition. A gap runs between the brick and the wooden fascia board for the length of the building.</p> <p><b>Suitability/access/evidence of bats</b><br/>Gaps between the stonework and fascia board provide suitable roosting opportunities for crevice dwelling bats.</p> | <p><i>B1 fascia gap – southern elevation</i></p> |

| | | | <div><p><i>B1 fascia gap</i></p><p><i>B1 fascia gap and lead flashing gap – south-eastern elevation</i></p></div> |

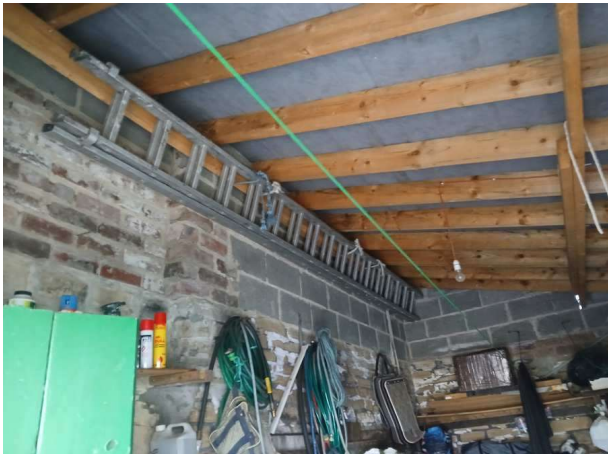
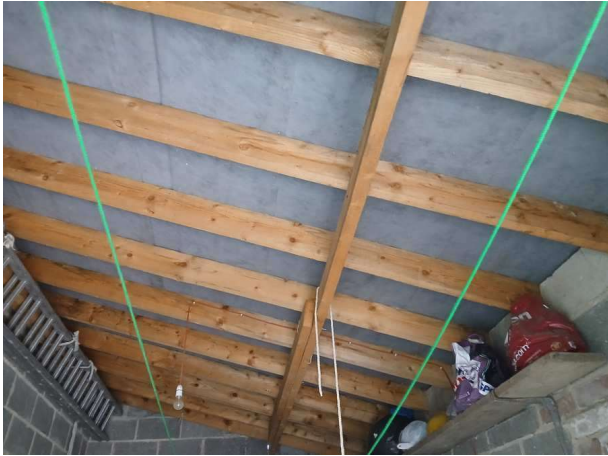
| Interior 1 | Concrete breezeblocks and brickwork | <p><b>Condition/description</b></p> <p>The condition with the garage was relatively good, and is open from ground to roof without a void space. Additionally, there were relatively thick spider webbing within. Webbing can be created quickly and is not always a reliable indicator of bat presence or absence. However, the webbing within the garage had a coating of dust and bits of detritus which indicates it has been there for a while and so could be indicative of an absence of recent internal flight activity. B1 was in largely good condition with no light ingress apart from the open door. Whilst crevices did exist, they were few and relatively shallow. The room was cluttered at ground level but above offered space for flight.</p> <p><b>Suitability/access/evidence of bats</b></p> <p>The inside of B1 has limited suitable roosting value for bats and client communications indicates that it is subject to near daily disturbance which renders it sub-optimal. No evidence of bats was located.</p> | <p><i>B1 internal void 1 – southern elevation</i></p> <p><i>B1 internal void 1 – southern elevation</i></p> |

| | | | <p><i>B1 internal void 1</i></p> |

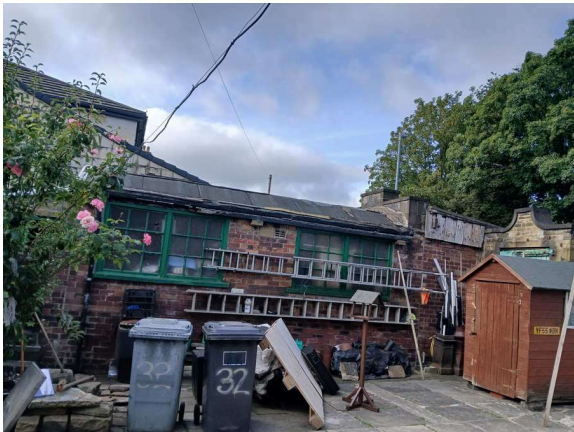
Building B2 -southern elevation

B2 is a single-storey, brick-built outbuilding with a timber ceiling used primarily for storage, all of which was covered with a curved roof. Compared to B1, B2 has a much higher number of both external and internal roosting features, as well as areas of light ingress other than the windows and door. Externally there are gaps and crevices in multiple places, including window frames, eaves and brick work. Internally there are even more, scattered through the structure, to the point that adding them to all to the habitat map would be impractical.

B2 is assessed for roosting habitat value as moderate. Whilst there is frequent disturbance and high light levels, there is a high number of external and internal features which may provide roosting habitat value to crevice dwelling bat species. These crevices could extend deeper and support higher numbers of bats, or hibernating opportunities.

Two bat emergence surveys are required during the active bat season (May – September) to establish presence or likely-absence of a bat roost in the building. The survey should be completed during the optimal survey period of mid-May to August inclusive.

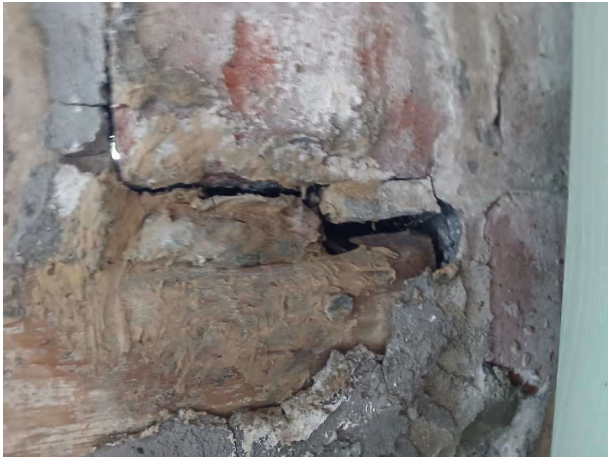
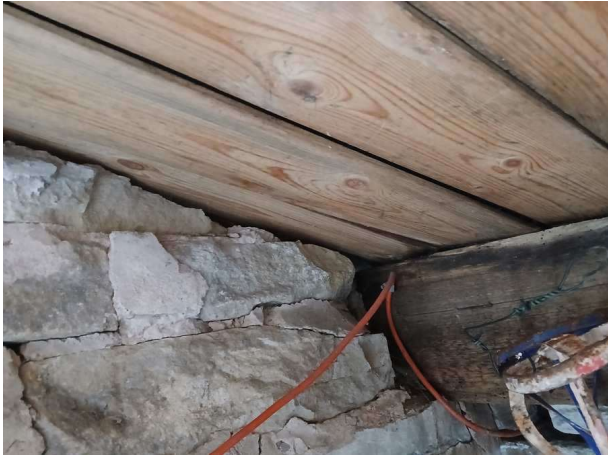
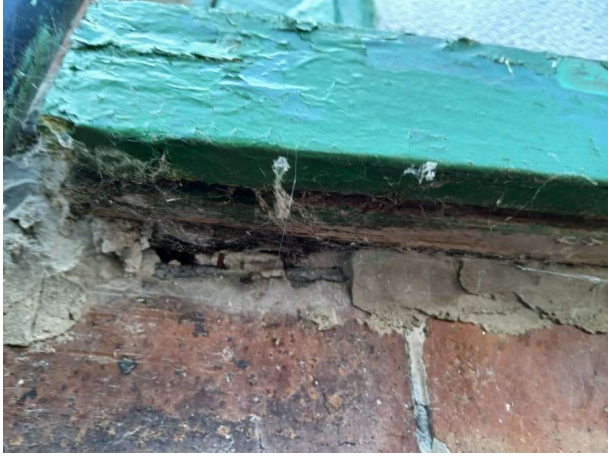
| Feature | Materials/Details | Condition / description / suitability | Photograph |
|---|---|---|---|
| Walls | Brick | <p><b>Condition/description</b></p> <p>The walls, both inside and out, contained a number of sizeable gaps, which cannot be fully determined without an endoscope inspection, could be utilised for roosting crevice dwelling species.</p> <p><b>Suitability/access/evidence of bats</b></p> <p>Brickwork gaps provide roosting potential, as well as possibly leading to deeper cavities within which could provide hibernation opportunities.</p> | <p>B2 walls</p> |

| | | | <p><i>B2 walls</i></p> <p><i>B2 walls – southern elevation</i></p> |

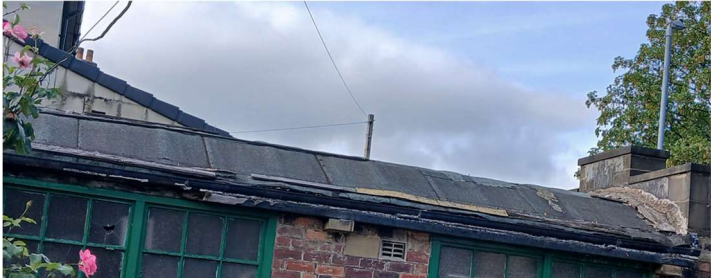
| Roof | Bitumen felt | <p><b>Condition/description</b></p> <p>The roof was made of felt, and had multiple areas of damage, including lifted felt and tears, particularly around the ridge area and the eaves area.</p> <p><b>Suitability/access/evidence of bats</b></p> <p>The roosting features identified can provide roosting opportunities for crevice dwelling species.</p> | <p><i>B2 roof – southern elevation</i></p> |

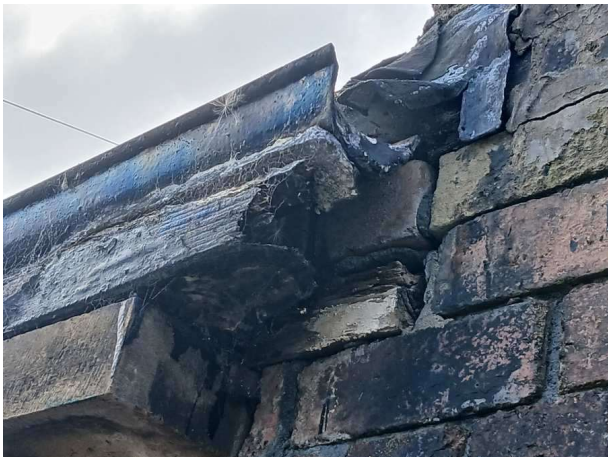
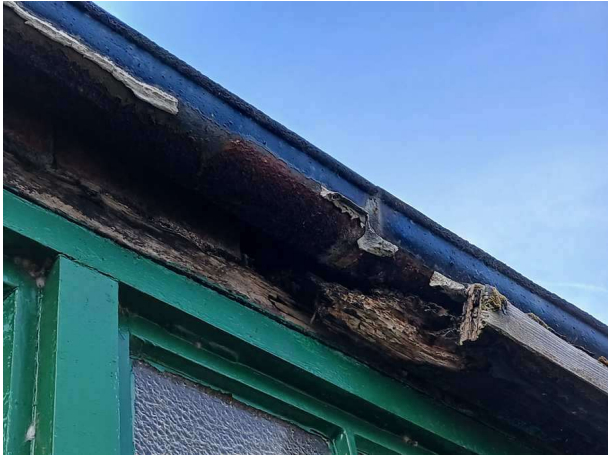
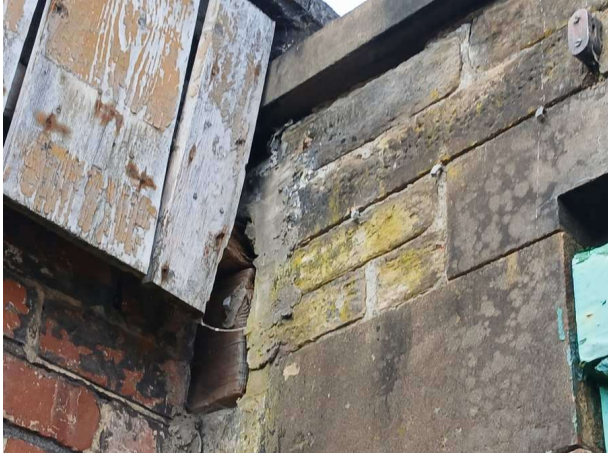
| Eaves | Timber board | <p><b>Condition/description</b></p> <p>The eaves had multiple areas of damage, including broken brickwork, as well as broken/rotting timber.</p> <p><b>Suitability/access/evidence of bats</b></p> <p>Of B2's external roosting features, it is the eaves that contained the most. Broken timber and holes within bricks offer roosting opportunities in their own right, but they might also lead to deeper cavities.</p> | <p><i>B2 eaves – southern elevation</i></p> |

| | | | <p><i>B2 eaves – southern elevation</i></p> <p><i>B2 eaves – south-western elevation</i></p> |

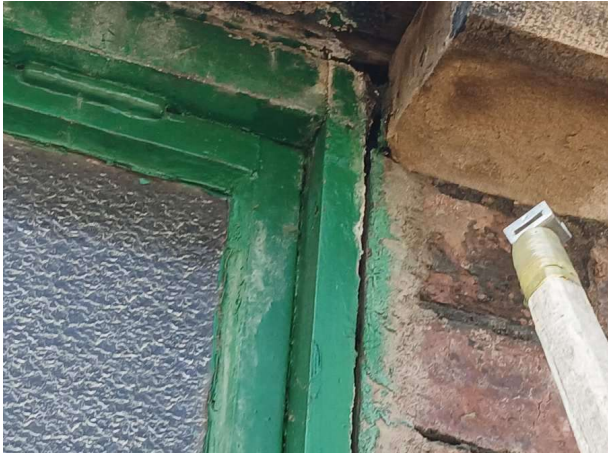
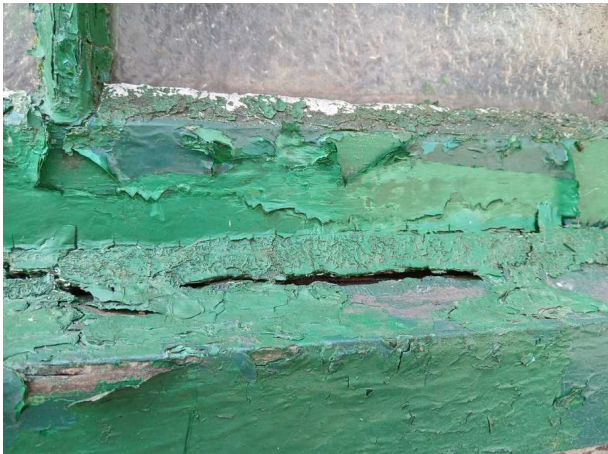
| Windows | Steel | <p><b>Condition/description</b><br/>The window frames contained gaps in places around edges.</p> <p><b>Suitability/access/evidence of bats</b><br/>The gaps and crevices between the window frames and brickwork could be used as roosting opportunities in their own right, but may also lead to deeper cavities within.</p> | <p><i>B2 window / doors frames and lintels – southern elevation</i></p> <p><i>B2 window / doors frames and lintels – southern elevation</i></p> |

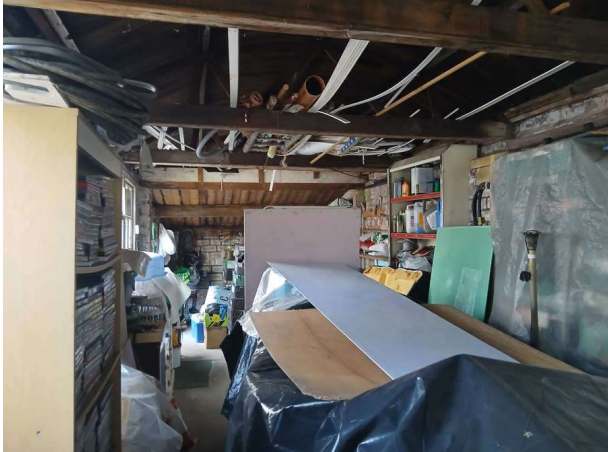
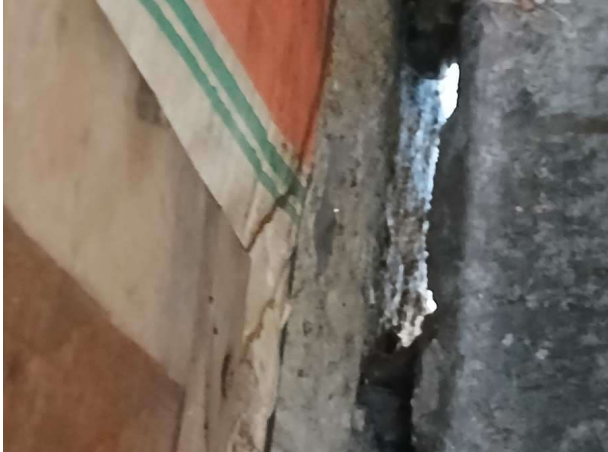
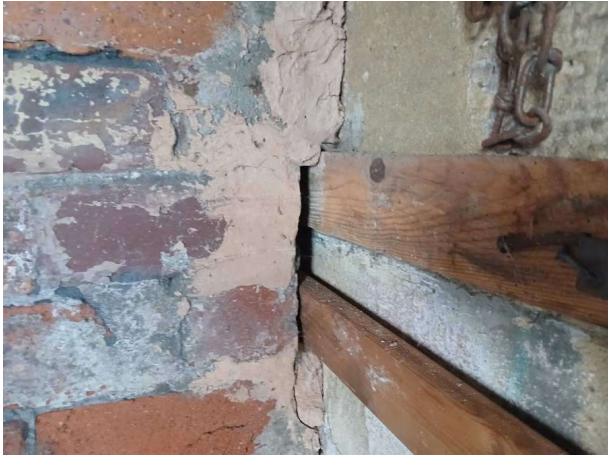
| Interior 1 | Timber rafters. | <p><b>Condition/description</b><br/>The building contained many holes and crevices in which bats may roost, and could extend into deeper wall cavities within. At a number of points, outside light was clearly visible from inside.</p> <p><b>Suitability/access/evidence of bats</b><br/>Despite the relative wealth of roosting features, the inside of the building was not particularly well suited as a bat roost, especially for void dwelling species. This is on account of the high lux levels from the windows, and the fact that according to client communications it receives nearly daily entry and disturbance. However, this would not be a significant deterrent for crevice dwelling species if they are within wall cavities. No evidence of bats located.</p> | <p><i>B2 interior 1 – eastern elevation</i></p> <p><i>B2 interior 1 – northern elevation</i></p> |

| | | | <p><i>B2 internal void 1 – southern elevation</i></p> |
