Scar Lane, Milnsbridge – Proposed Industrial Development S278 Works

Stage 1 Road Safety Audit

Report Title:	Scar Lane, Milnsbridge – Proposed Industrial Development S278 Works
Report Produced for:	Haigh Huddleston & Associates
Report Dated:	04 June 2026
Document Reference & Revision:	MAL/SLMPIDS278/RSA1 Rev 0
Report Produced by:	Meraki Alliance, Watkin Avenue, Old Colwyn, Conway LL29 9NN Neil Jones - Tel:+44 (0) 7737682487
On behalf of:	Kirklees Council

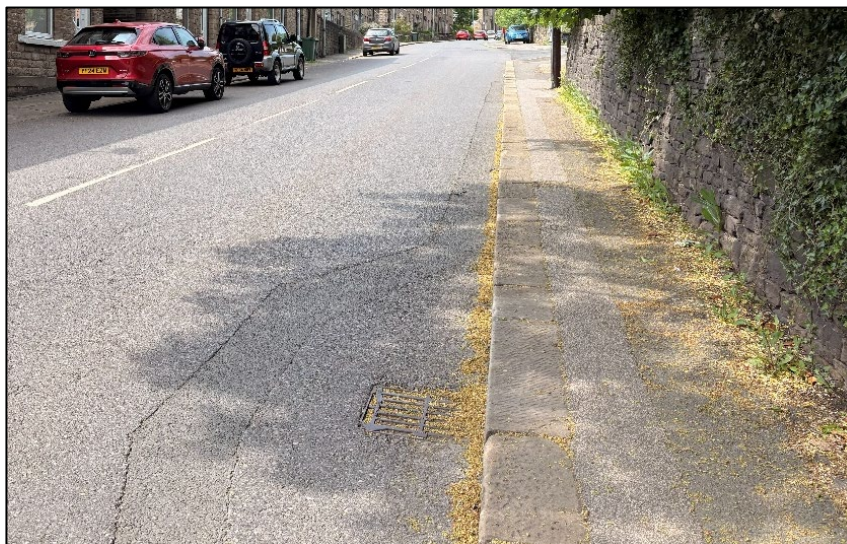
During the site visit, the audit team identified a blocked gully immediately to the north of the proposed access (see photo).

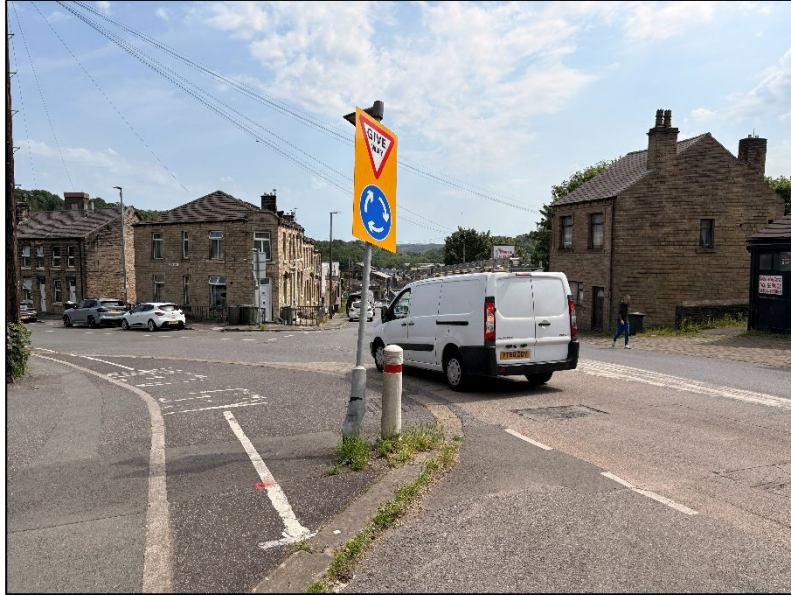
The give way and roundabout sign on the Scar Lane eastbound entry onto the mini roundabout had been struck and is leaning over (see photo). It could be in danger of falling into the carriageway or being struck once again by another vehicle as it is leaning towards the running lane.

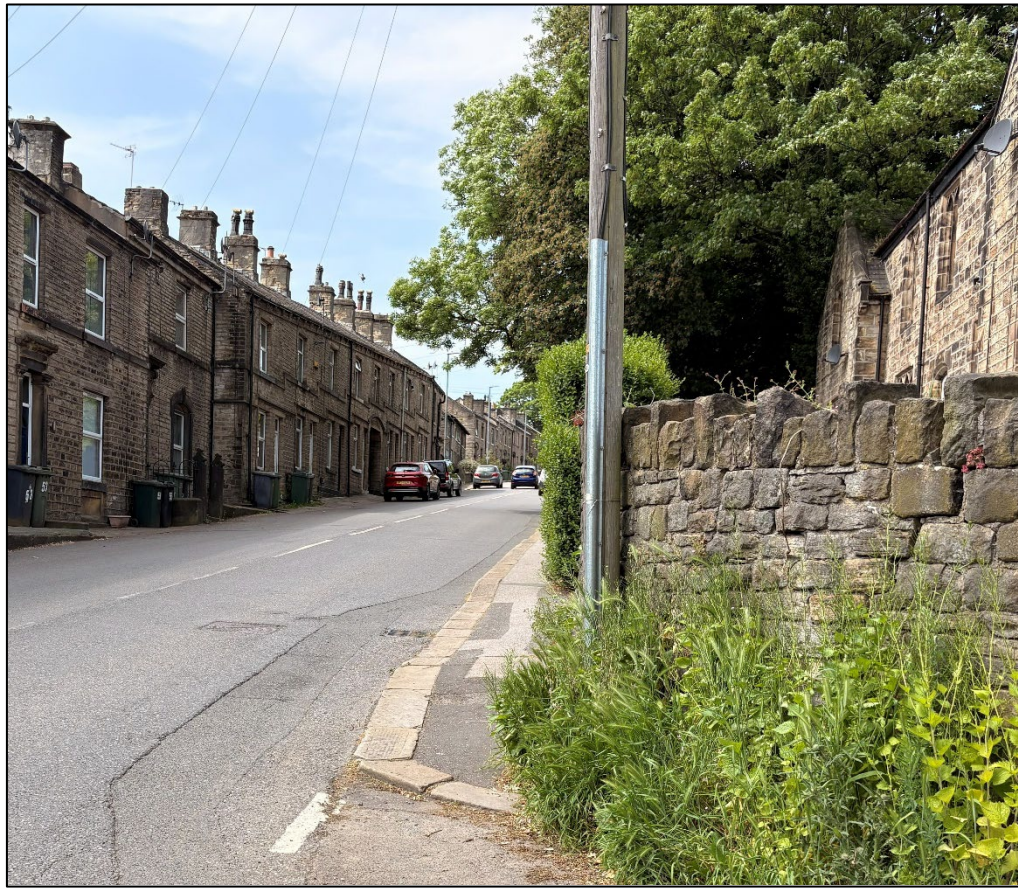
PROBLEM		1-2
Location:	Proposed development access	
Summary:	Increase in cross path collisions or pedestrian collisions, due to obstructed visibility	
<p>Proposed visibility splays at the junction indicated on the design drawings are achieved though established hedgerow to the rear of the footway, which could impede intervisibility between users at the proposed access and vehicles on Scar Lane. If intervisibility is impeded there is a risk of collisions resulting from vehicles exiting the access into the path of an approaching vehicle.</p>

RECOMMENDATION		
<p>Ensure that the visibility splay is achieved and is kept free of obstructions, in perpetuity by undertaking site clearance.</p>
