**Phase 1 Geoenvironmental Risk Assessment and  
Phase 2 Ground Investigation**

**LAND TO REAR OF 323 DUNFORD ROAD  
HADE EDGE  
HOLMFIRTH**

**Jones Homes (Yorkshire) Limited**

Report Number 4441

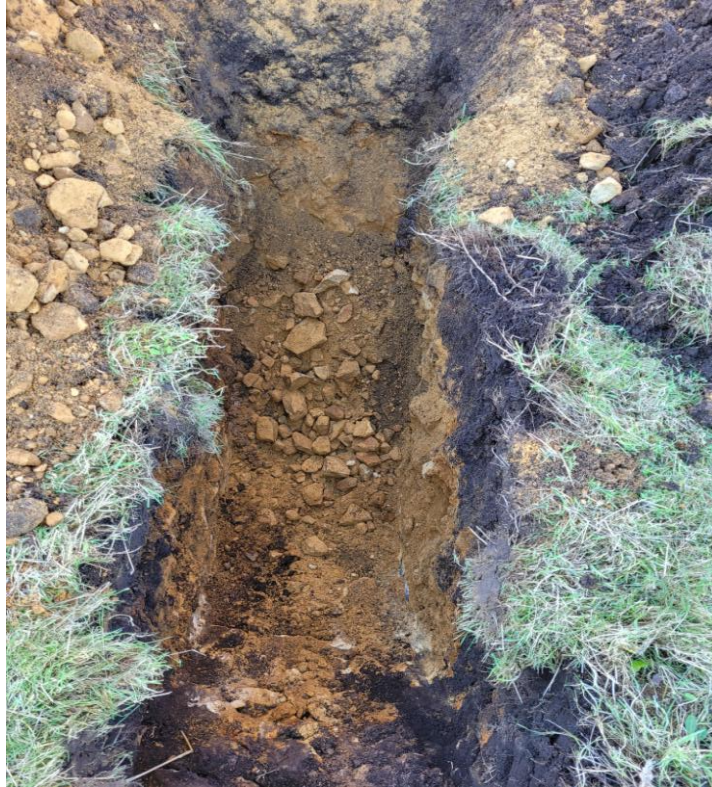
*Typical trial pit*

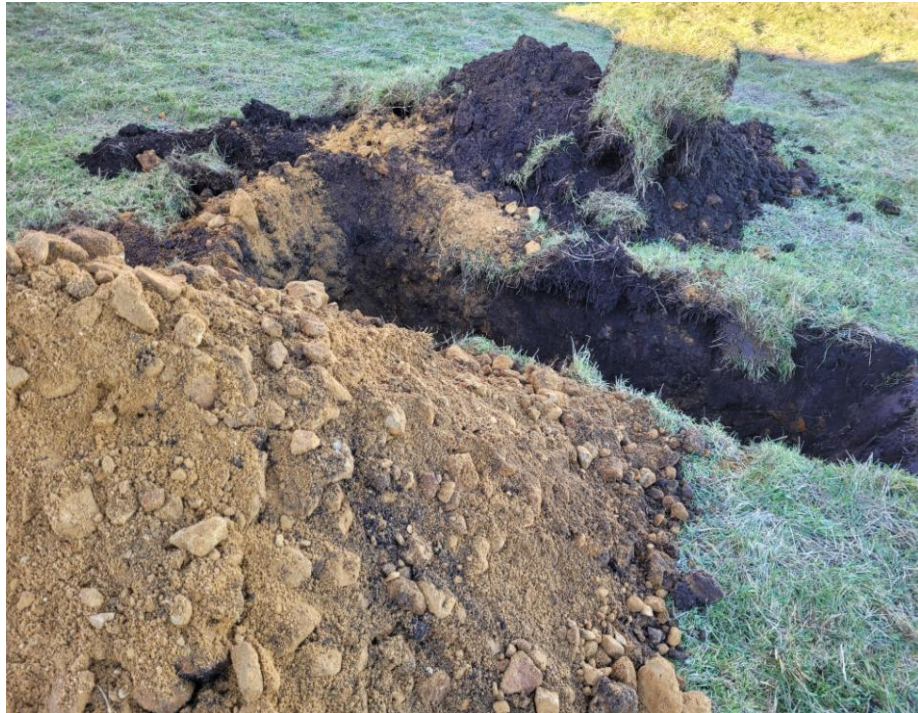
*Typical arisings from trial pits*

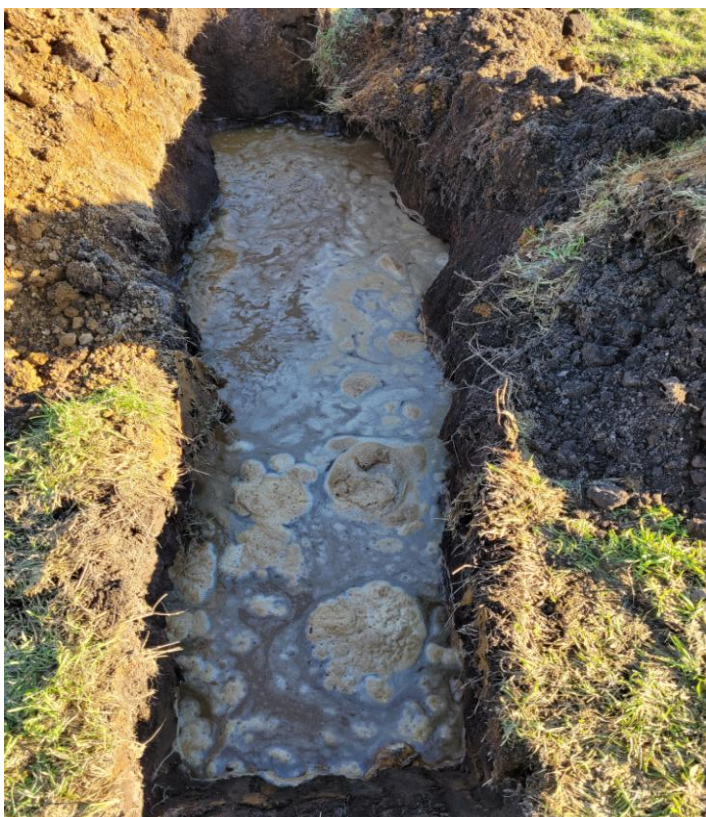
11.2.1 Soakaway tests were carried out in trial pits TP1, TP3, TP4, TP6 and TP8 in accordance with BRE Digest 365: Soakaway Design. This involved filling the trial pits with water from a water tanker and recording the fall in water level over a period of time. From this it is possible to calculate the Soil Infiltration Rate (SIR) based on the trial pit dimensions and the rate of dissipation. All the tests were carried out in the lower eastern half of the site, as access was not possible to the western half.

*Typical soakaway test*

11.2.9 It is therefore concluded that soakaways will be suitable for road and roof drainage on this site, providing a larger excavator is used to provide greater depths, which intercept fissured sandstone bedrock.

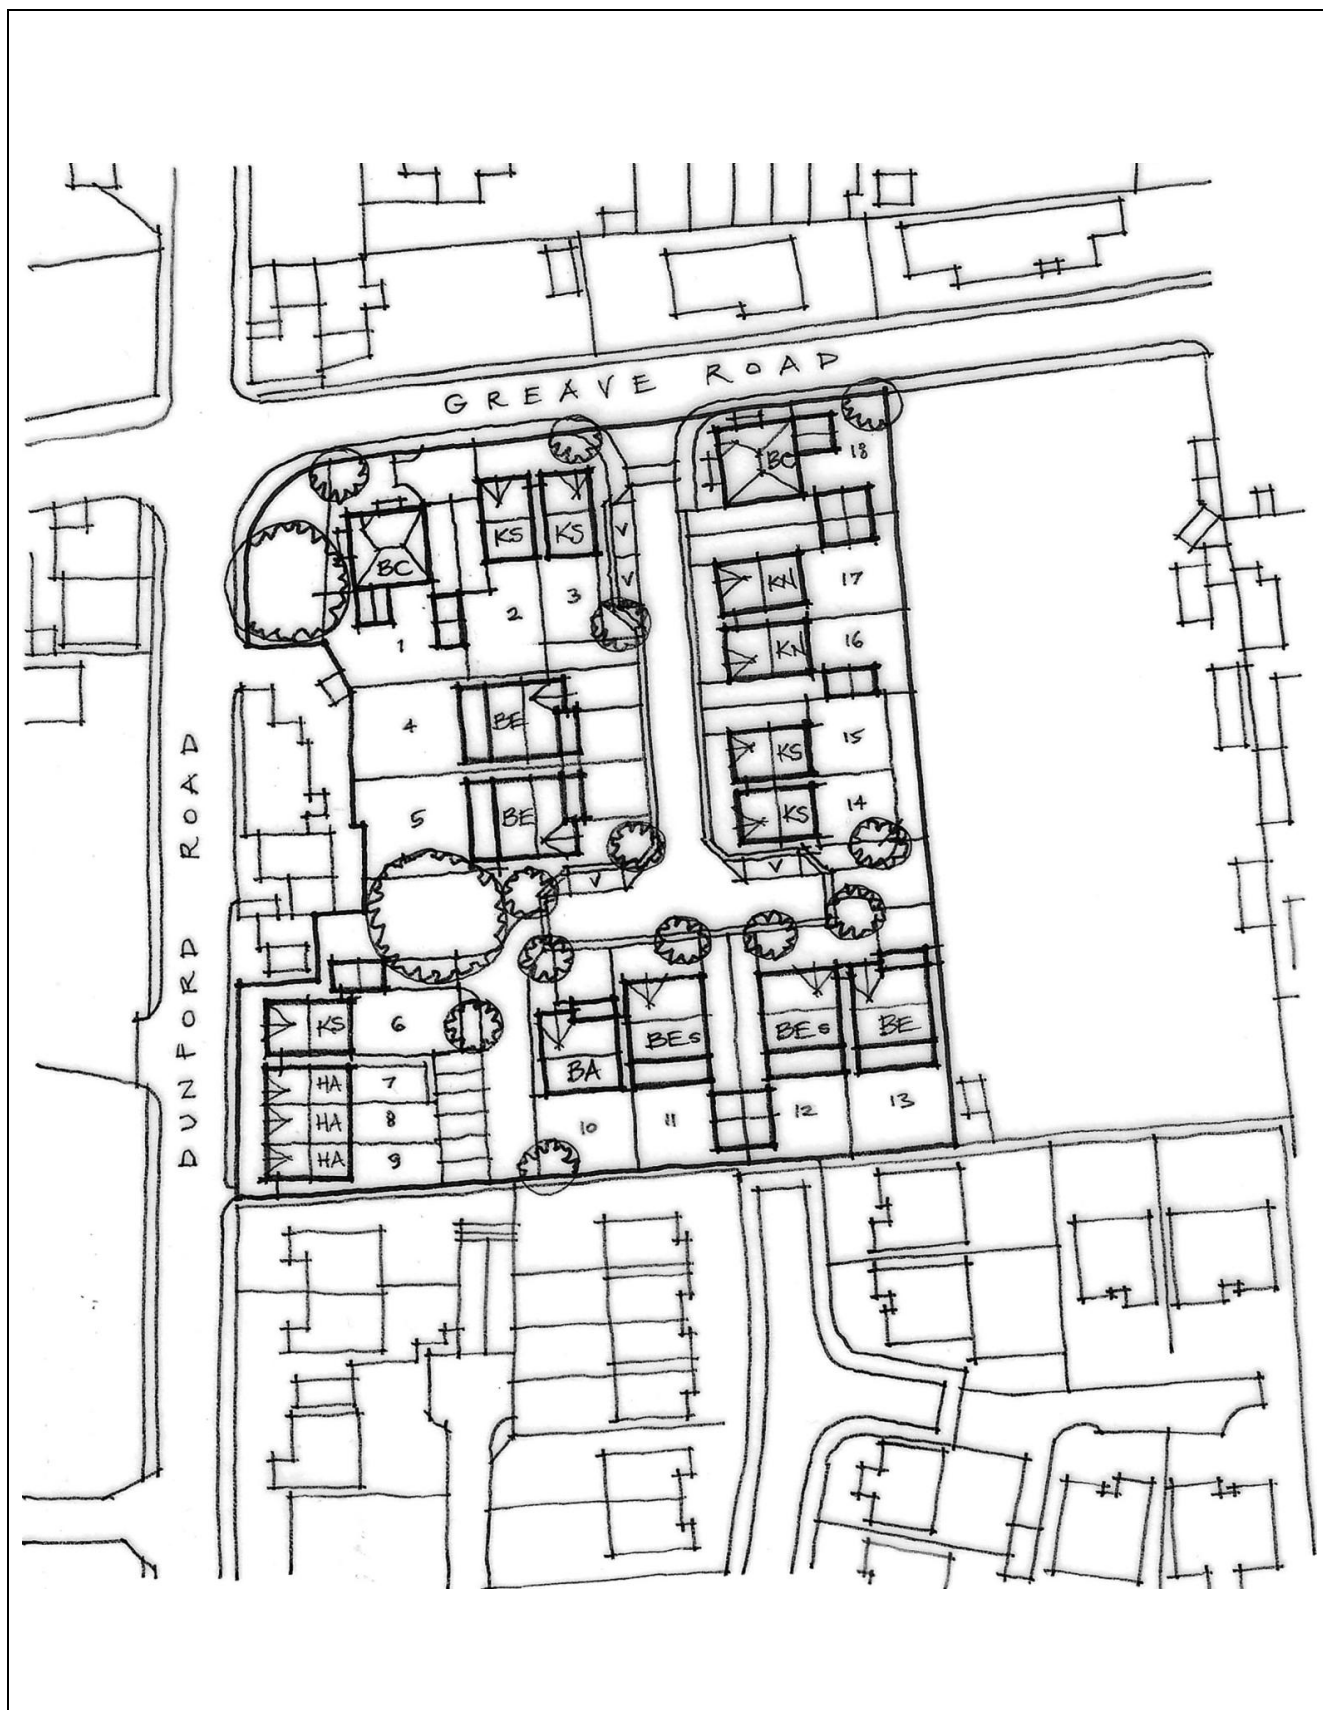
Figure: 2

**323 Dunford Road, Hade Edge**  
Development Proposals
