**ARBORICULTURAL IMPACT ASSESSMENT  
to BS 5837:2012**

**Land to the Rear of 323 Dunford Road  
Hade Edge  
Huddersfield  
West Yorkshire  
HD9 2RT**

22720-B/AJB

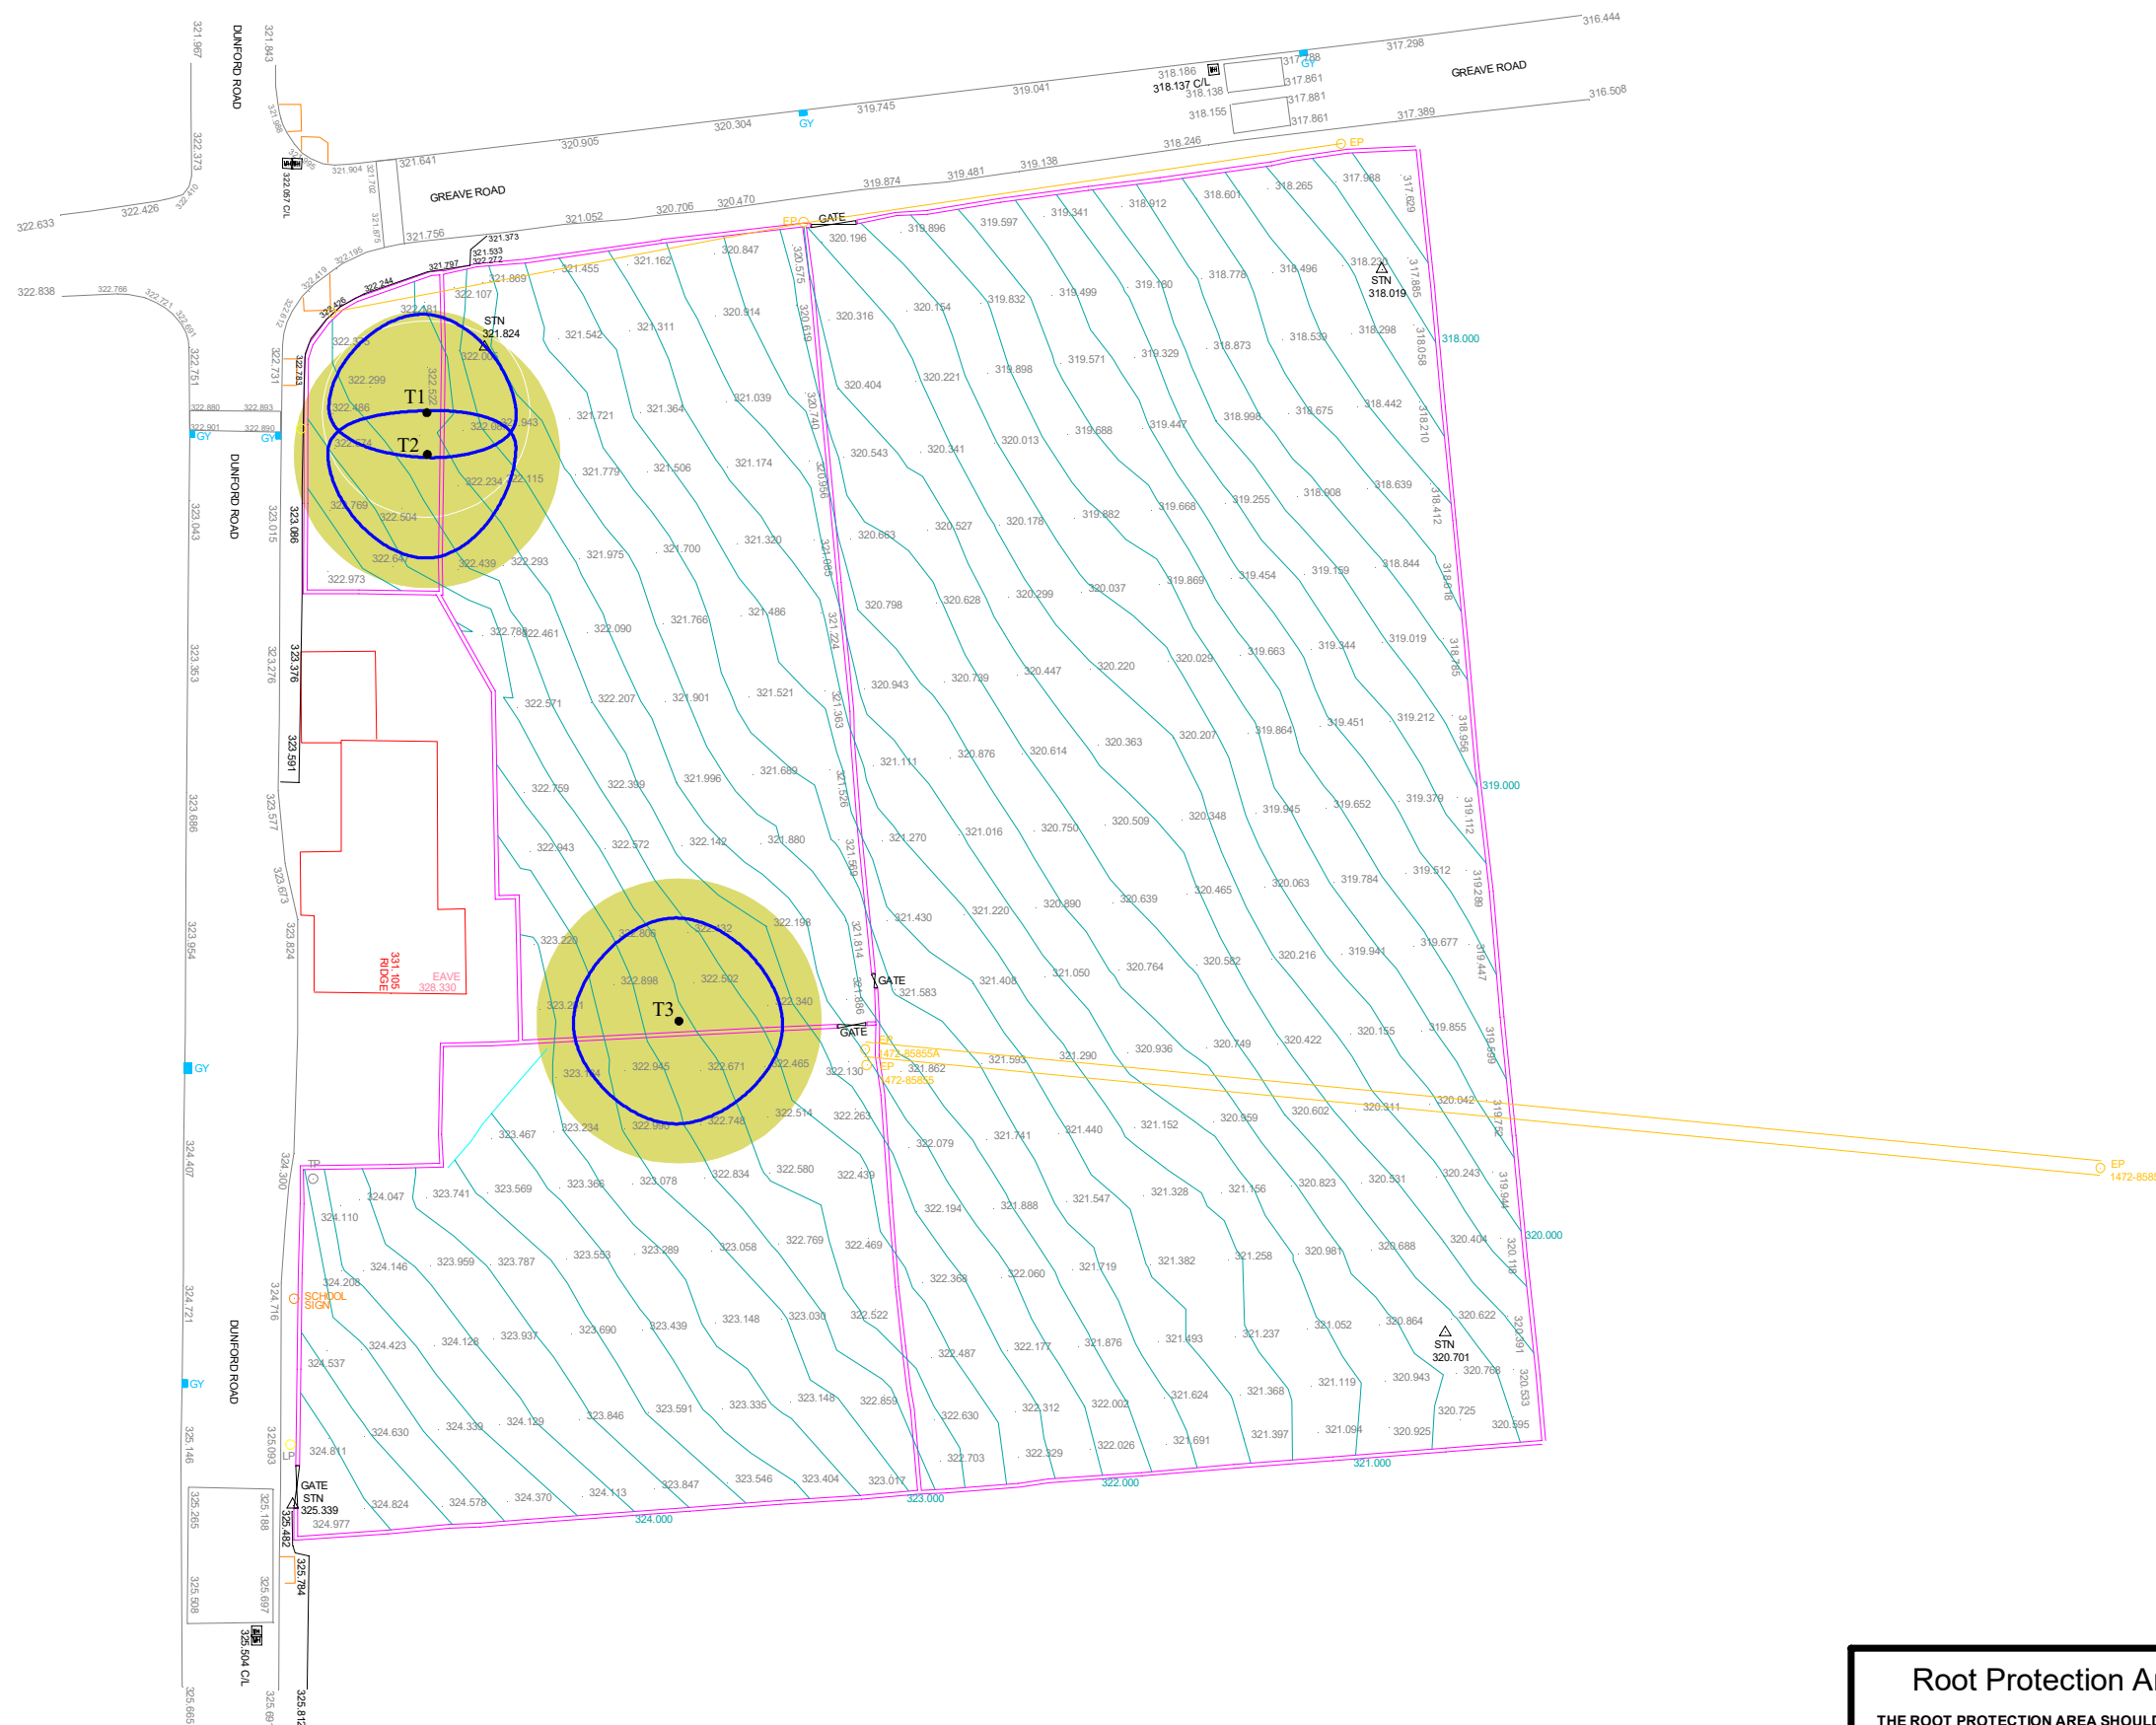
IF IT IS NECESSARY FOR THE DEVELOPMENT TO ENCROACH INTO THE RPA OF A TREE WHICH IS TO BE RETAINED THEN SPECIALIST CONSTRUCTION TECHNIQUES AND MATERIALS MUST BE CONSIDERED.

- 2.1 The tree information recorded during the original survey is detailed in the tables at **Appendix 1**. A full explanation of the tables can be found at **Appendix 2**. Please refer also to the Tree Constraints Plan at **Appendix 5** for tree locations.

- 4.6 The protection of retained trees can be achieved by the creation of a Construction Exclusion Zone based on the Root Protection Area of a tree. The Root Protection Area of each tree or group is marked on the Tree Constraints Plan at **Appendix 5**.

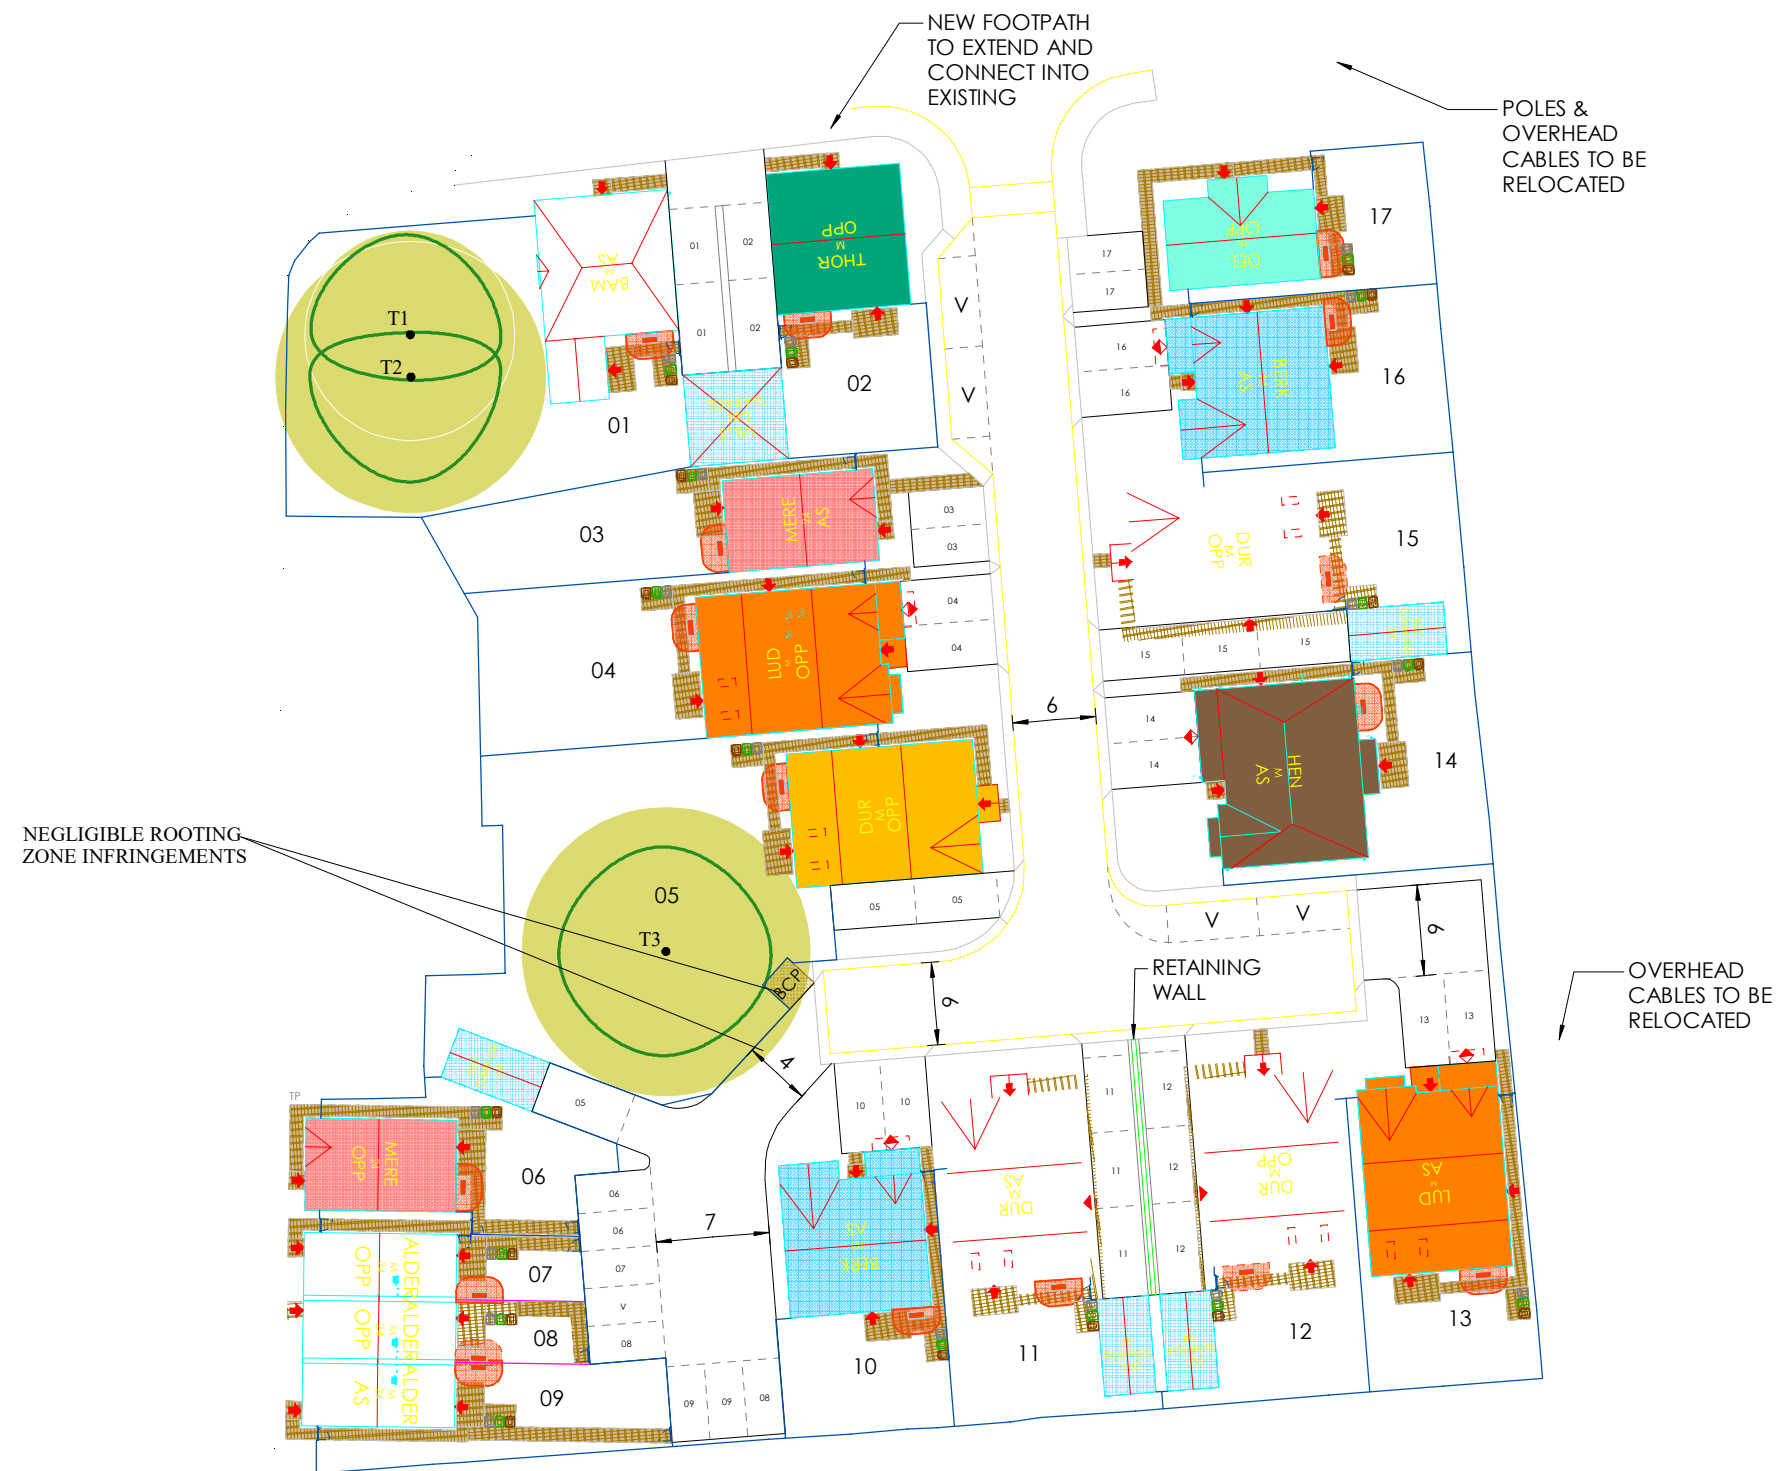
**Appendix 6: Arboricultural Implications Plan**

NEGLIGIBLE ROOTING  
ZONE INFRINGEMENTS

RETAINING  
WALL

- 3.4.1.1 As annotated on the plan at Appendix 6, only negligible infringements are required within the RPA of **T3** for the required access road and bin collection point.

- 3.4.3.1 Other than a negligible infringement within the root protection area of **T3** (as annotated on the plan at **Appendix 6**), the proposed scheme does not require the construction of hard surfaces within the RPA of retained trees. As such no specialised construction techniques/surface treatments will be required for this purpose.
