PHASE 1 & PHASE 2
SITE INVESTIGATION &
GEO-ENVIRONMENTAL APPRAISAL

LAND
AT
ROWLEY HILL
FENAY BRIDGE
HUDDERSFIELD
HD8 0JF

Document Status: FINAL
Revision: v1

Job N° MGEO 2512 HD8 0JF

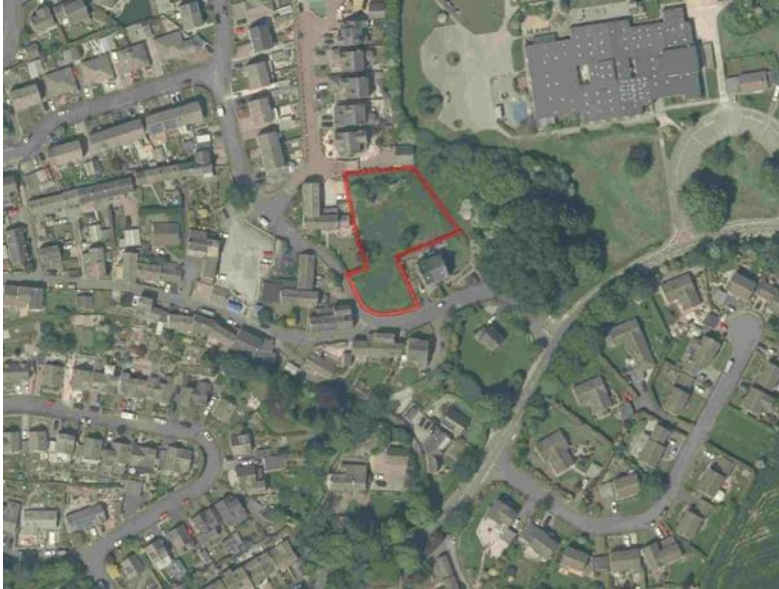
Figure 2 –Extract satellite image with site outlined in red

The site was accessed from Common End Lane with a gated access to an area of rough ground in the south. Existing residential development was present to the north, south and west.

The ground level rose gently in elevation to the north with the topographic low in the south of the site near to the existing access.

There were several mature trees on the eastern site boundary and a level area across the centre and rising to the northern site boundary.

A drain run was present along the central part of the site discharging to the south-west based upon the position of existing access chambers.

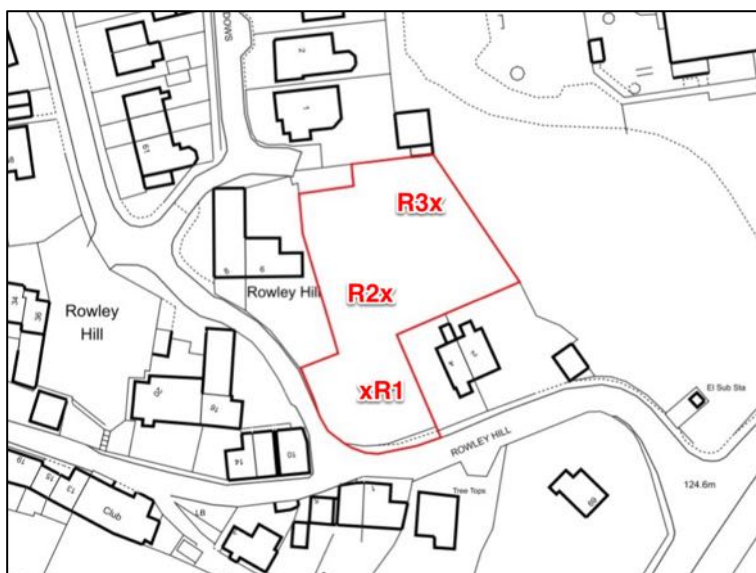
Figure 4 – Rotary borehole location plan

Three rotary open-hole boreholes were drilled to 10m depth at the site at the locations identified as BH1 to BH3 in the plan presented as figure 4 below and included as part of appendix C.

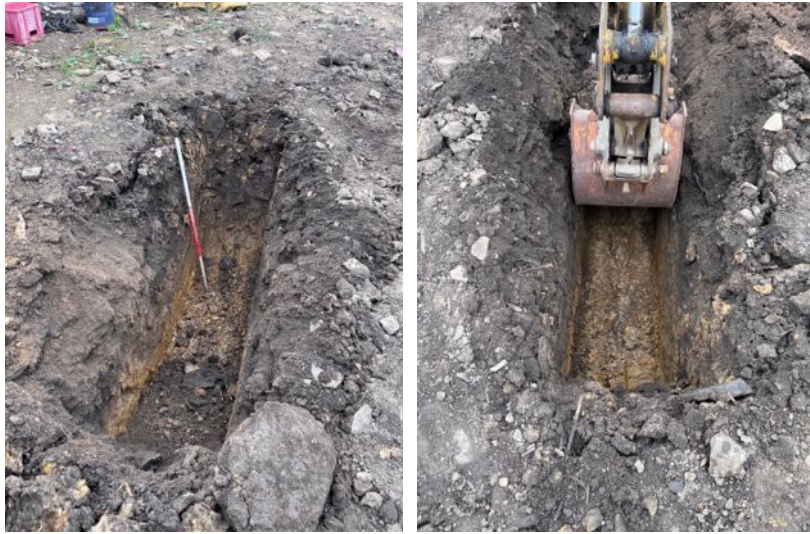
TP4 pit

Trial pit TP4 was excavated using a JCB 3CX with a back hoe to confirm the ground conditions underlying the site and undertake a soakaway test. The trial pit position was located near to where the soakaway system would likely be located as part of the planned development.

The trial pit was excavated to approximately 1.5m bgl and terminated within the extremely weak brown and grey thinly laminated fine grained sandstone noted

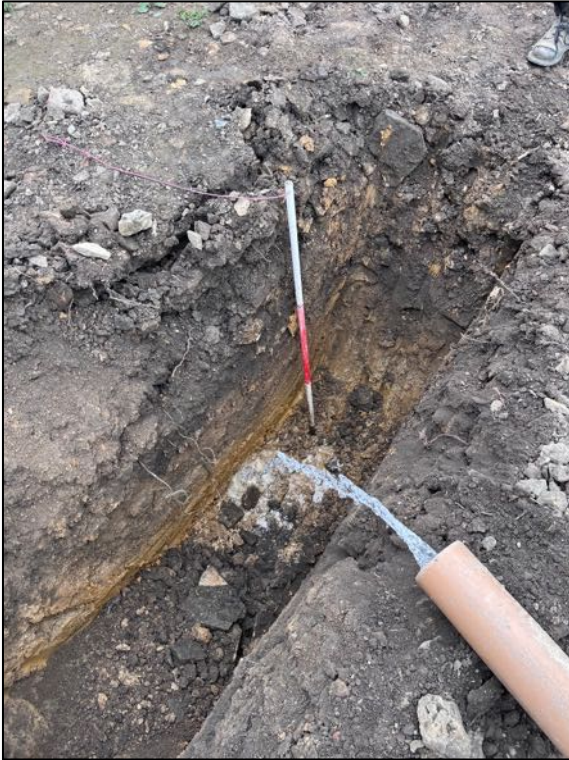
TP4 filling operation for soakaway test

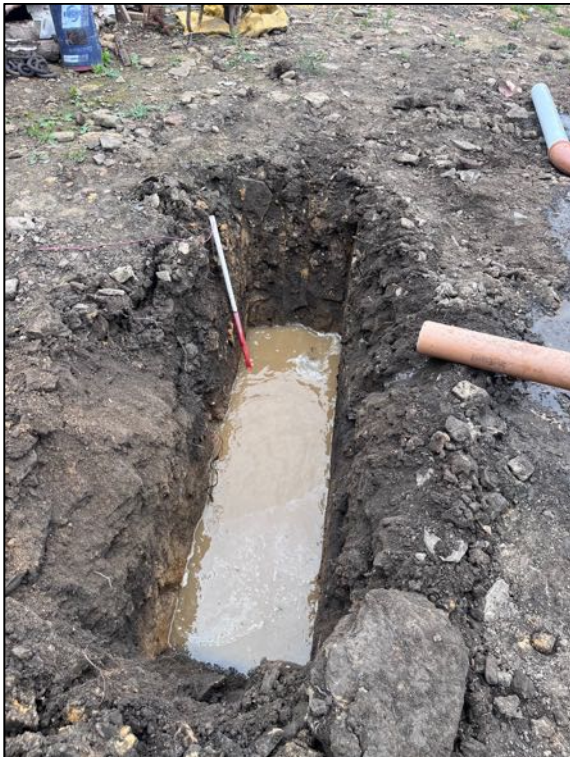
The soakaway test as conducted was considered sufficient to confirm that a soakaway system is unlikely to provide the indicated infiltration rate required for the accommodation of surface water drainage for surface run-off from the site. It is noted that the existing residential properties on land to the south are at a lower elevation relative to the site. Soakaways should be positioned at least 5m away from the foundations of any permanent structures. Given the site setting and development proposal it is assumed that some form of attenuation scheme is likely to be more suitable.

TP4 soakaway test after 1 hr

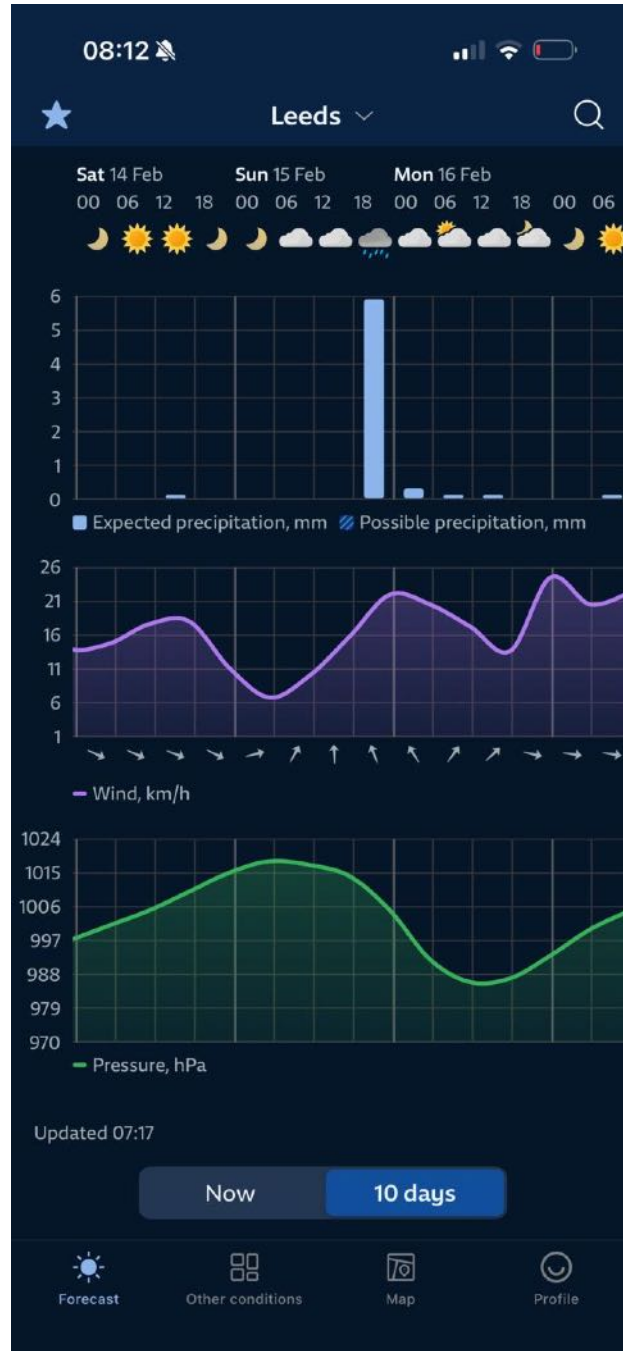
Barometric Pressure curves prior to sampling for all visits:

Sampling on Wednesday 16th January, and again 25th February 2027 worst case scenario: 00:15hrs.
