## Phase 2: Site Investigation

**Tesla SUC Leeds Birstall Additional Works**

# PHASE 2 SITE INVESTIGATION REPORT

## TESLA SUC LEEDS BIRSTALL ADDITIONAL WORKS

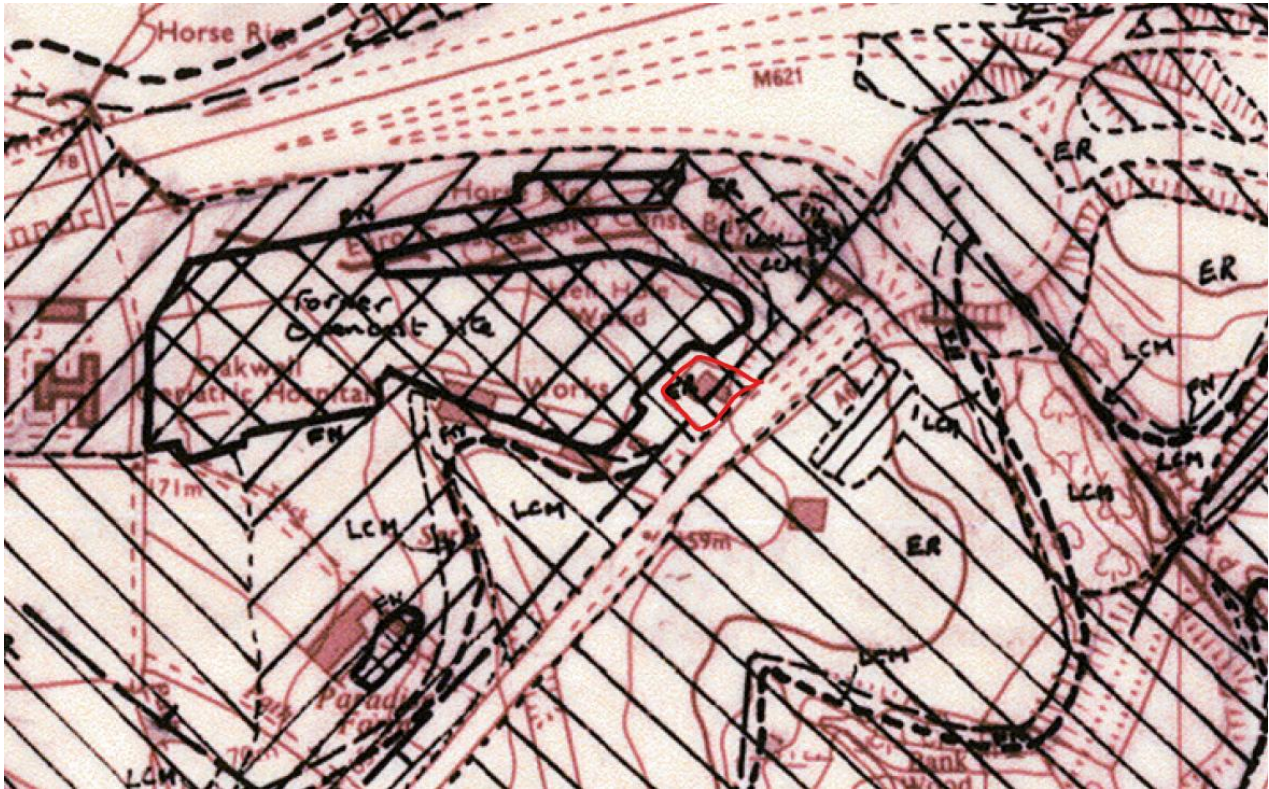
The above BGS map extract (*British Geological Survey (BGS): 1:10 000 geological map series sheet SE22NW Solid and Drift Geology (1999)*) shows that the extent of the opencast appears to reach the northwestern boundary of the site.

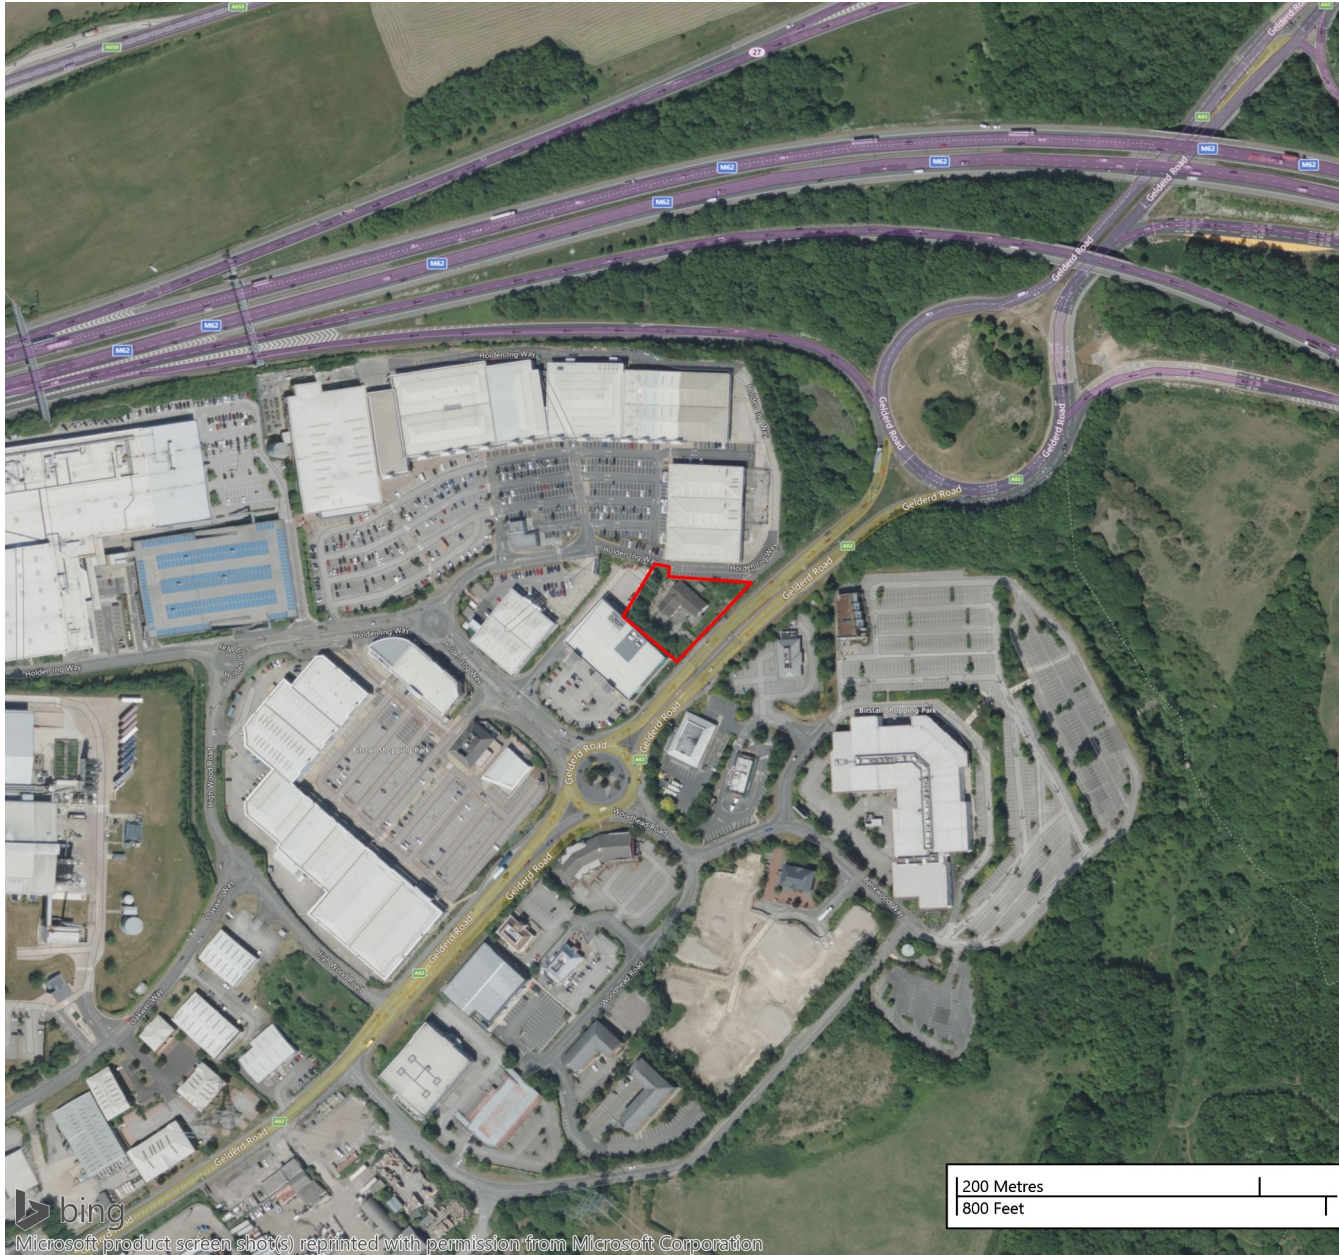
**Figure Title**

The site investigation described in this report was carried out by Solmek to the instructions of Fresh Design (International) Ltd to undertake a site investigation on a parcel of land at Tesla SUC, Gelderd Road, Birstall, WF17 9LS. A site location plan is presented in Appendix A, Figure 1.

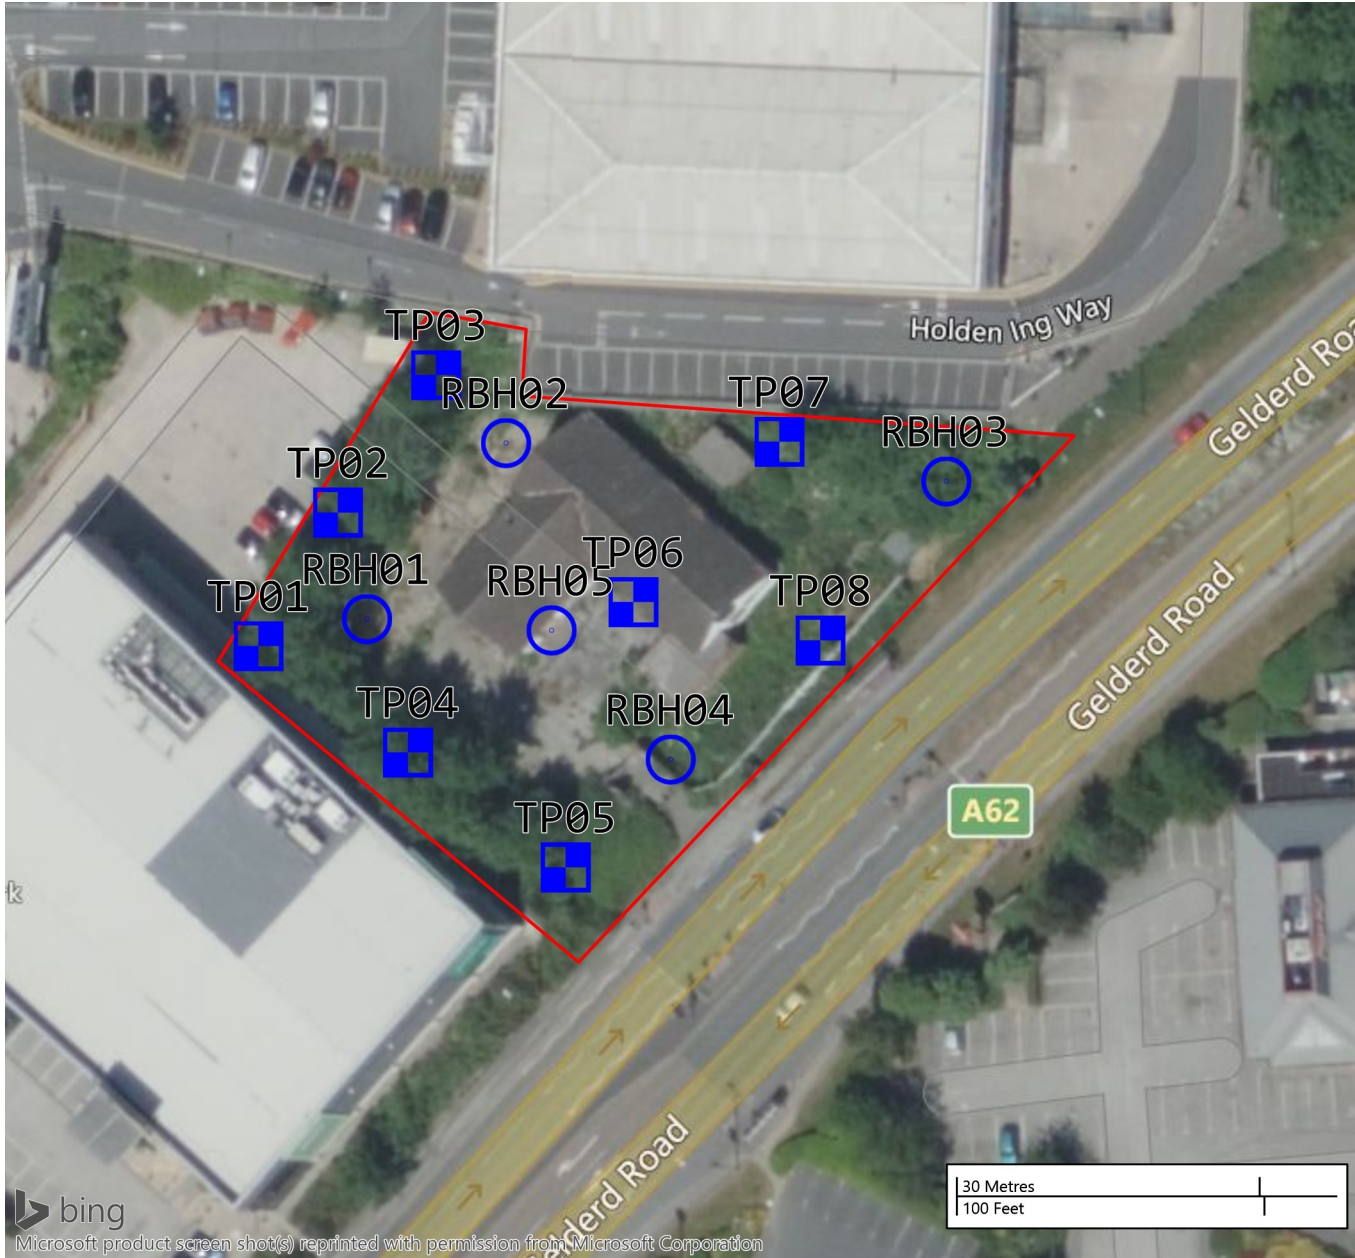
**Figure Title**

Descriptions of the strata encountered in the trial pits and boreholes together with details of sampling and groundwater are presented in Appendix B of this report. A plan showing the location of the trial pits and boreholes can be found in Appendix A (Figure 2). Selected photographs of the trial pits are presented in Appendix B.

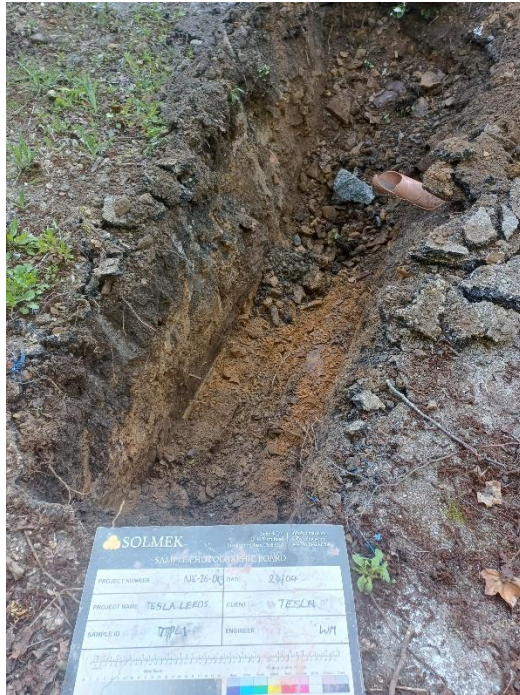
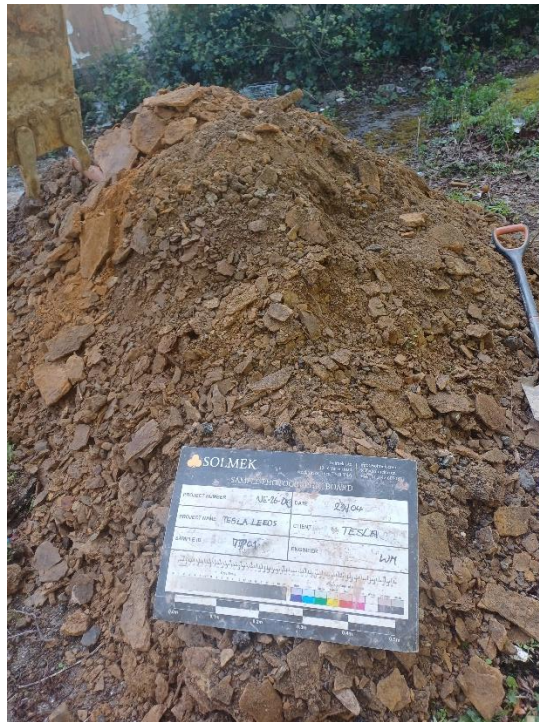
Title	Date
Figures 3 & 4	June 2026
Project	
Tesla, Geldard Road, Birstall	
Client	
Fresh Design (International) Ltd

Figure 3: TP01

Figure 4: TP01 Spoil

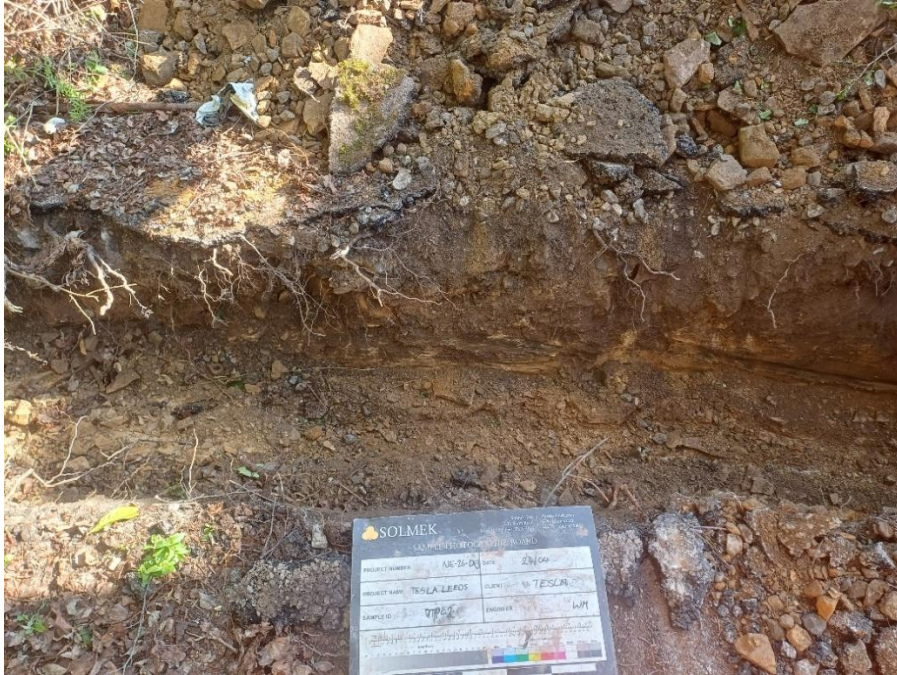
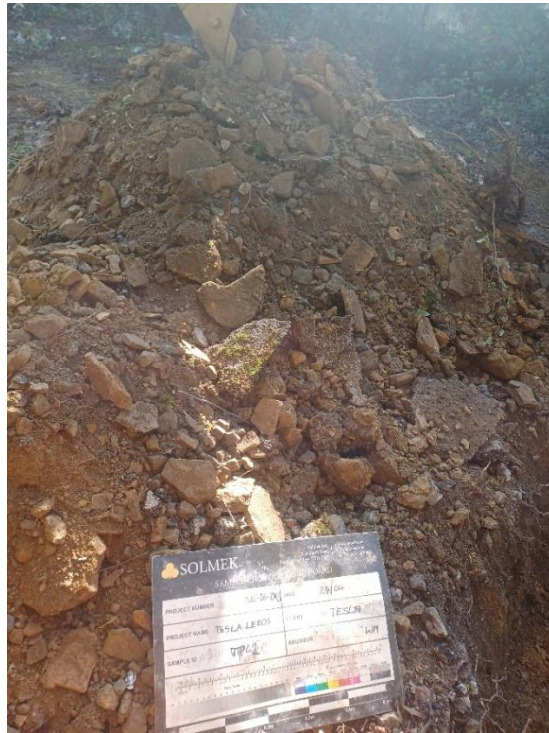
<b>Title</b>	<b>Date</b>
Figures 5 & 6	June 2026
<b>Project</b>	
Tesla, Geldard Road, Birstall	
<b>Client</b>	
Fresh Design (International) Ltd

Figure 5: TP02

Figure 6: TP02 Spoil

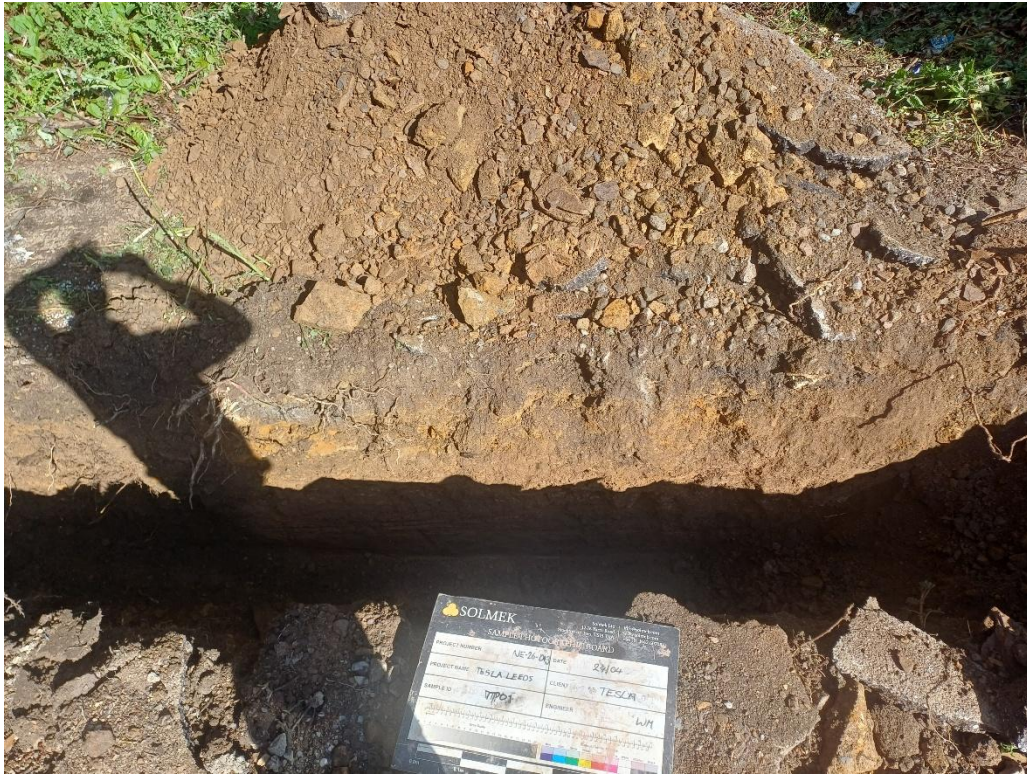
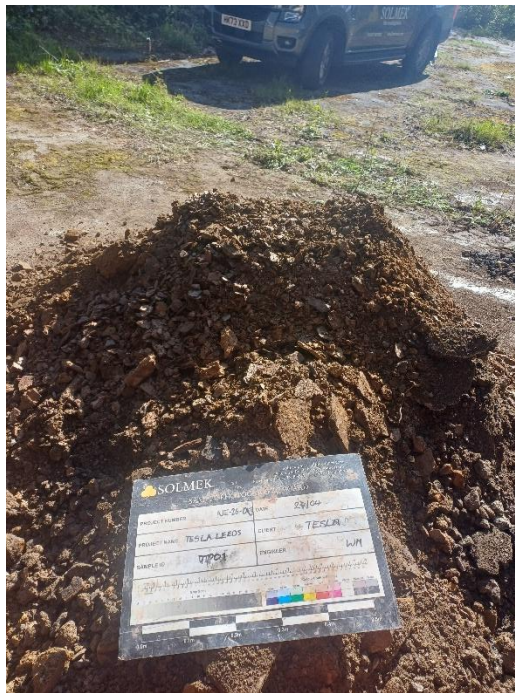
Title	Date
Figures 7 & 8	June 2026
Project	
Tesla, Geldard Road, Birstall	
Client	
Fresh Design (International) Ltd

Figure 7: TP03

Figure 8: TP03 Spoil

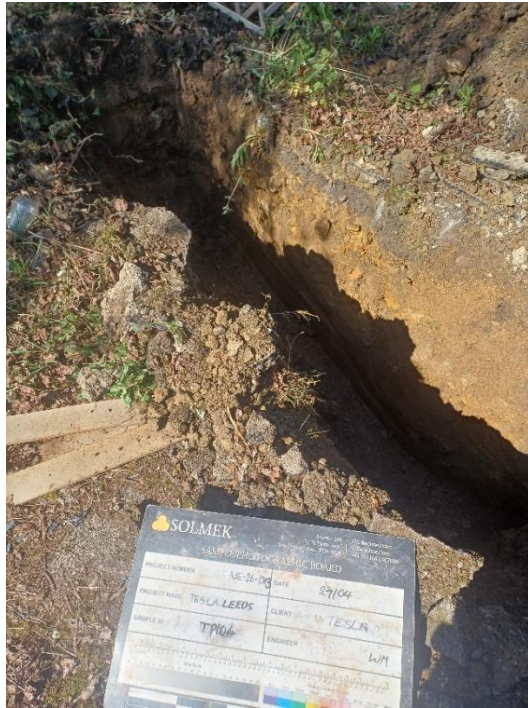
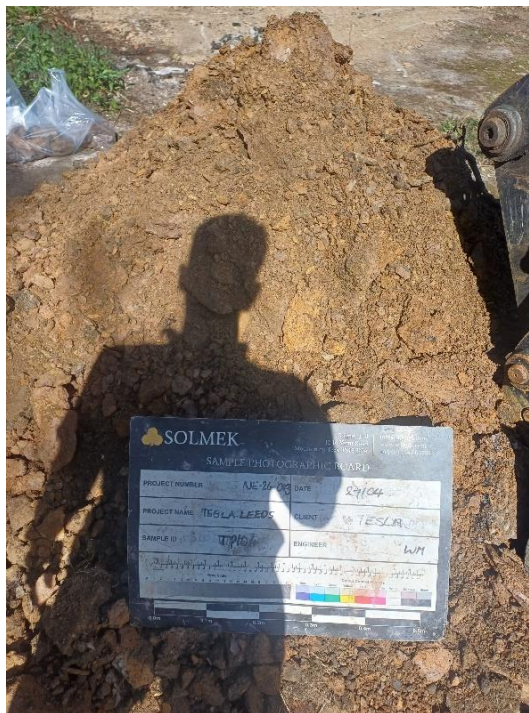
Title	Date
Figures 9 & 10	June 2026
Project	
Tesla, Geldard Road, Birstall	
Client	
Fresh Design (International) Ltd

Figure 9: TP04

Figure 10: TP04 Spoil

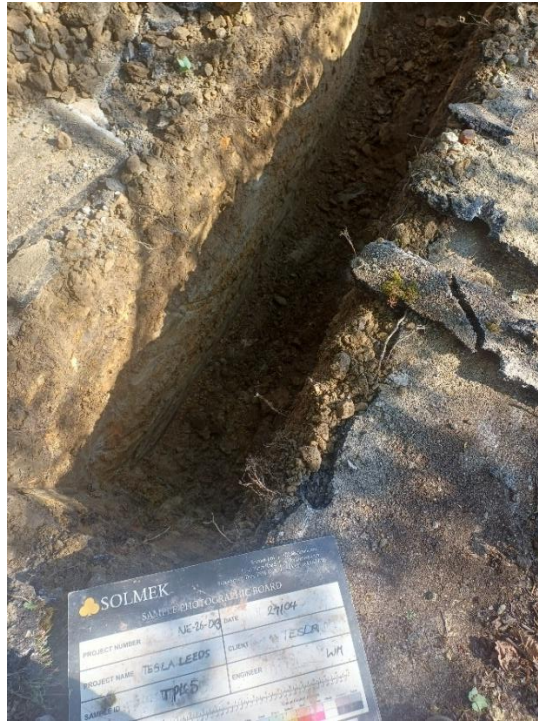
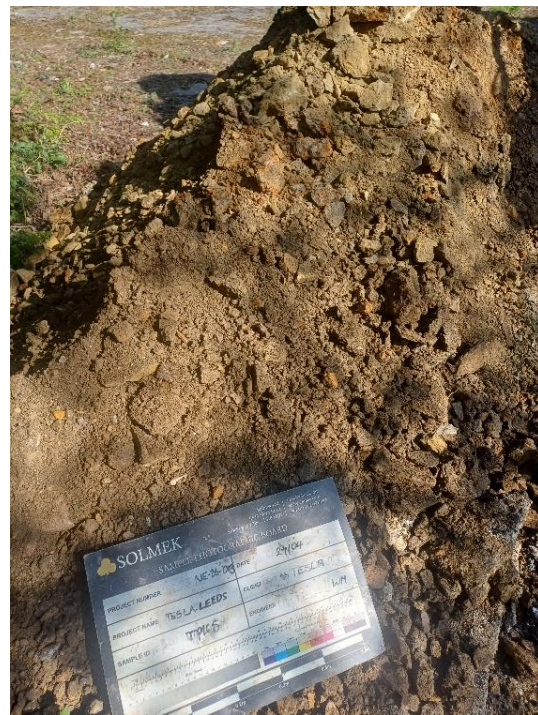
<b>Title</b>	<b>Date</b>
Figures 11 & 12	June 2026
<b>Project</b>	
Tesla, Geldard Road, Birstall	
<b>Client</b>	
Fresh Design (International) Ltd

Figure 11: TP05

Figure 12: TP05 Spoil

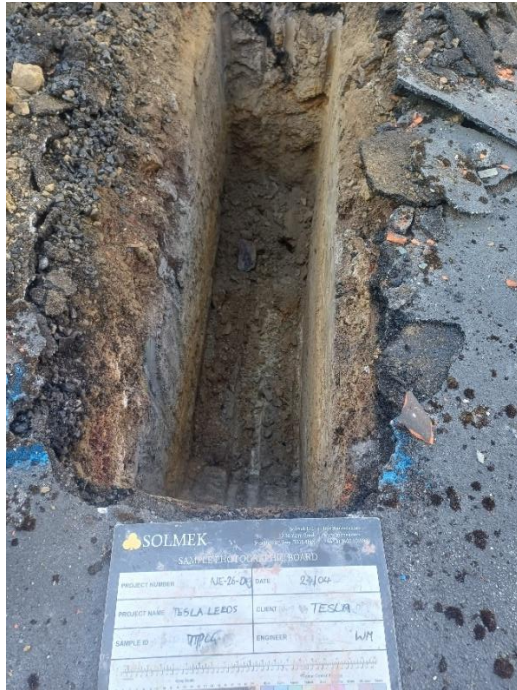
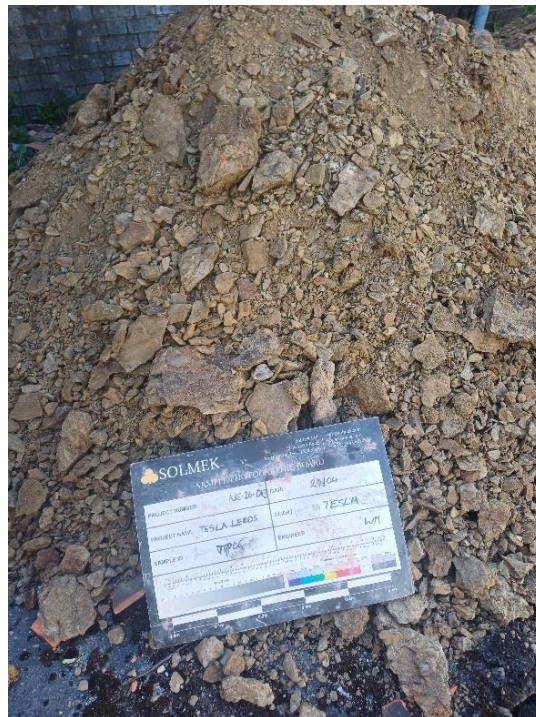
<p style="font-size: 24pt; font-weight: bold; margin-left: 10px;">SOLMEK</p>
Figures 13 & 14	June 2026	
<b>Project</b>		
Tesla, Geldard Road, Birstall		
<b>Client</b>		
Fresh Design (International) Ltd

Figure 13: TP06

Figure 14: TP06 Spoil

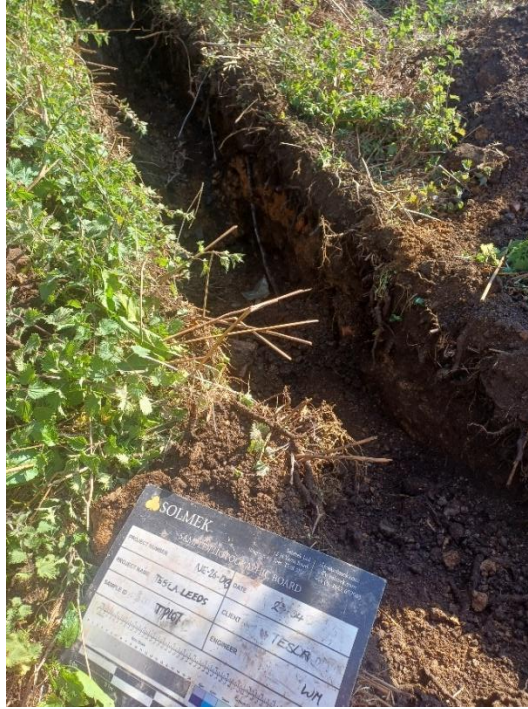
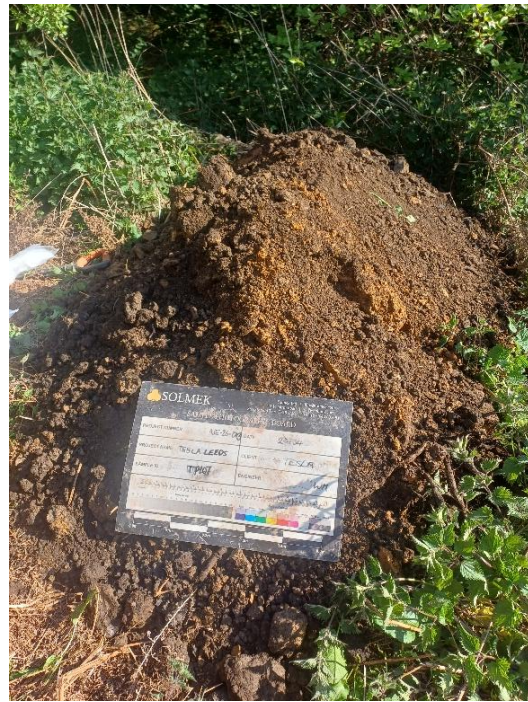
<b>Title</b>	<b>Date</b>
Figures 15 & 16	June 2026
<b>Project</b>	
Tesla, Geldard Road, Birstall	
<b>Client</b>	
Fresh Design (International) Ltd

Figure 15: TP07

Figure 16: TP07 Spoil

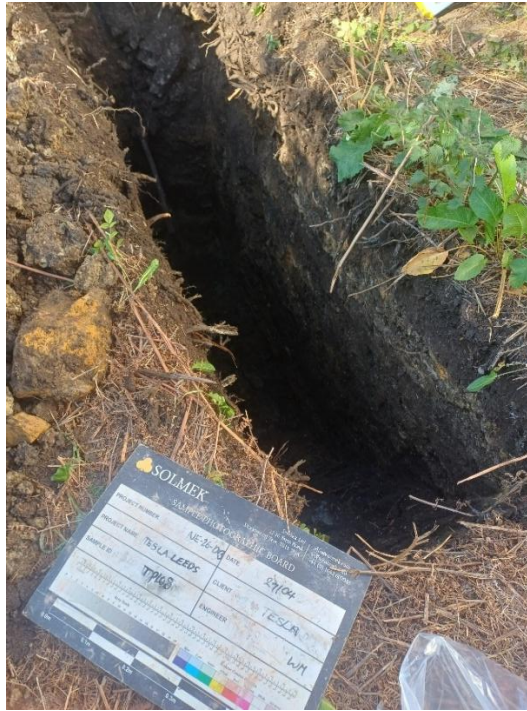
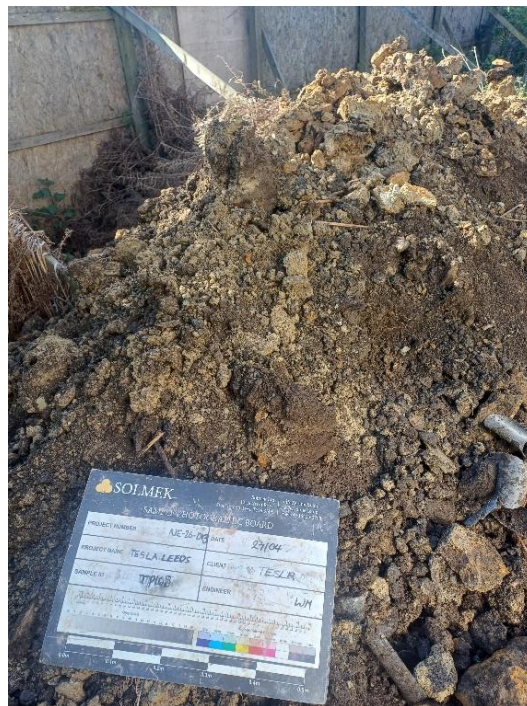
Title	Date
Figures 17 & 18	June 2026
Project	
Tesla, Geldard Road, Birstall	
Client	
Fresh Design (International) Ltd

Figure 17: TP08

Figure 18: TP08 Spoil

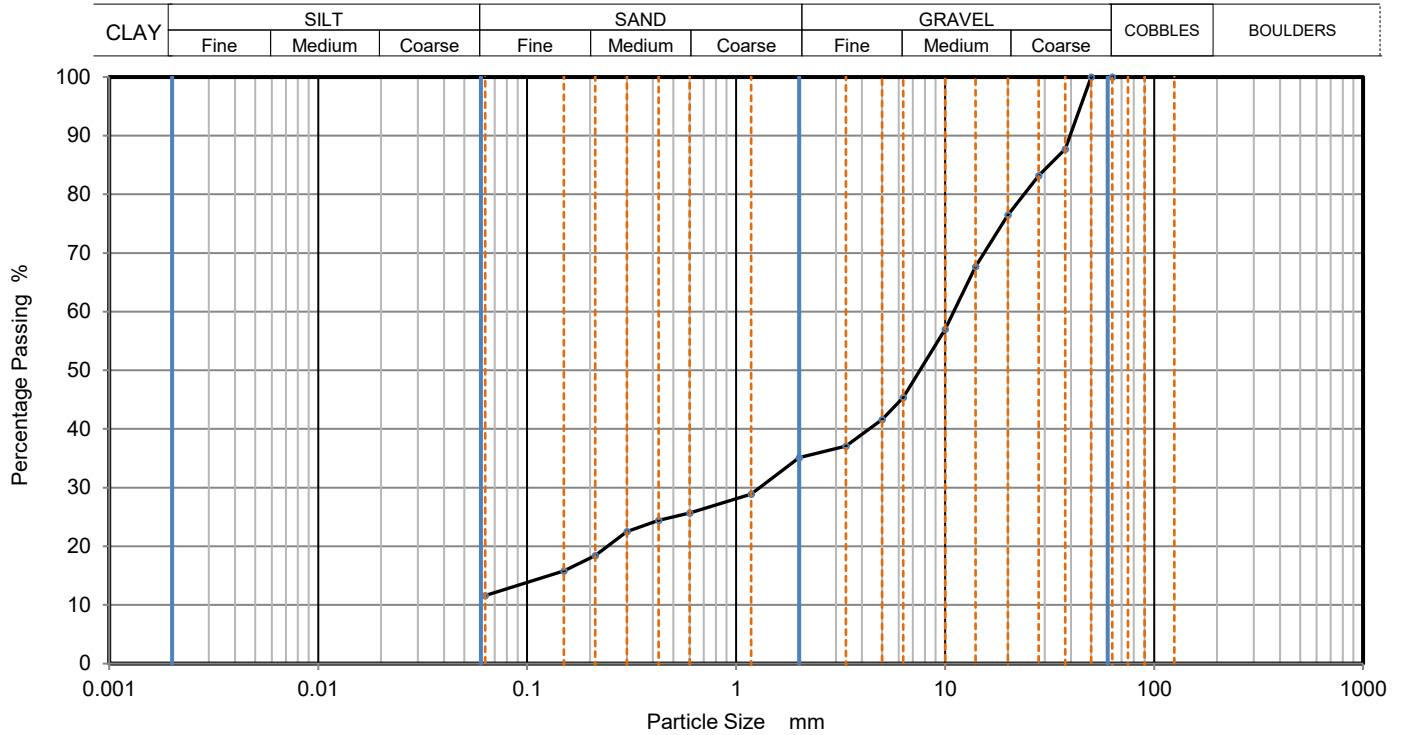
<b>PARTICLE SIZE DISTRIBUTION</b>				Job Ref	<b>NE-26-043</b>
				Borehole/Pit No.	TP02
Site Name	Tesla, Birstall, Leeds			Sample No.	
Soil Description	Clayey, Very Sandy, GRAVEL			Depth, m	0.05
Specimen Reference	TP02	Specimen Depth	0.05 m	Sample Type	B
Test Method	ISO 17892 -4, by sieving on pre-dried or dry sample			KeyLAB ID	G2MT2026051487

Sieving		Sedimentation	
Particle Size mm	% Passing	Particle Size mm	% Passing
63	100		
50	100		
37.5	88		
28	83		
20	77		
14	68		
10	57		
6.3	45		
5	42		
3.35	37		
2	35		
1.18	29		
0.6	26		
0.425	24		
0.3	23		
0.212	18		
0.15	16		
0.063	12

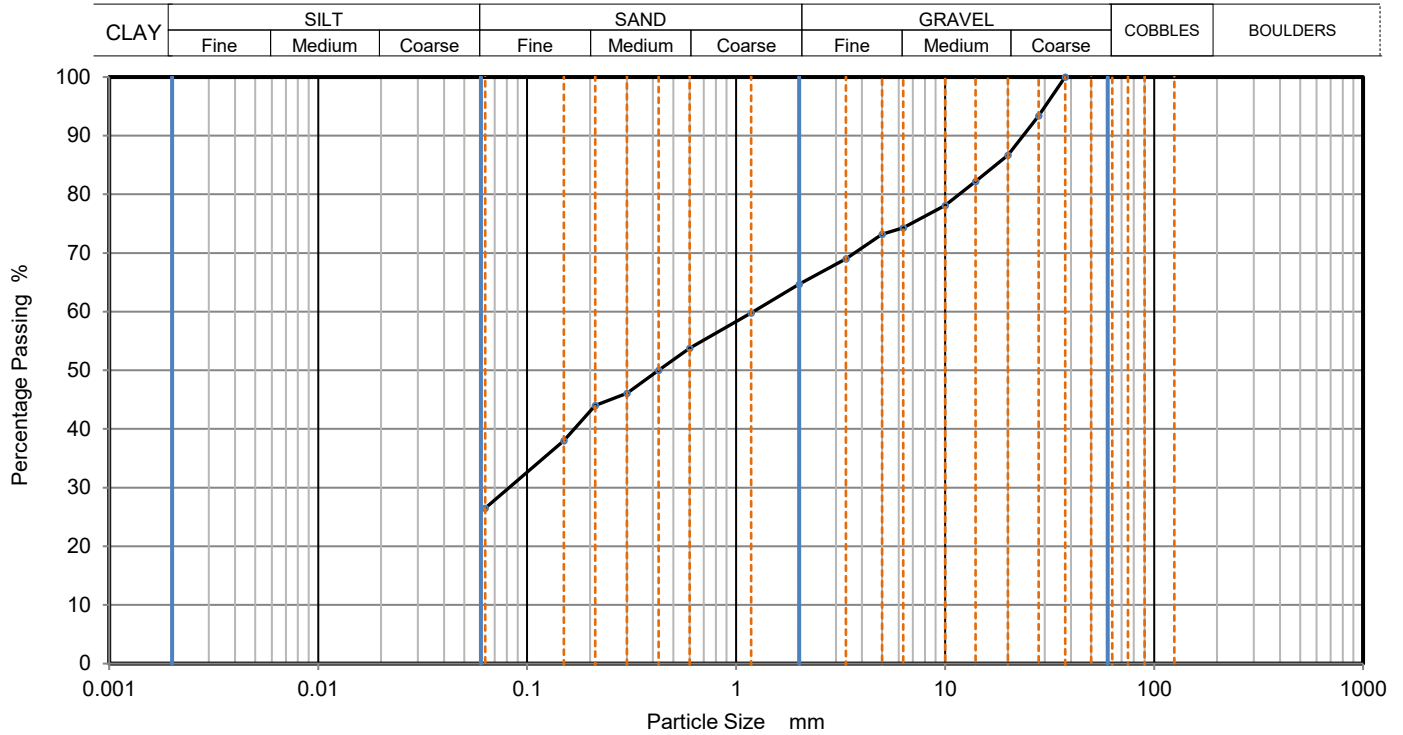
<b>PARTICLE SIZE DISTRIBUTION</b>				Job Ref	<b>NE-26-043</b>
				Borehole/Pit No.	TP07
Site Name	Tesla, Birstall, Leeds			Sample No.	
Soil Description	Very Clayey, Very Gravelly SAND			Depth, m	0.00
Specimen Reference	TP07	Specimen Depth	0 m	Sample Type	B
Test Method	ISO 17892 -4, by sieving on pre-dried or dry sample			KeyLAB ID	G2MT2026051494

Sieving		Sedimentation	
Particle Size mm	% Passing	Particle Size mm	% Passing
37.5	100		
28	93		
20	87		
14	82		
10	78		
6.3	74		
5	73		
3.35	69		
2	65		
1.18	60		
0.6	54		
0.425	50		
0.3	46		
0.212	44		
0.15	38		
0.063	27

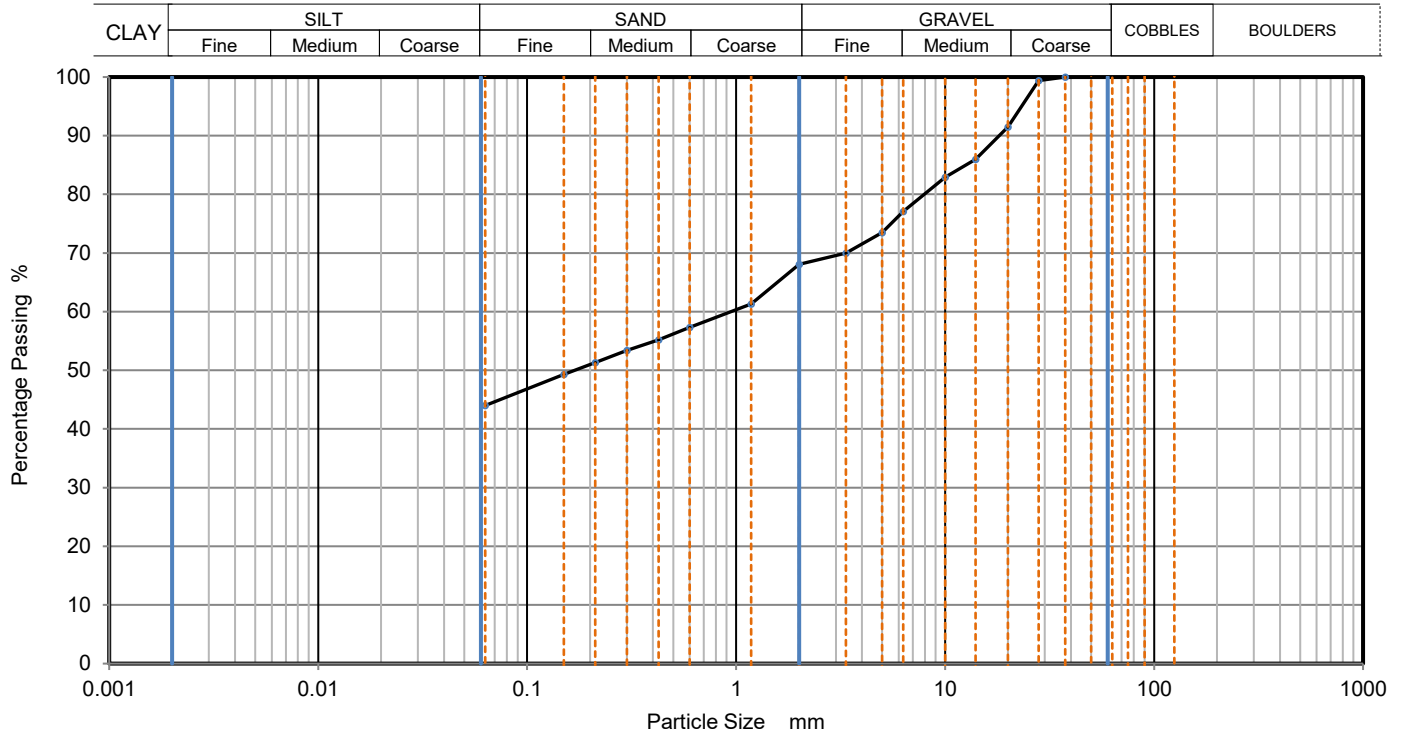
<b>PARTICLE SIZE DISTRIBUTION</b>				Job Ref	<b>NE-26-043</b>
				Borehole/Pit No.	TP08
Site Name	Tesla, Birstall, Leeds			Sample No.	
Soil Description	Very Sandy, Very Gravelly CLAY			Depth, m	1.00
Specimen Reference	TP08	Specimen Depth	1 m	Sample Type	B
Test Method	ISO 17892 -4, by sieving on pre-dried or dry sample			KeyLAB ID	G2MT2026051495

Sieving		Sedimentation	
Particle Size mm	% Passing	Particle Size mm	% Passing
37.5	100		
28	99		
20	92		
14	86		
10	83		
6.3	77		
5	74		
3.35	70		
2	68		
1.18	61		
0.6	57		
0.425	55		
0.3	53		
0.212	51		
0.15	49		
0.063	44

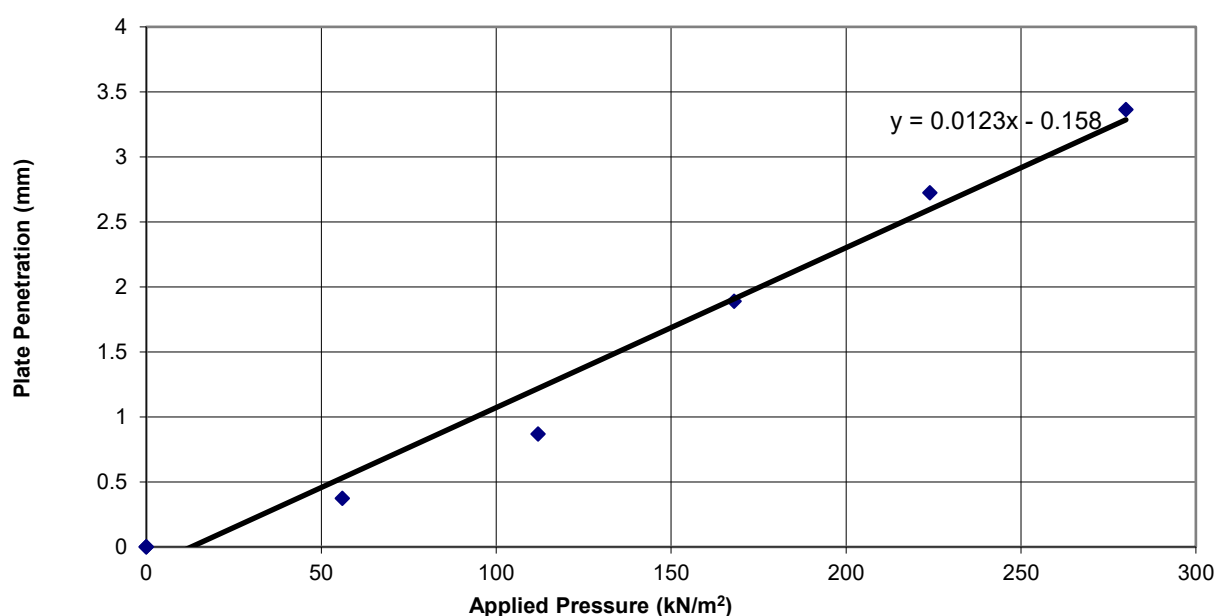
<b>PLATE BEARING TEST</b>		<b>Date:</b>	24/04/2026
<b>Project Number:</b>	NE-26-043	<b>Test No:</b>	TP01-PBT
<b>Project Name:</b>	Tesla, Leeds	<b>Test Level:</b>	0.1
<b>Test Method: BS 1377 : Part 9 : 1990 (Incremental Method)</b>		<b>Weather:</b>	Sunny
<b>Plate Diameter:</b>	0.305 m	<b>Load Applied:</b>	280 kPa
<b>Kentledge Type:</b>	9.2T SUPRA HMK 102B	<b>Remarks:</b>	Weathered mudstone bedrock

Pressure (kN/m <sup>2</sup> )	Plate Penetration (mm)
Initial	0	0
Stage 1	56	0.38
Stage 2	112	0.87
Stage 3	168	1.89
Stage 4	224	2.73
Stage 5	280	3.37
Stage 6	0	
Stage 7		
Stage 8

Conversion Factor	0.45	Produced by: <i>William McCarthy</i>
Stress Applied @ 1.25mm	117.36 kN/m <sup>2</sup>	
Total Plate Deflection	3.37 mm	Checked by: <i>[Signature]</i>
Plate Diameter	305 mm	
k305	93892

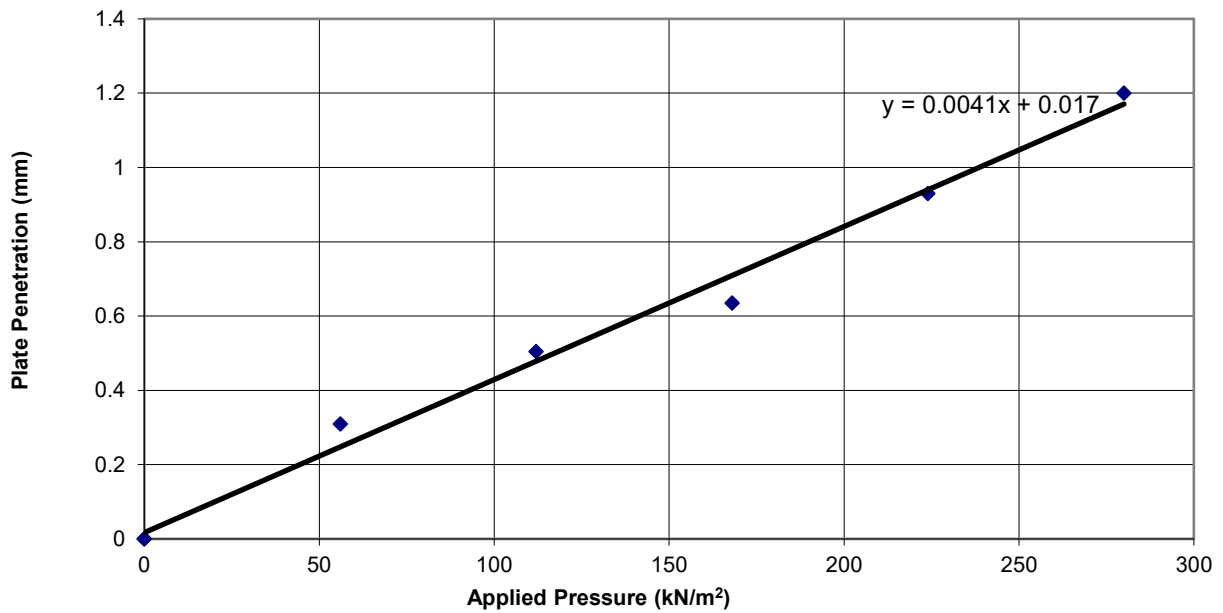
<b>PLATE BEARING TEST</b>		<b>Date:</b>	24/04/2026
<b>Project Number:</b>	NE-26-043	<b>Test No:</b>	TP03-PBT
<b>Project Name:</b>	Tesla, Leeds	<b>Test Level:</b>	0.2
<b>Test Method: BS 1377 : Part 9 : 1990 (Incremental Method)</b>		<b>Weather:</b>	Sunny
<b>Plate Diameter:</b>	0.305 m	<b>Load Applied:</b>	280 kPa
<b>Kentledge Type:</b>	9.2T SUPRA HMK 102B	<b>Remarks:</b>	Natural clay.

Pressure (kN/m <sup>2</sup> )	Plate Penetration (mm)
Initial	0	0
Stage 1	56	0.31
Stage 2	112	0.51
Stage 3	168	0.64
Stage 4	224	0.93
Stage 5	280	1.20
Stage 6	0	
Stage 7		
Stage 8

Conversion Factor	0.45	Produced by: <i>William McCarthy</i>
Stress Applied @ 1.25mm	300.27 kN/m <sup>2</sup>	
Total Plate Deflection	1.20 mm	Checked by: <i>[Signature]</i>
Plate Diameter	305 mm	
k305	240214

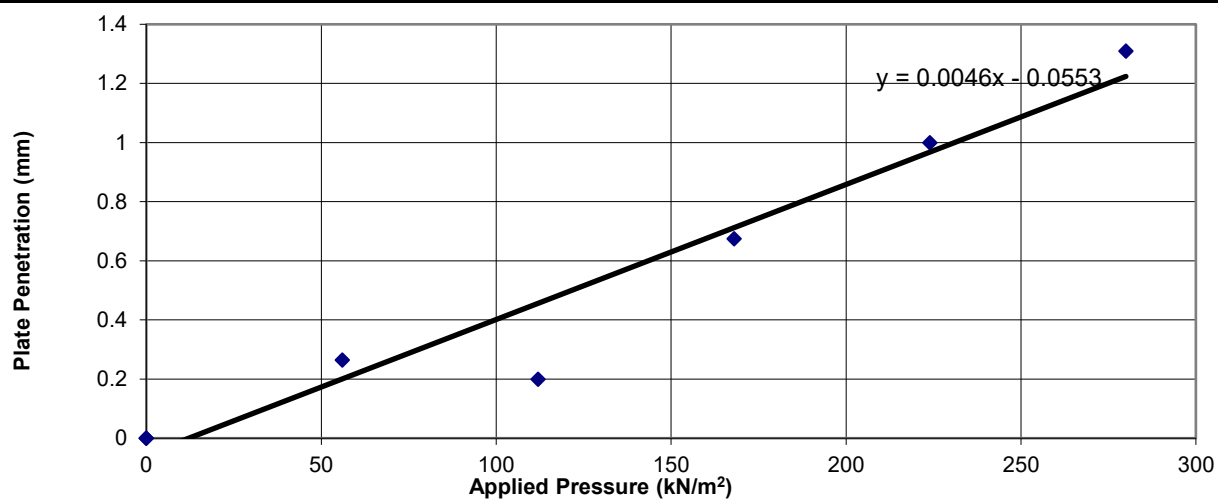
<b>PLATE BEARING TEST</b>		<b>Date:</b>	27/04/2026
<b>Project Number:</b>	NE-26-043	<b>Test No:</b>	TP05-PBT
<b>Project Name:</b>	Tesla, Leeds	<b>Test Level:</b>	0.2
<b>Test Method: BS 1377 : Part 9 : 1990 (Incremental Method)</b>		<b>Weather:</b>	Sunny
<b>Plate Diameter:</b>	0.305 m	<b>Load Applied:</b>	280 kPa

Pressure (kN/m <sup>2</sup> )	Plate Penetration (mm)	
Initial	0	0	
Stage 1	56	0.27	
Stage 2	112	0.20	28.000
Stage 3	168	0.68	
Stage 4	224	1.00	
Stage 5	280	1.31	
Stage 6	0		
Stage 7			
Stage 8

Conversion Factor	0.45	Produced by: <i>William McCarthy</i> Checked by: <i>[Signature]</i>
Stress Applied @ 1.25mm	283.34 kN/m <sup>2</sup>	
Total Plate Deflection	1.31 mm

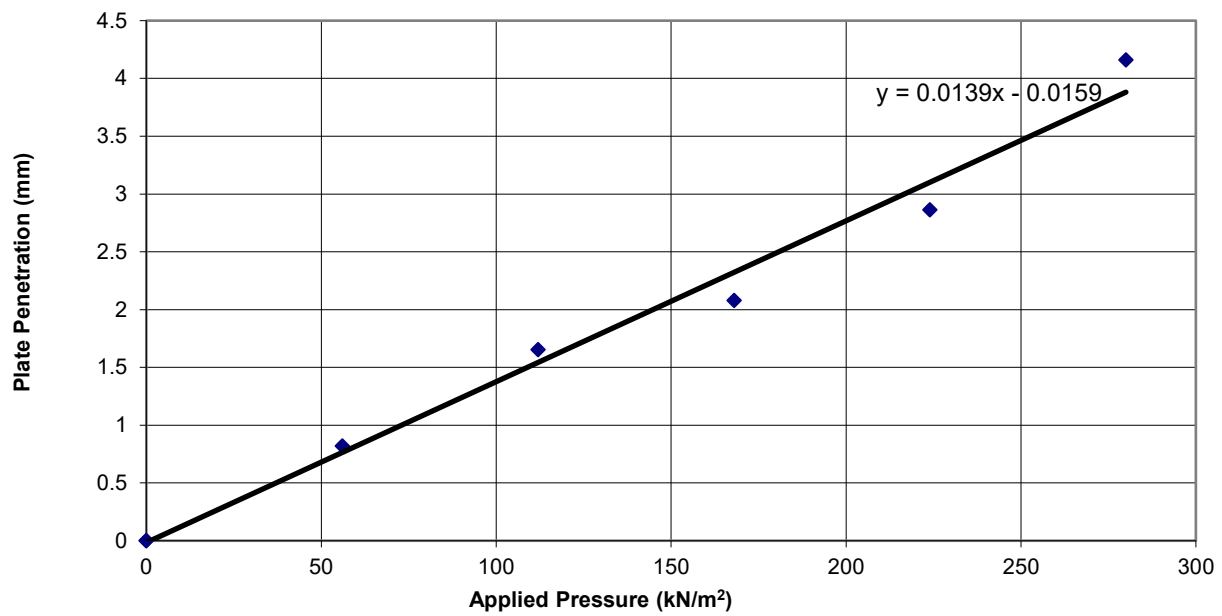
<b>PLATE BEARING TEST</b>		<b>Date:</b>	24/04/2026
<b>Project Number:</b>	NE-26-043	<b>Test No:</b>	TP06-PBT
<b>Project Name:</b>	Tesla, Leeds	<b>Test Level:</b>	0.2
<b>Test Method: BS 1377 : Part 9 : 1990 (Incremental Method)</b>		<b>Weather:</b>	Sunny
<b>Plate Diameter:</b>	0.305 m	<b>Load Applied:</b>	280 kPa
<b>Kentledge Type:</b>	9.2T SUPRA HMK 102B	<b>Remarks:</b>	Weathered mudstone bedrock

Pressure (kN/m <sup>2</sup> )	Plate Penetration (mm)
Initial	0	0
Stage 1	56	0.82
Stage 2	112	1.66
Stage 3	168	2.08
Stage 4	224	2.87
Stage 5	280	4.16
Stage 6	0	
Stage 7		
Stage 8

Conversion Factor	0.45	Produced by: <i>William McCarthy</i>
Stress Applied @ 1.25mm	91.29 kN/m <sup>2</sup>	
Total Plate Deflection	4.16 mm	Checked by: <i>[Signature]</i>
Plate Diameter	305 mm	
k305	73029

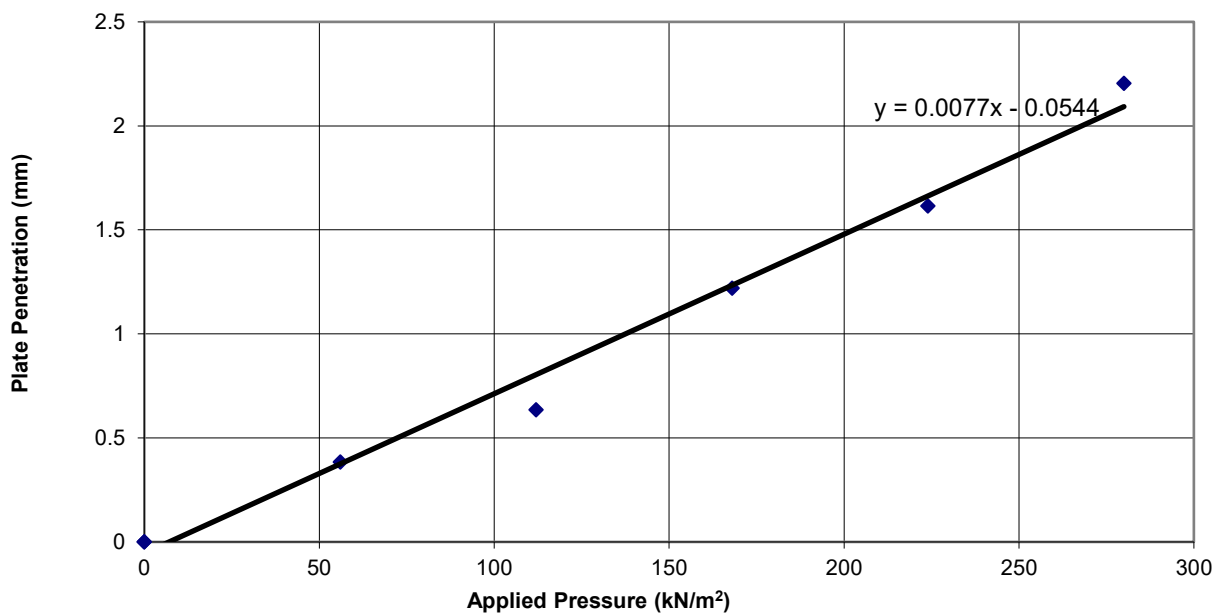
<b>PLATE BEARING TEST</b>		<b>Date:</b>	27/04/2026
<b>Project Number:</b>	NE-26-043	<b>Test No:</b>	TP08-PBT
<b>Project Name:</b>	Tesla, Leeds	<b>Test Level:</b>	0.2
<b>Test Method: BS 1377 : Part 9 : 1990 (Incremental Method)</b>		<b>Weather:</b>	Sunny
<b>Plate Diameter:</b>	0.305 m	<b>Load Applied:</b>	280 kPa
<b>Kentledge Type:</b>	9.2T SUPRA HMK 102B	<b>Remarks:</b>	Made ground

Pressure (kN/m <sup>2</sup> )	Plate Penetration (mm)
Initial	0	0
Stage 1	56	0.39
Stage 2	112	0.64
Stage 3	168	1.22
Stage 4	224	1.62
Stage 5	280	2.21
Stage 6	0	
Stage 7		
Stage 8

Conversion Factor	0.45	Produced by: <i>William McCarthy</i>
Stress Applied @ 1.25mm	170.75 kN/m <sup>2</sup>	
Total Plate Deflection	2.21 mm	Checked by: <i>[Signature]</i>
Plate Diameter	305 mm	
k305	136596
