## Phase 1 Desk Study Site Investigation Report

| <b>LOCATION</b> | Land at Back Marriot Street, Dewsbury WF13 1PA |
| <b>OUR REF.</b> | G26181 |

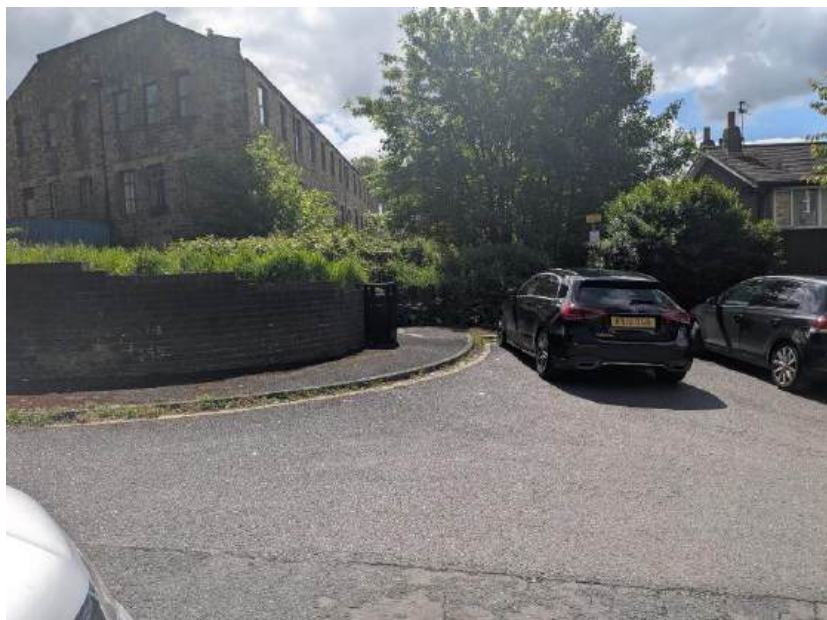
**Photograph 1:** Entrance to site from Camroyd Street to the north.

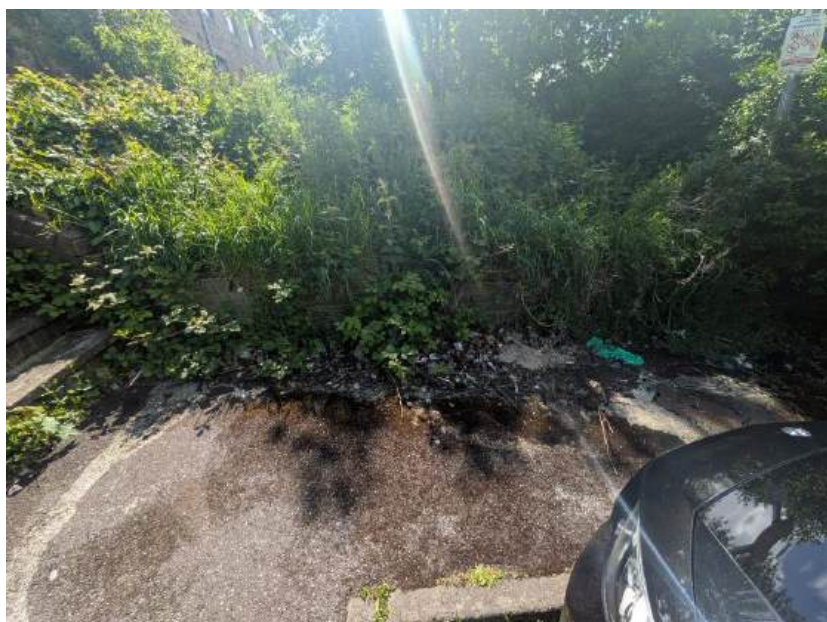
At the time of the walkover survey, the site was observed to be extremely overgrown and largely inaccessible in places due to dense vegetation. Ground cover consists predominantly of tall vegetation, dense scrub, and overgrown grassland, with several mature trees concentrated toward the centre of the site. Vegetation density significantly restricts movement across the site and limits visibility in some areas. Evidence of fly-tipping and general waste deposition was also noted during the survey, including discarded mattresses and other miscellaneous refuse within the vegetated areas. The site is currently undeveloped, with no permanent structures or formal areas of hardstanding present within the boundary. Topographically, the land is generally level, with a slight fall in elevation from south to north. A masonry retaining wall is present along the northern boundary, retaining higher ground to the rear. The structure is heavily overgrown and its condition could not be fully assessed during the walkover. The presence of the wall indicates a change in ground level and possible made ground behind it.

**Photograph 2:** Northern area of the site, showing a low masonry retaining wall along the boundary.

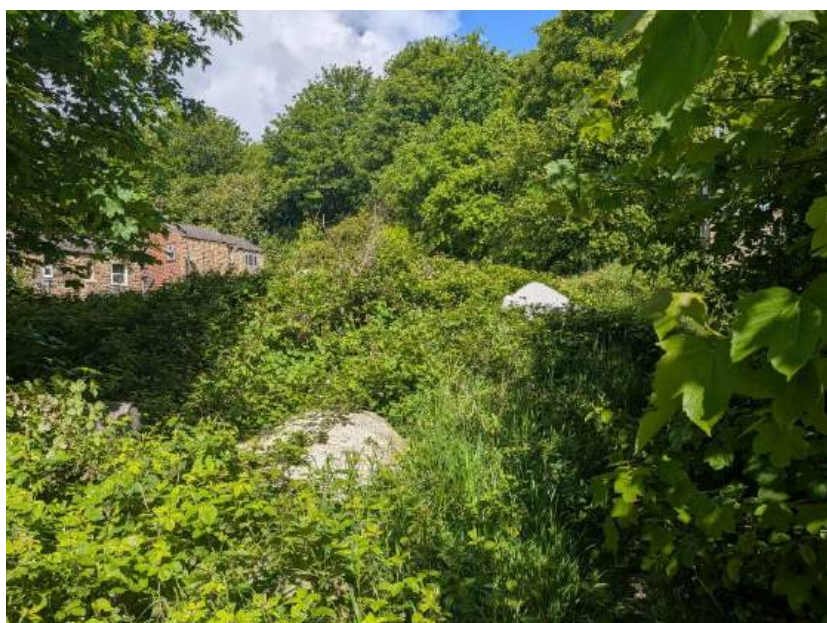
**Photograph 3:** View across the site looking north, showing dense overgrown vegetation and localised evidence of fly-tipping.
