Report No: C723/RS  
Date: July 2025

**REMEDIATION STRATEGY**  
**for land adjacent to**  
**480 HALIFAX ROAD, LIVERSEDGE,**  
**WEST YORKSHIRE**

Prepared for  
**Barnes Homes Yorkshire Ltd**

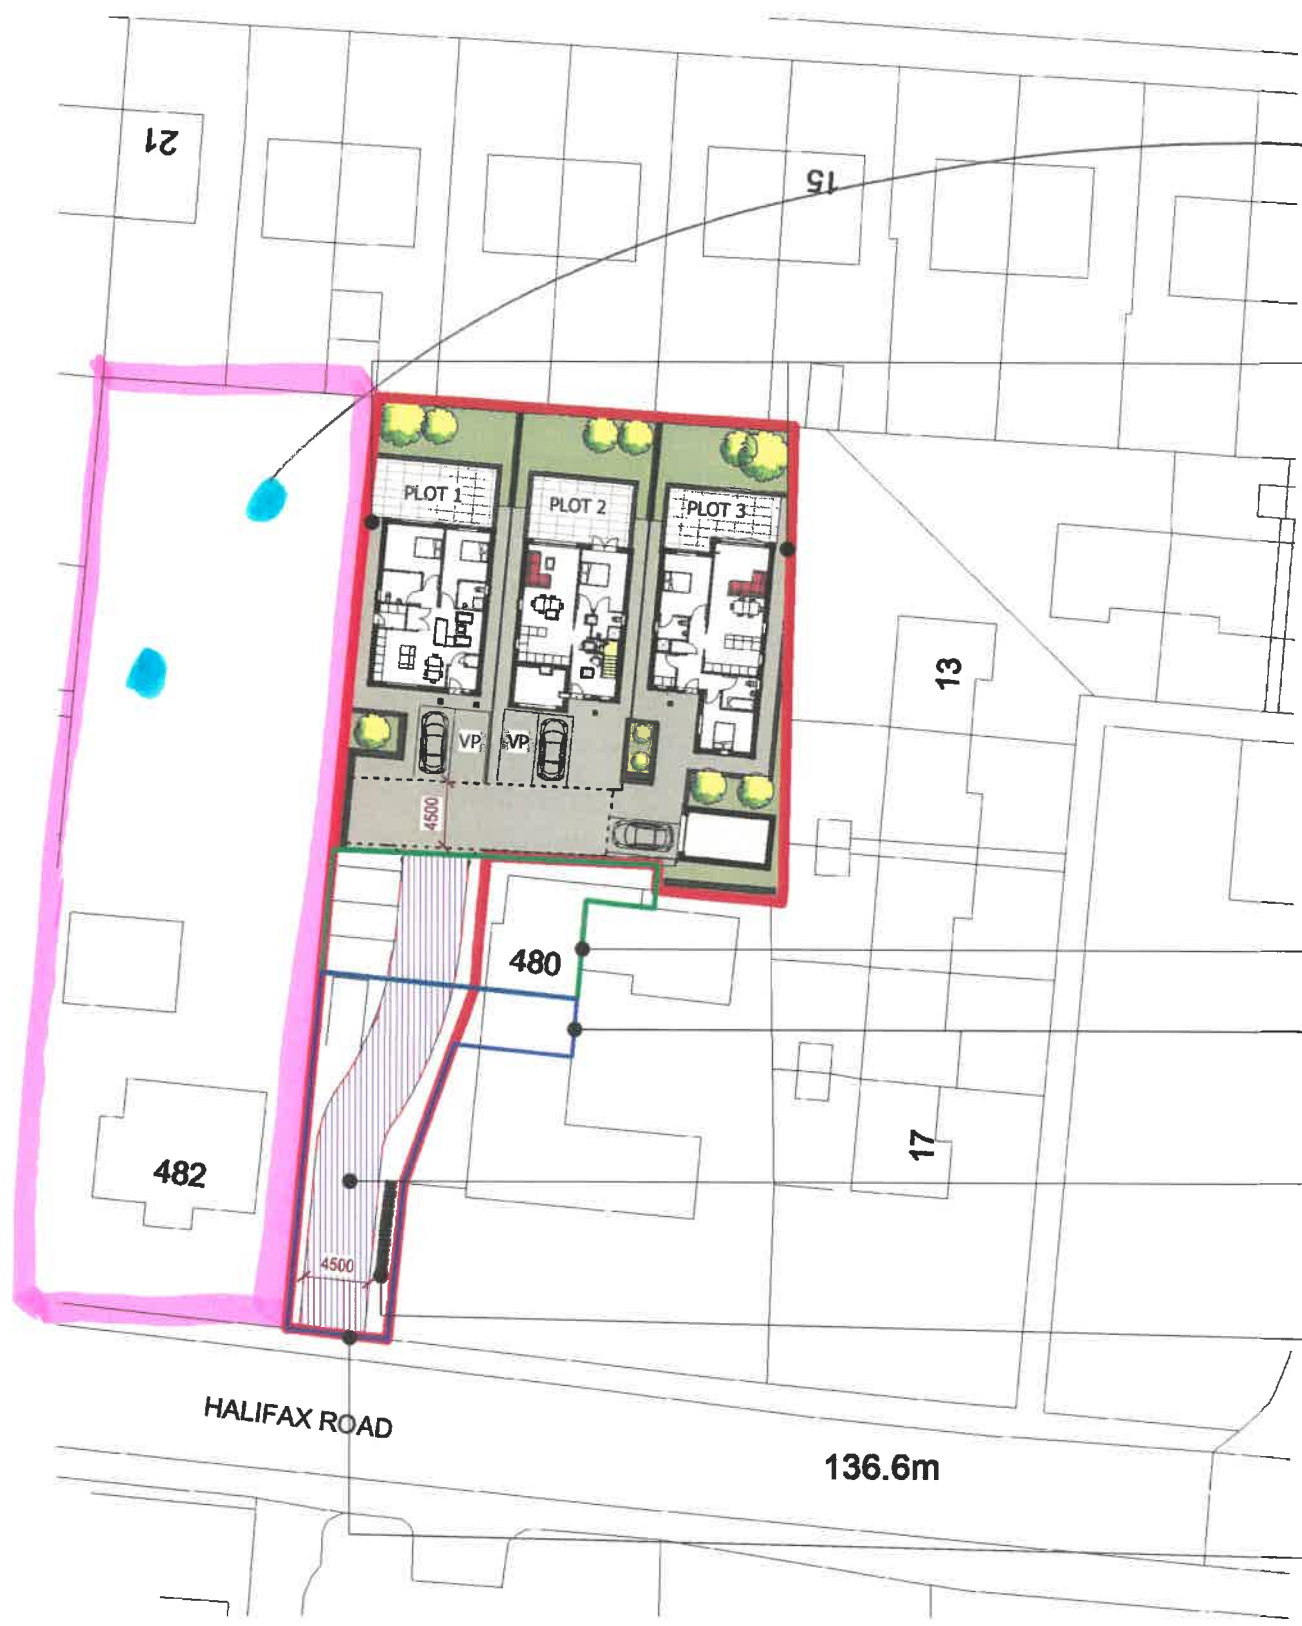
2 x additional dog-hole

MIN. 1m WALKWAY TO SITE PERIMETER

The proposed development is shown on the drawing prepared by Barnes Architectural Services Ltd, a copy of which is presented in Appendix A of this report.

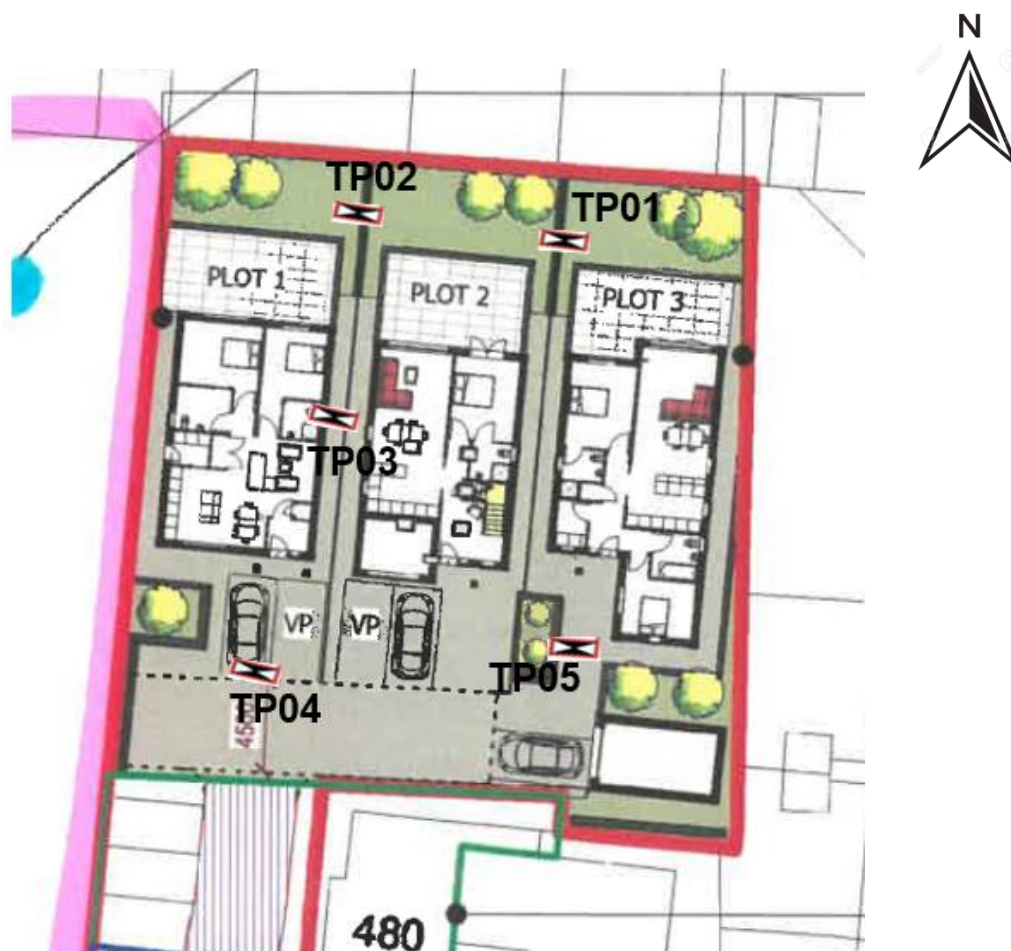
The exploratory hole positions were set out and the fieldwork supervised by a G&M engineering geologist. The locations of the exploratory holes are shown below;

The location and spatial distribution of the trial pits was considered adequate to suitably characterise the shallow soils present on site.

- Excavation of five trial pits to depths of between 0.8 m and 1.20 m below ground level (bgl).

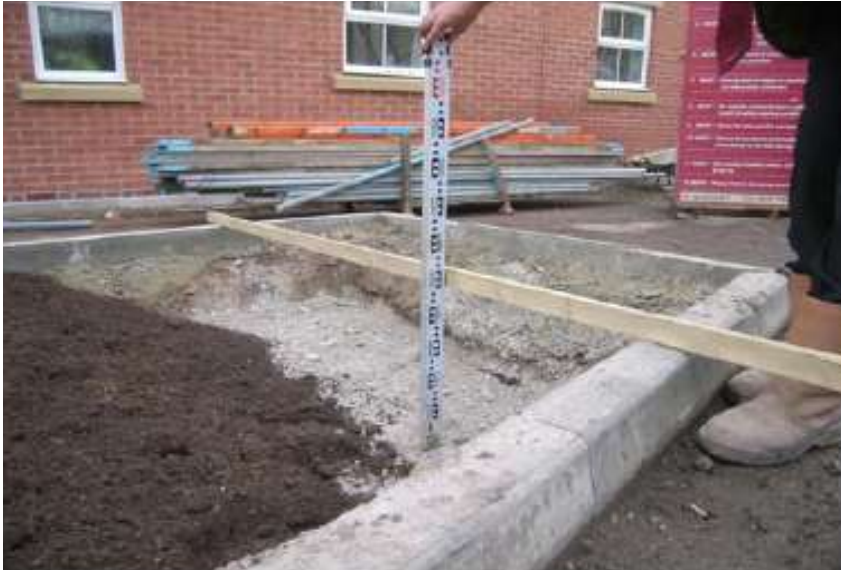
Photograph 1:  
Depth check of inert  
cover within area of  
public open space.  
Physical break layer  
and topsoil visible.

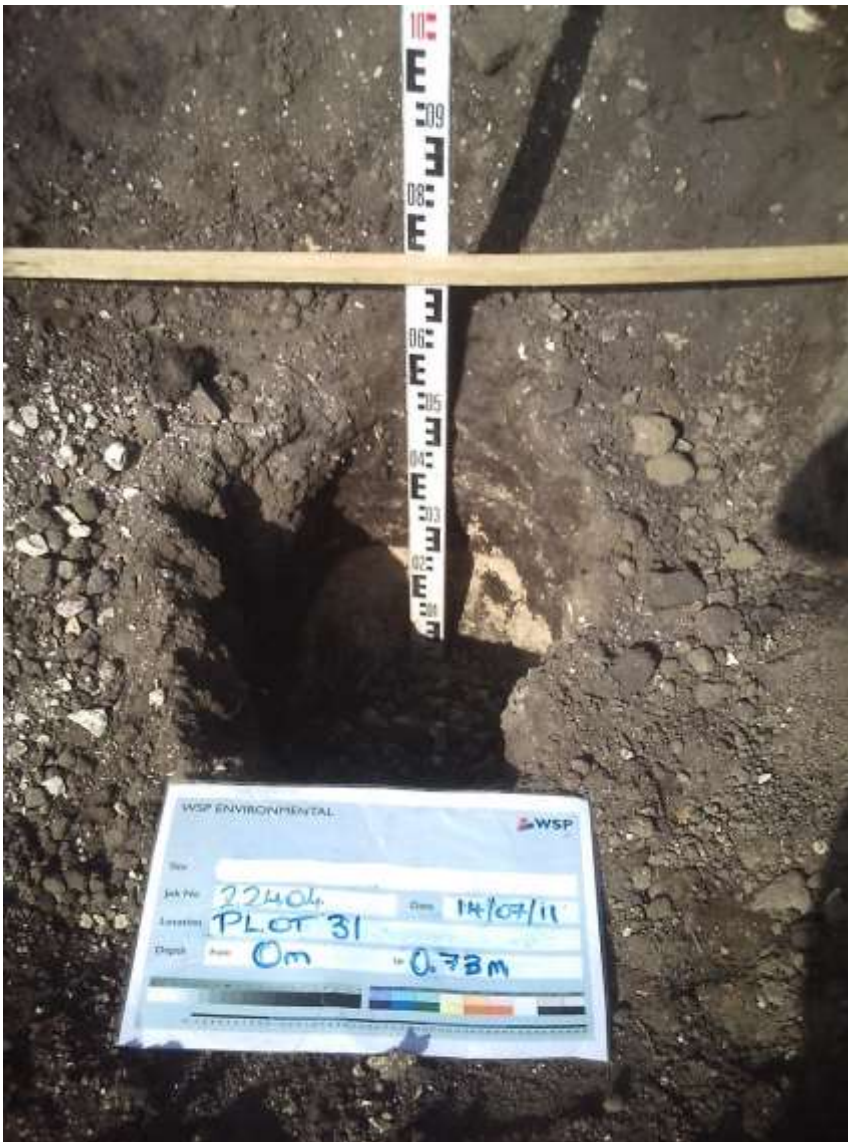
Photograph 2:  
Depth check of inert  
cover with Site &  
Location Information  
Board.

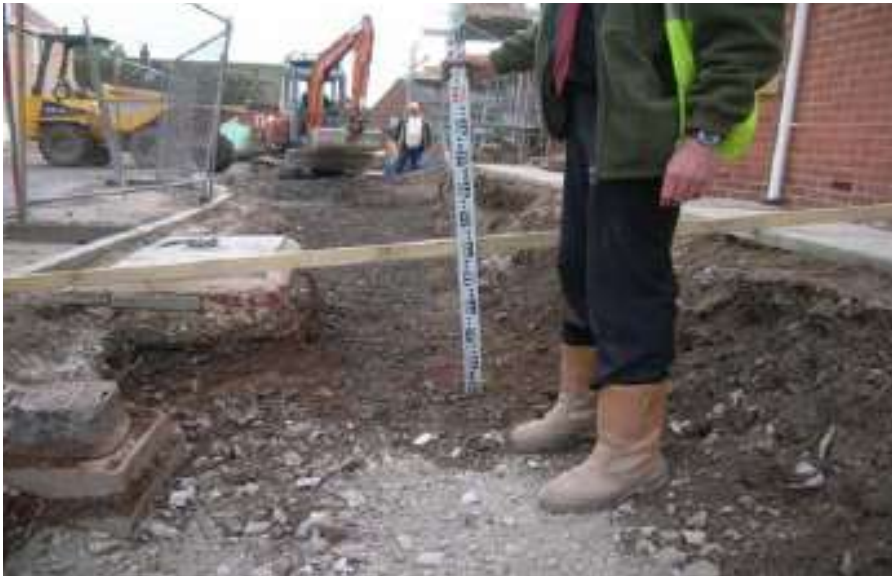
Photograph 3:  
Depth check of inert cover within areas of front gardens.

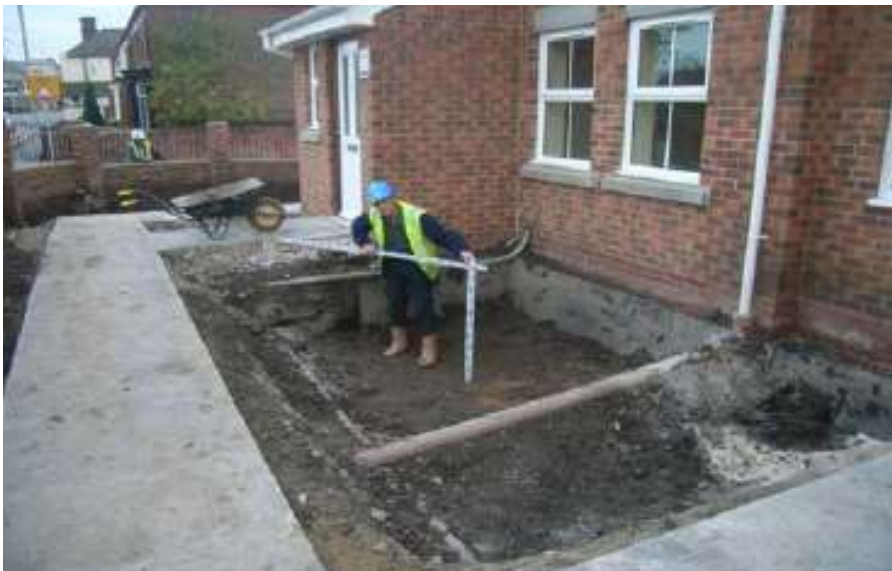
Photograph 4:  
Depth check of inert cover within areas of front gardens.

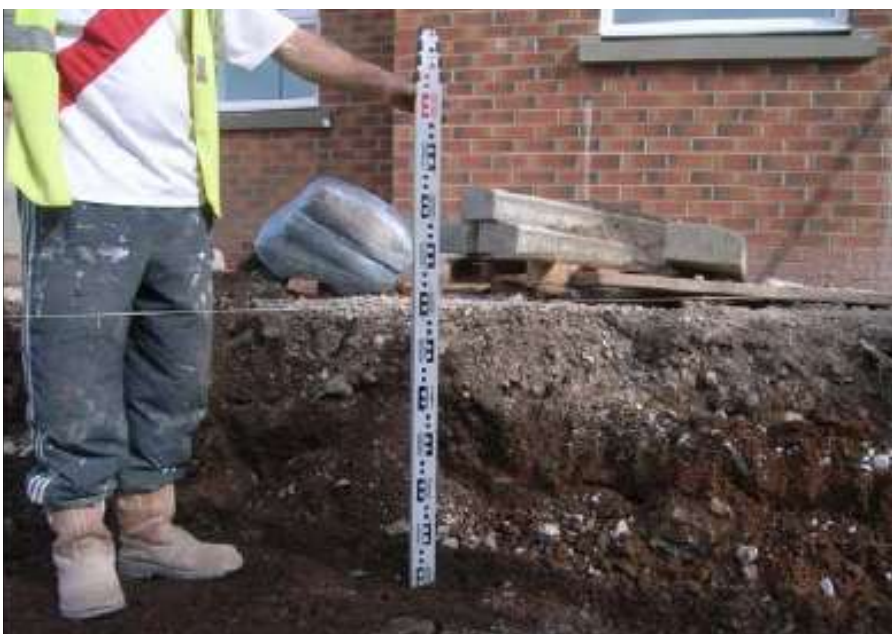
Photograph 5:  
Depth check of inert cover within rear gardens. Taut string line spans across excavation.

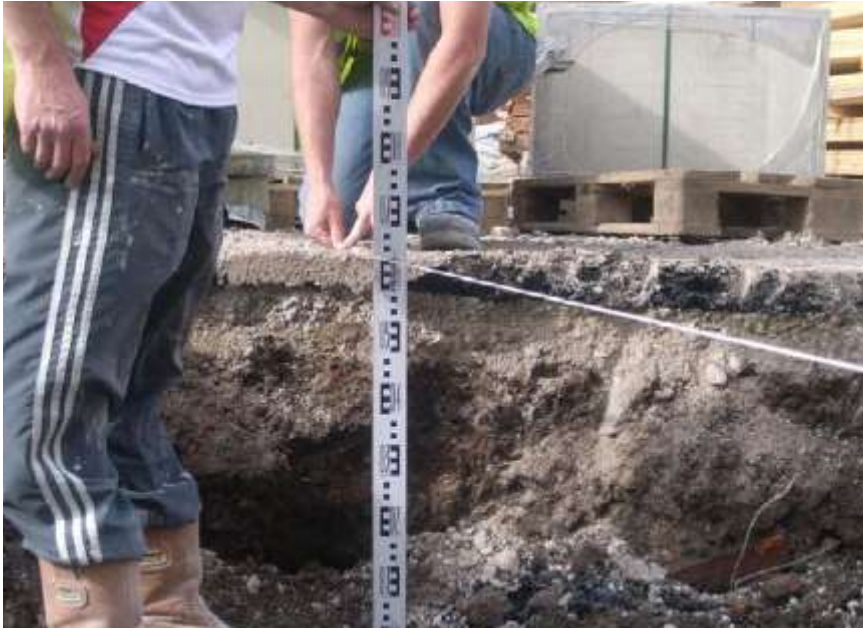
Photograph 6:  
Depth check of inert  
cover within rear  
gardens. Taut string  
line spans across  
excavation.

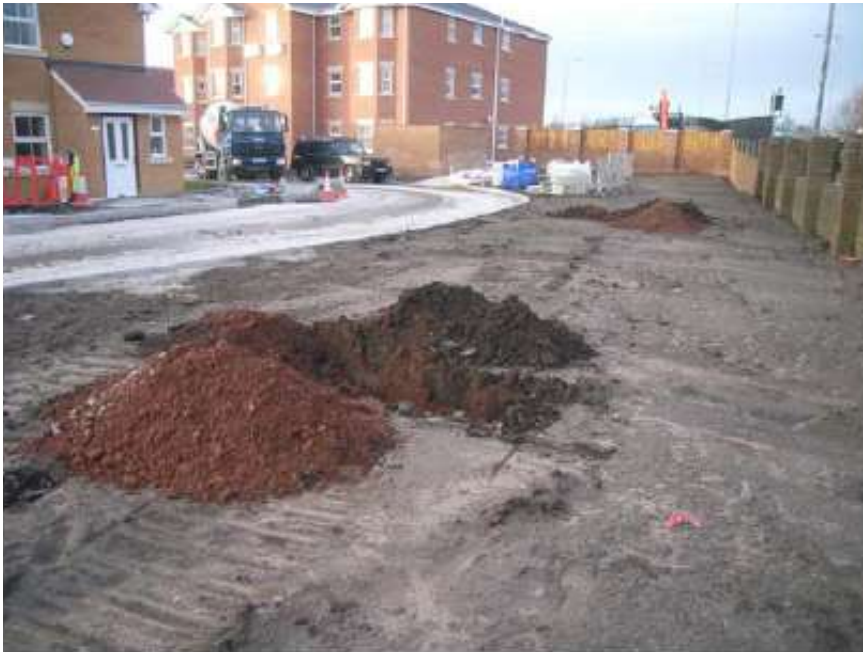
Photograph 7:  
Shows the spatial  
location of the  
verification pit.

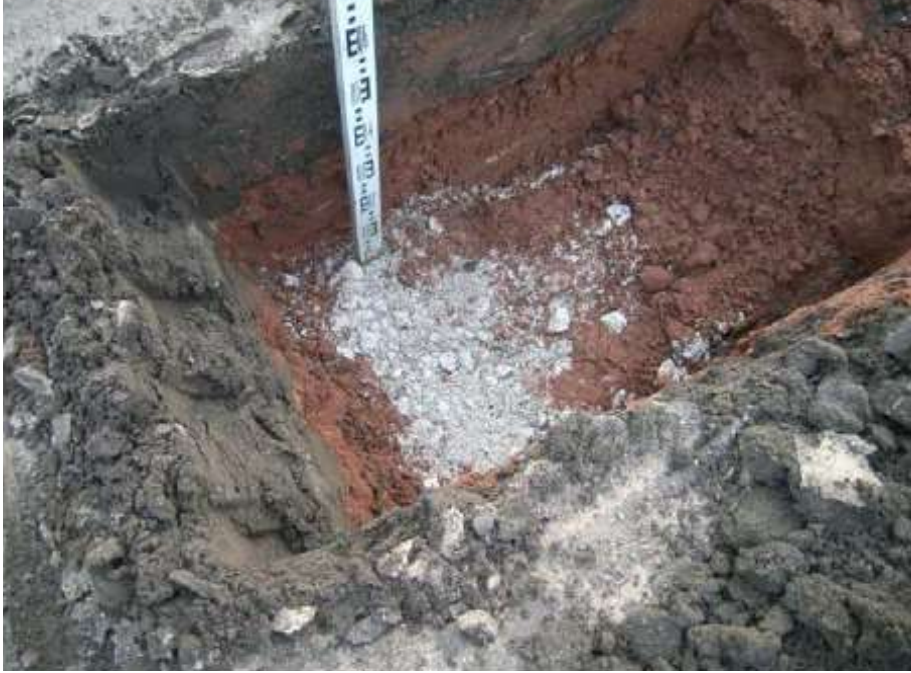
Photograph 8: Excavation within public open space and verification pit showing the presence of a remediation break layer at the base, a crushed sandstone inert fill overlain by topsoil.

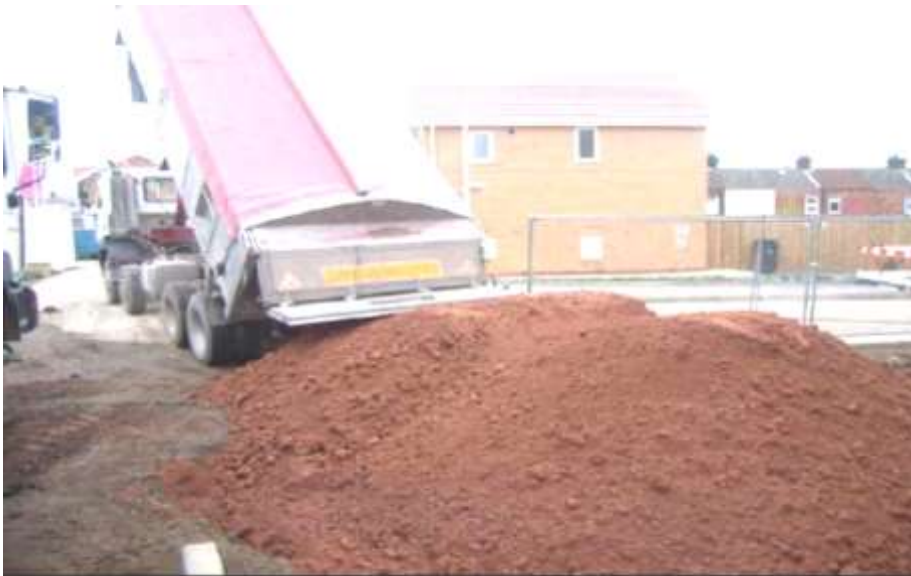
Photograph 9: Inert crushed sandstone being delivered. The spatial area of the remediation can be observed from these photographs (old terrace housing).

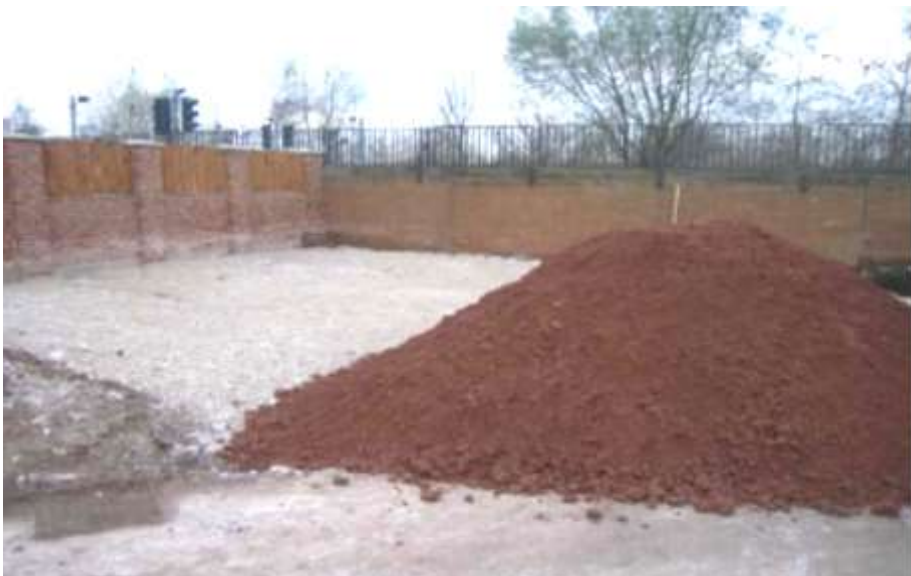
Photograph 10: Inert crushed sandstone being delivered with visible remediation break layer. The spatial area of the remediation can be observed from these photographs (traffic lights).

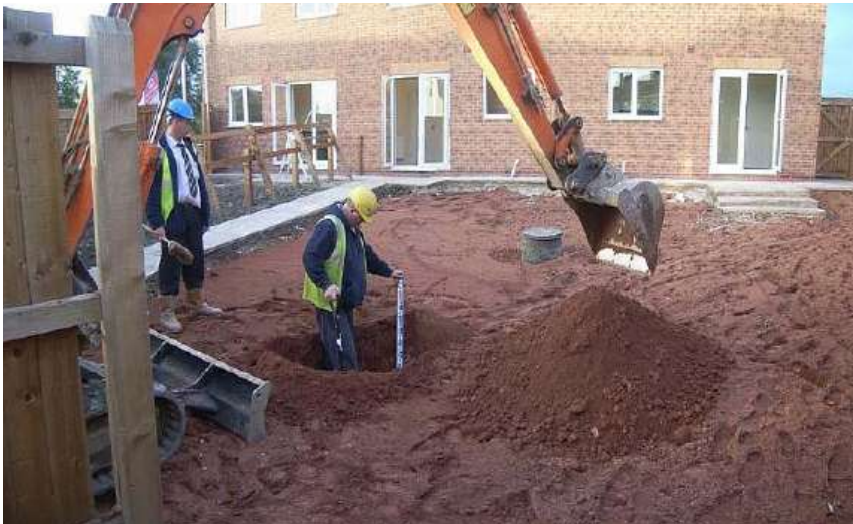
Photograph 11:  
Shows the remediation of the rear garden, with a significant depth (1.0m) of inert cover. This photograph has been stitched to form a panoramic photograph and hence there is slight distortion

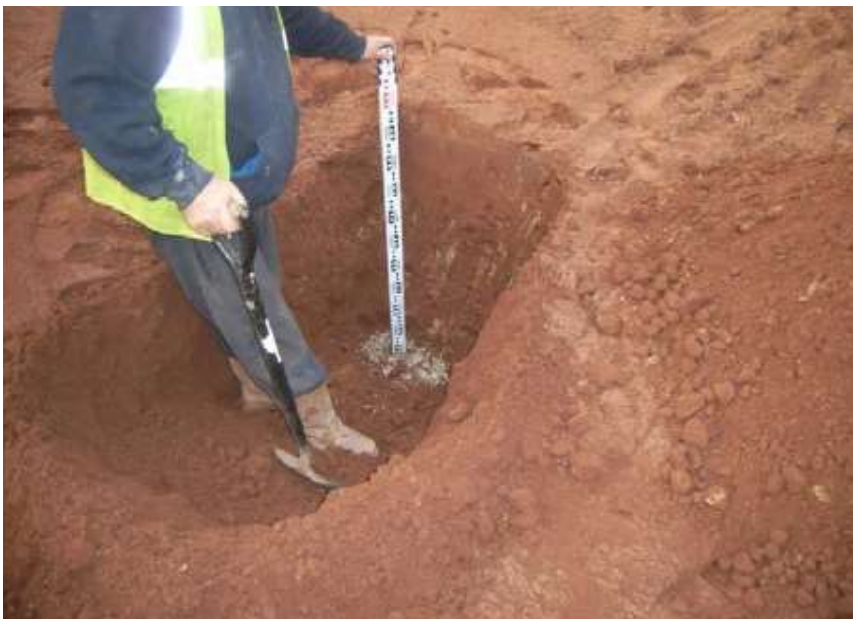
Photograph 12:  
Shows the remediation of the rear garden, with a significant depth (1.0m) of inert cover. Remediation break layer visible at the base of the excavation.
