# Bat Roost Assessment

BE-1392-01

The Coach House, Healey House, Netherton,  
Huddersfield, HD4 7DZ

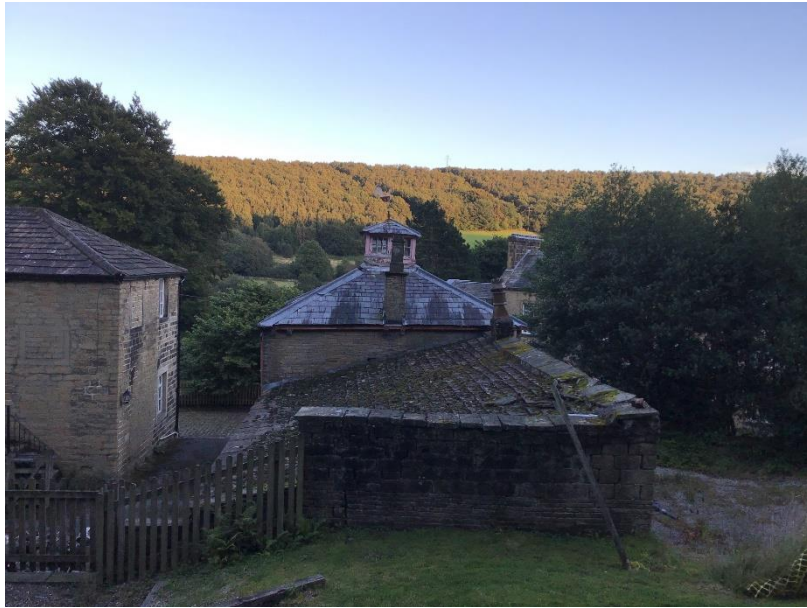
*North aspect, with extension in foreground*

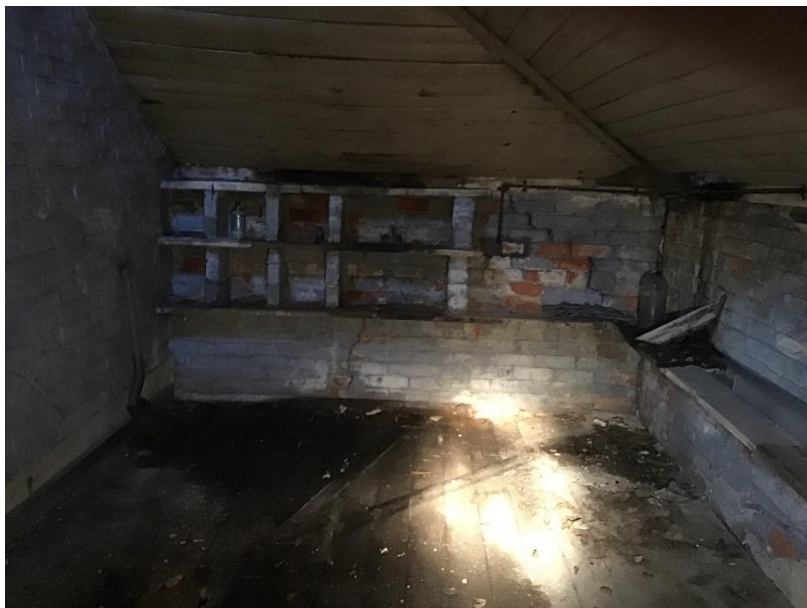
The first floor of the building was well-lit by the skylight within the centre of the roof. The building had no separate roof void. The interior of the first floor was lined with wooden sarking, which was lifted in places, revealing a cavity between the sarking and the roof void to a depth of approximately 20 cm. Feeding remains of peacock butterfly (*Aglaia io*) and yellow underwing (*Noctua pronuba*) were observed throughout the first floor. Approximately five bat droppings, consistent in shape, size and texture to brown long-eared bat (*Plecotus auritus*) were observed within the building.

*First floor*

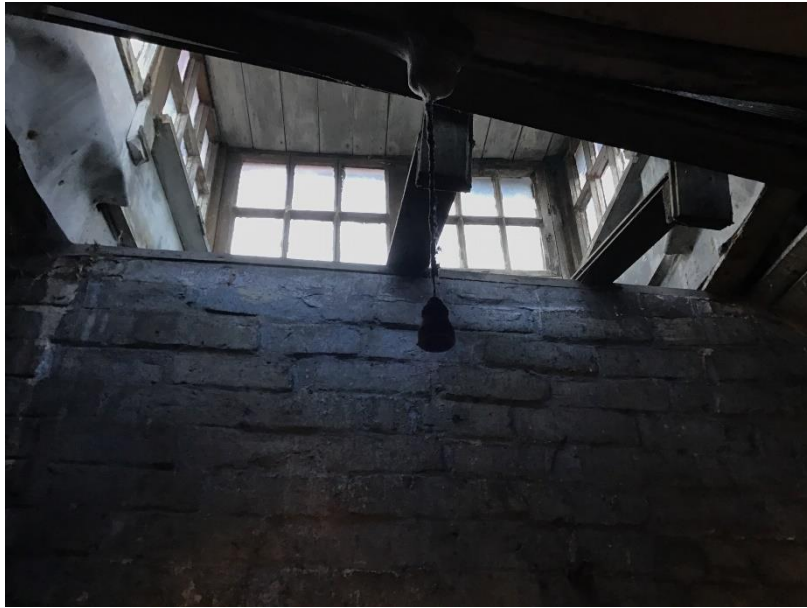
The building consisted of a two-storey stone-built building with a hipped roof. The stonework on the exterior of the building was rendered and in relatively good condition. The roof was in poor condition, with numerous lifted roof tiles on all aspects. Lead flashing on the roof hips was loose, with visible gaps. There was a raised skylight within the centre of the roof, with broken windows providing access into the building.

*Skylight*

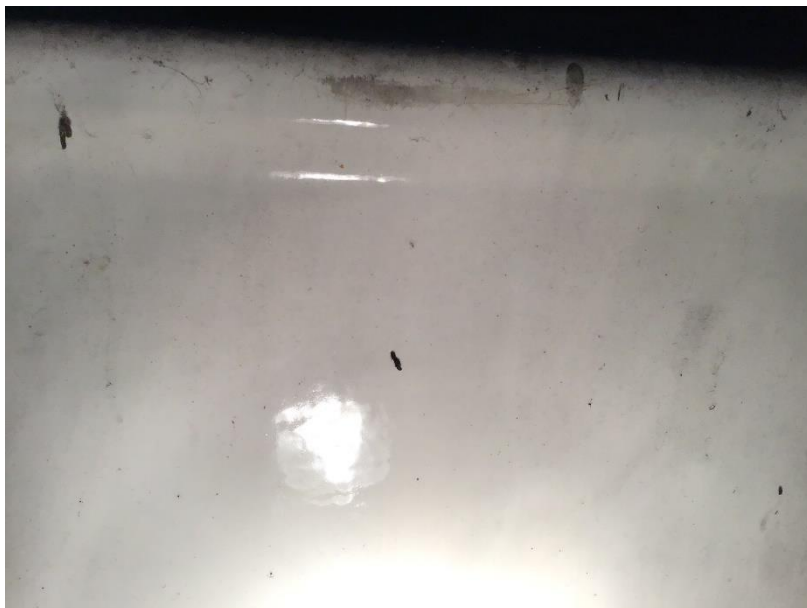
The scoping survey identified small numbers of bat droppings and feeding remains within the building. The activity surveys identified a single brown long-eared bat roosting within the building. Taking account of the low number of droppings within the building, and the peak count of one bat emerging from the building, it is anticipated that the building comprises a day roost used by a single or low number of males and/or non-breeding females.

*Bat droppings*

The building contains a day roost of brown long-eared bat, which will necessitate destruction due to the development proposals. Works must be carried out under a Natural England EPS licence. This can only be applied for once planning permission is in place. The EPS licence must include a method statement to avoid the killing or injury of individual bats. An outline method statement is provided in **Appendix 3: Method Statement**. This method statement may need to be revised as part of the EPS licence application.

A bat box of type Schwegler 1FF (or similar) will be installed on a tree prior to the commencement of works, to ensure continuation of roosting habitat during the development.

In order to compensate for the loss of a bat roost, the development must include the incorporation of bat roosting habitat. An integrated bat box must be incorporated into the masonry of the building. This will be of type Schwegler 1FR, or similar. The location of the proposed roost must be detailed within the development plans.

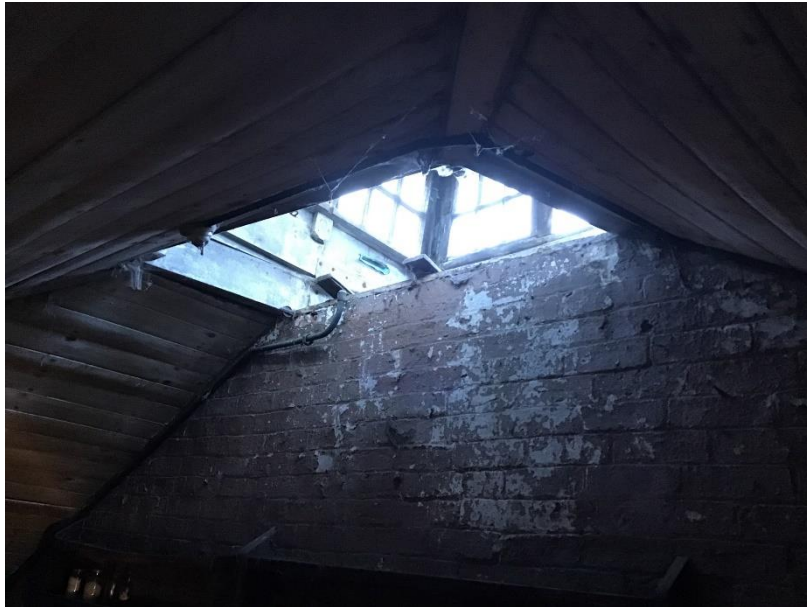
*Skylight and sarking*

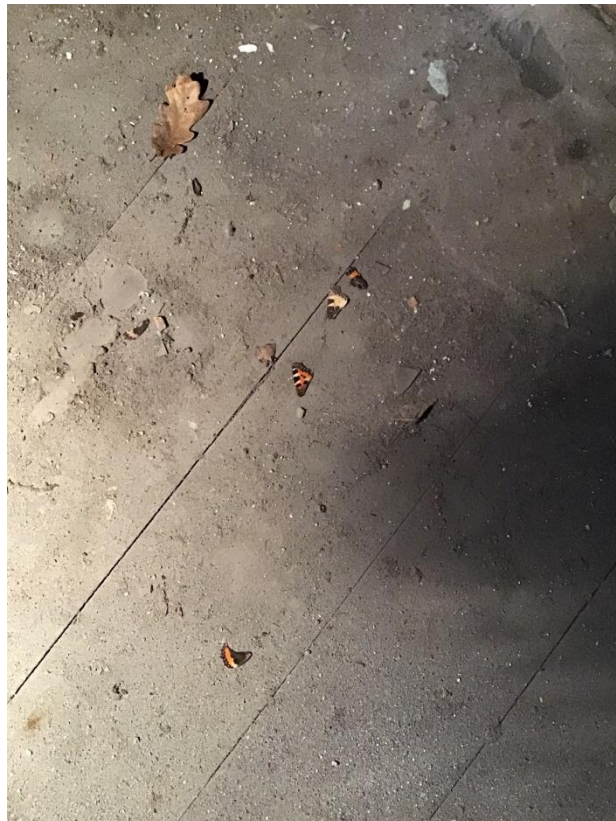
There was an extension on the north aspect of the building, which had a half pitched roof, and was open on the east aspect. Peacock butterfly feeding remains were observed on the wall within the extension, although no further signs of bats were observed.

Feeding remains were also identified within the open sided extension on the north aspect of the building. No droppings were identified within this area, and it is anticipated that this provides a feeding perch for brown long-eared bats.

*Feeding remains*
