# GEO-ENVIRONMENTAL REPORT

# Report on a Phase 2 Geo-environmental Investigation

| Location: | <b>Land at Reinwood Road</b><br>Reinwood Road, Huddersfield, West Yorkshire, HD3 4DS | |
| Report No. | C5092/25/E/7765_Rev1 | Report date: November 2025 |

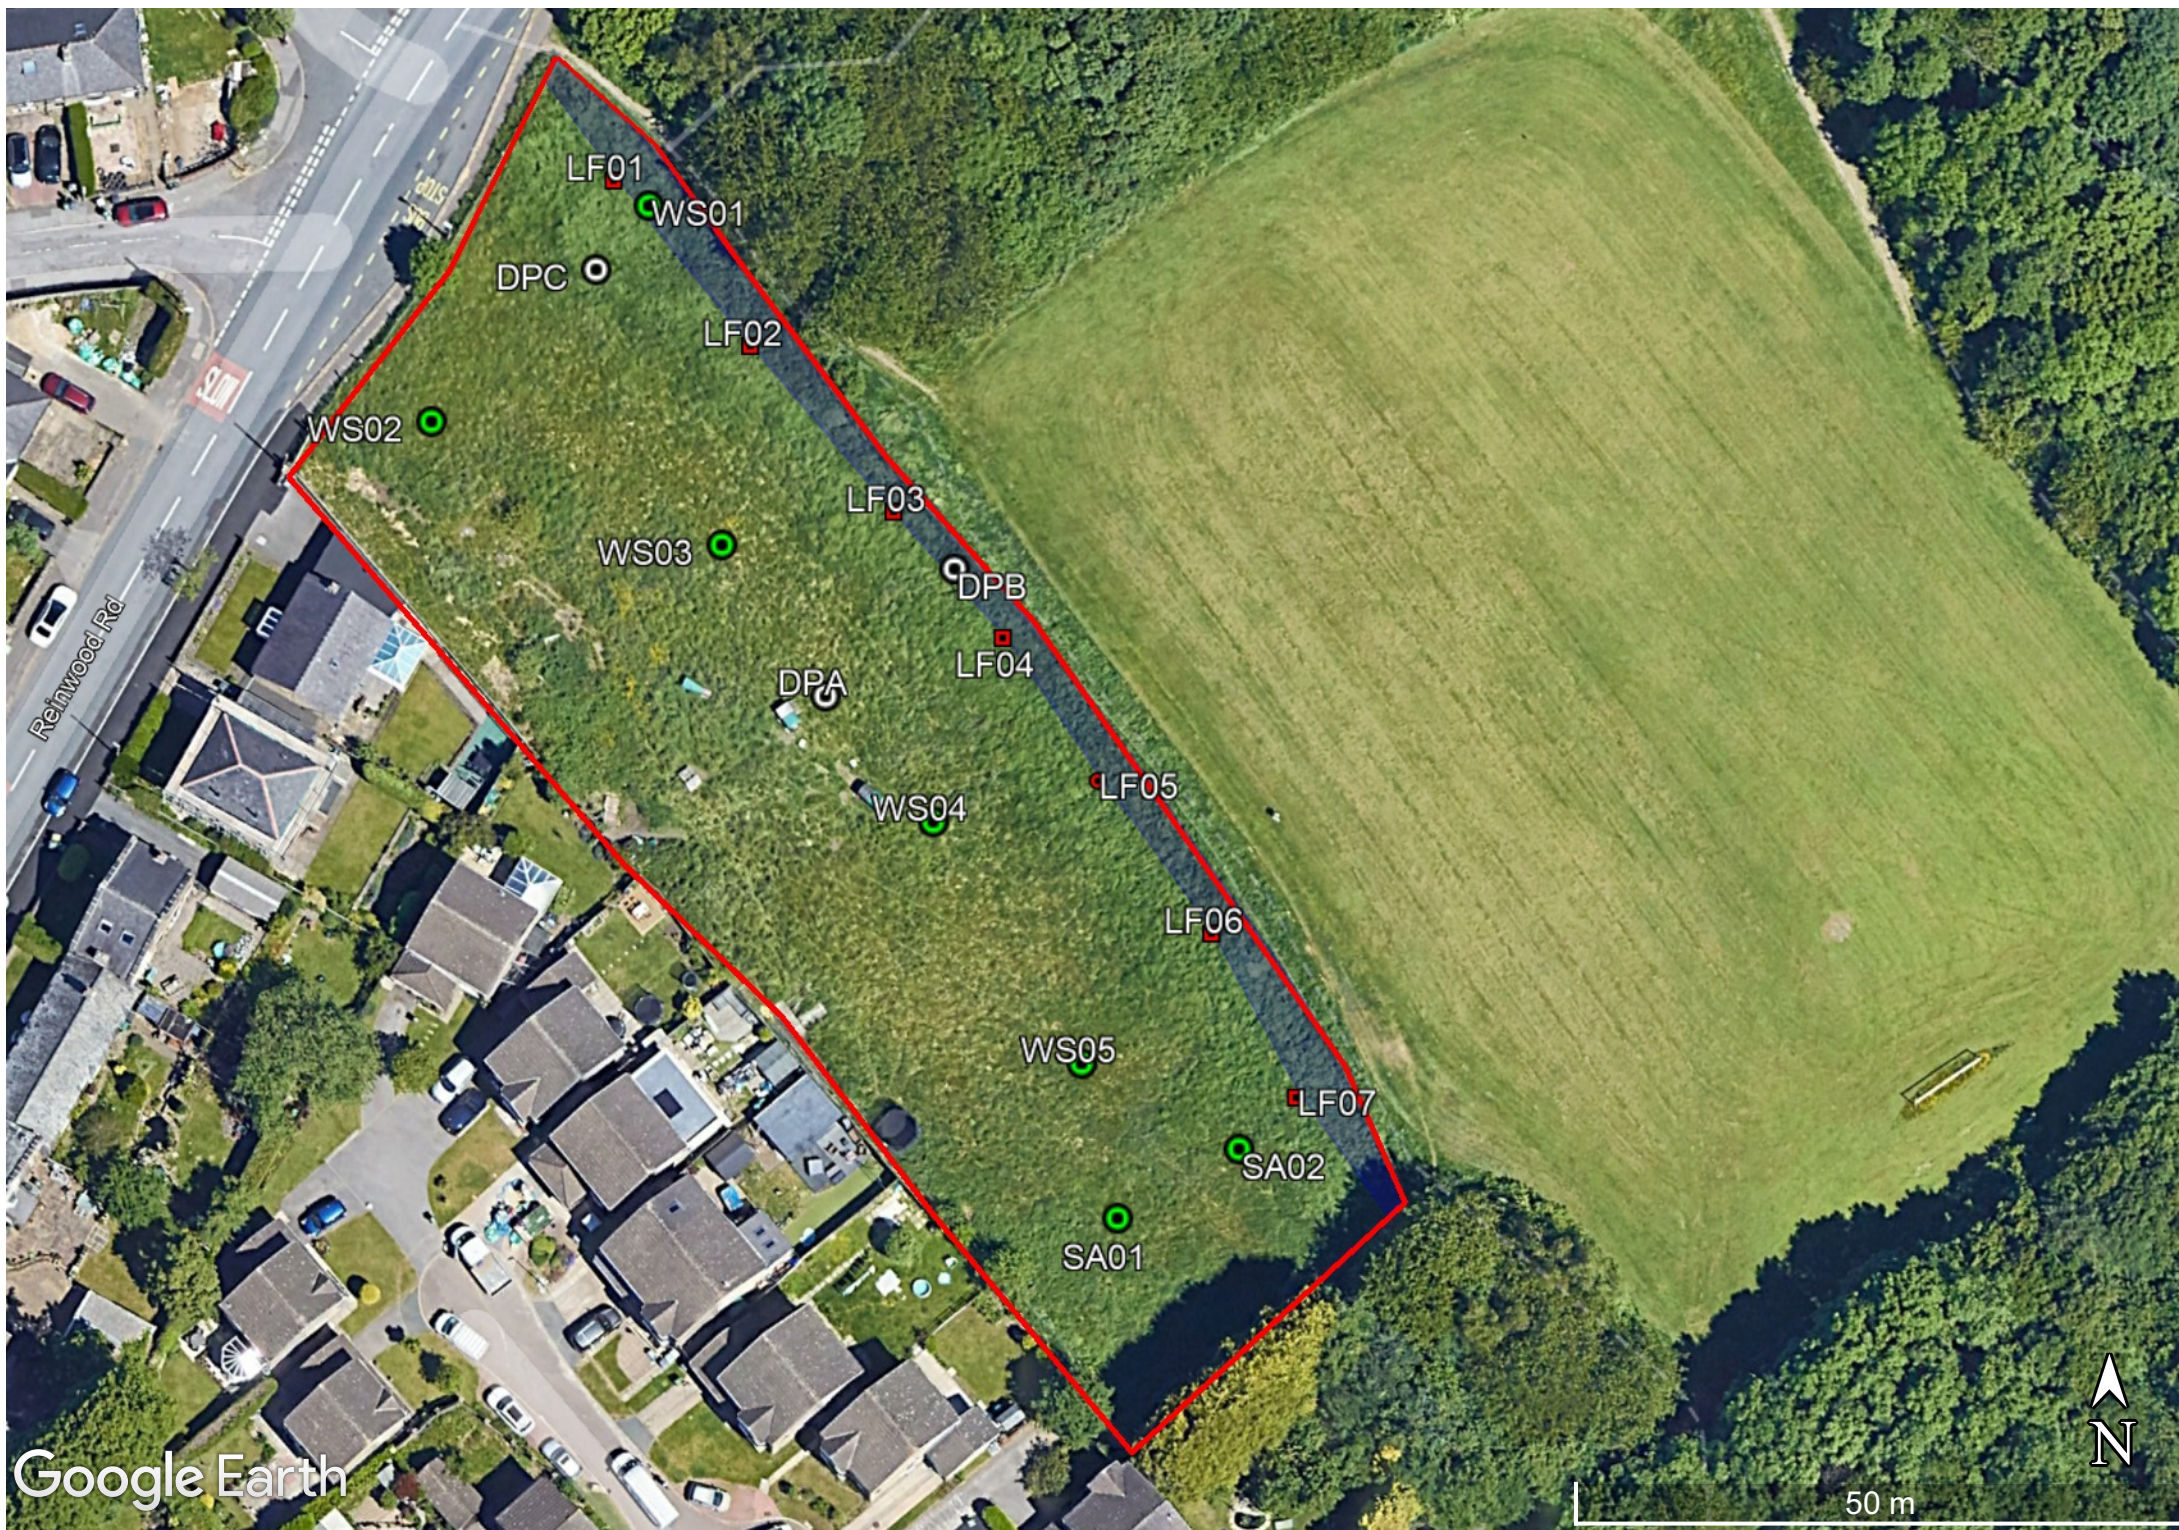
### Site Plan

Dynamic penetration tests were undertaken to positions noted on the site plan. A summary of the results is presented below:

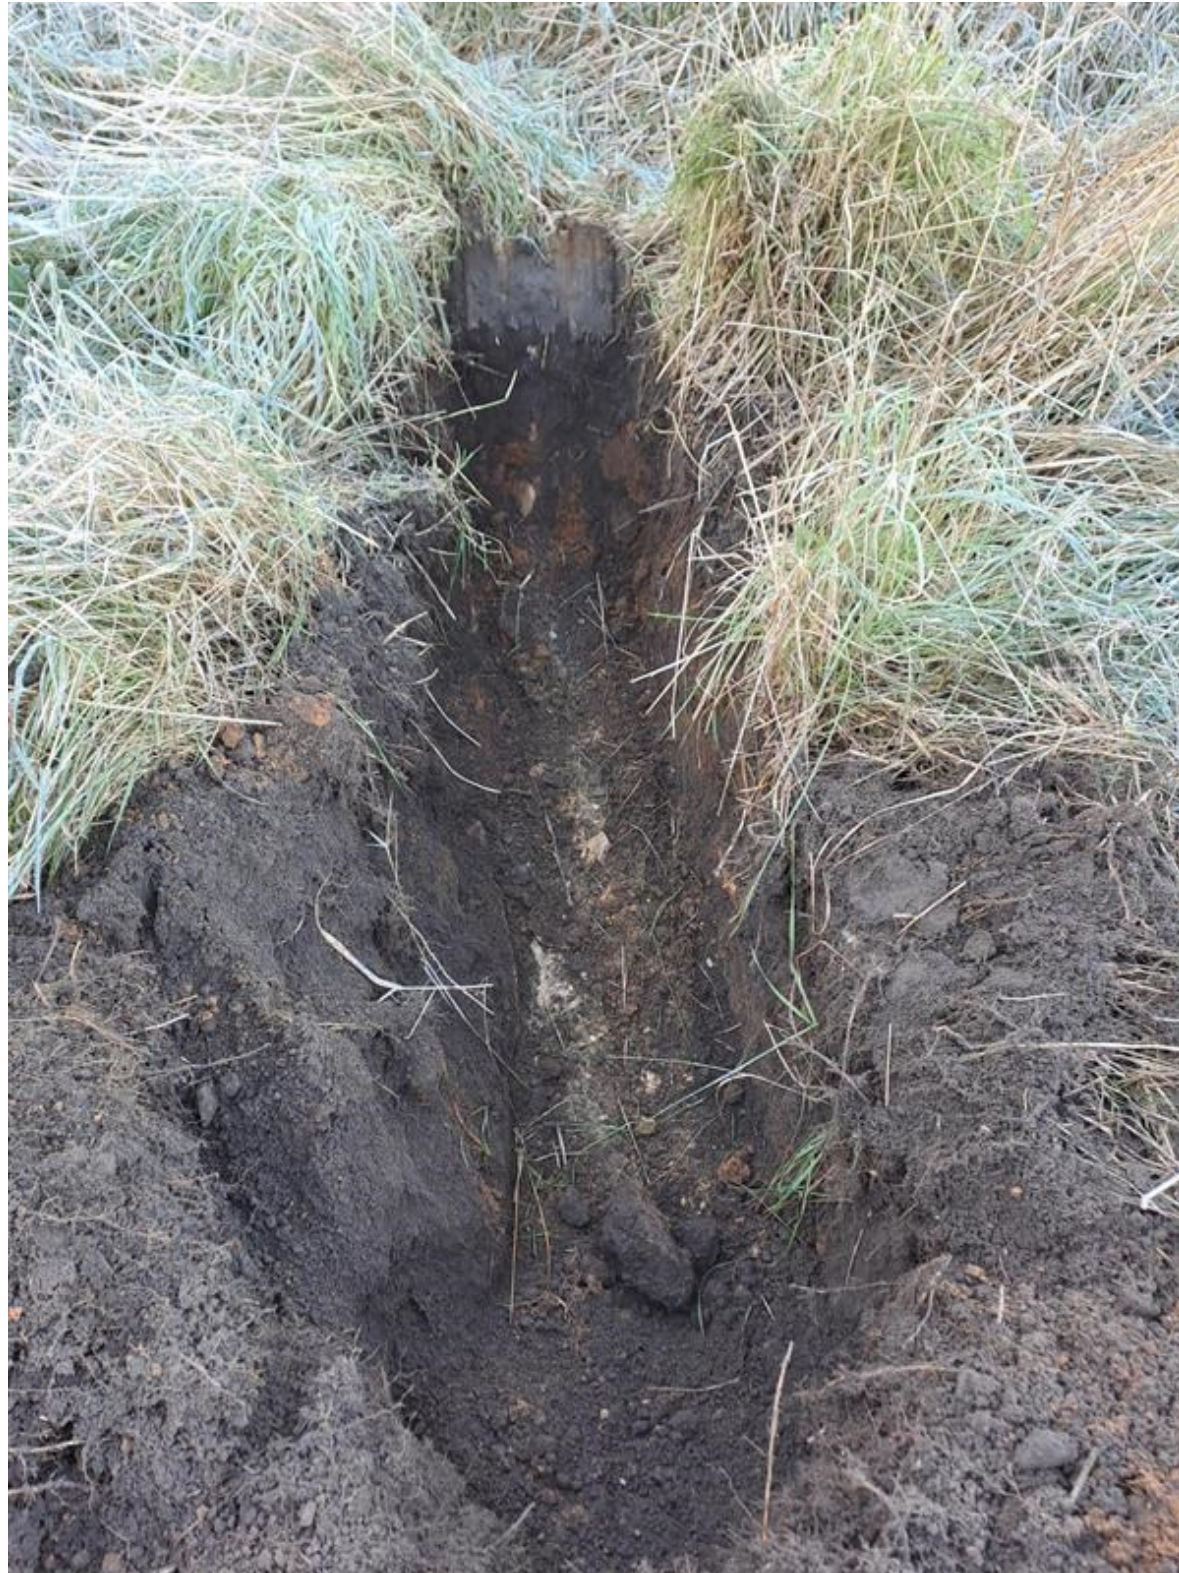
Photo 1: SA01

It should be appreciated that shallow sandstone prevented deep investigation for soakaway suitability. During the soakaway tests the water level did not achieve a fall from 75% to 25% of the effective depth of the storage volume in SA01. During this test, the water level movement ceased at a depth of 0.46m. It is considered that the initial movement was observed as water filled any gaps and fissures within the residual sandstone at the side of the pit. On this basis, the test could not be completed within the scope of the method provided in BRE Digest 365 due to the poor soakage rate of the exposed soils. Due to the negligible water movement it was not possible to extrapolate the results obtained in order to obtain a soil infiltration rate. The tests were fully completed within trial pit SA02.

The soils encountered beneath the topsoil were found to be typical of the weathered fraction of the underlying Soft Bed Flags. While the strata conditions appear to be comparable across the site, soakaways implemented will be reliant on the infiltration rates of the underlying bedrock. In this instance, fractures within the sandstone will be the main route of infiltration which may be inconsistent. Therefore, unless a suitable design can be created by a suitable competent person then soakaways cannot be recommended at this site and an alternative form of drainage should be adopted.
