| PRELIMINARY STRUCTURAL HAZARD ASSESSMENT | | | | | | |

| NEWSOME MILL | | | |
| REMNANT MILL BUILDING | | | |
| STRUCTURAL ASSESSMENT | | | |

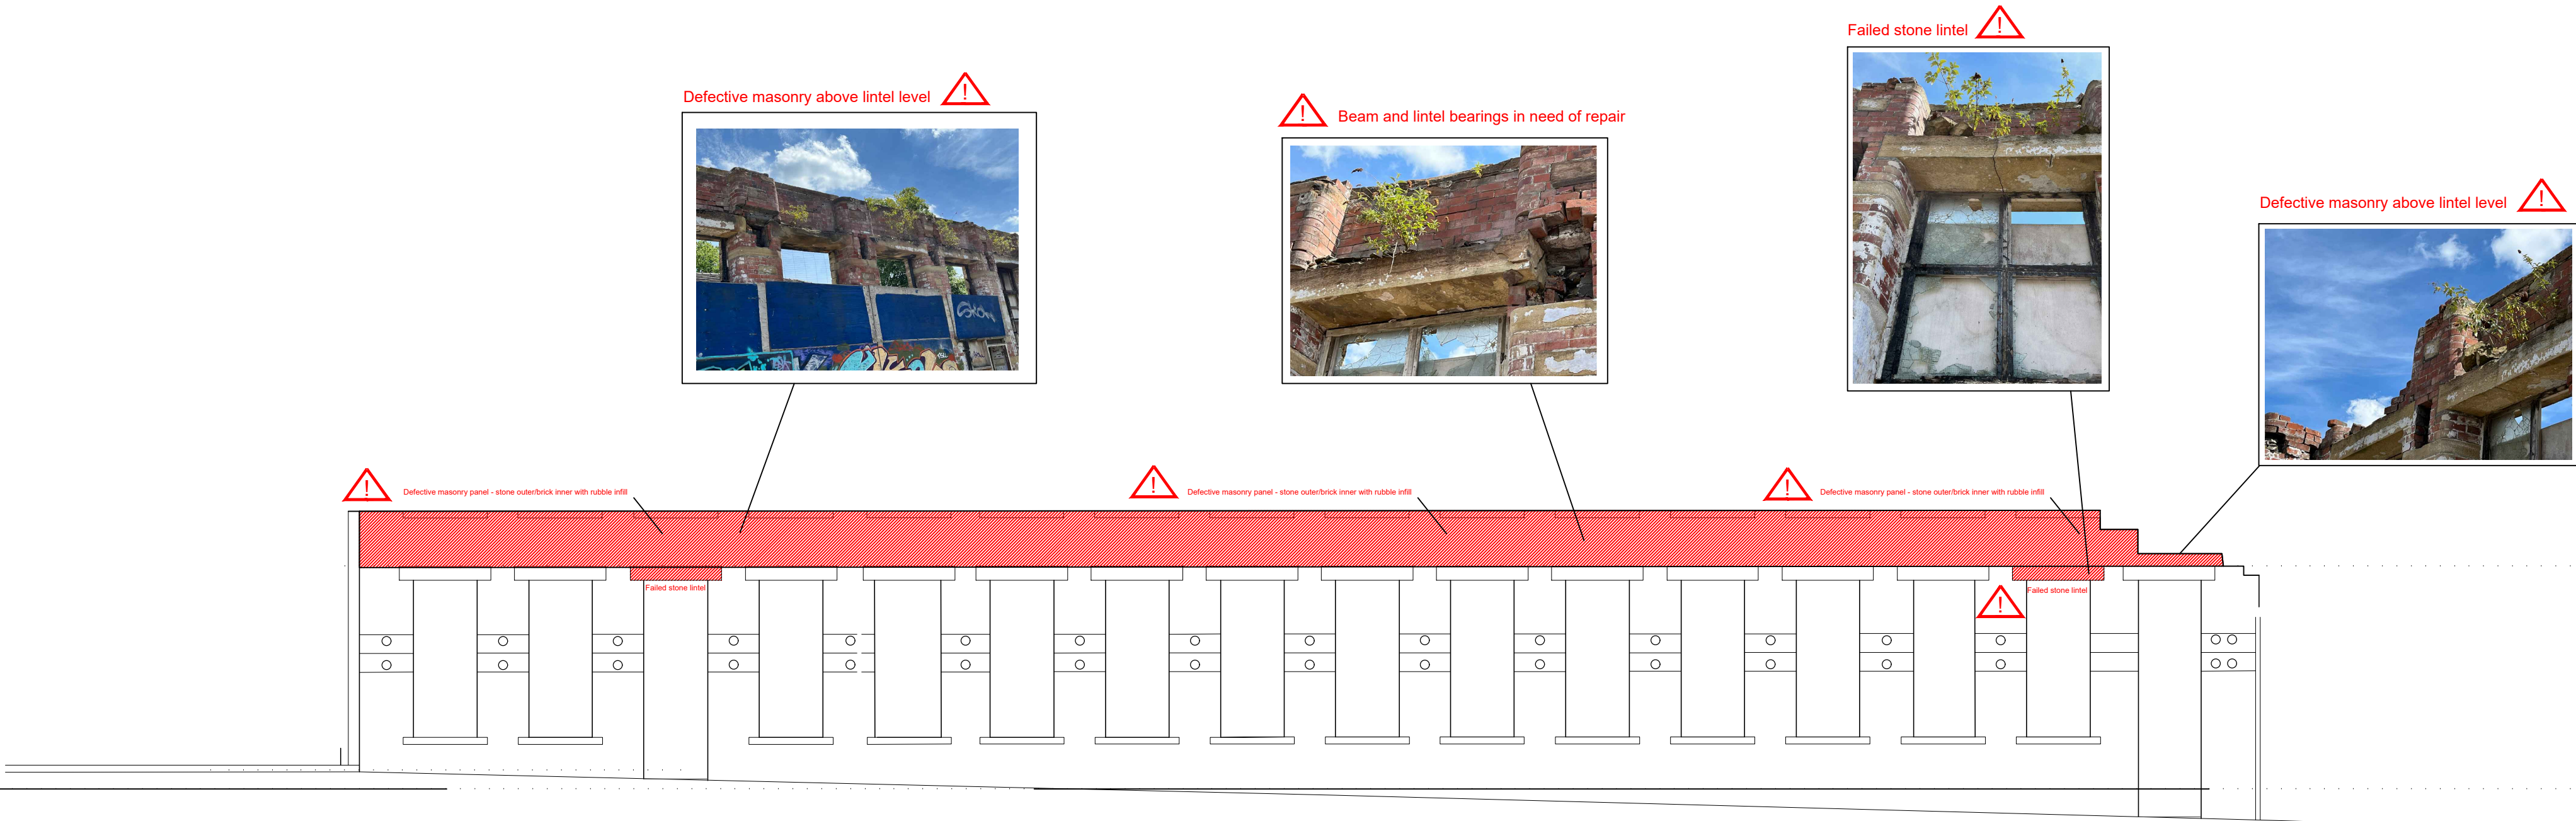
REMNANT MILL STRUCTURE (A) - ELEVATION 2

| PRELIMINARY STRUCTURAL HAZARD ASSESSMENT | | | | | | |
|---|---|---|---|---|---|---|
| | See drawing | General public, workforce (including investigation contractors, consultants and surveyors), listed building fabric | Cordon off site and ensure no public access. Close Ruth Street to pedestrians on site side. Carry out comprehensive repair works to restore structural integrity of remnant building fabric | Immediate | Open | Land owner |

NOTE - DETAILED IMPLEMENTATION OF ESSENTIAL STRUCTURAL REPAIR WORKS TO LISTED BUILDING FABRIC TO BE AGREED FOLLOWING PLANNING AND LISTED BUILDING CONSULTATIONS

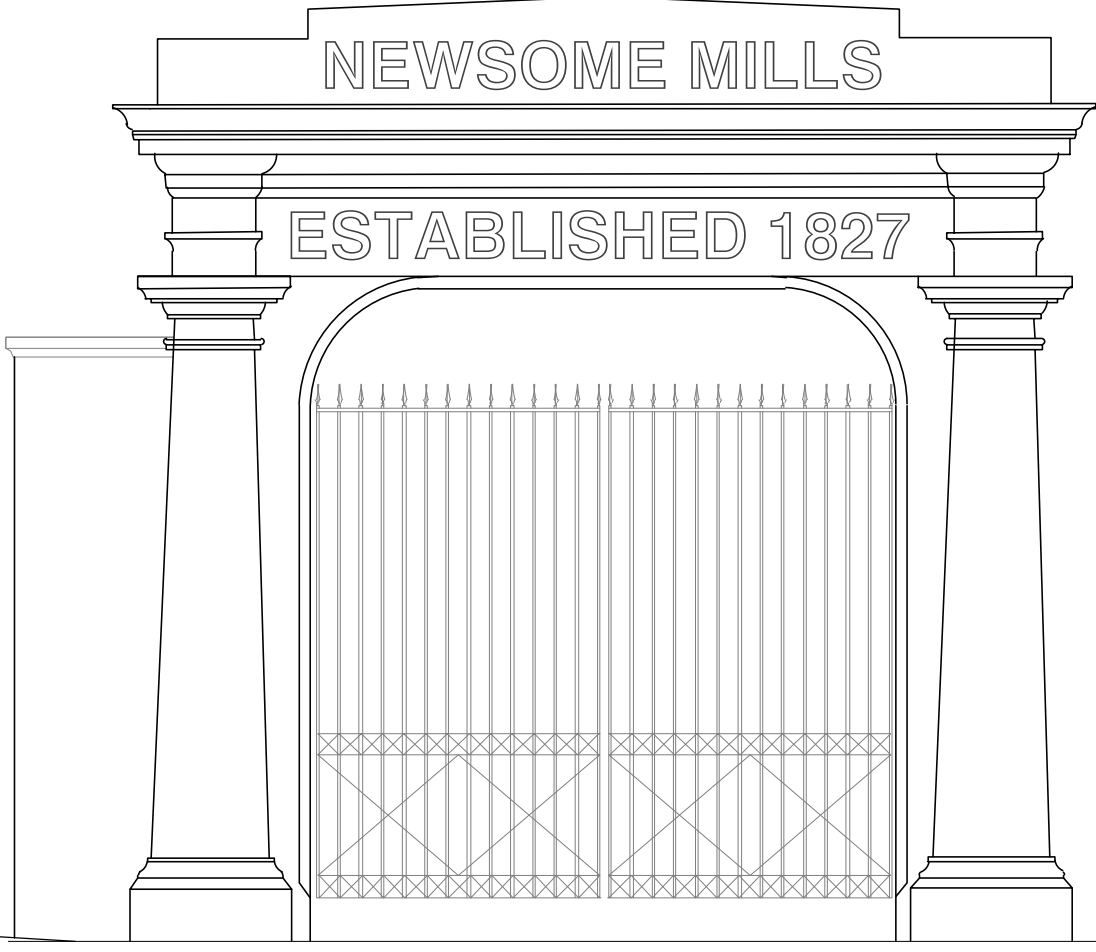
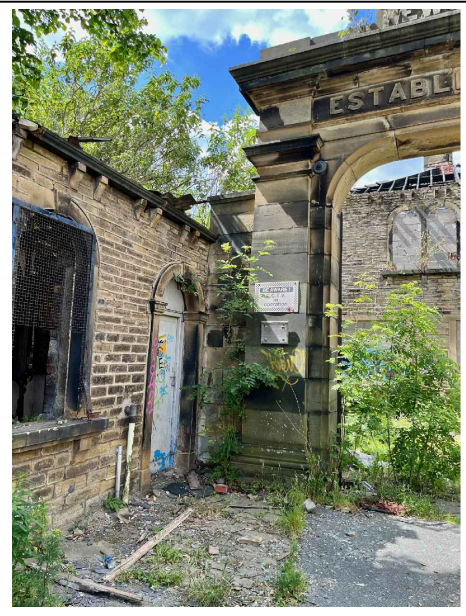
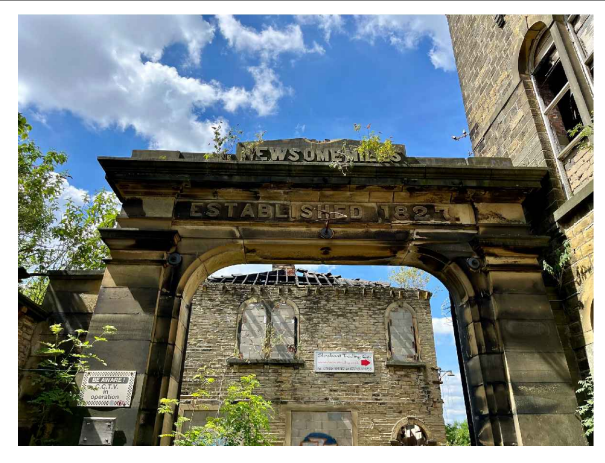
ELEVATION 1

SUBSTANTIAL STONE BUILT MILL ENTRANCE GATEWAY STRUCTURE WITH FLAT BOTTOM ARCH AND NO OBVIOUS EVIDENCE OF SIGNIFICANT STRUCTYRAL DISTRESS  
INSPECTION OF COPING STONES RECOMMENDED ALONG WITH VERTICALITY SURVEY

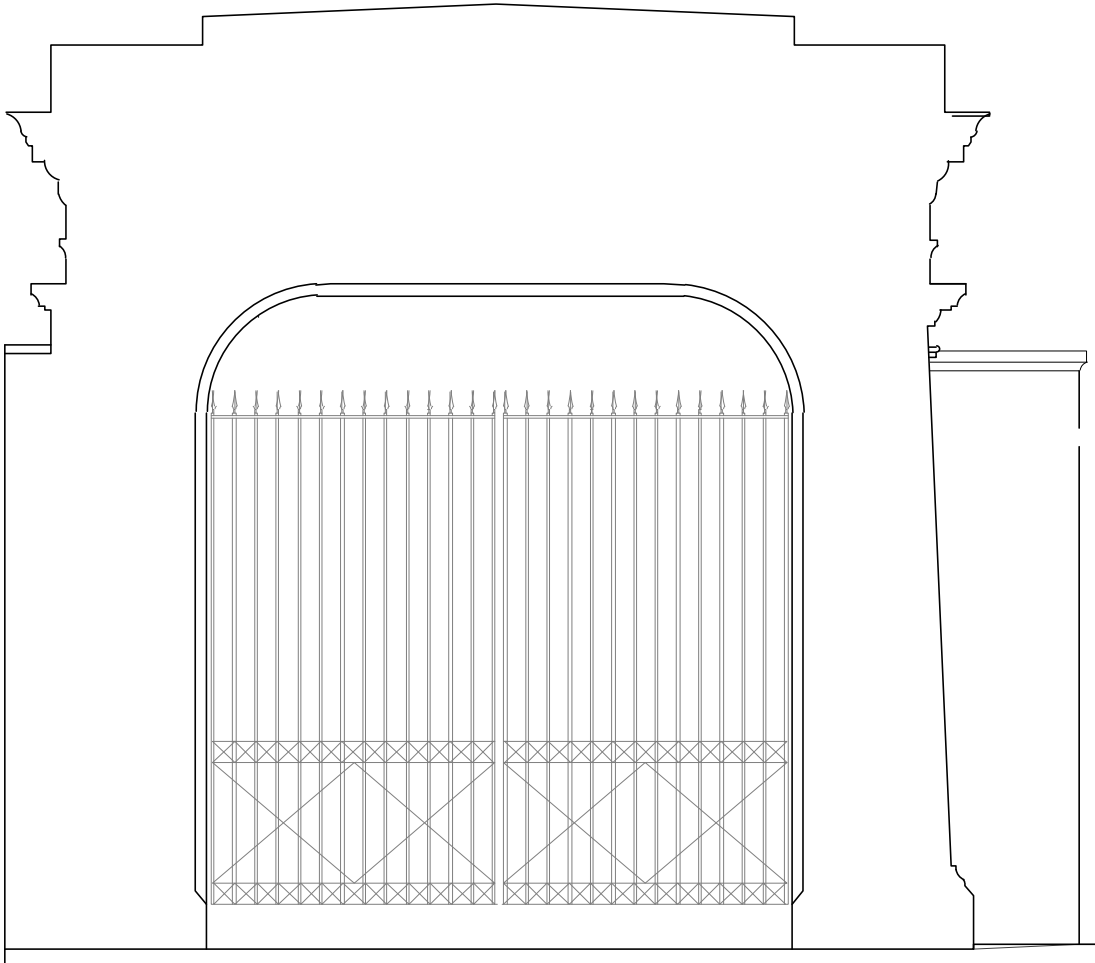
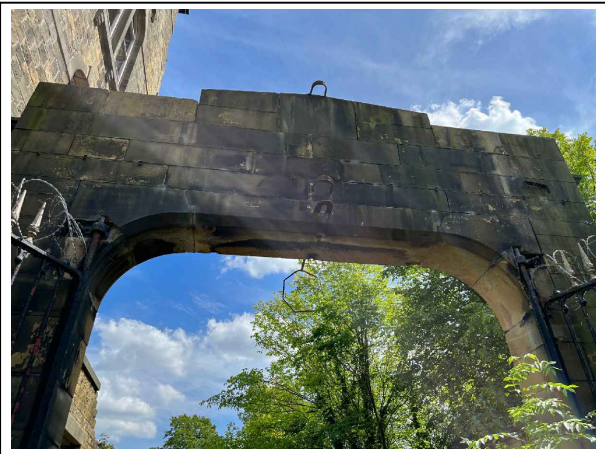
ELEVATION 2

SUBSTANTIAL STONE BUILT MILL ENTRANCE GATEWAY STRUCTURE WITH FLAT BOTTOM ARCH AND NO OBVIOUS EVIDENCE OF SIGNIFICANT STRUCTYRAL DISTRESS  
INSPECTION OF COPING STONES RECOMMENDED ALONG WITH VERTICALITY SURVEY

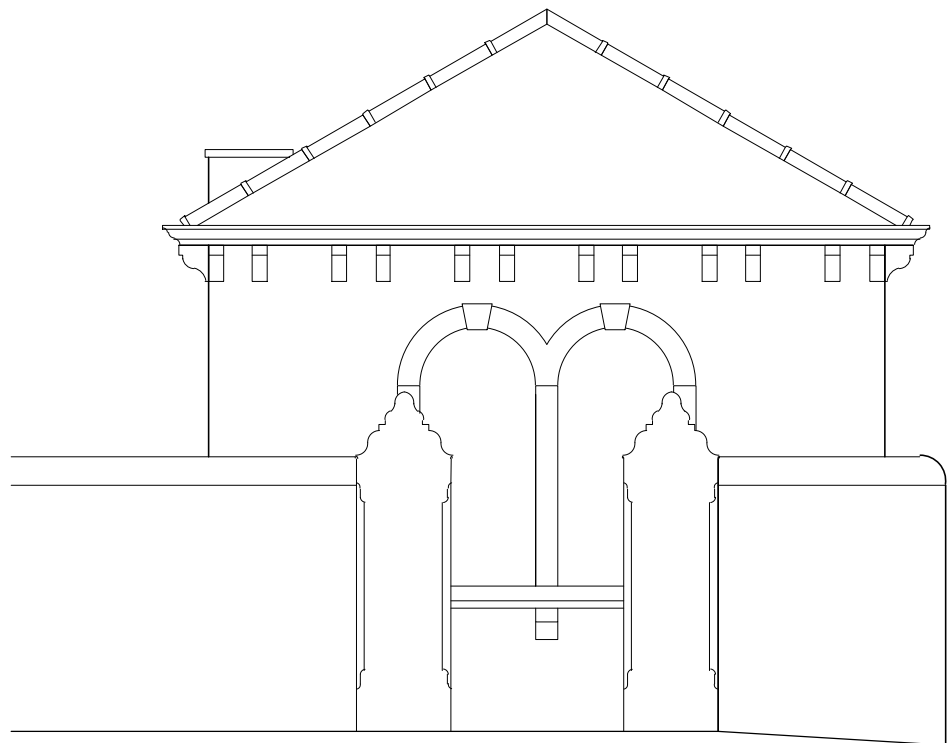
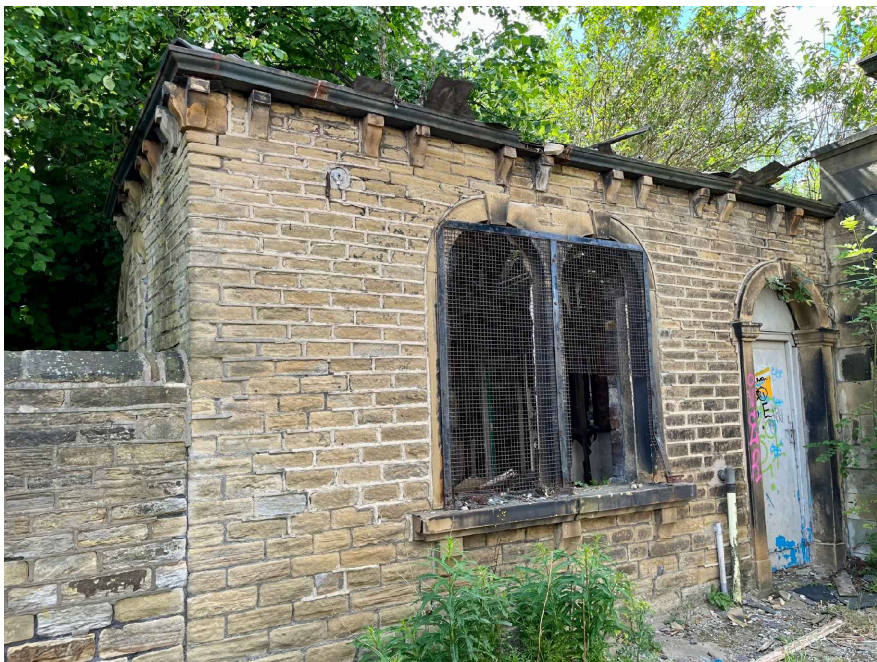
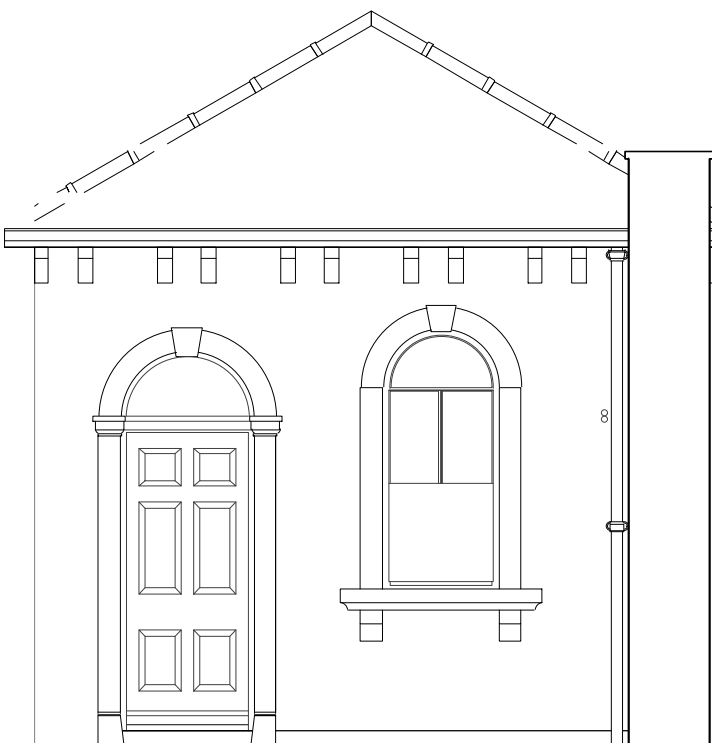
SUBJECT TO FURTHER STRUCTURAL INSPECTION WORK  
FOLLOWING REMOVAL OF SITE VEGETATION

| PRELIMINARY STRUCTURAL HAZARD ASSESSMENT | | | | | | |
|---|---|---|---|---|---|---|
| | See drawing | General public, workforce (including investigation contractors, consultants and surveyors), listed building fabric | Cordon off site and ensure no public access. Close Ruth Street to pedestrians on site side. Carry out site vegetation removal to permit further structural inspection works | Immediate | Open | Land owner |
