**PIPERWELL FARM, SHEPLEY.**

**ECOLOGICAL IMPACT ASSESSMENT.**

**Ref No: 251009/EcIA/3.**

**Date: 26<sup>th</sup> June 2026.**

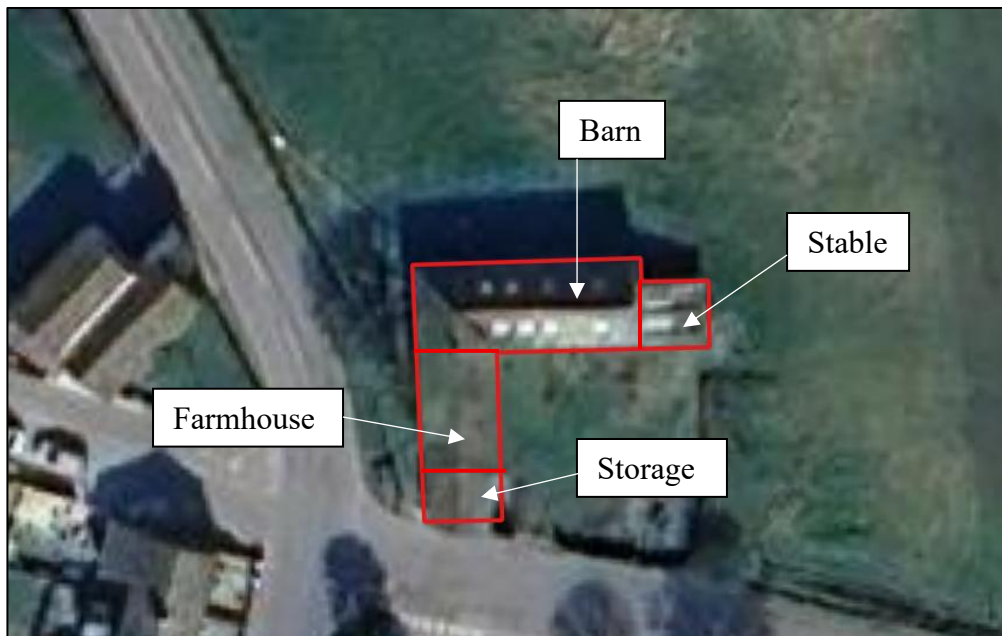
3.2.3. The survey area comprises a two-storey stone-built farmhouse, with an attached two-storey stone-built barn, and an attached single-storey stone-built stable. The layout of the property is shown in the aerial image below. Each part of the property has been labelled for the purposes of this report.

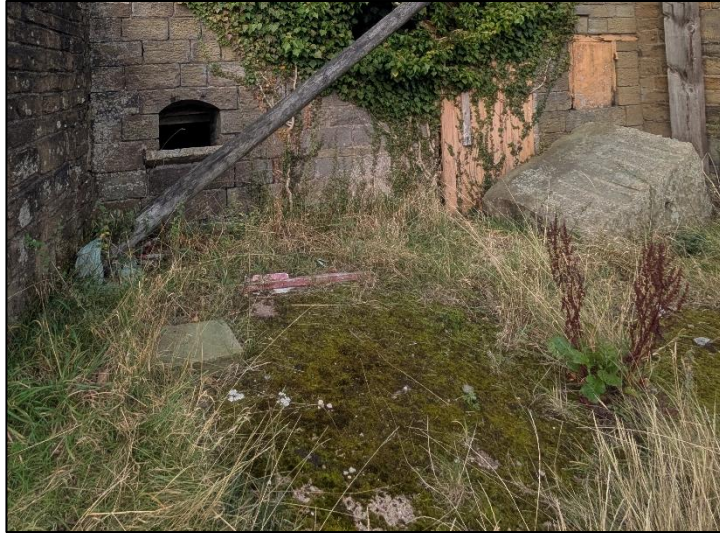
An area to the south of the buildings comprised ruderal and ephemeral vegetation including broadleaved dock (*Rumex obtusifolius*), perennial ryegrass (*Lolium perenne*), nettle (*Urtica dioica*), ivy (*Hedera helix*), Yorkshire fog (*Holcus lanatus*), cow parsley (*Anthriscus sylvestris*), cock's-foot (*Dactylis glomerata*), bramble (*Rubus fruticosus*),

and small elder shrubs (*Sambucus nigra*). The area appears to have once been a courtyard which has been left to naturally regenerate over time.

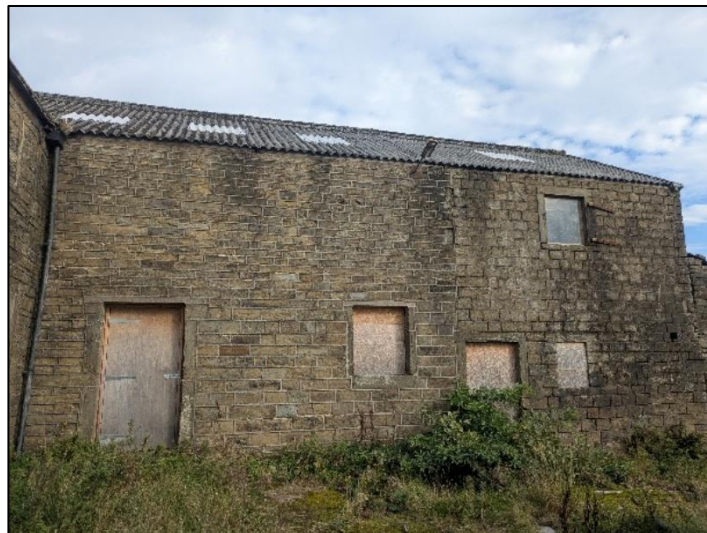
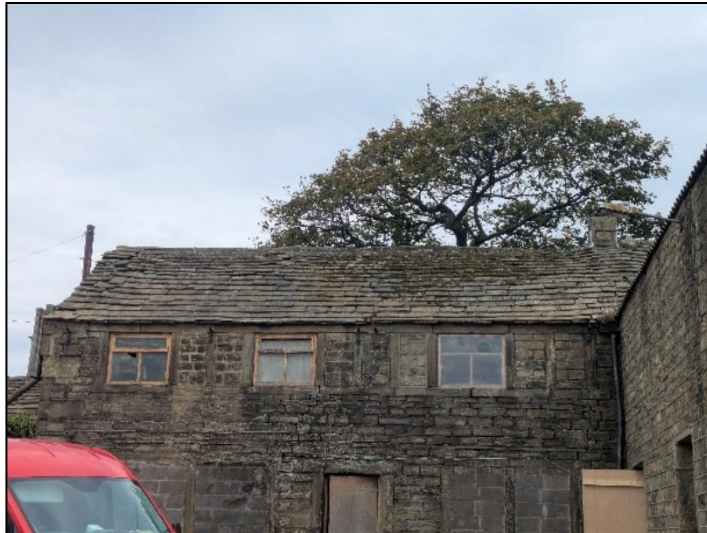
A single two-storey, stone-built farmhouse with an attached two-storey, stone-built barn and multiple single-storey extensions was present. The building is described in more detail in section 3.5.4.

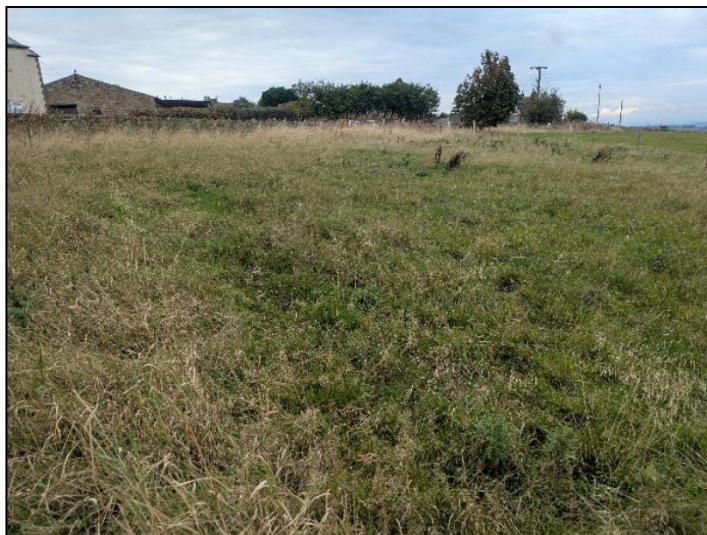
3.4.4.1. The building was surrounded an enclosed grassland field. Historical satellite imagery suggests that this field was once part of the quarry to the north of the survey area, and has since been left to regenerate and regularly mown. The grassland comprises perennial ryegrass (*Lolium perenne*), cock's-foot (*Dactylis glomerata*), Yorkshire fog (*Holcus lanatus*), false oat-grass (*Arrhenatherum elatius*), common bent (*Agrostis capillaris*), creeping thistle (*Cirsium arvense*), broadleaved dock (*Rumex obtusifolius*), ragwort (*Jacobaea vulgaris*), and cow parsley (*Anthriscus sylvestris*).

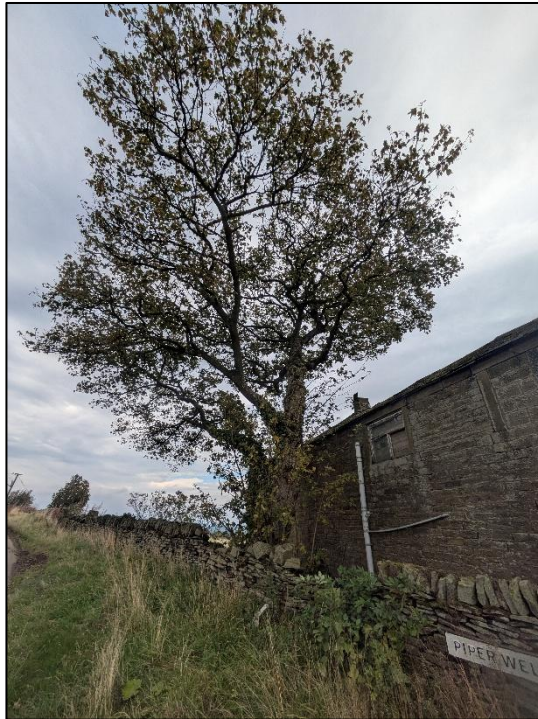
3.4.4.2. A single sycamore (*Acer pseudoplatanus*) was present close to the western aspect of the building.

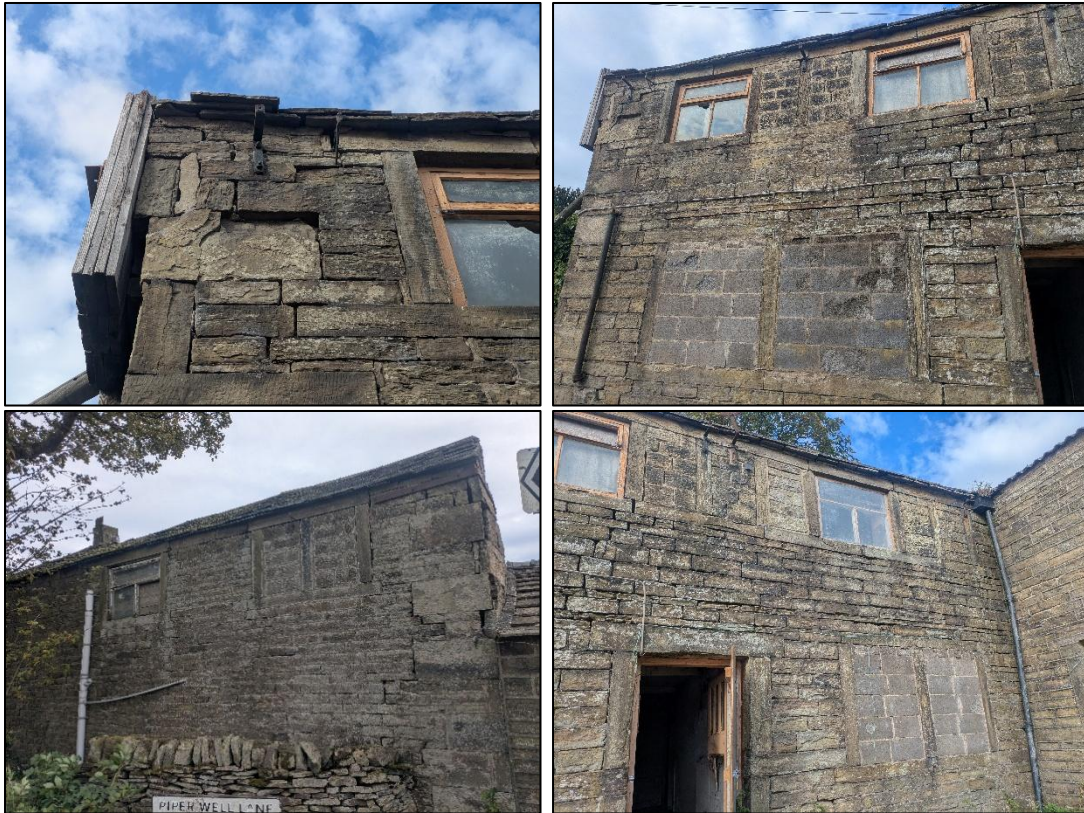
3.5.4.1.1. The building has a stone construction, and the walls are in poor condition with multiple cracks, gaps or crevices throughout all aspects of the building which were suitable for roosting bats. Additionally, at least one of the windows was cracked,

providing a potential access point into the building. Examples of the overall condition of the walls are provided in the photographs below.

3.5.4.1.6. Overall, due to the large number of potential access points into the loft space, and also many potential roost features under tiles or within gaps in the stonework of the walls, the farmhouse is assessed as having **high potential** for roosting bats

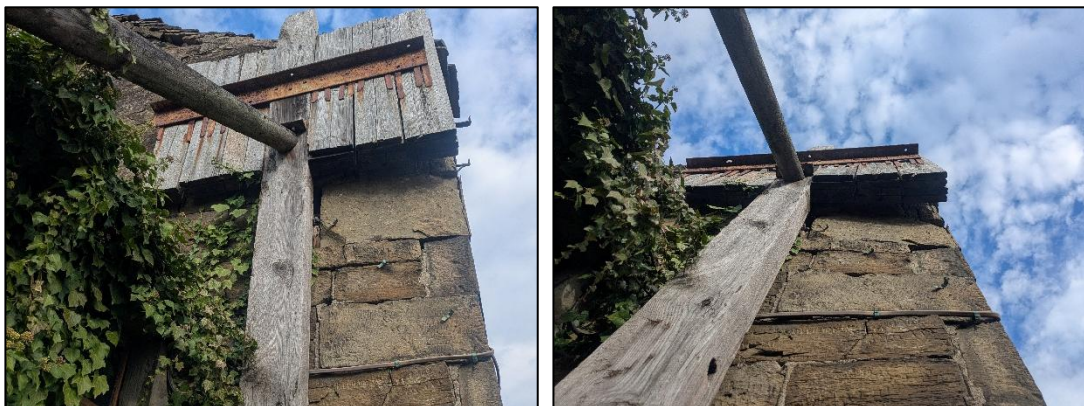
3.5.4.1.2. In addition, a timber frame has been erected on the southern gable end of the building to support the wall due to structural instability. There are gaps between the frame and the wall, providing potential roost features for bats. Furthermore, there are gaps between the timber boards used to construct the frame, providing further potential roost features within the frame itself.

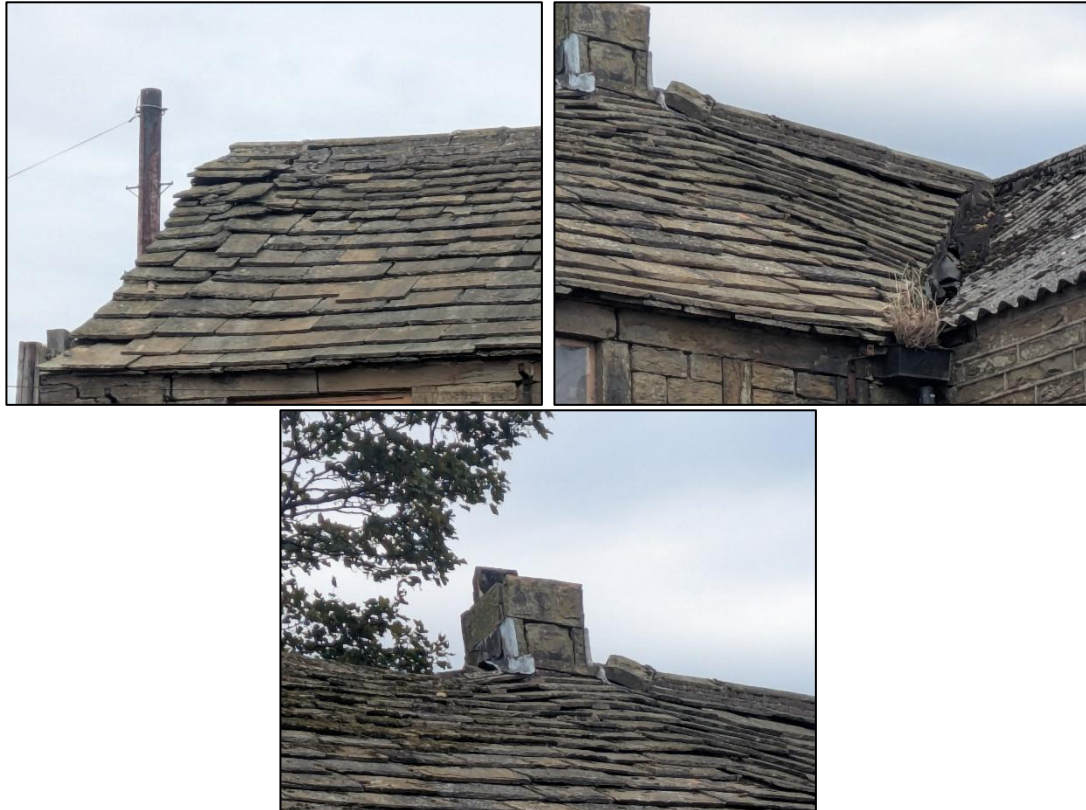
3.3.1.3. The roof is a pitched roof with stone tiles, which is in poor condition with many lifted, slipped, broken or missing tiles providing multiple potential roost features or

entry points into the building for bats. There are also gaps underneath many of the ridge tiles providing potential roost features for bats. In addition, a stone chimney stack is present which has gaps in the mortar, providing further potential roost features for bats.

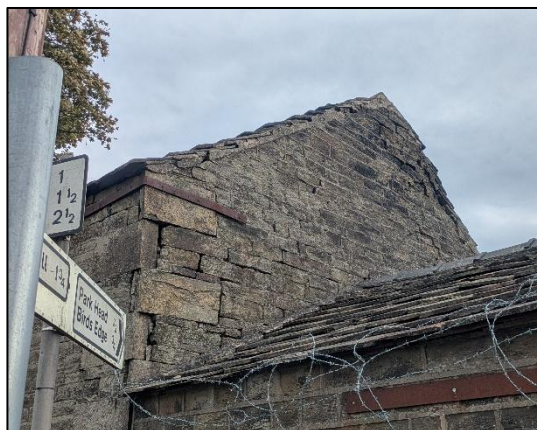
3.5.4.1.4. One gable end is present on the southern aspect of the building. The gable end has multiple gaps in the stonework and multiple areas of missing mortar beneath the roof tiles, providing potential roost features and/or potential access points into the building for roosting bats.

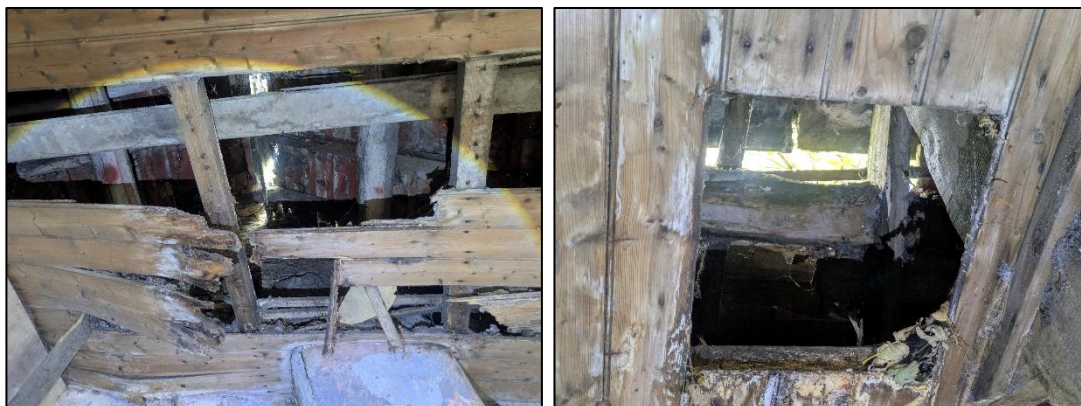
3.5.4.1.5. Internally, the loft space could not be inspected due to safety concerns around the stability of the floors. However, the loft space could be viewed from holes where

the ceiling had partially collapsed. These viewing points showed an unlined roof with several gaps through which daylight could be seen. No field evidence of bats was found on the upper floor of the building underneath the gaps to the loft space, but it appeared that the floor had been recently swept.

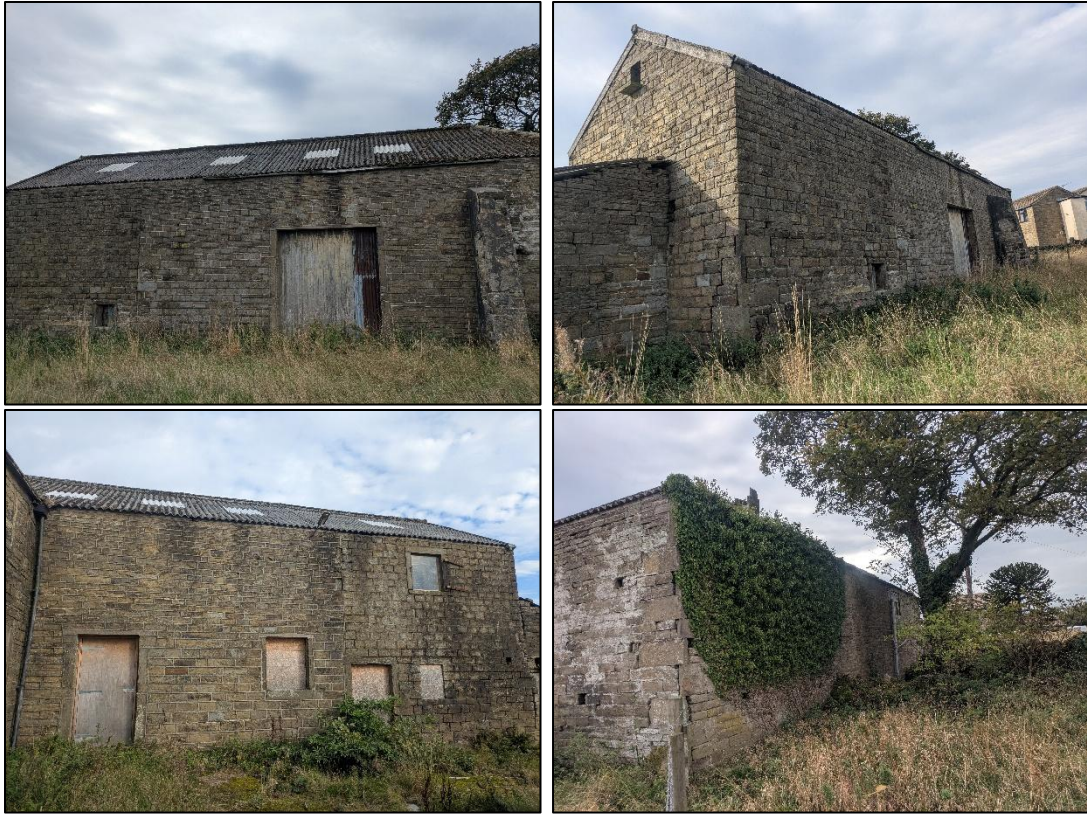
3.5.4.2.1. The building has a stone construction, and the walls are in poor condition with multiple cracks, gaps or crevices throughout all aspects of the building which were suitable for roosting bats. The walls are cavity walls, and several gaps lead to potentially large gaps within the cavity, providing potential roost features for multiple bats. The windows and doors were generally well-sealed by plywood boards. However, a purpose-built owl entry point is present on the eastern gable end, providing a potential entry point into the building for bats.

3.5.4.2.8. Overall, due to the large number of potential access points into the barn, and also many potential roost features under tiles or within gaps in the stonework of the walls, the barn is assessed as having **high potential** for roosting bats

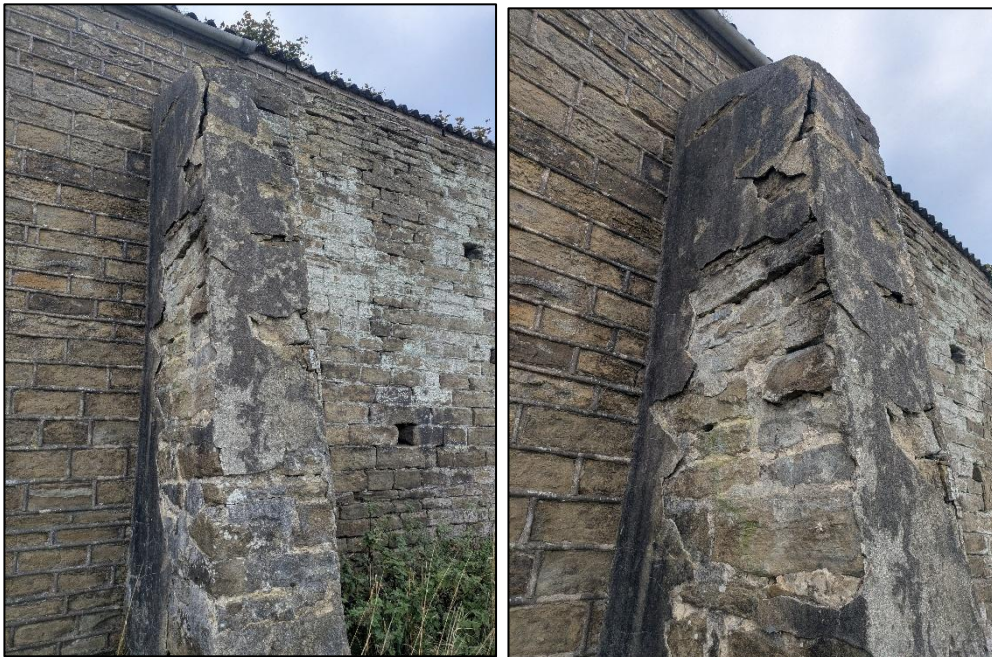
3.5.4.2.2. A stone-built column is present on the northern aspect of the building, which is partially covered with mortar. Most of the mortar has weathered away, leaving exposed gaps within the stonework and gaps underneath the mortar itself, providing potential roost features for bats.

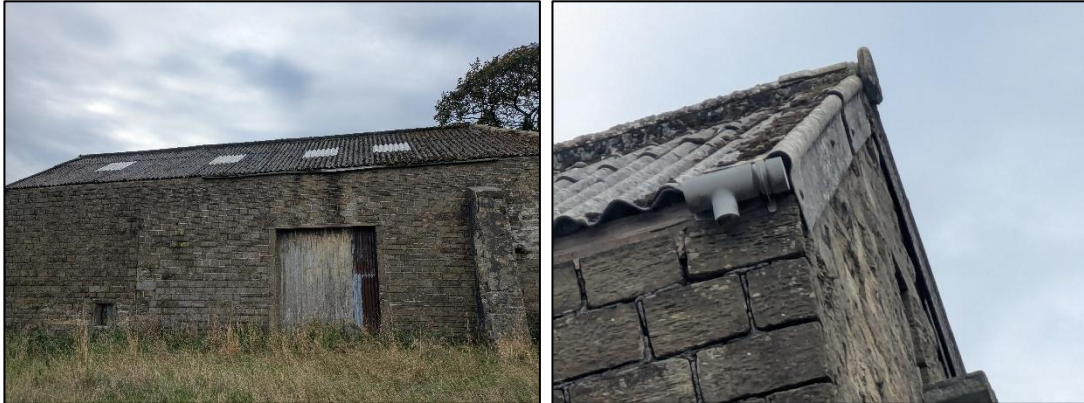
3.5.4.2.3. The roof is a pitched roof with corrugated asbestos roofing sheets and clear plastic skylights. The roofing sheets extend on to the eastern gable end, where they are lifted away from the wall. The gaps between the sheets and the walls provide potential roost features for bats.

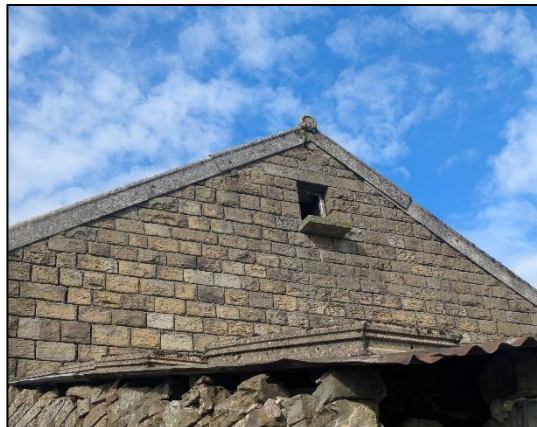
3.5.4.2.4. One gable end is present on the eastern aspect of the building. The gable end has multiple gaps in the stonework, as well as a large owl access point, providing potential roost features and/or potential access point for bats.

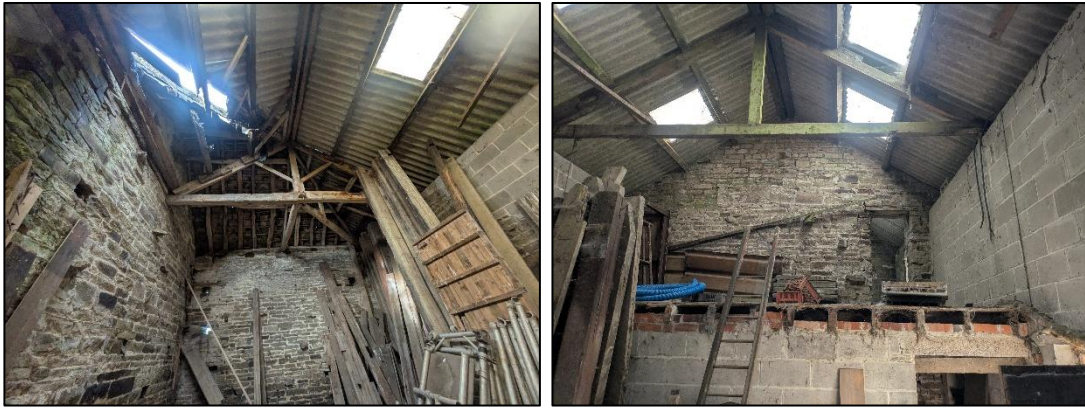
3.5.4.2.5. Internally, the majority of the barn is open and double height with a vaulted ceiling. There is a large gap in the roof where it has partially collapsed, providing potential access for bats. Furthermore, there are several gaps in the walls through which daylight can be seen. Parts of the walls have been lined with breezeblocks. However, where the stone walls remain, there are gaps within the stonework which could be accessed by roosting bats.

3.5.4.2.6. No field evidence of bats was found inside the barn, but the floor was partly covered by straw and other materials, and therefore it is possible that any droppings on the floor may have been obscured.

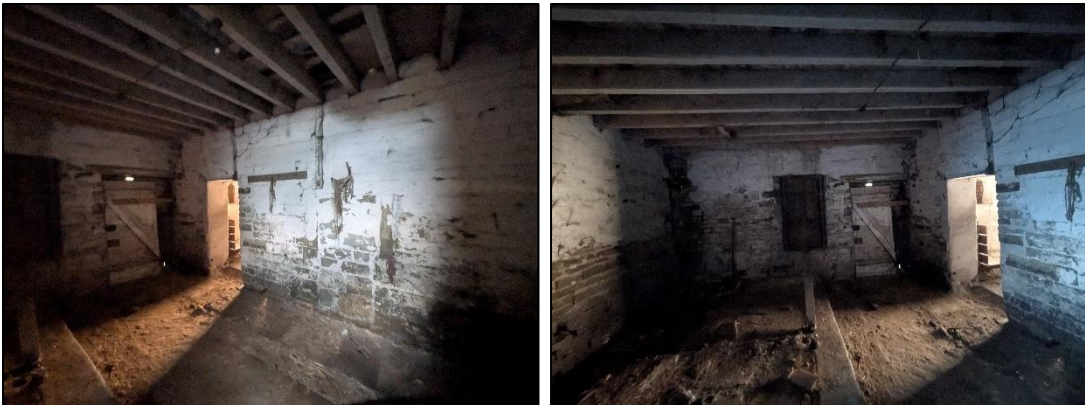
3.5.4.2.7. Two rooms are present on the ground floor in the eastern part of the barn. A small number of gaps to the outside were present in the walls. However, no field evidence of bats was found in these rooms. A further room was present above these rooms, but this was not accessible during this survey.

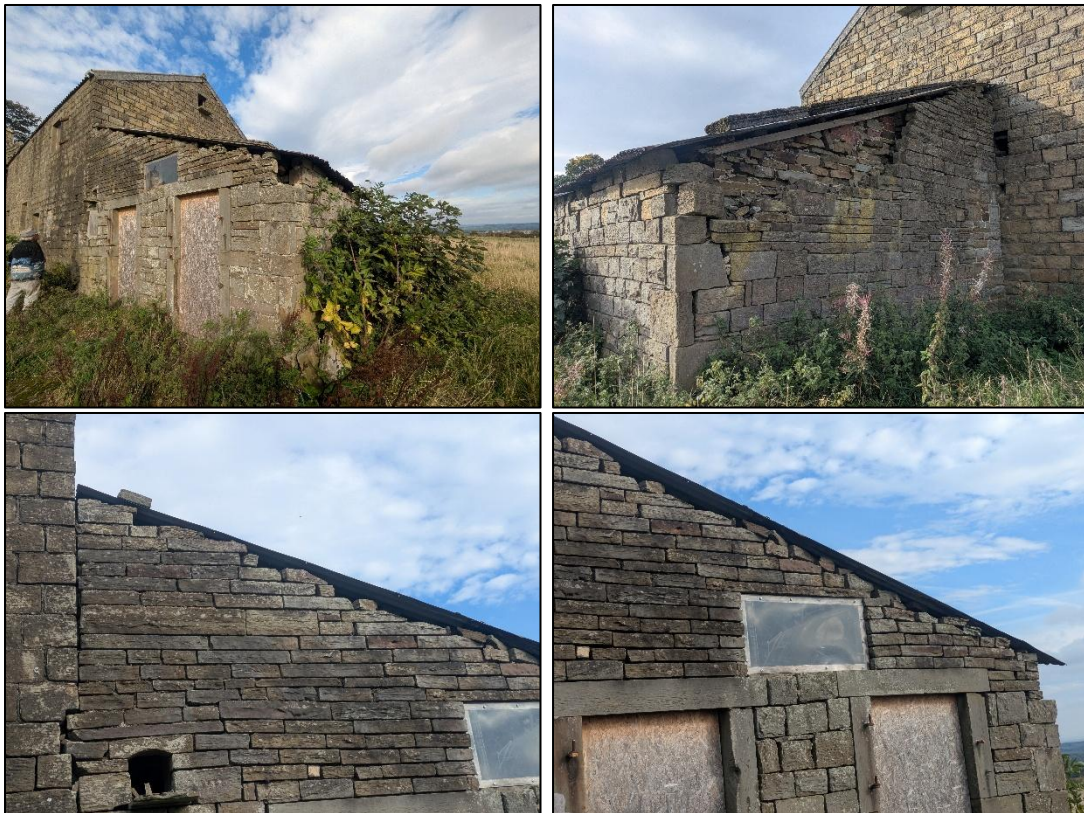
3.5.4.3.1. The building has a stone construction, and the walls are in poor condition with multiple cracks, gaps or crevices throughout all aspects of the building which were suitable for roosting bats. Part of the wall on the northern aspect has collapsed, exposing cavities in the wall and also large entry points for bats. In addition, there is a smaller barn owl entry point on the southern aspect of the building, providing further access into the building.

3.5.4.3.4. Overall, due to the large number of potential access points into the walls or within gaps in the stonework of the walls, the stables are assessed as having **high potential** for roosting bats

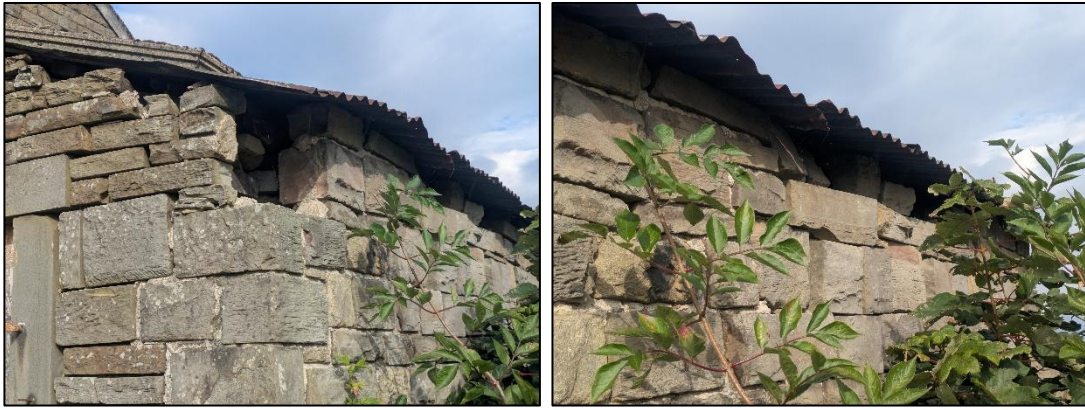
3.5.4.3.2. The roof is a mono-pitched roof with corrugated metal sheeting, which is generally unsuitable for roosting bats. However, the roof was poorly sealed to the building, providing access to any potential roost features internally or into the cavity walls.

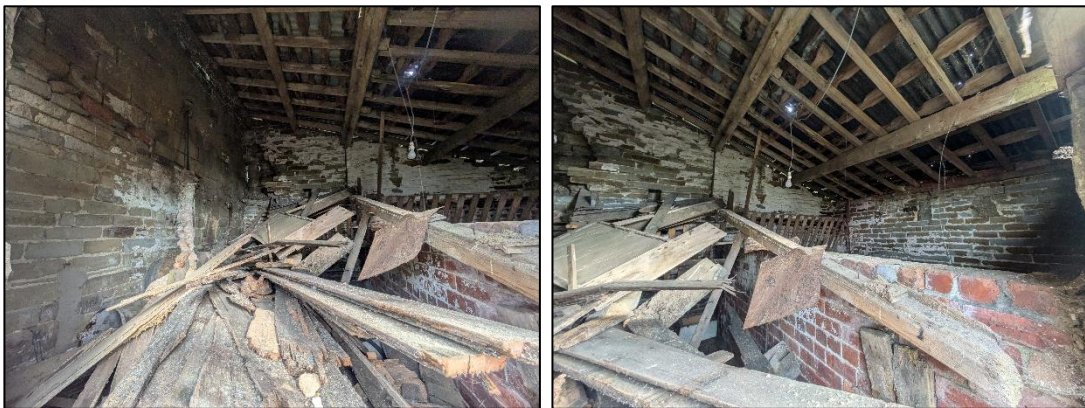
3.5.4.3.3. Internally, access was limited due to the presence of a large amount of materials blocking entry. For this reason, a thorough search for field evidence of bats could not be carried out. However, daylight was visible from many points where the roof meets the walls. Multiple gaps leading into the cavity walls could be seen internally.

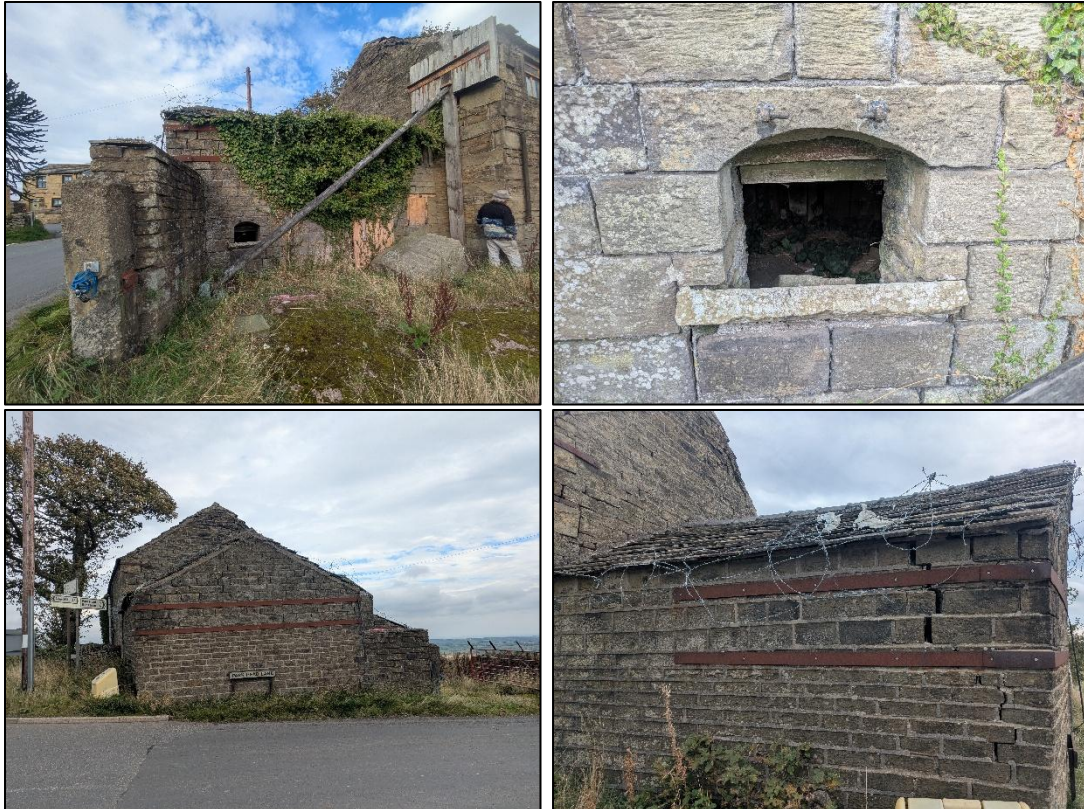
3.5.4.4.1. The building has a stone construction with metal brackets around the eastern, southern and western aspects. The walls are in poor condition with multiple cracks, gaps or crevices throughout all aspects of the building which were suitable for roosting bats. A small open window was present on the eastern aspect, providing potential entry into the building for bats.

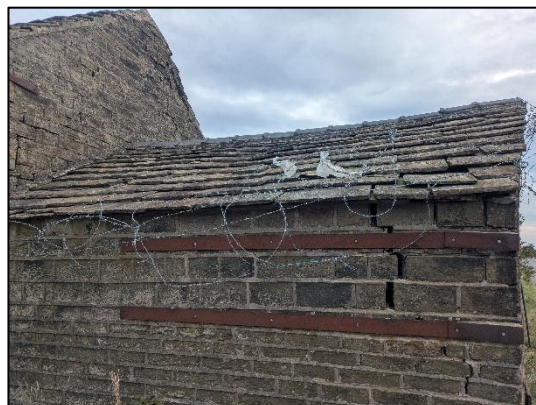
3.5.4.4.2. The roof is a pitched roof with stone tiles, which is in poor condition with many lifted, slipped, broken or missing tiles providing multiple potential roost features or entry points into the building for bats.

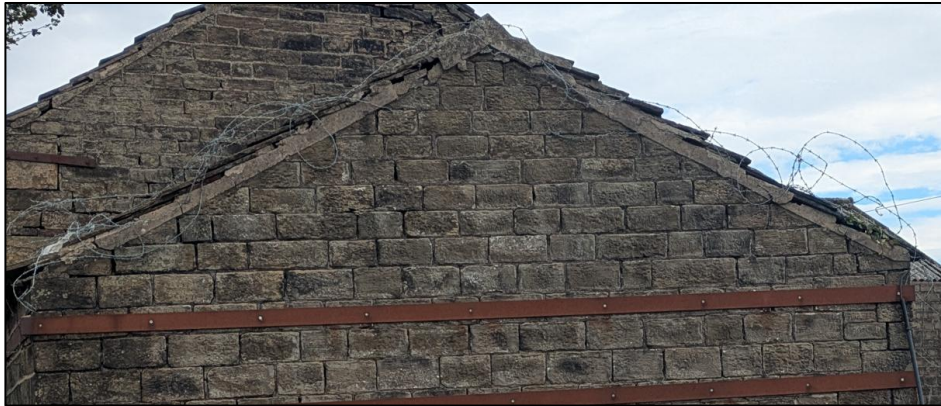
3.5.4.4.3. One gable end is present on the southern aspect of the building. The gable end has multiple gaps in the stonework and multiple areas of missing mortar beneath the roof tiles, providing potential roost features and/or potential access points into the building for roosting bats. However, barbed wire is also spread across this gable end where the roof meets the walls, potentially limiting the suitability of these features for bats.

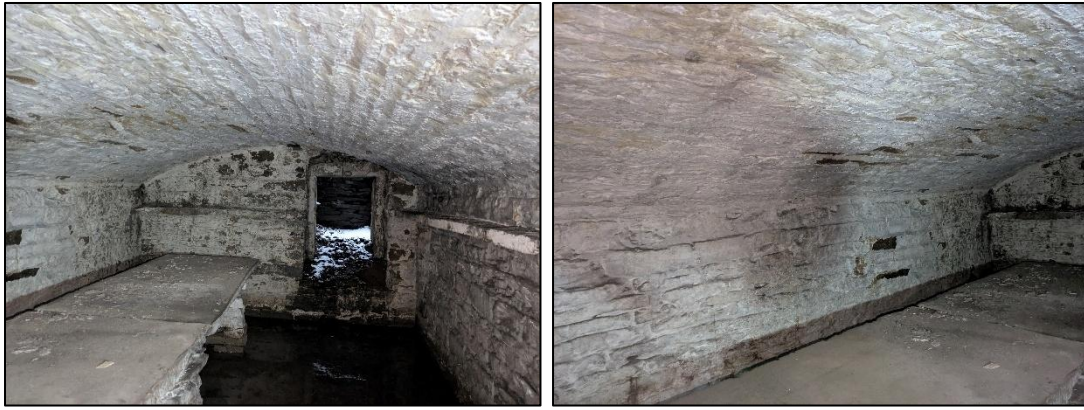
3.5.4.5. A cellar was present underneath the farmhouse. This had an open doorway, providing potential access for bats, but also exposing the cellar to winds and changing temperatures. The walls and ceiling were limewashed, and no potential roost features were identified. No bats, droppings or field evidence was identified in the cellar. Therefore, the cellar was assessed as having **negligible potential for roosting or hibernating bats**.

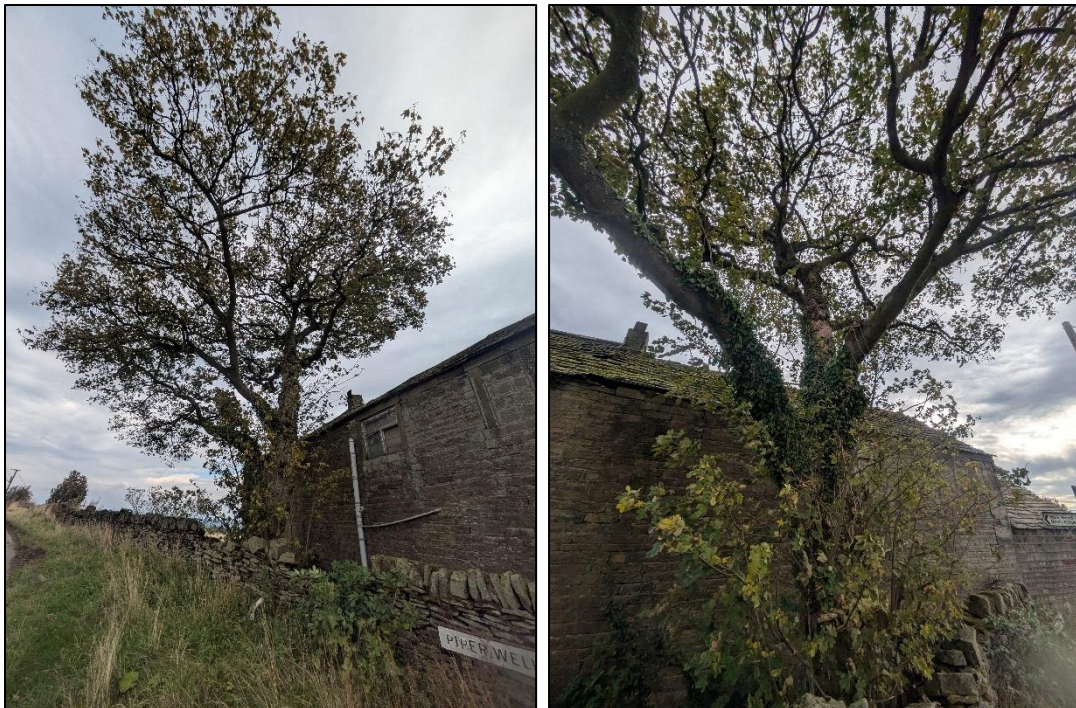
3.5.4.6. A sycamore (*Acer pseudoplatanus*) was present on the western side of the building. No potential roost features were identified in the tree.

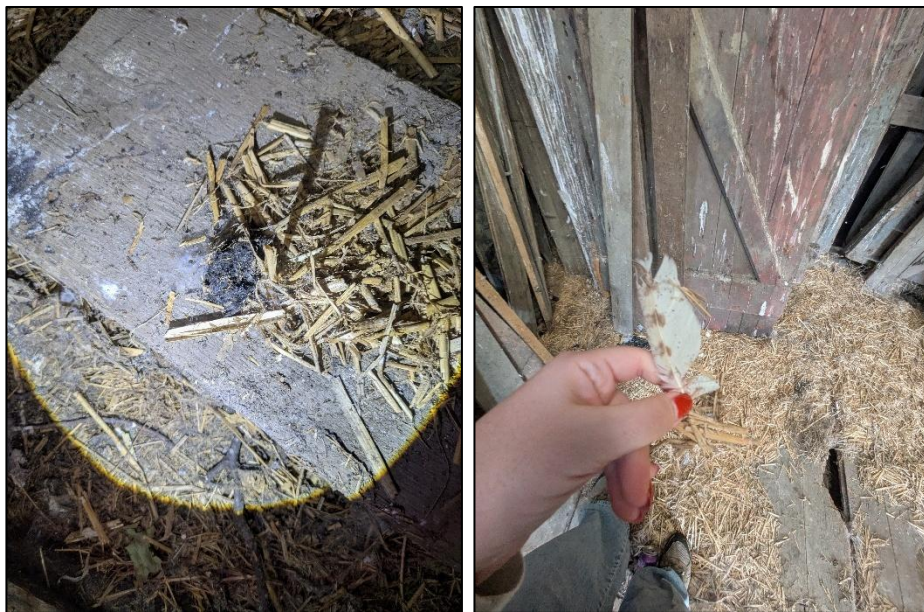
3.5.5.2. In addition, barn owl pellets and feathers were identified throughout the open section of the barn. The number of pellets found was more than ten, which suggests that the barn is a regular roost. The pellets varied in age from this current breeding season (less than eight months old) to more than a year old. In addition, multiple adult feathers were identified, as well as many droppings beneath timber ledges. The barn owl access point identified in section 3.5.4.2.1. leads directly into this barn via the upstairs room which could not be accessed during this survey. Therefore, it is possible that further field evidence, or the barn owls themselves, may have been present in that room. From the field evidence found in the accessible parts of the building, it is considered likely that barn owls are using the barn for breeding.

5.2.1.2. Furthermore, evidence of barn owl nesting, including a large number of pellets of various ages, adult and juvenile feathers, and droppings, was found inside the “Barn” during the PRA survey. Without appropriate mitigation in place, the proposed conversion of the buildings could have a high impact on barn owls if carried out at a time when the owls are nesting. Furthermore, without appropriate mitigation, the development of the building would result in the loss of a nesting site.

5.2.2.2.1. No works to the Barn or works to other parts of the building that has potential to cause disturbance to barn owls within the barn will take place between March and August inclusive.

5.2.2.2.2. In addition, as the barn owl nesting season can vary in timing, the works will be immediately preceded by a nesting bird survey carried out by a competent person who also holds a survey licence for barn owls. This should take place no more than three days prior to works commencing. If the barn owls are found to be nesting in one of the buildings, then no works can begin that will cause any disturbance to the barn owl or its nest until the last dependent young has stopped returning to the nest. Similarly, if any other bird species are found to be nesting, the works in the vicinity of the nest will be restricted until the young have fledged.

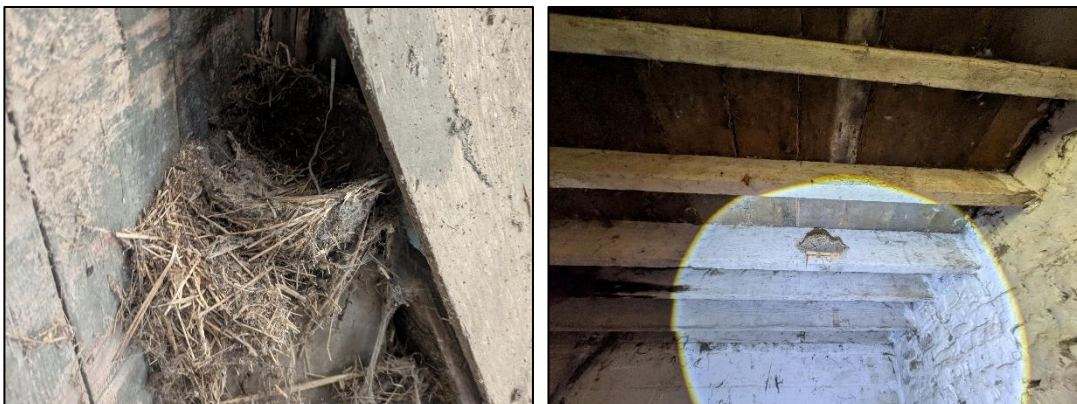
3.5.5.3. In addition, two further disused nests were identified, including one swallow nest and one other species.

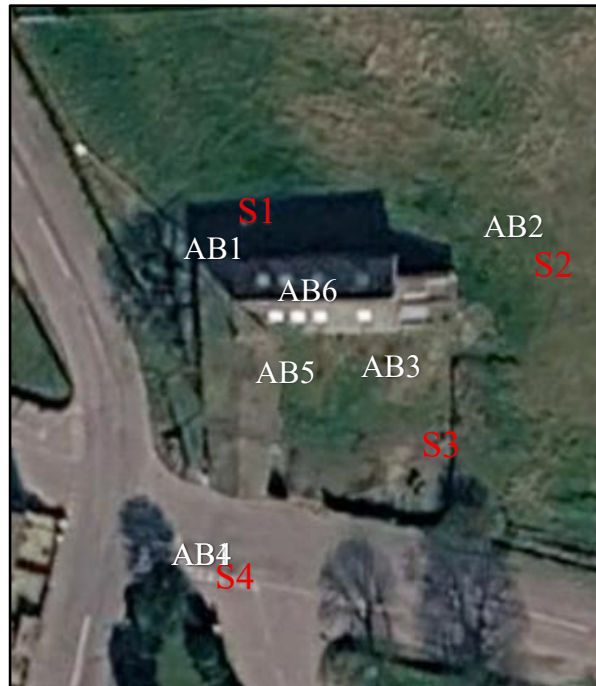
3.6.3.3. All surveyors were equipped with Batbox Duet detectors and two-way radios. Five Anabat Ranger static recorders and one Anabat Chorus static recorder were deployed around the site to record bat activity for subsequent computer analysis using Anabat Insight Software.

3.6.3.4. The aerial photograph below shows where the Surveyors (S) and Anabats (AB) were located throughout the survey.

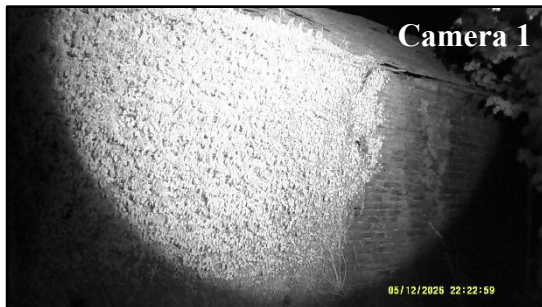
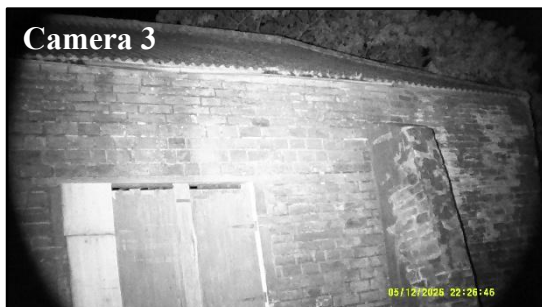
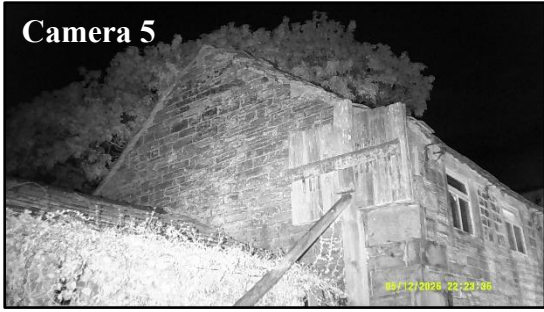
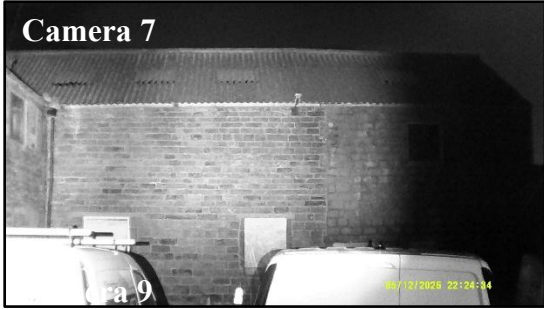
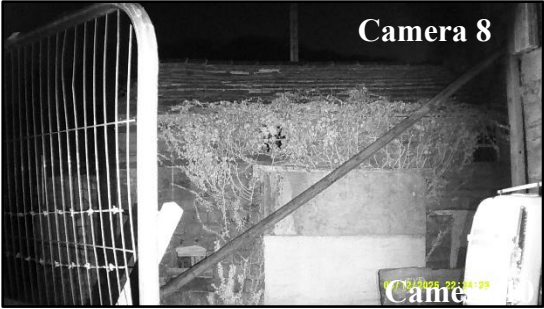
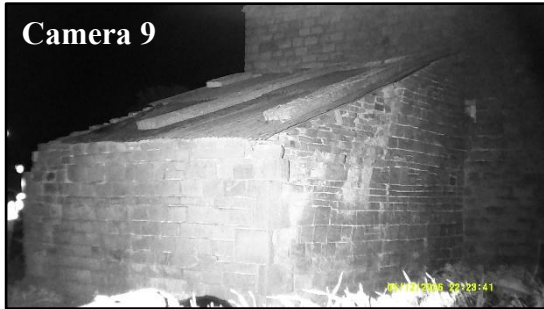
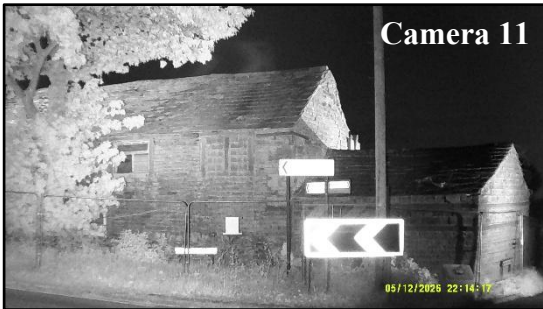
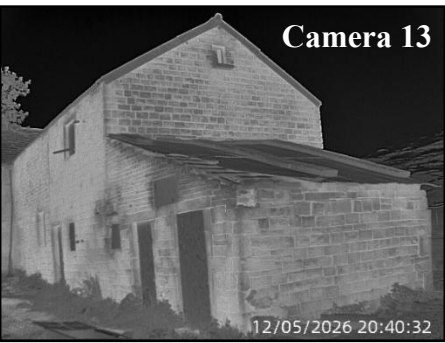
3.6.3.7. The photographs below show the view of each camera at the darkest point of the survey.

3.6.3.9. None of the surveyors observed any bats emerge from the building during the survey, this was confirmed through subsequent analysis of the video footage captured on the night.

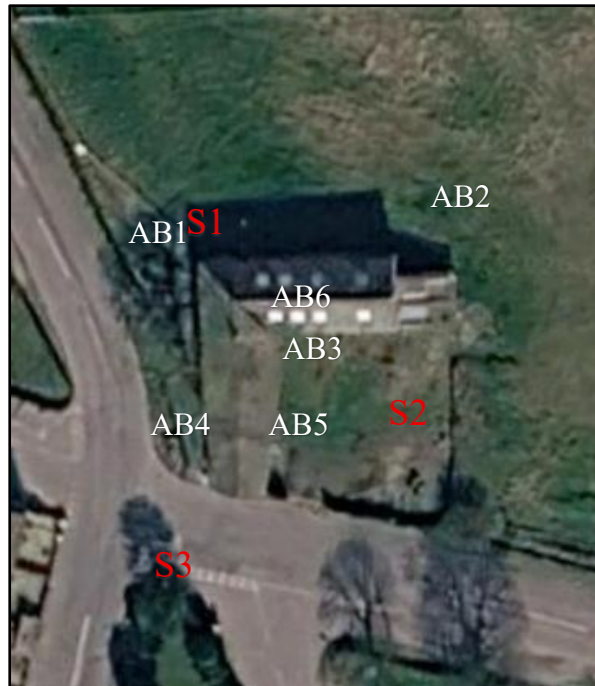
3.6.3.3. All surveyors were equipped with Batbox Duet detectors and two-way radios. Six Anabat Ranger static recorders were deployed around the site to record bat activity for subsequent computer analysis using Anabat Insight Software.

3.6.3.4. The aerial photograph below shows where the Surveyors (S) and Anabats (AB) were located throughout the survey.

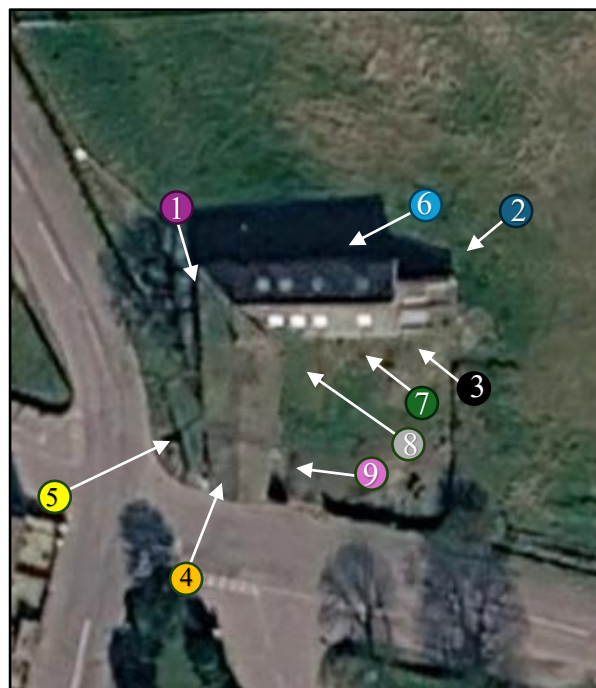
3.6.3.5. Five infra-red cameras and infra-red torches as well as four thermal cameras were set up around the building, ensuring that all suitable features were covered.

3.6.3.6. The aerial photograph below shows where the cameras were positioned along with their approximate field of view.

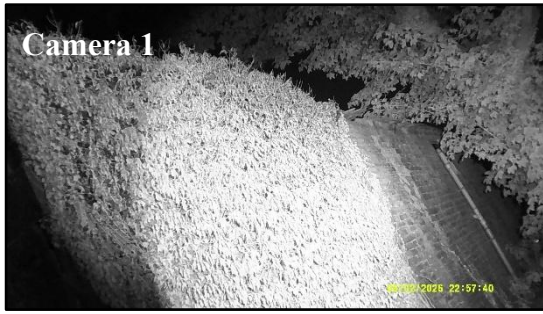
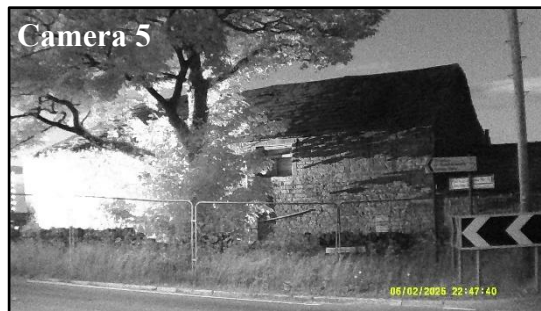
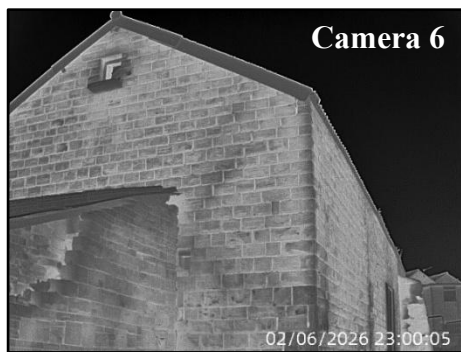
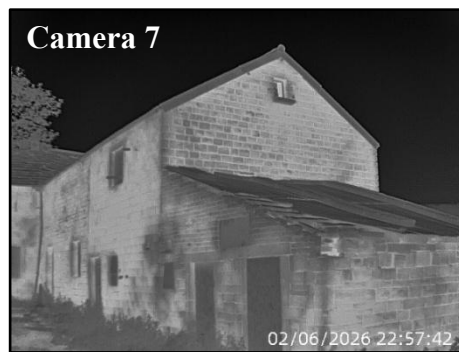
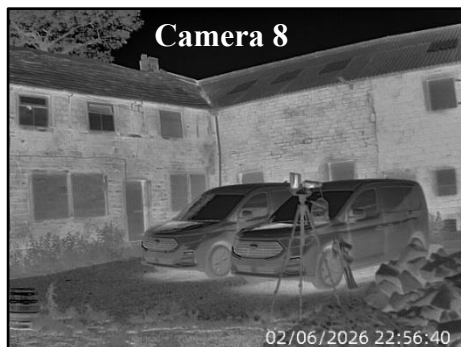
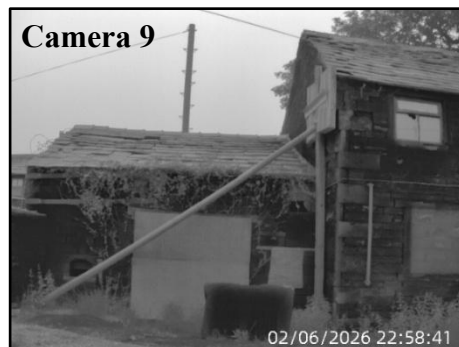
3.6.3.7. The photographs overleaf show the view of each camera at the darkest point of the survey.

3.6.3.9. None of the surveyors observed any bats emerge.

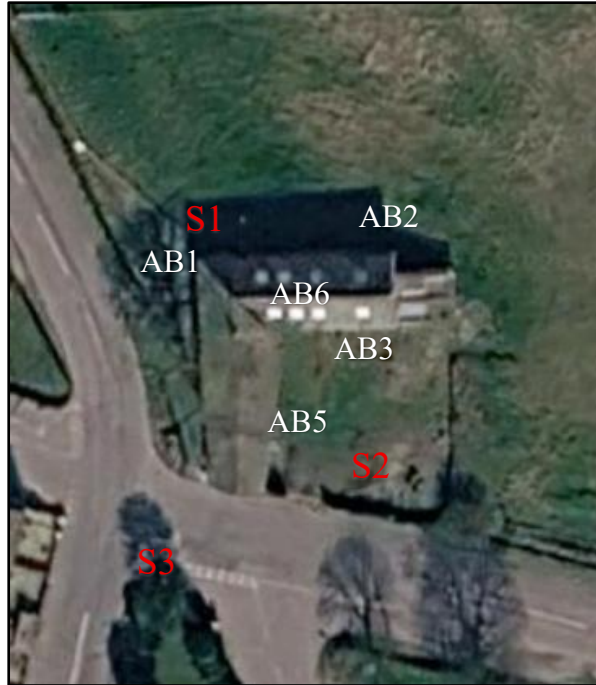
3.6.5.3. All surveyors were equipped with Batbox Duet detectors and two-way radios. Six Anabat Ranger static recorders were deployed around the site to record bat activity for subsequent computer analysis using Anabat Insight Software.

3.6.5.4. The aerial photograph below shows where the Surveyors (S) and Anabats (AB) were located throughout the survey.
