**PIPERWELL FARM, SHEPLEY.**

**ECOLOGICAL IMPACT ASSESSMENT.**

**Ref No: 251009/EcIA/3.**

**Date: 26<sup>th</sup> June 2026.**

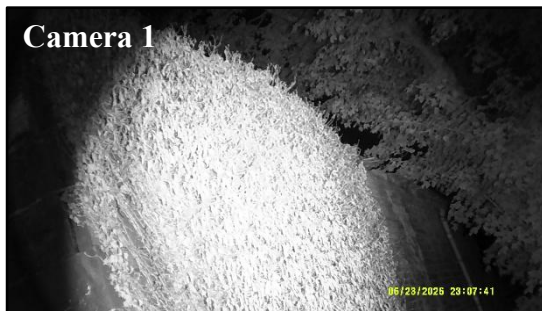
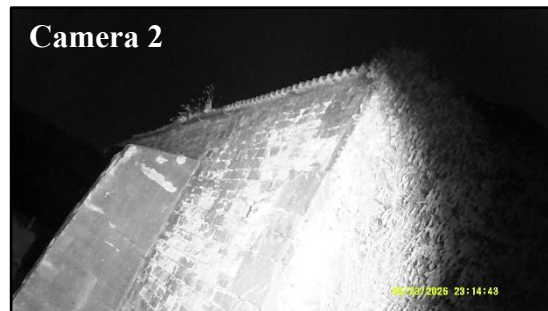
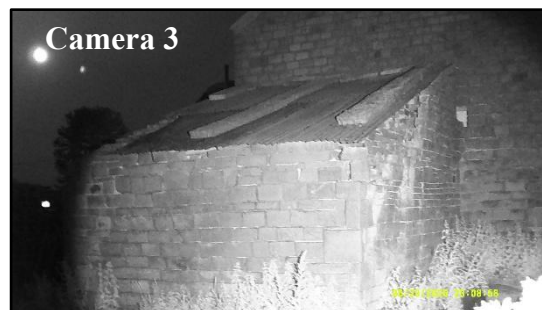
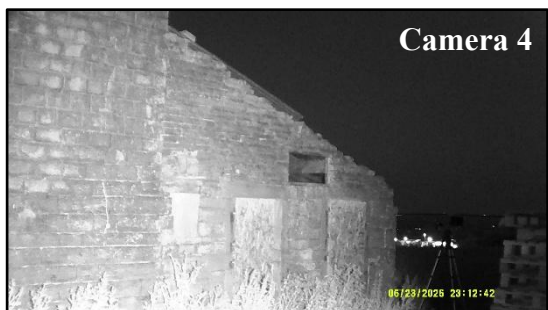
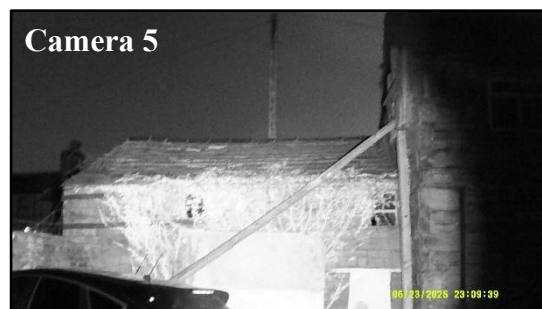
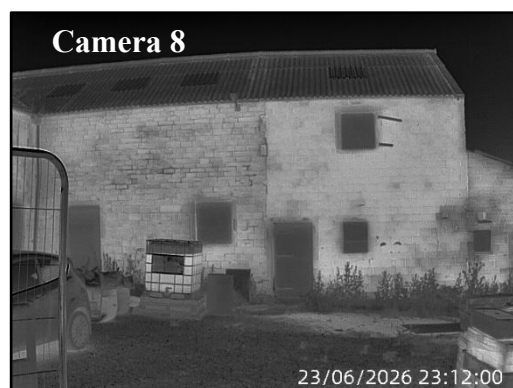
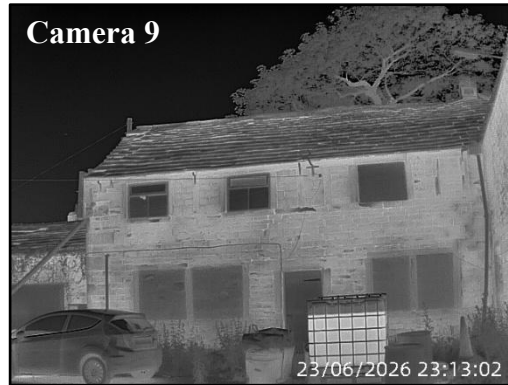
3.6.5.7. The photographs below show the view of each camera at the darkest point of the survey.

3.6.5.9. None of the surveyors observed any bats emerge.

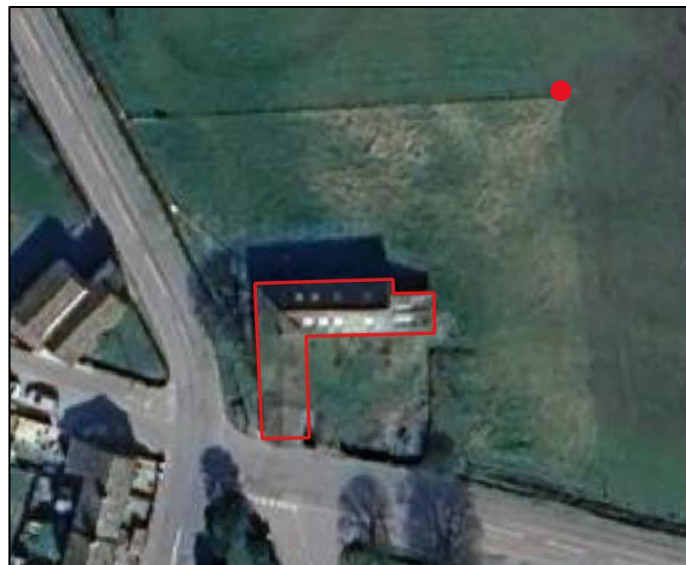
5.2.2.1.4. The location of nest box is shown on the aerial image below.

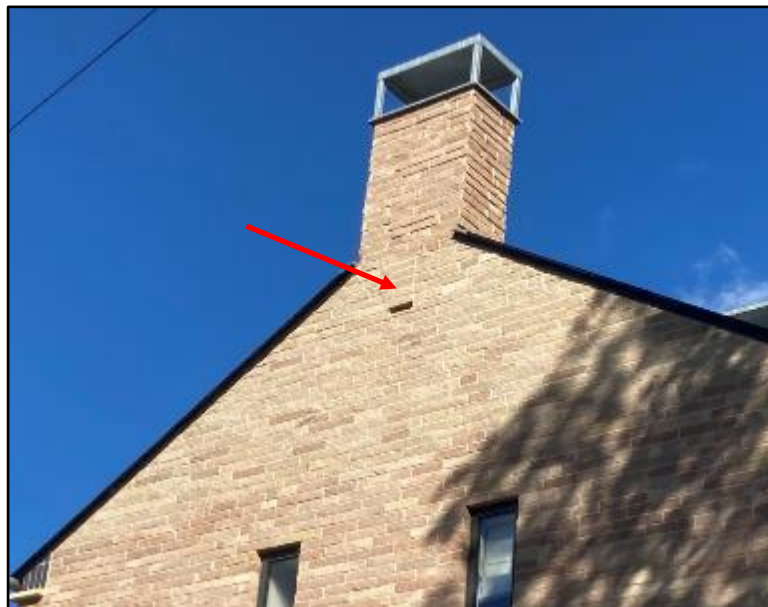
6.3. An integrated Habibat bat box with custom facing, like shown below, will be installed in a suitable location on the southern aspect, at least 3m from ground level or as high as possible.

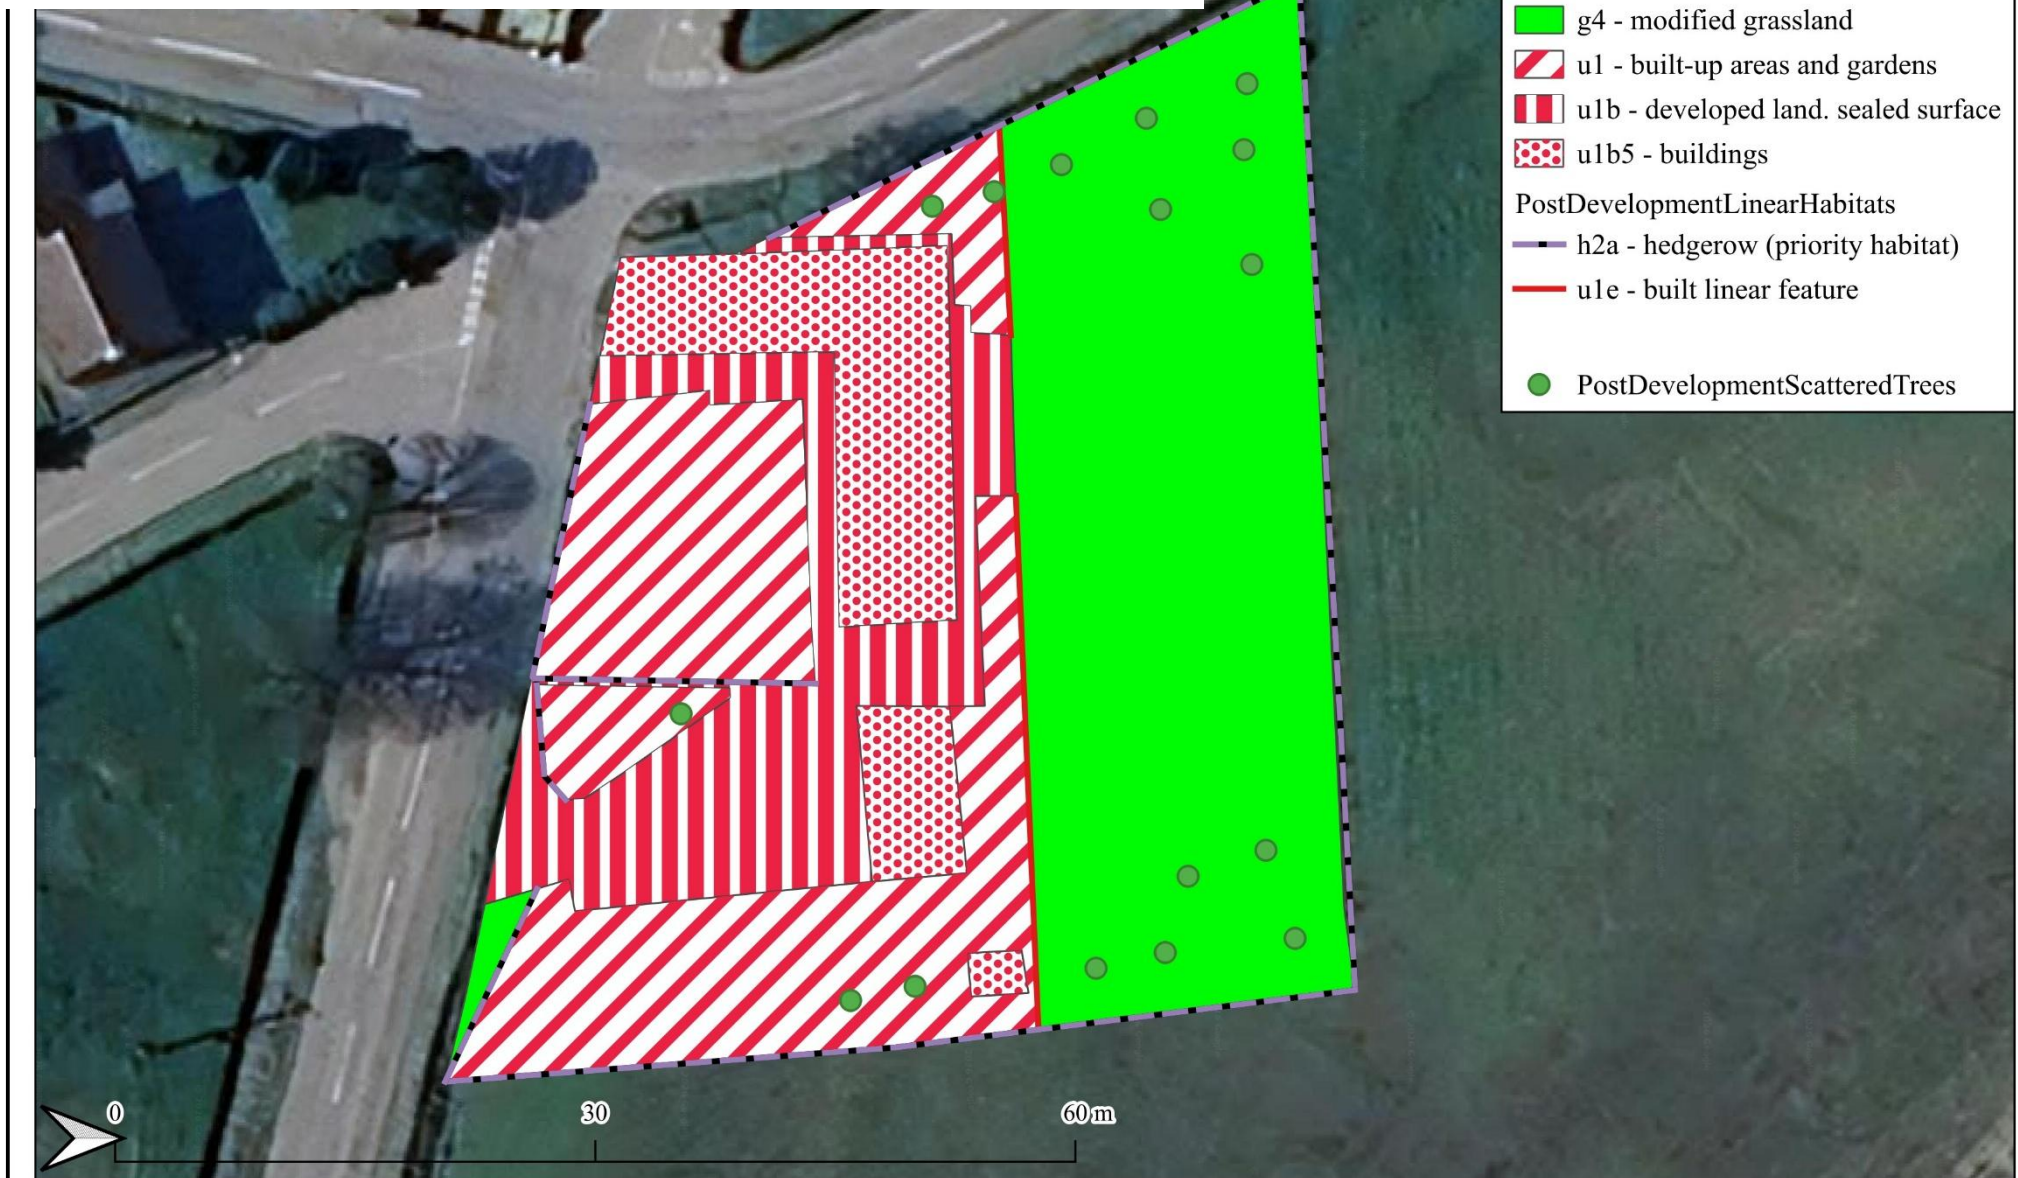
## Appendix VI. ANNOTATED MAP OF THE SURVEY AREA. (POST-DEVELOPMENT)

4.2.2. This was calculated using the current site layout plans provided at the time of this report, shown in Appendix VI. The calculations are based on the enhancement of a fenced off area of poor condition modified grassland in the east of the survey area to create a species-rich modified grassland, as well as the planting of sixteen small trees.
