**PIPERWELL FARM, SHEPLEY.**

**PRELIMINARY ROOST ASSESSMENT.**

**Ref No: 251009.**

**Date: 8<sup>th</sup> October 2025.**

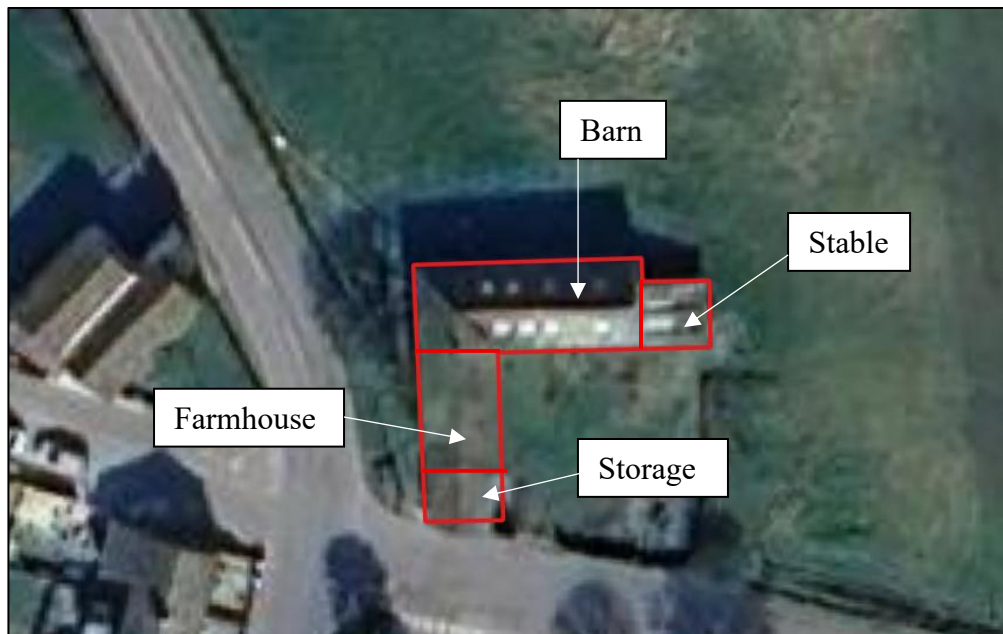
3.2.3. The survey area comprises a two-storey stone-built farmhouse, with an attached two-storey stone-built barn, and an attached single-storey stone-built stable. The layout of the property is shown in the aerial image below. Each part of the property has been labelled for the purposes of this report.

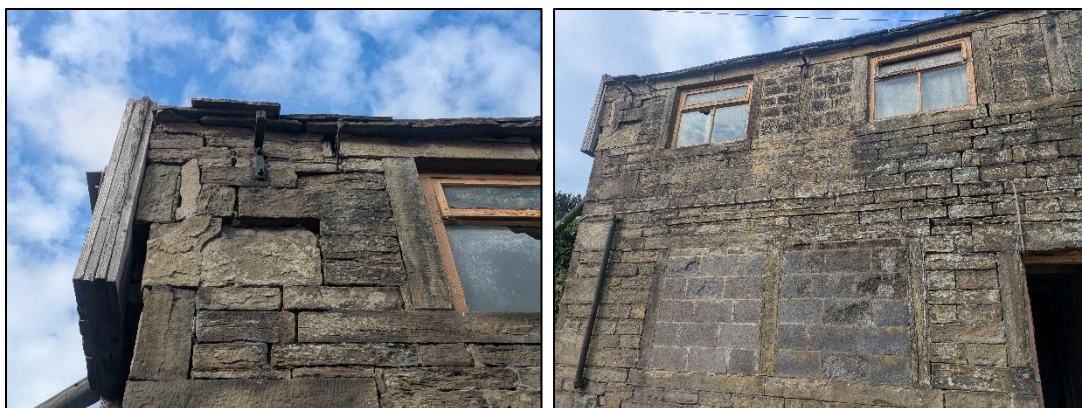
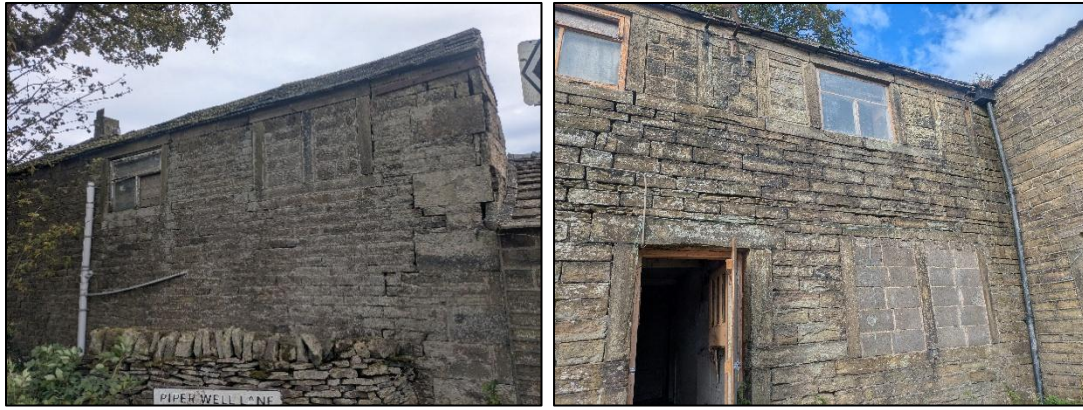
3.3.1.1. The building has a stone construction, and the walls are in poor condition with multiple cracks, gaps or crevices throughout all aspects of the building which were suitable for roosting bats. Additionally, at least one of the windows was cracked, providing a potential access point into the building. Examples of the overall condition of the walls are provided in the photographs below.

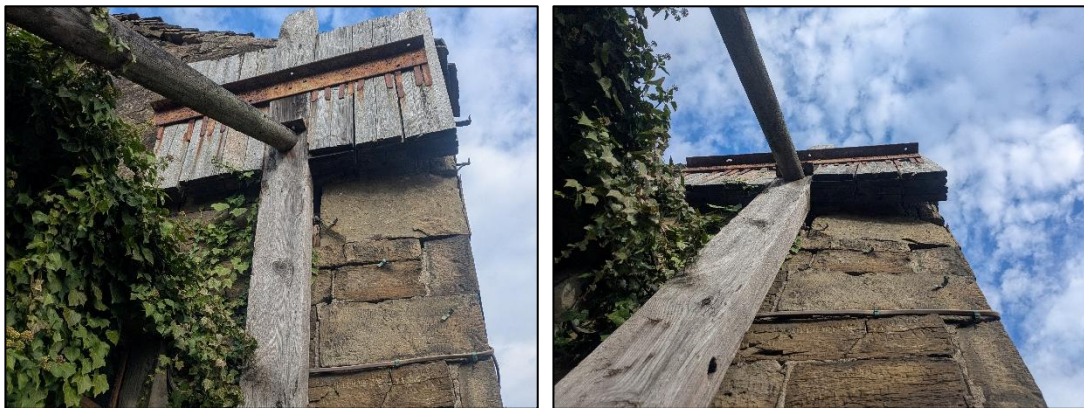
3.3.1.2. In addition, a timber frame has been erected on the southern gable end of the building to support the wall due to structural instability. There are gaps between the frame and the wall, providing potential roost features for bats. Furthermore, there are gaps between the timber boards used to construct the frame, providing further potential roost features within the frame itself.

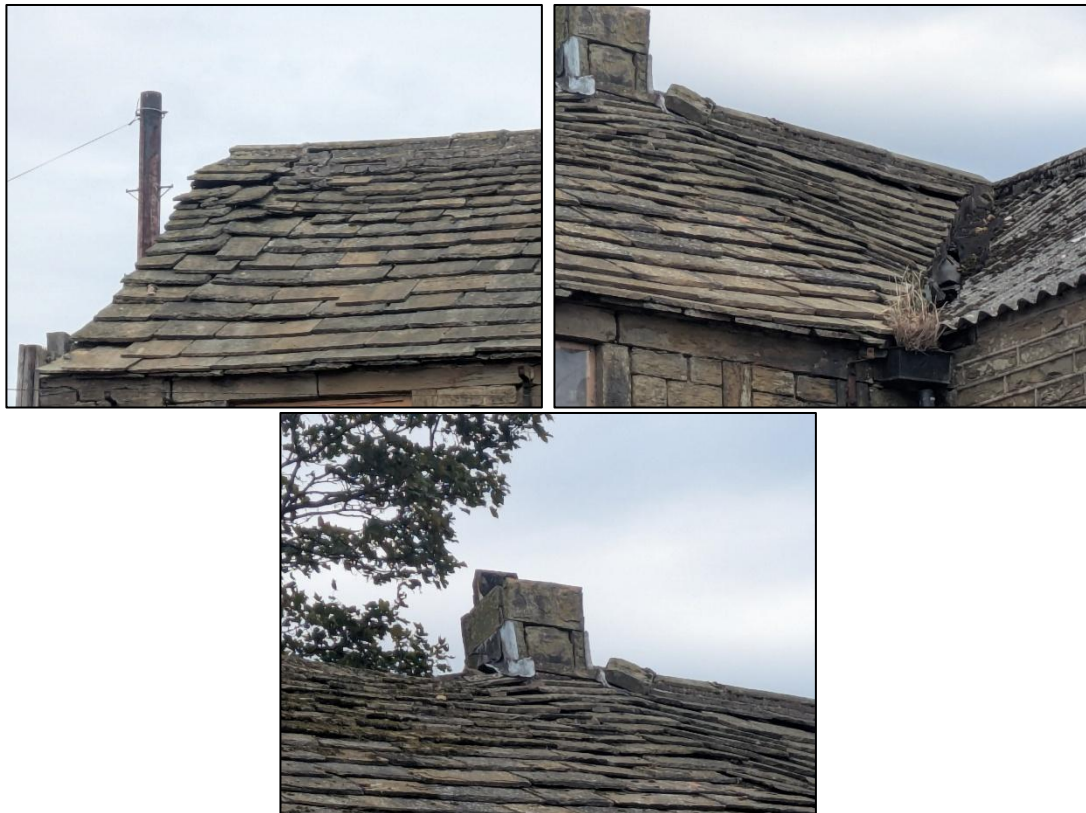
3.3.1.3. The roof is a pitched roof with stone tiles, which is in poor condition with many lifted, slipped, broken or missing tiles providing multiple potential roost features or entry points into the building for bats. There are also gaps underneath many of the ridge tiles providing potential roost features for bats. In addition, a stone chimney stack is present which has gaps in the mortar, providing further potential roost features for bats.

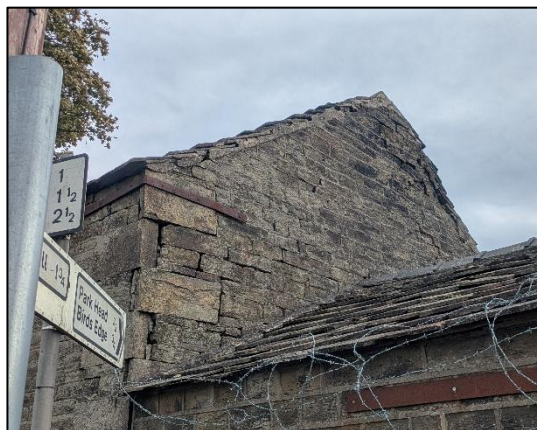
3.3.1.4. One gable end is present on the southern aspect of the building. The gable end has multiple gaps in the stonework and multiple areas of missing mortar beneath the roof tiles, providing potential roost features and/or potential access points into the building for roosting bats.

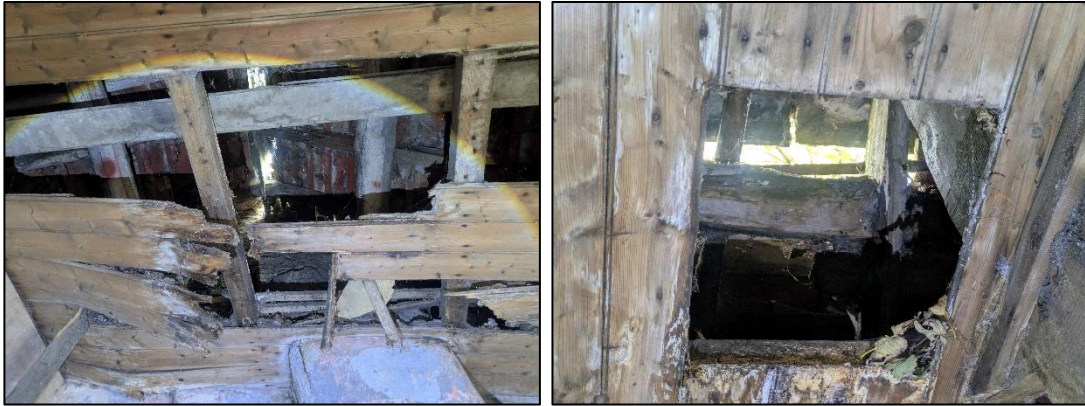
3.3.1.5. Internally, the loft space could not be inspected due to safety concerns around the stability of the floors. However, the loft space could be viewed from holes where the ceiling had partially collapsed. These viewing points showed an unlined roof with several gaps through which daylight could be seen. No field evidence of bats was found on the upper floor of the building underneath the gaps to the loft space, but it appeared that the floor had been recently swept.

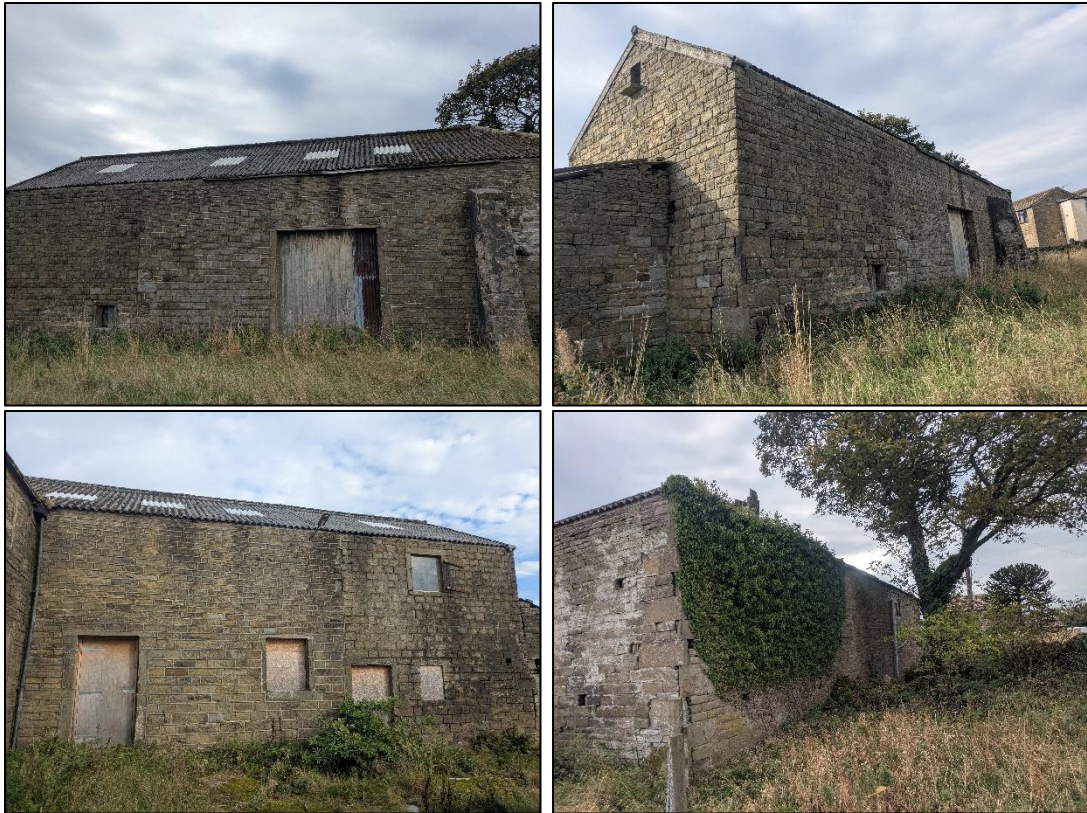
3.3.2.1. The building has a stone construction, and the walls are in poor condition with multiple cracks, gaps or crevices throughout all aspects of the building which were suitable for roosting bats. The walls are cavity walls, and several gaps lead to potentially large gaps within the cavity, providing potential roost features for multiple bats. The windows and doors were generally well-sealed by plywood boards. However, a purpose-built owl entry point is present on the eastern gable end, providing a potential entry point into the building for bats.

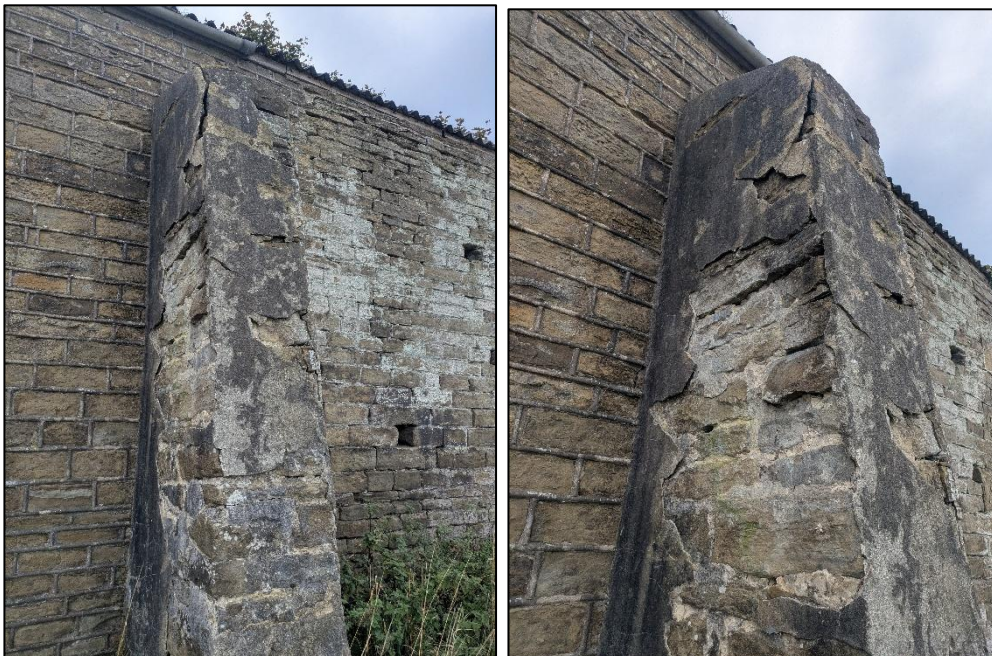
3.3.2.2. A stone-built column is present on the northern aspect of the building, which is partially covered with mortar. Most of the mortar has weathered away, leaving exposed gaps within the stonework and gaps underneath the mortar itself, providing potential roost features for bats.

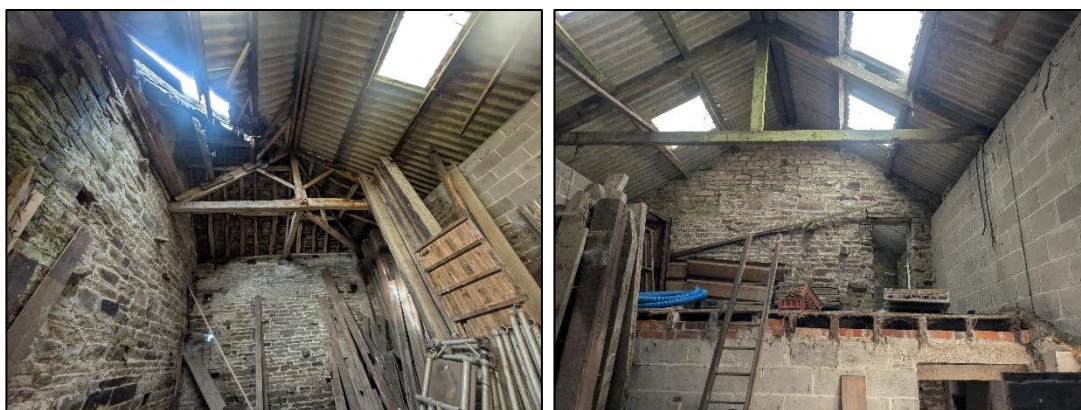
3.3.2.5. Internally, the majority of the barn is open and double height with a vaulted ceiling. There is a large gap in the roof where it has partially collapsed, providing potential access for bats. Furthermore, there are several gaps in the walls through which daylight can be seen. Parts of the walls have been lined with breezeblocks. However, where the stone walls remain, there are gaps within the stonework which could be accessed by roosting bats.

3.3.2.6. No field evidence of bats was found inside the barn, but the floor was partly covered by straw and other materials, and therefore it is possible that any droppings on the floor may have been obscured.

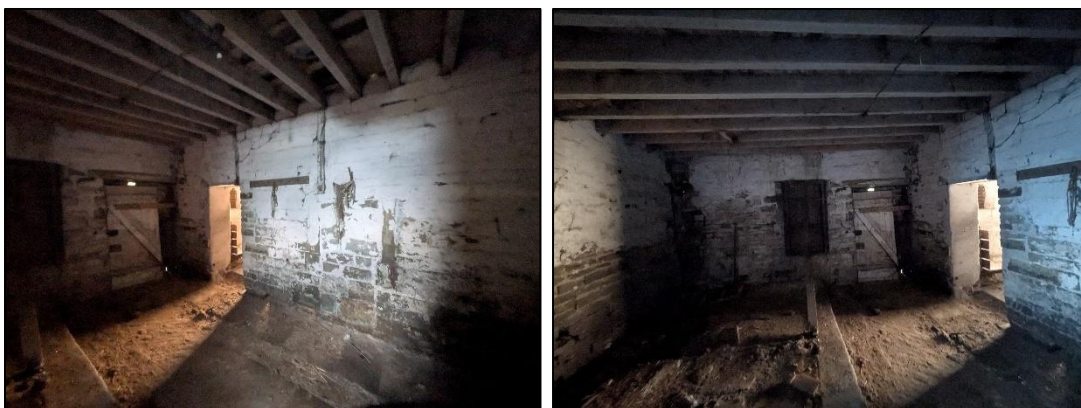
3.3.2.7. Two rooms are present on the ground floor in the eastern part of the barn. A small number of gaps to the outside were present in the walls. However, no field evidence of bats was found in these rooms. A further room was present above these rooms, but this was not accessible during this survey.

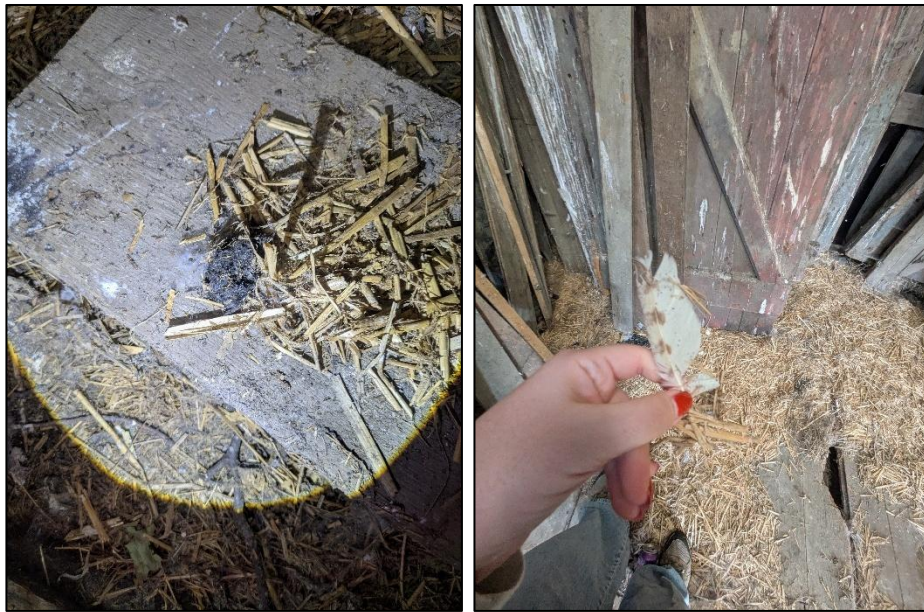
3.3.2.10. Barn owl pellets and feathers were identified throughout the open section of the barn. The number of pellets found was more than ten, which suggests that the barn

is a regular roost. The pellets varied in age from this current breeding season (less than eight months old) to more than a year old. In addition, multiple adult feathers were identified, as well as many droppings beneath timber ledges. The barn owl access point identified in section 3.3.2.4. leads directly into this barn via the upstairs room which could not be accessed during this survey. Therefore, it is possible that further field evidence, or the barn owls themselves, may have been present in that room. From the field evidence found in the accessible parts of the building, it is considered likely that barn owls are using the barn for breeding.

5.3. As the barn has been identified as a barn owl roost and it is likely that barn owls are using the barn for nesting, it is recommended that a mitigation strategy is prepared outlining measures to protect barn owls during and after the works. This will include restrictions on the timings of the works, i.e. no works to the barn to be carried out during the nesting season (March to August inclusive). In addition, the mitigation strategy will require a pre-works survey, provision of a temporary roost site during the works, and the provision of a permanent roost site within the barn. For the permanent roost site, is recommended that a small loft space is built around the existing barn owl entrance hole, is at least 500mm deep from the entrance hole, and is easily accessible by the occupants for occasional cleaning.

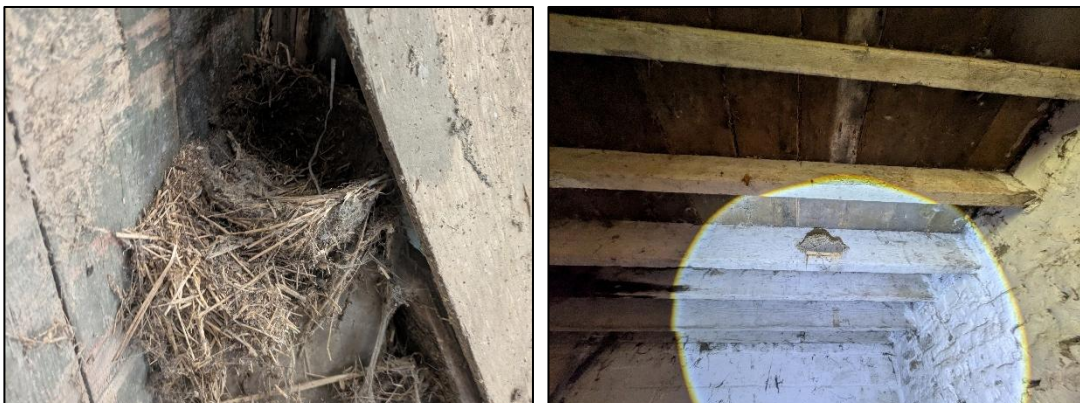
3.3.2.11. In addition, two further disused nests were identified, including one swallow nest and one other species.

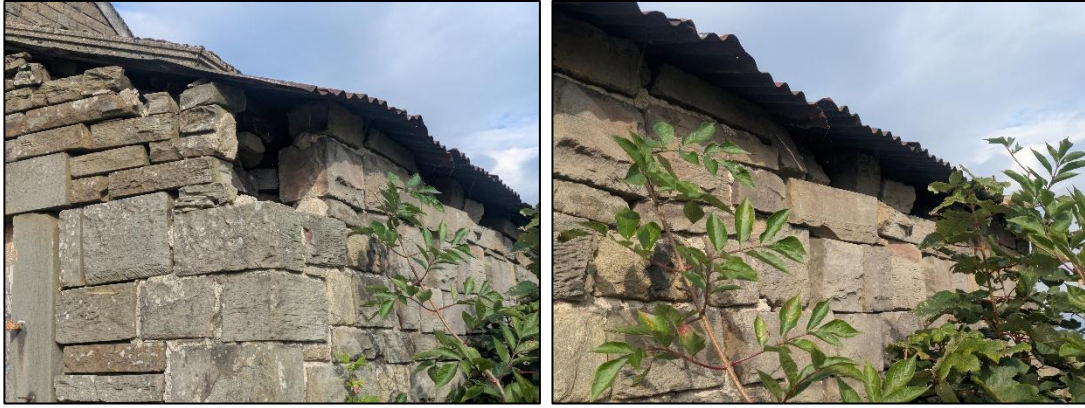
3.3.3.2. The roof is a mono-pitched roof with corrugated metal sheeting, which is generally unsuitable for roosting bats. However, the roof was poorly sealed to the building, providing access to any potential roost features internally or into the cavity walls.

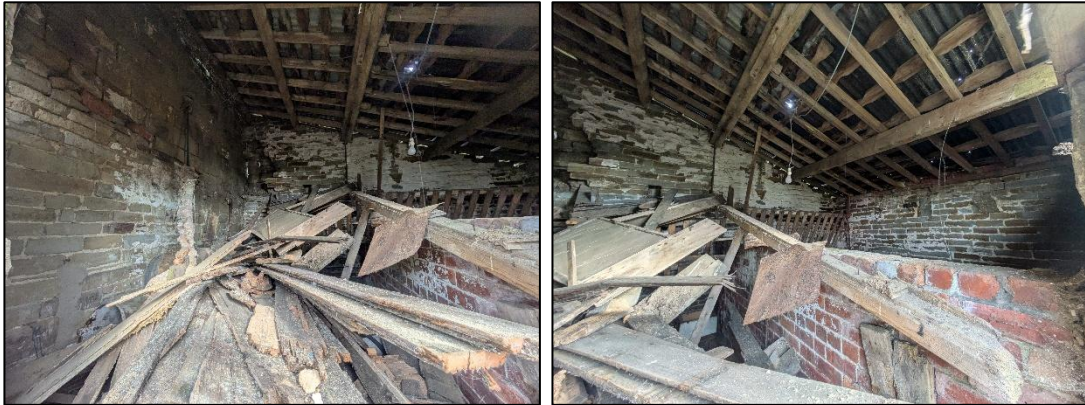
3.3.3.3. Internally, access was limited due to the presence of a large amount of materials blocking entry. For this reason, a thorough search for field evidence of bats could not be carried out. However, daylight was visible from many points where the roof meets the walls. Multiple gaps leading into the cavity walls could be seen internally.

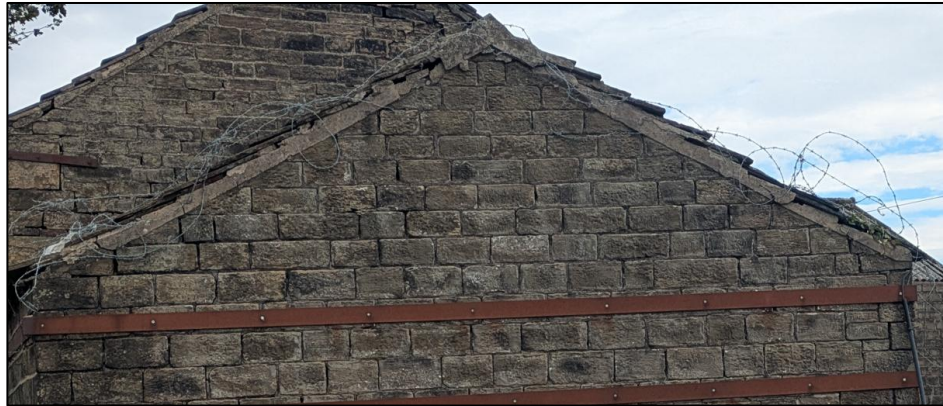
3.3.4.3. One gable end is present on the southern aspect of the building. The gable end has multiple gaps in the stonework and multiple areas of missing mortar beneath the roof tiles, providing potential roost features and/or potential access points into the building for roosting bats. However, barbed wire is also spread across this gable end where the roof meets the walls, potentially limiting the suitability of these features for bats.
