## **Phase 2 Intrusive Contamination Risk Assessment & Soakaway Tests**

### **Detached Dwelling**

**No.15 Shelley Woodhouse Lane,  
Huddersfield HD8 8NB**

4276 P2 Britology – Shelly Woodhouse Lane, HD8 8NB

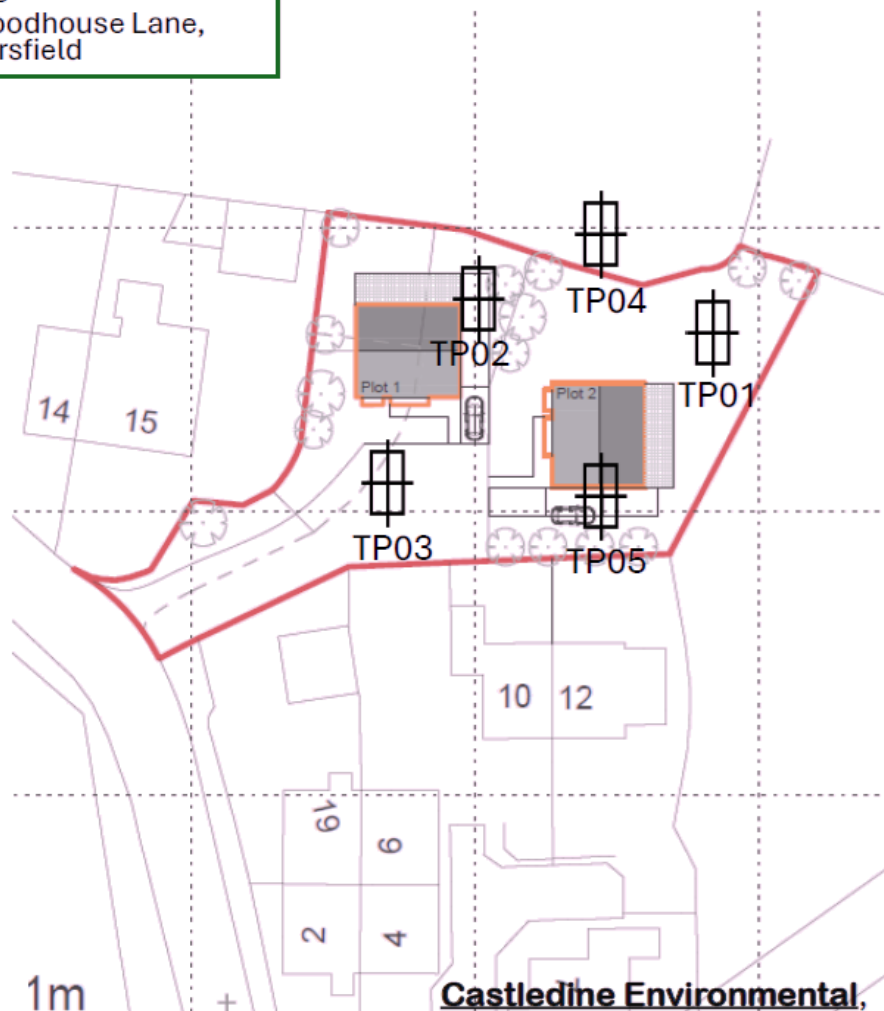
**SITE INVESTIGATION PLAN**

A location plan of the exploratory hole locations can be found as **Appendix B**.

Site Investigation Plan  
4276 Shelley Woodhouse Lane,  
Huddersfield

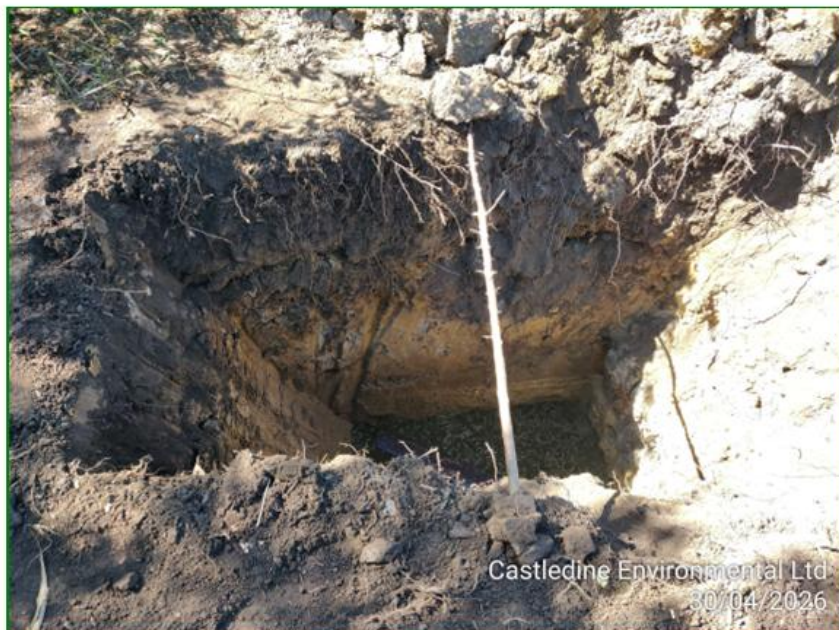
Photo No.1: TP01

| Location | Purpose |
|---|---|
| TP01 | Proposed rear garden area for contamination assessment in areas where soils are most likely to be exposed to receptors. 5.00m from site boundaries and proposed building footings for placement of soakaway. |

Evidence of contamination on the site was limited to some anthropogenic inclusions in the made ground topsoil, including sharps in TP01.

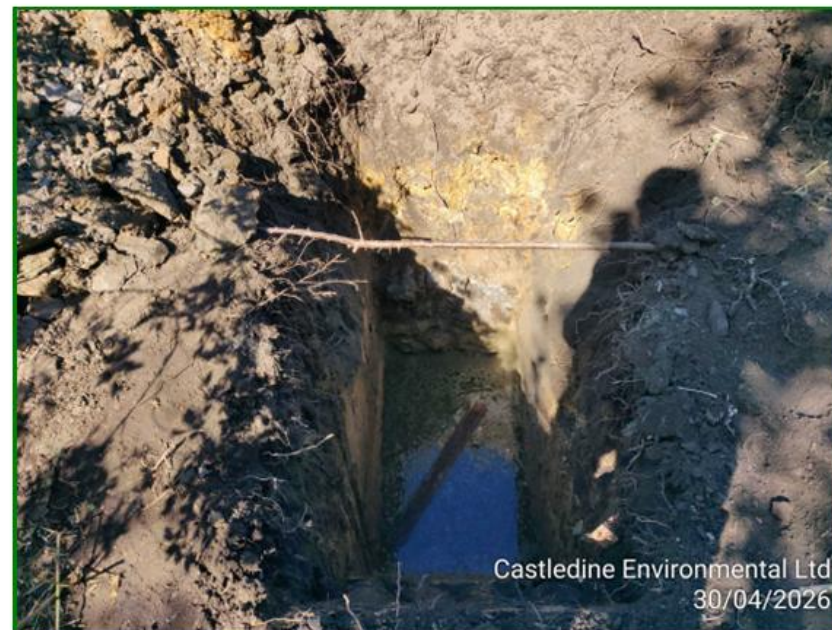
Photo No.2: TP01 soakaway

Soakaway testing found a very low infiltration rate, and 25% effective depth in the first test was not obtainable over the course of a working day in either pit. In TP02 water movement was imperceptible.

The tests were considered to have failed, and the faster draining of the two, infiltration rate would likely be in the low  $\times 10^{-6}$  region for the first test alone which indicate that the strata would not be suitable for soakaway drainage. Logs are included in Appendix D.

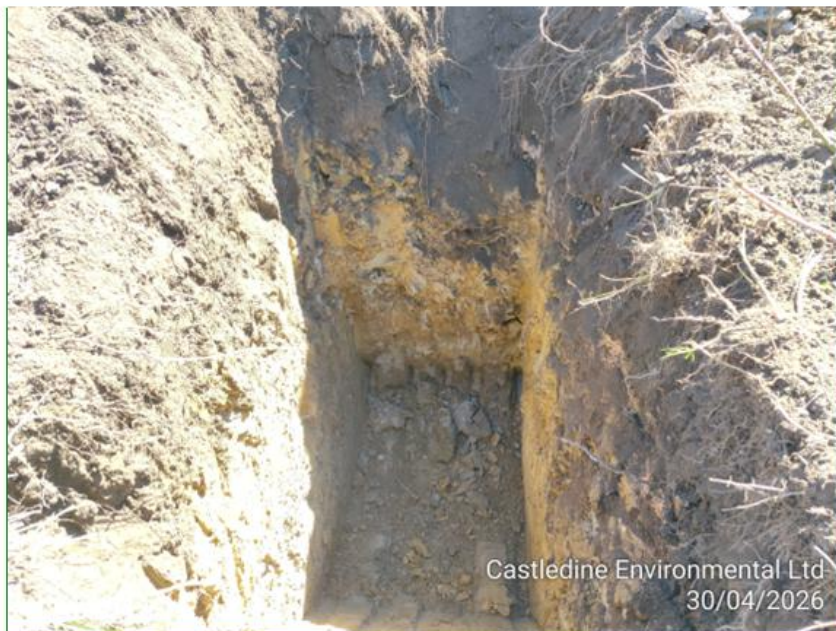
Photo No.3: TP03

| Location | Purpose |
|---|---|
| TP03 | Area adjacent to drive and possible made ground. |

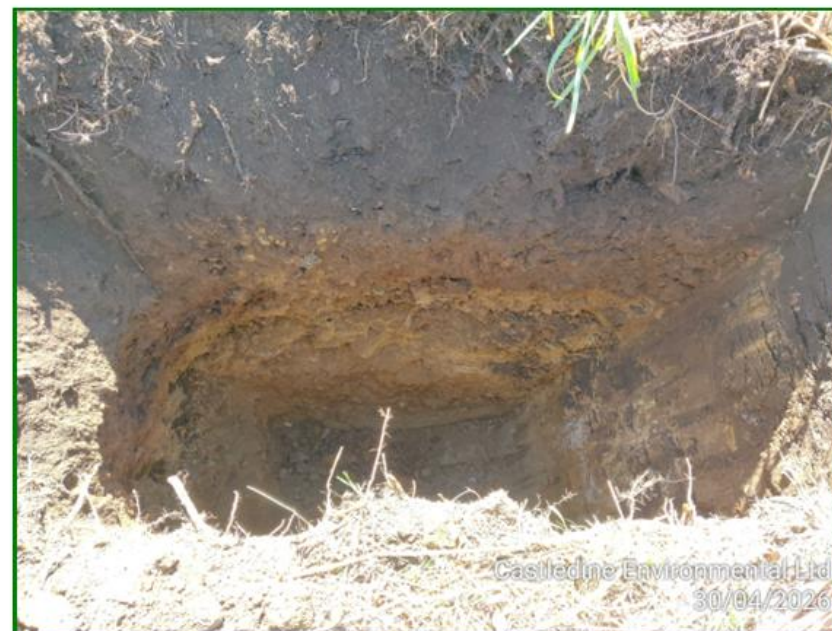
Photo No.4: TP04

| Location | Purpose |
|---|---|
| TP04 (off site) | Requested to offer a broader picture of site geology. |

The ground conditions on site can be broadly summarised as made ground topsoil or coarse granular stockpiles overlying residual mudstone in the form of clay, becoming gravel with depth. Residual sandstone was also encountered in TP04, overlaying the mudstone.

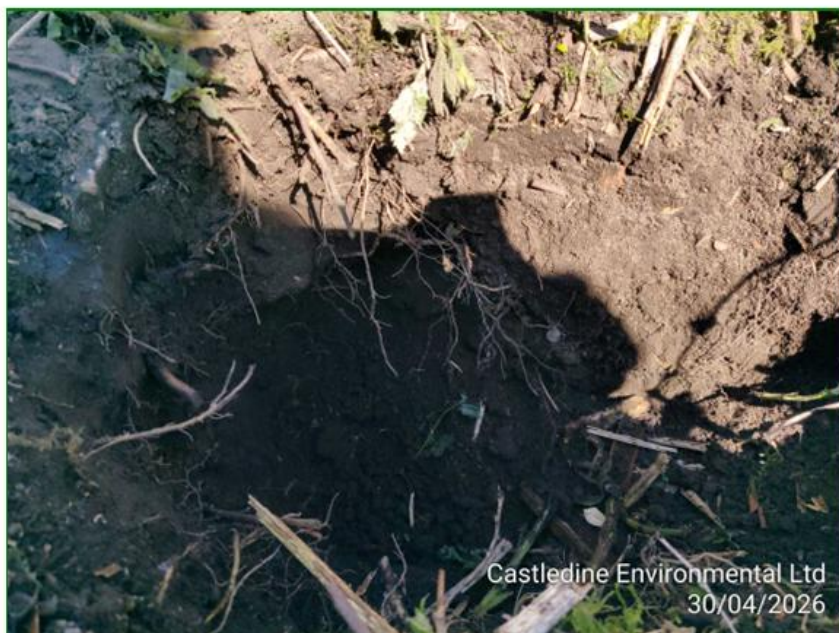
Photo No.5: TP05

A hand pit (TP05) was excavated using a spade, breaker bar and post-hole excavator to 0.50m.

This was excavated in a proposed garden area and near the historical southern structure to identify any made ground and/or contaminants.
