## Letter Report

Revised Risk Assessment (contaminated land)

**Re: 14 Thornhill Park Avenue, Dewsbury**

Further to your email of 24 June 2026 please find hereafter our Revised Risk Assessment (contaminated land) and Validation Report (*the Report*) that has been prepared in support of the discharge of Conditions 7 to 10 of planning application ref. 2025/62/93084 relating to the above development (*the Site*).

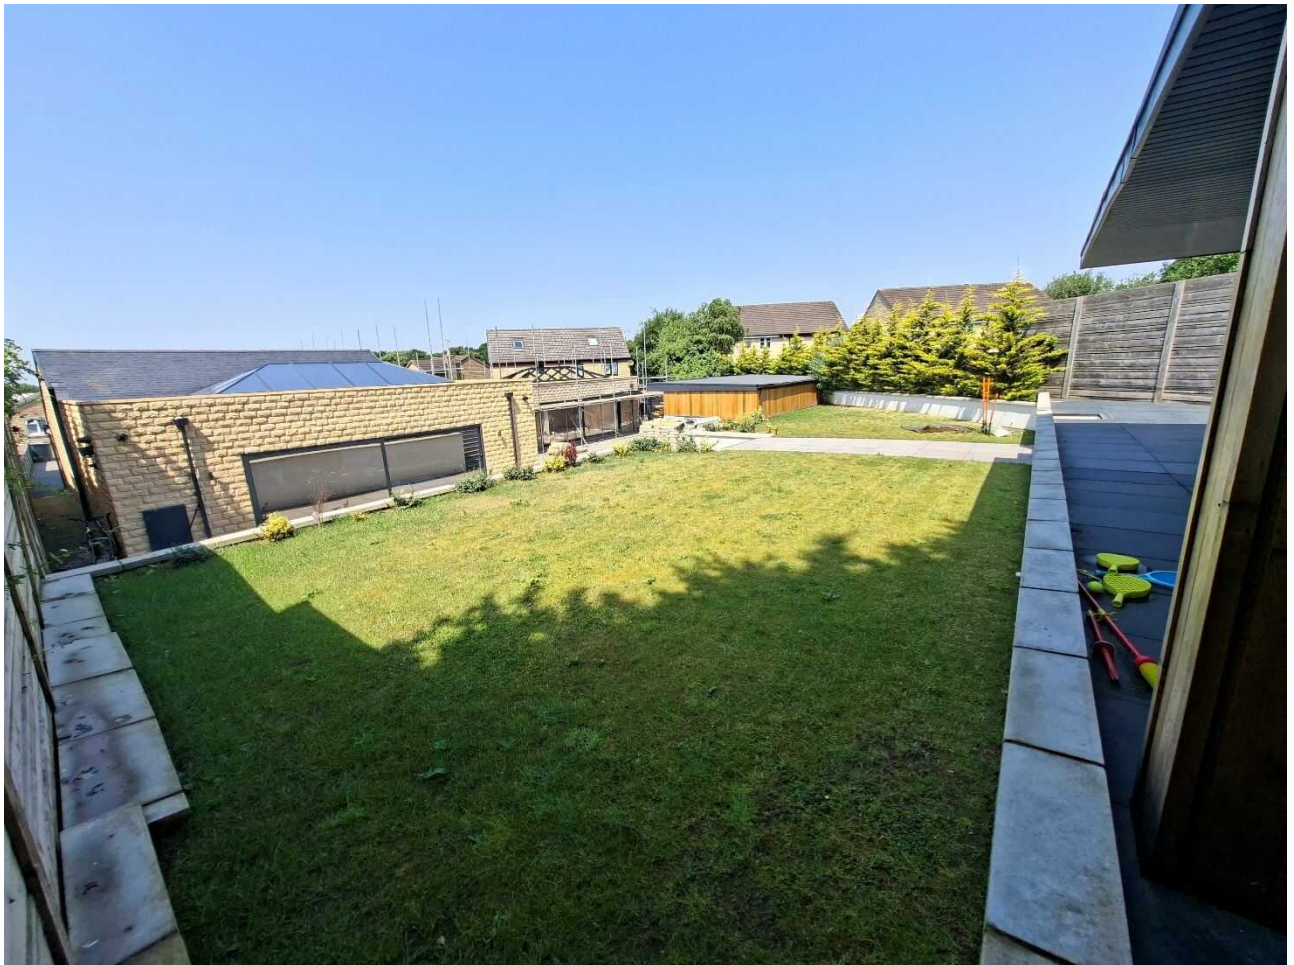
***Photograph 1*** – View north-east from Site's north-western / western corner illustrating general arrangement of rear garden area and extent of soft landscaping – all other external areas are covered by paving / hardstanding.

The reprofiling and landscaping of the rear garden is understood to have included for: a) the placement of excavation arisings (natural clay soils) to form an elevated, grassed terrace - *Photograph 1*; and, b) the formation of extensive hardstanding (paving) areas - *Photograph 1*.

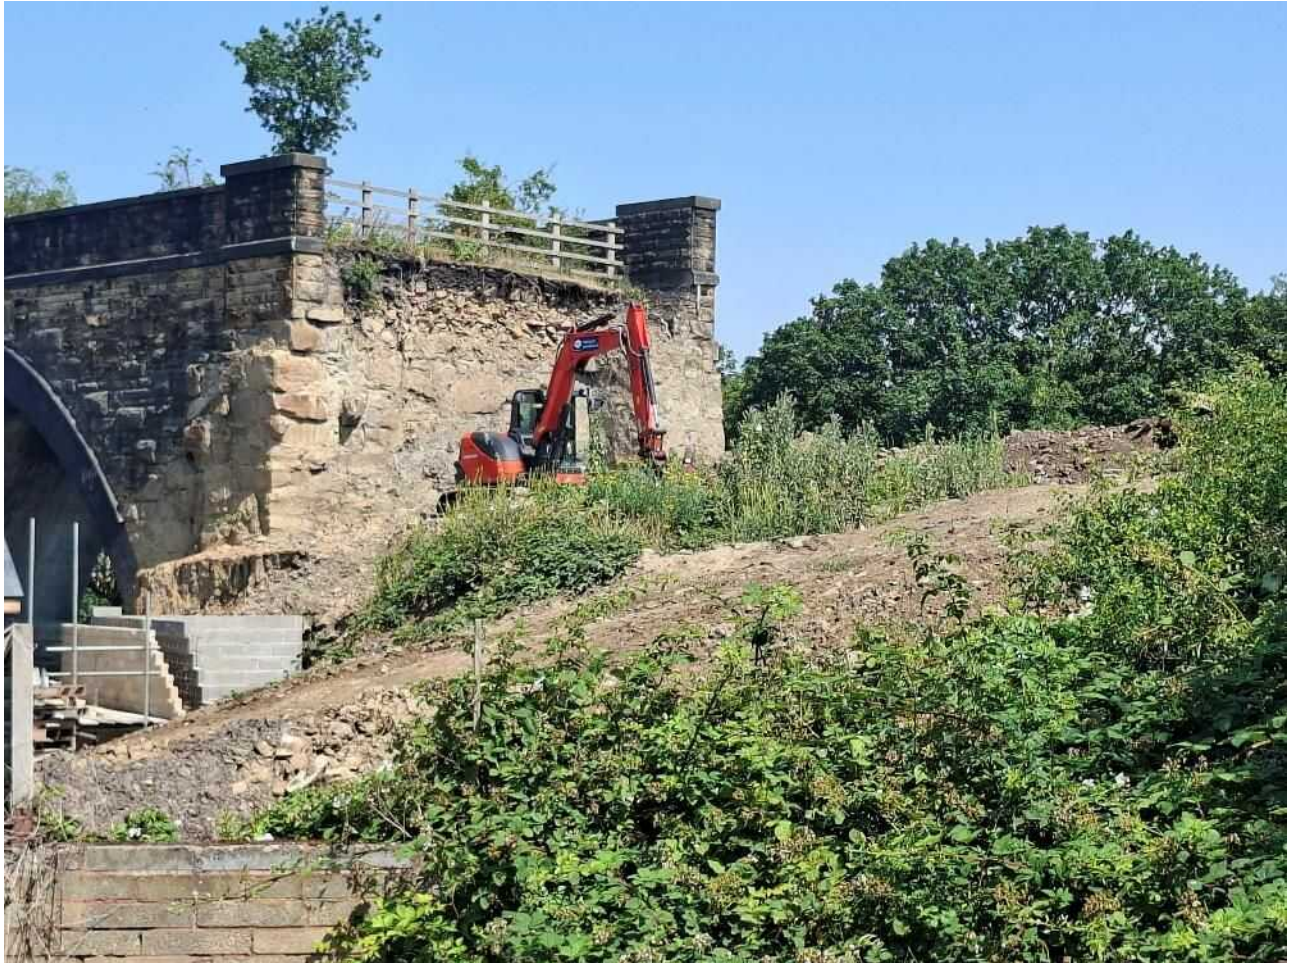
**Photograph 2** – View north-west of the Site towards former railway bridge and associated groundworks, that was a continuation of the raise railway line that ran near the Site's north-western boundary – illustrating the nature of the material recently excavated from the embankment (rock fill) present along the temporary access slope.

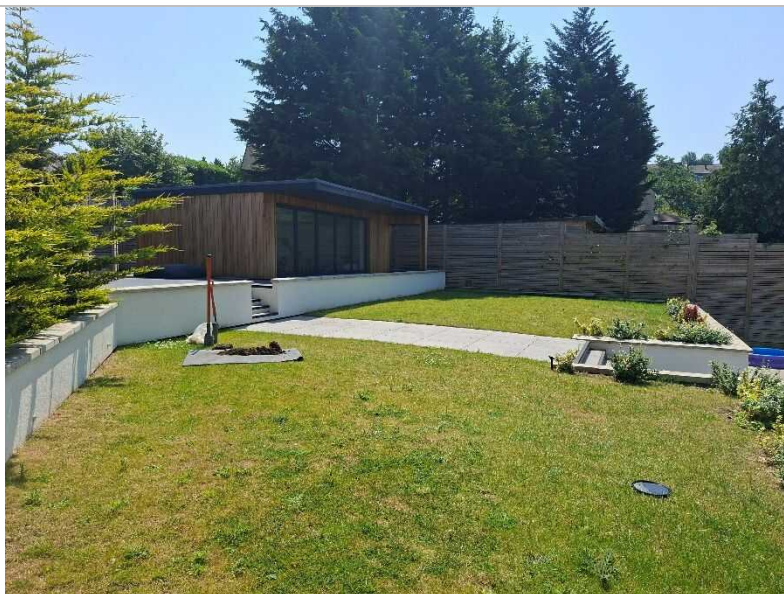
### HP101 location

**Notes:** targeting northern boundary where existing soils are more likely to be present at shallower depths

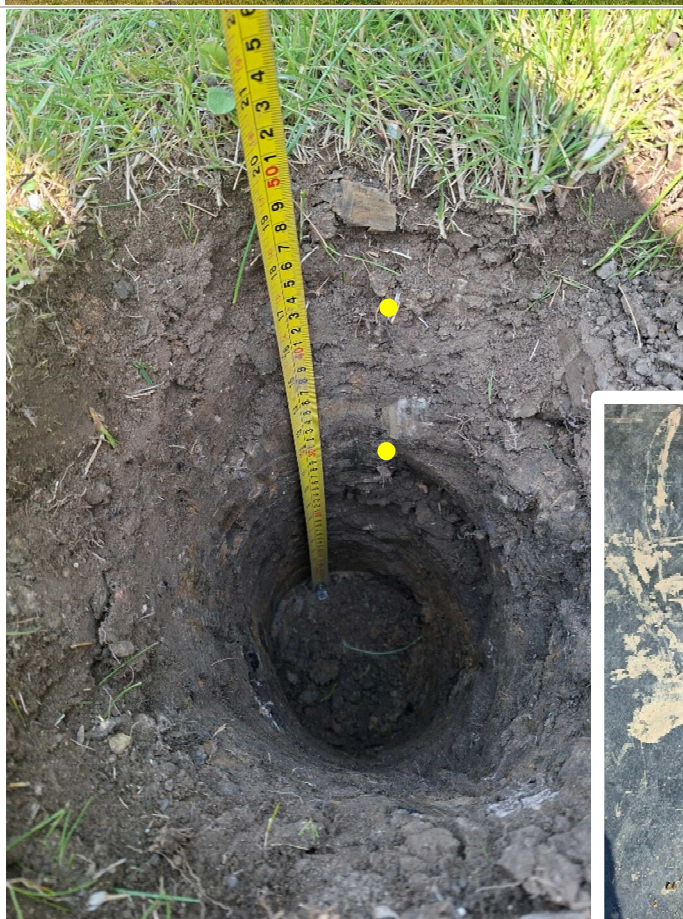
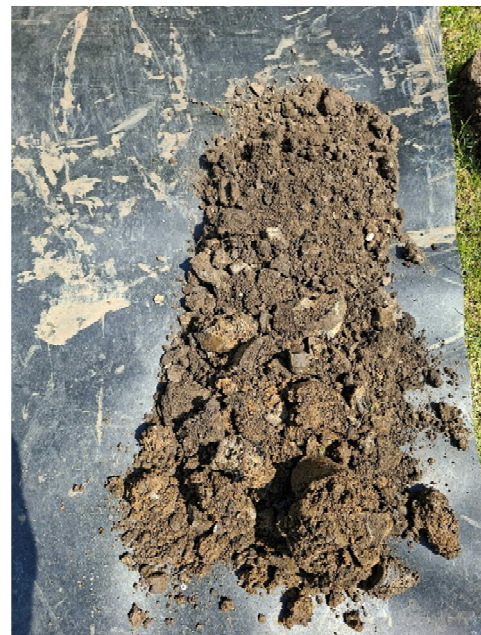
### HP101 location

150 mm dark brown sandy gravelly SILT over 450 mm light brown, light grey and dark brown mottled firm to stiff, slightly sandy, gravelly CLAY

INSERT: arisings from trial pit

**Notes:** Samples obtained at 0.05-0.10 m and 0.25 to 0.35 m depth (as illustrated by yellow dots)

A photographic record of these trial pits is enclosed but in overview, when excavated to 0.50 m depth, the trial pits confirmed the presence of a 'thin' (less than 100 mm) of dark brown silt (Topsoil) over the residual depth of 'reworked natural soils' (slightly sandy, gravelly CLAY with cobbles). No evidence of rock fill or railway ballast was noted over this depth with the boundary between placed and in-situ soils unlikely to be readily definable. In any case, no evidence of potentially harmful or polluting material was revealed within the exploratory trial holes nor any evidence of non-natural material that might otherwise suggest the material is not 'natural' in origin.
