Our Ref: ORH/20/L3a/OG

23<sup>rd</sup> July 2026

Whitehall Road West, Birkenshaw  
Planning application number 2025/92161.  
Information in relation to Condition 5 and 6 covering Plots 1 to 23

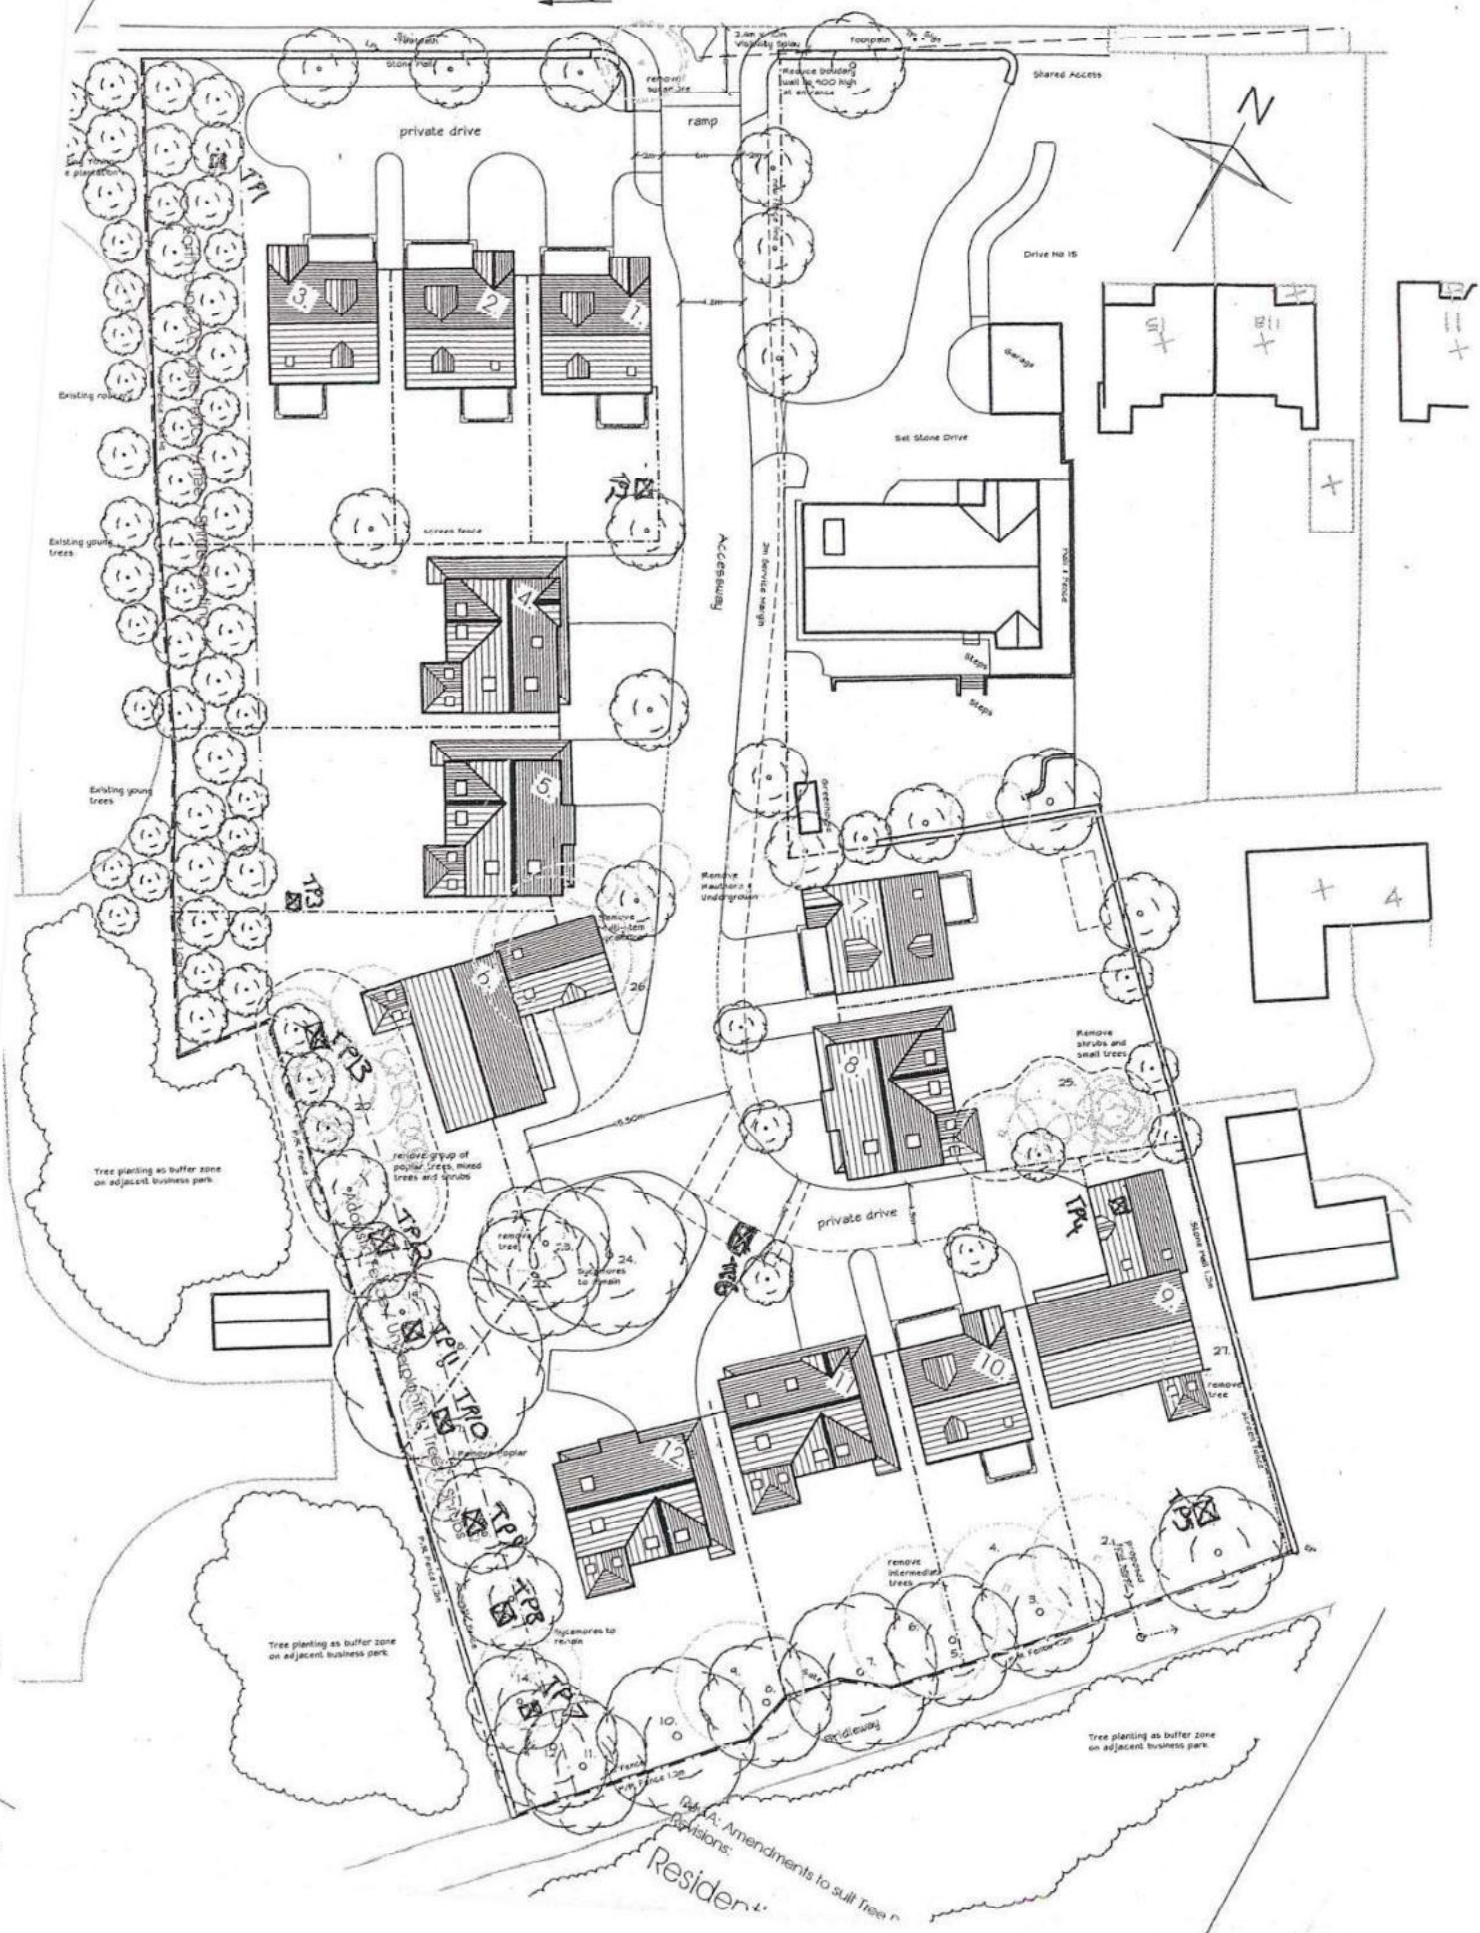
## JNP INVESTIGATION

- JNP Group Consulting Engineer – Letter Report NG7020.L004/WHI/NDT/kef, dated 08 September 2008. This investigation covered the southern end of the site and comprised 13 trial pits to between 0.5m and 1.6m depth. Logs in Appendix A.
- RSK Geoscience – Site Investigation reference 350520-R01 (00), dated November 2022. This investigation also covered the southern end of the site and comprised 8 window samples to between 0.75m and 2.42m depth. Logs in Appendix B.
- ARP Geotechnical – Combined Stage 1 /Stage 2 Geo Environmental Report, referenced ORH/20r1, dated August 2023. This investigation covered the northern end of the site and comprised 8 machine excavated trial pits to between 2.8m and 4.3m depth. Logs in Appendix C.
- ARP Geotechnical – Intrusive Coal Mining Investigation, reference ORH/20/AJjcl1. This
