# Geoenvironmental Appraisal

## Land at Roslyn Avenue, Netherton For KCS Developments Ltd

Report no: 5080/1

Date: July 2024

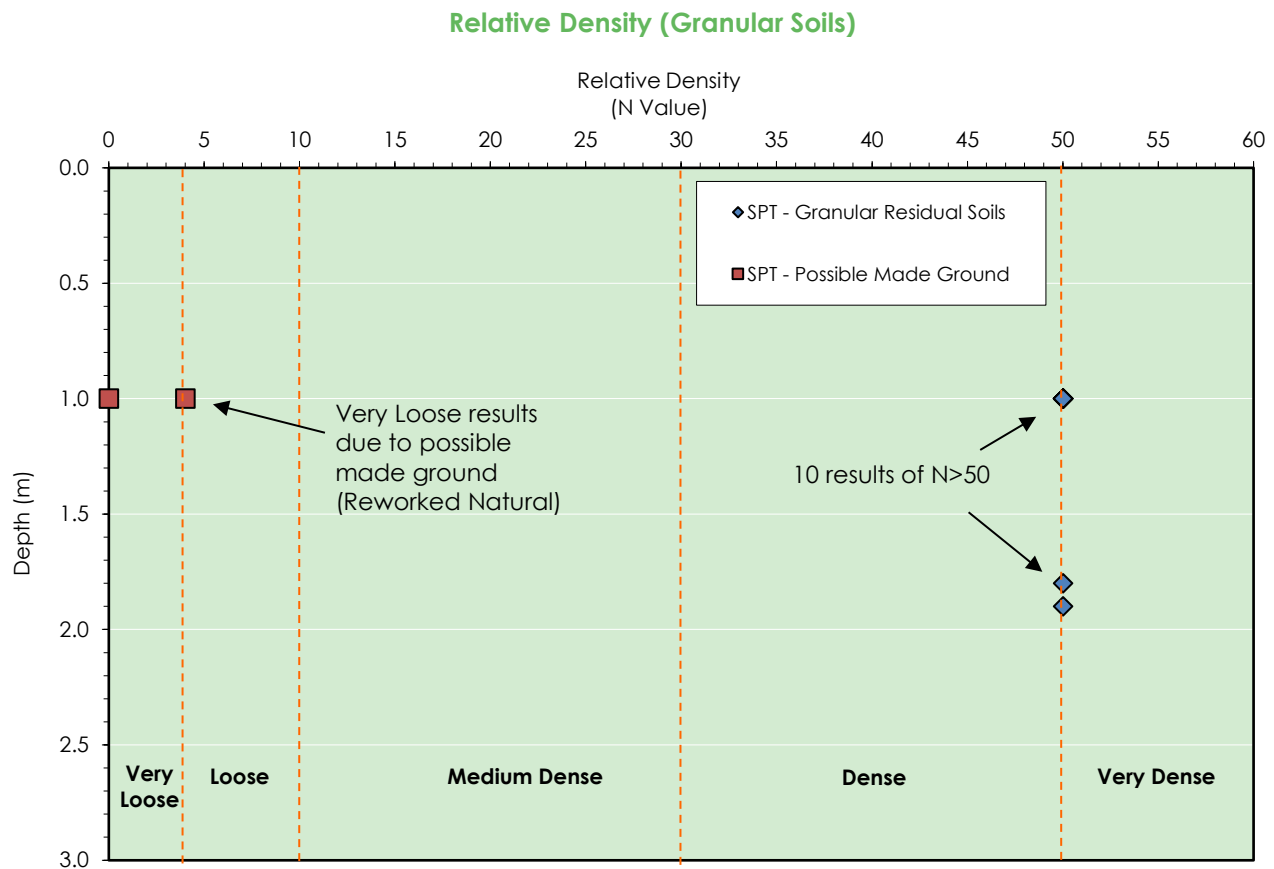
- 13.5.3 The plot below presents a summary of SPT 'N' values.

- 13.5.4 All of the SPTs (excluding the two within the possible made ground) within the Granular Residual Soils returned N values of N>50. These values are likely unrepresentative of the granular soils and are likely more representative of the underlying Sandstone bedrock.

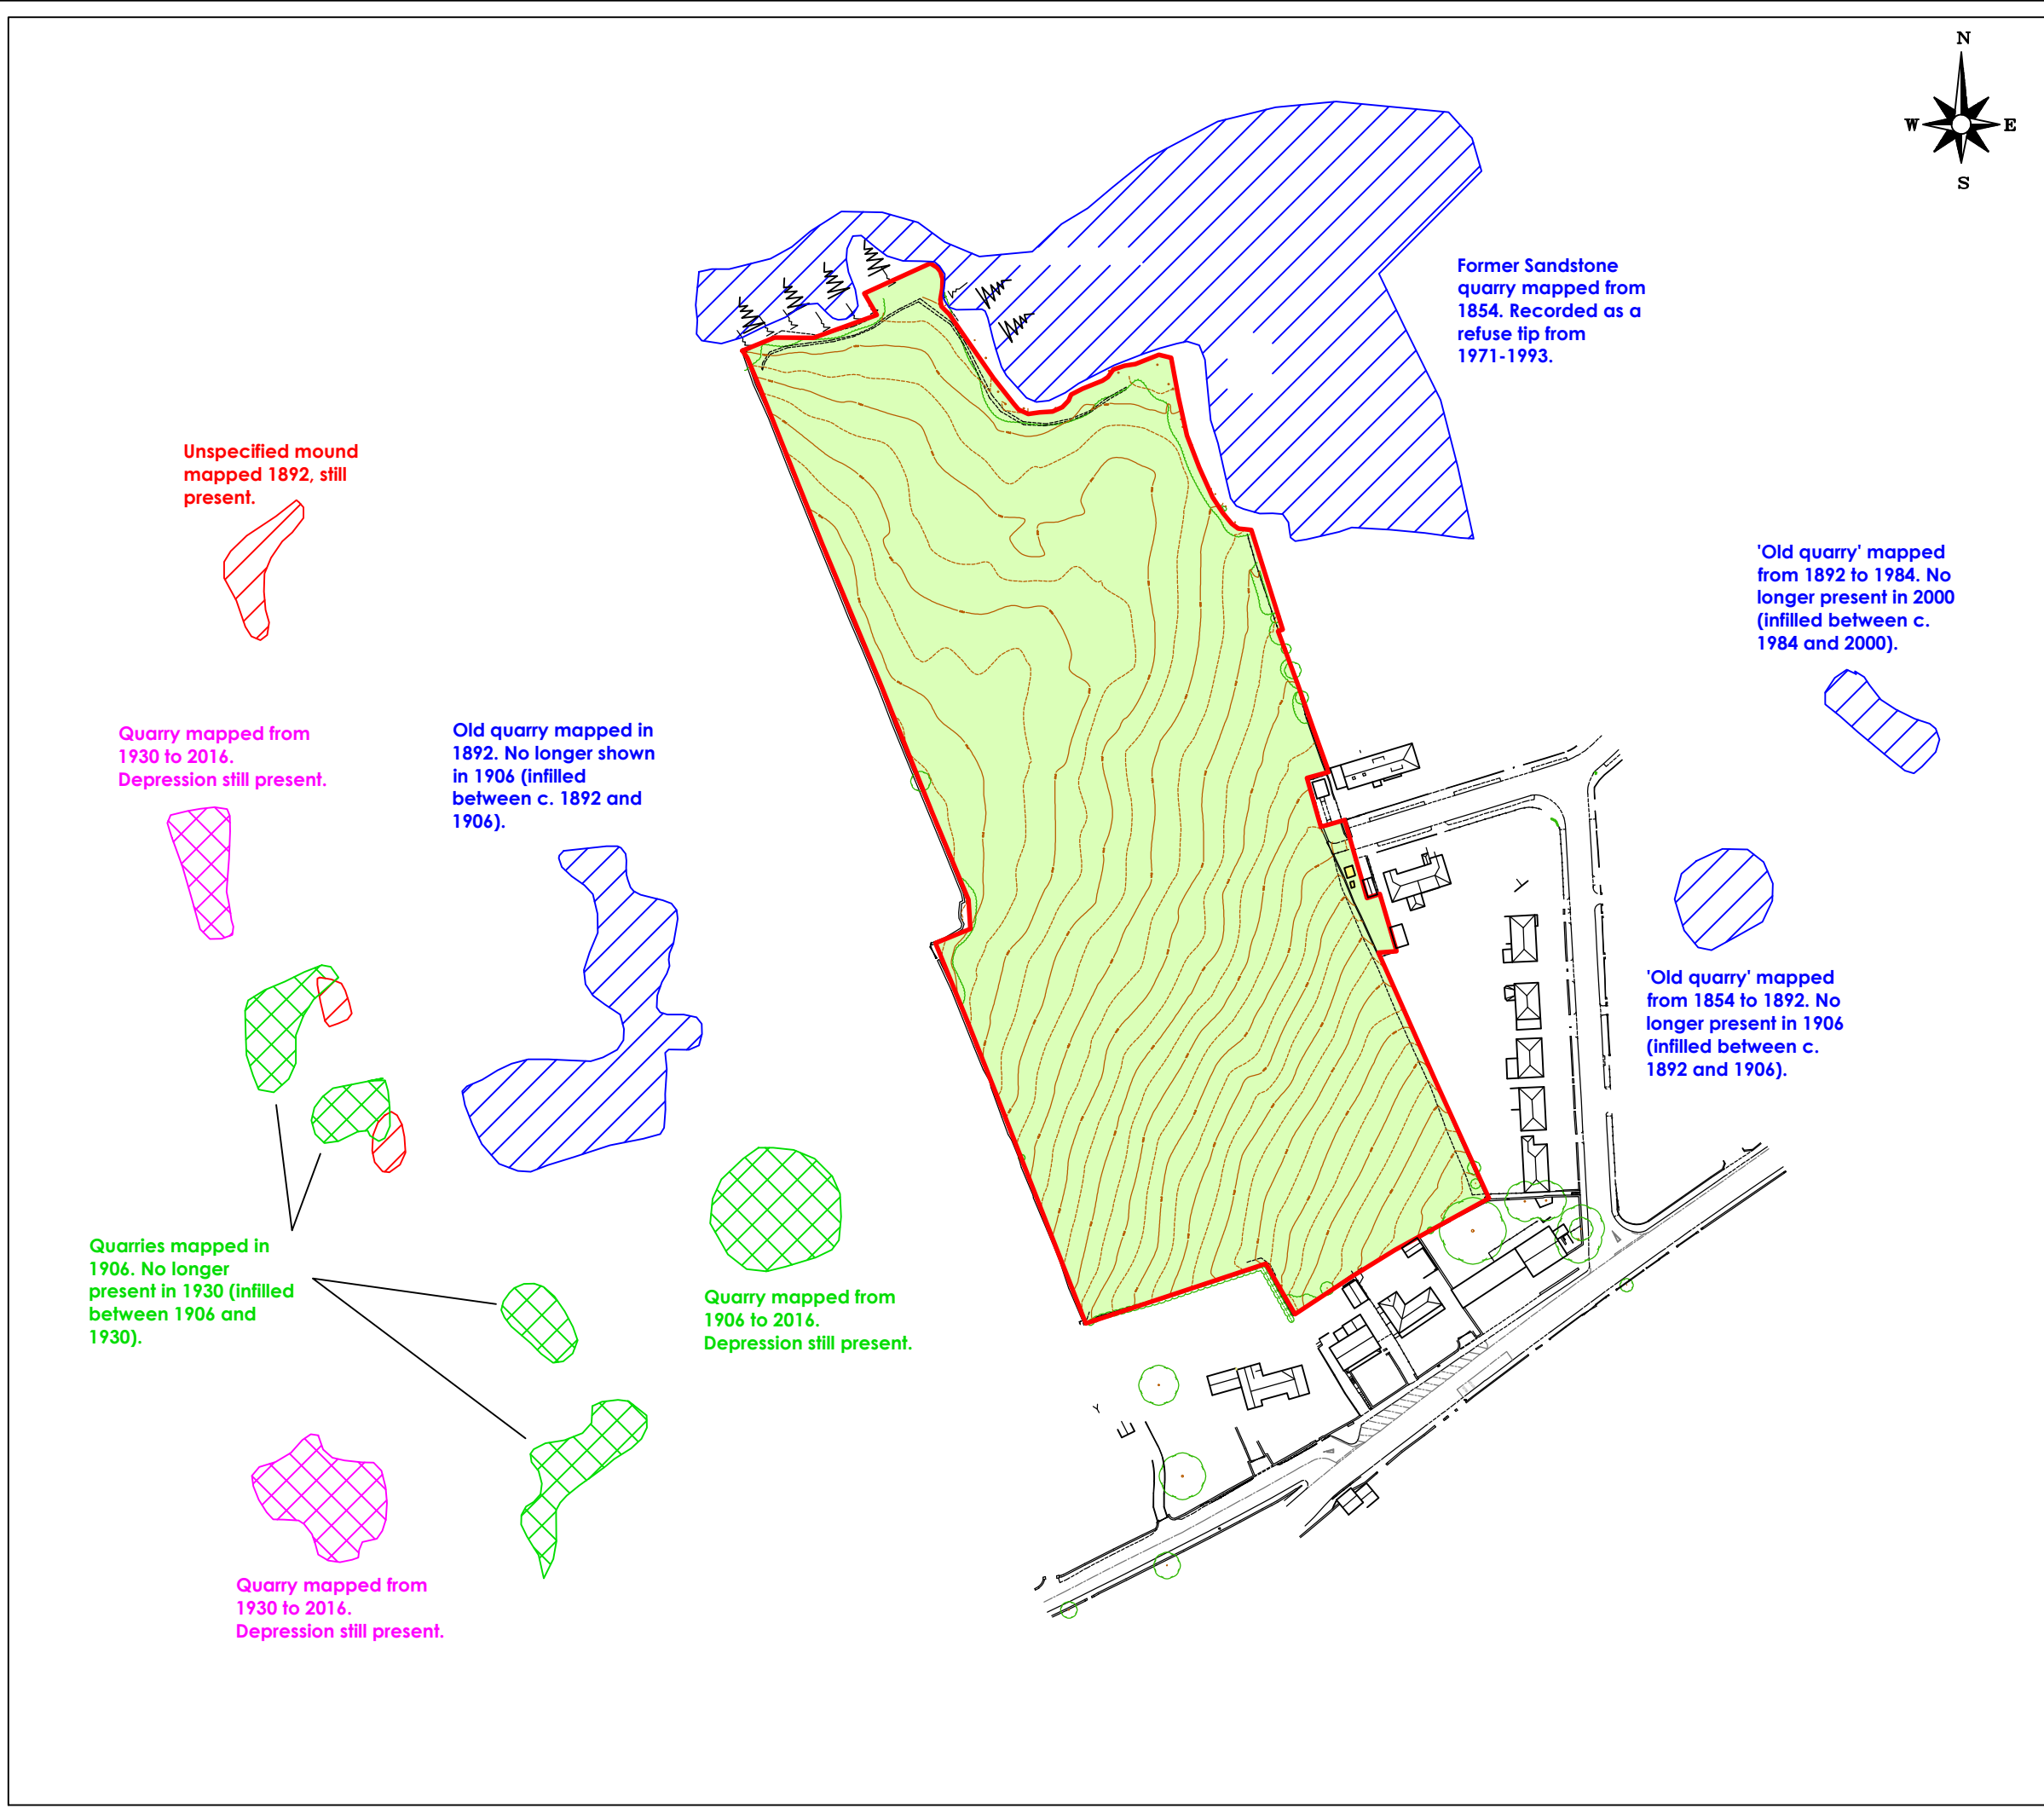
| SCALE | NOT TO SCALE | SHEET | A3 | DRAWING NO. | 5080/4 | REVISION | |

- GRASS & OVERGROWN AREAS
- BUILDING
- SANDSTONE QUARRIES (1892 OS MAP)
- UNSPECIFIED FEATURES (1892 OS MAP)
- SANDSTONE QUARRIES (1906 OS MAP)
- SANDSTONE QUARRIES (1932 OS MAP)
- APPROXIMATE SITE BOUNDARY

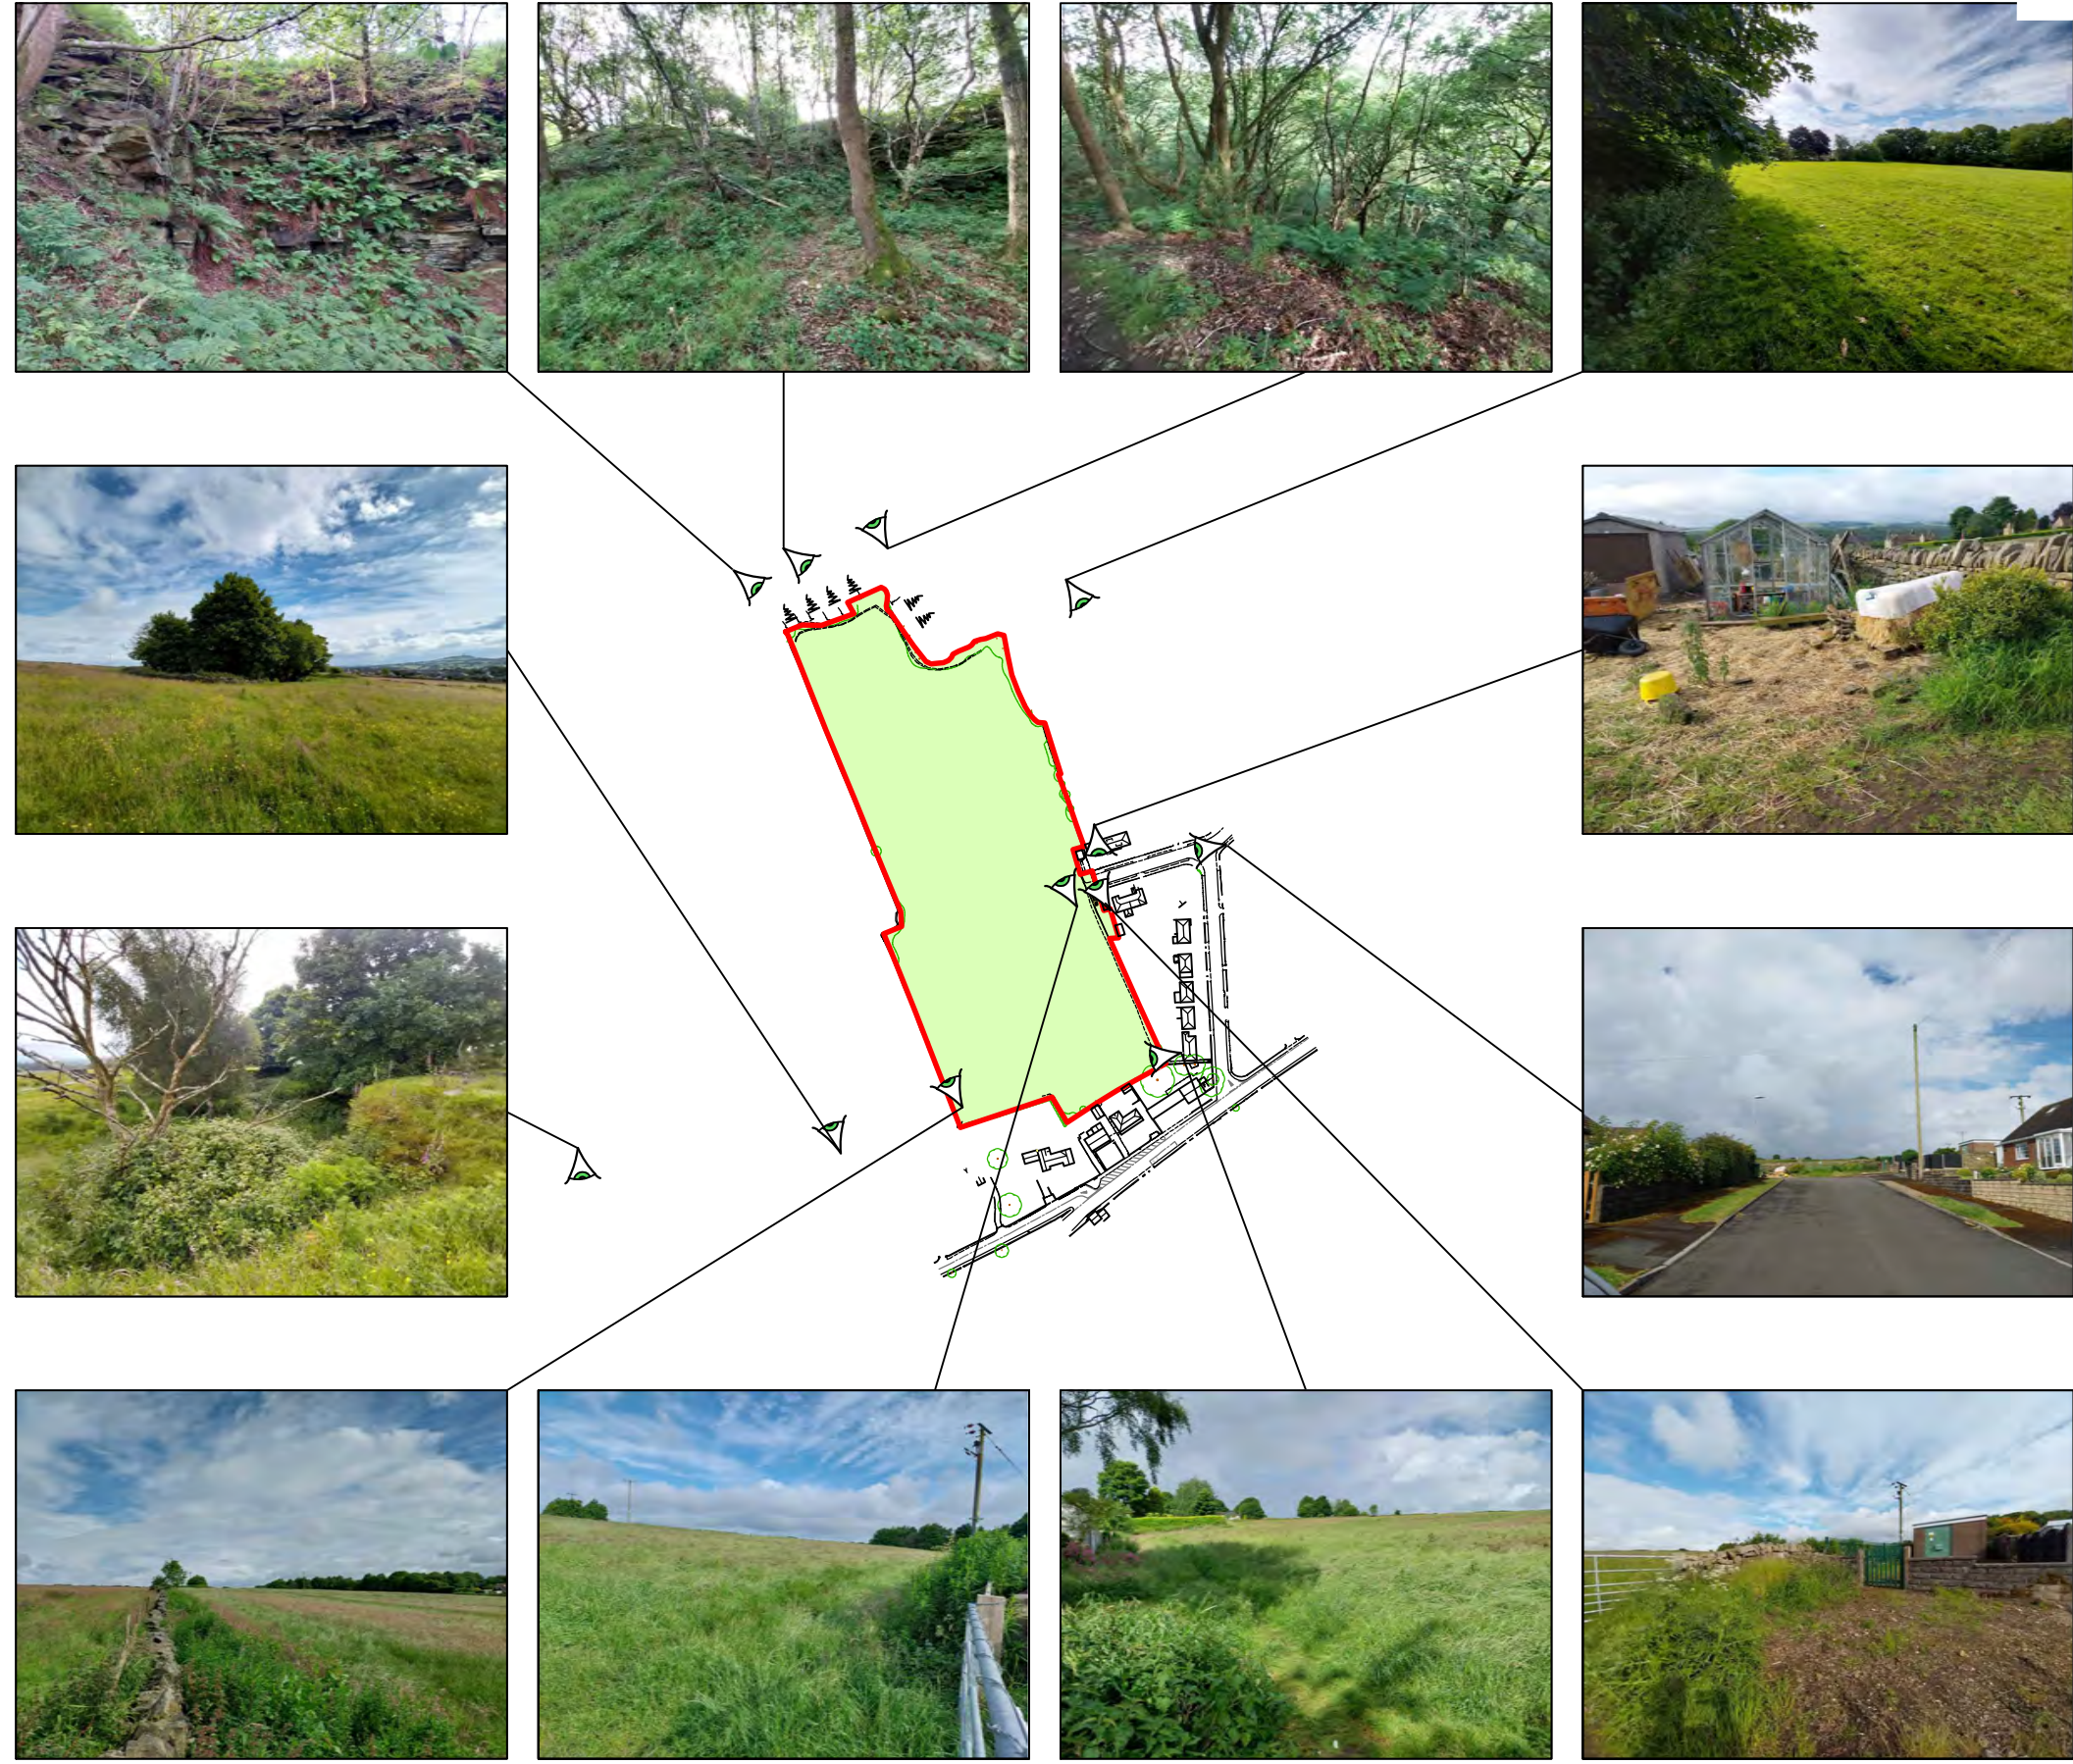
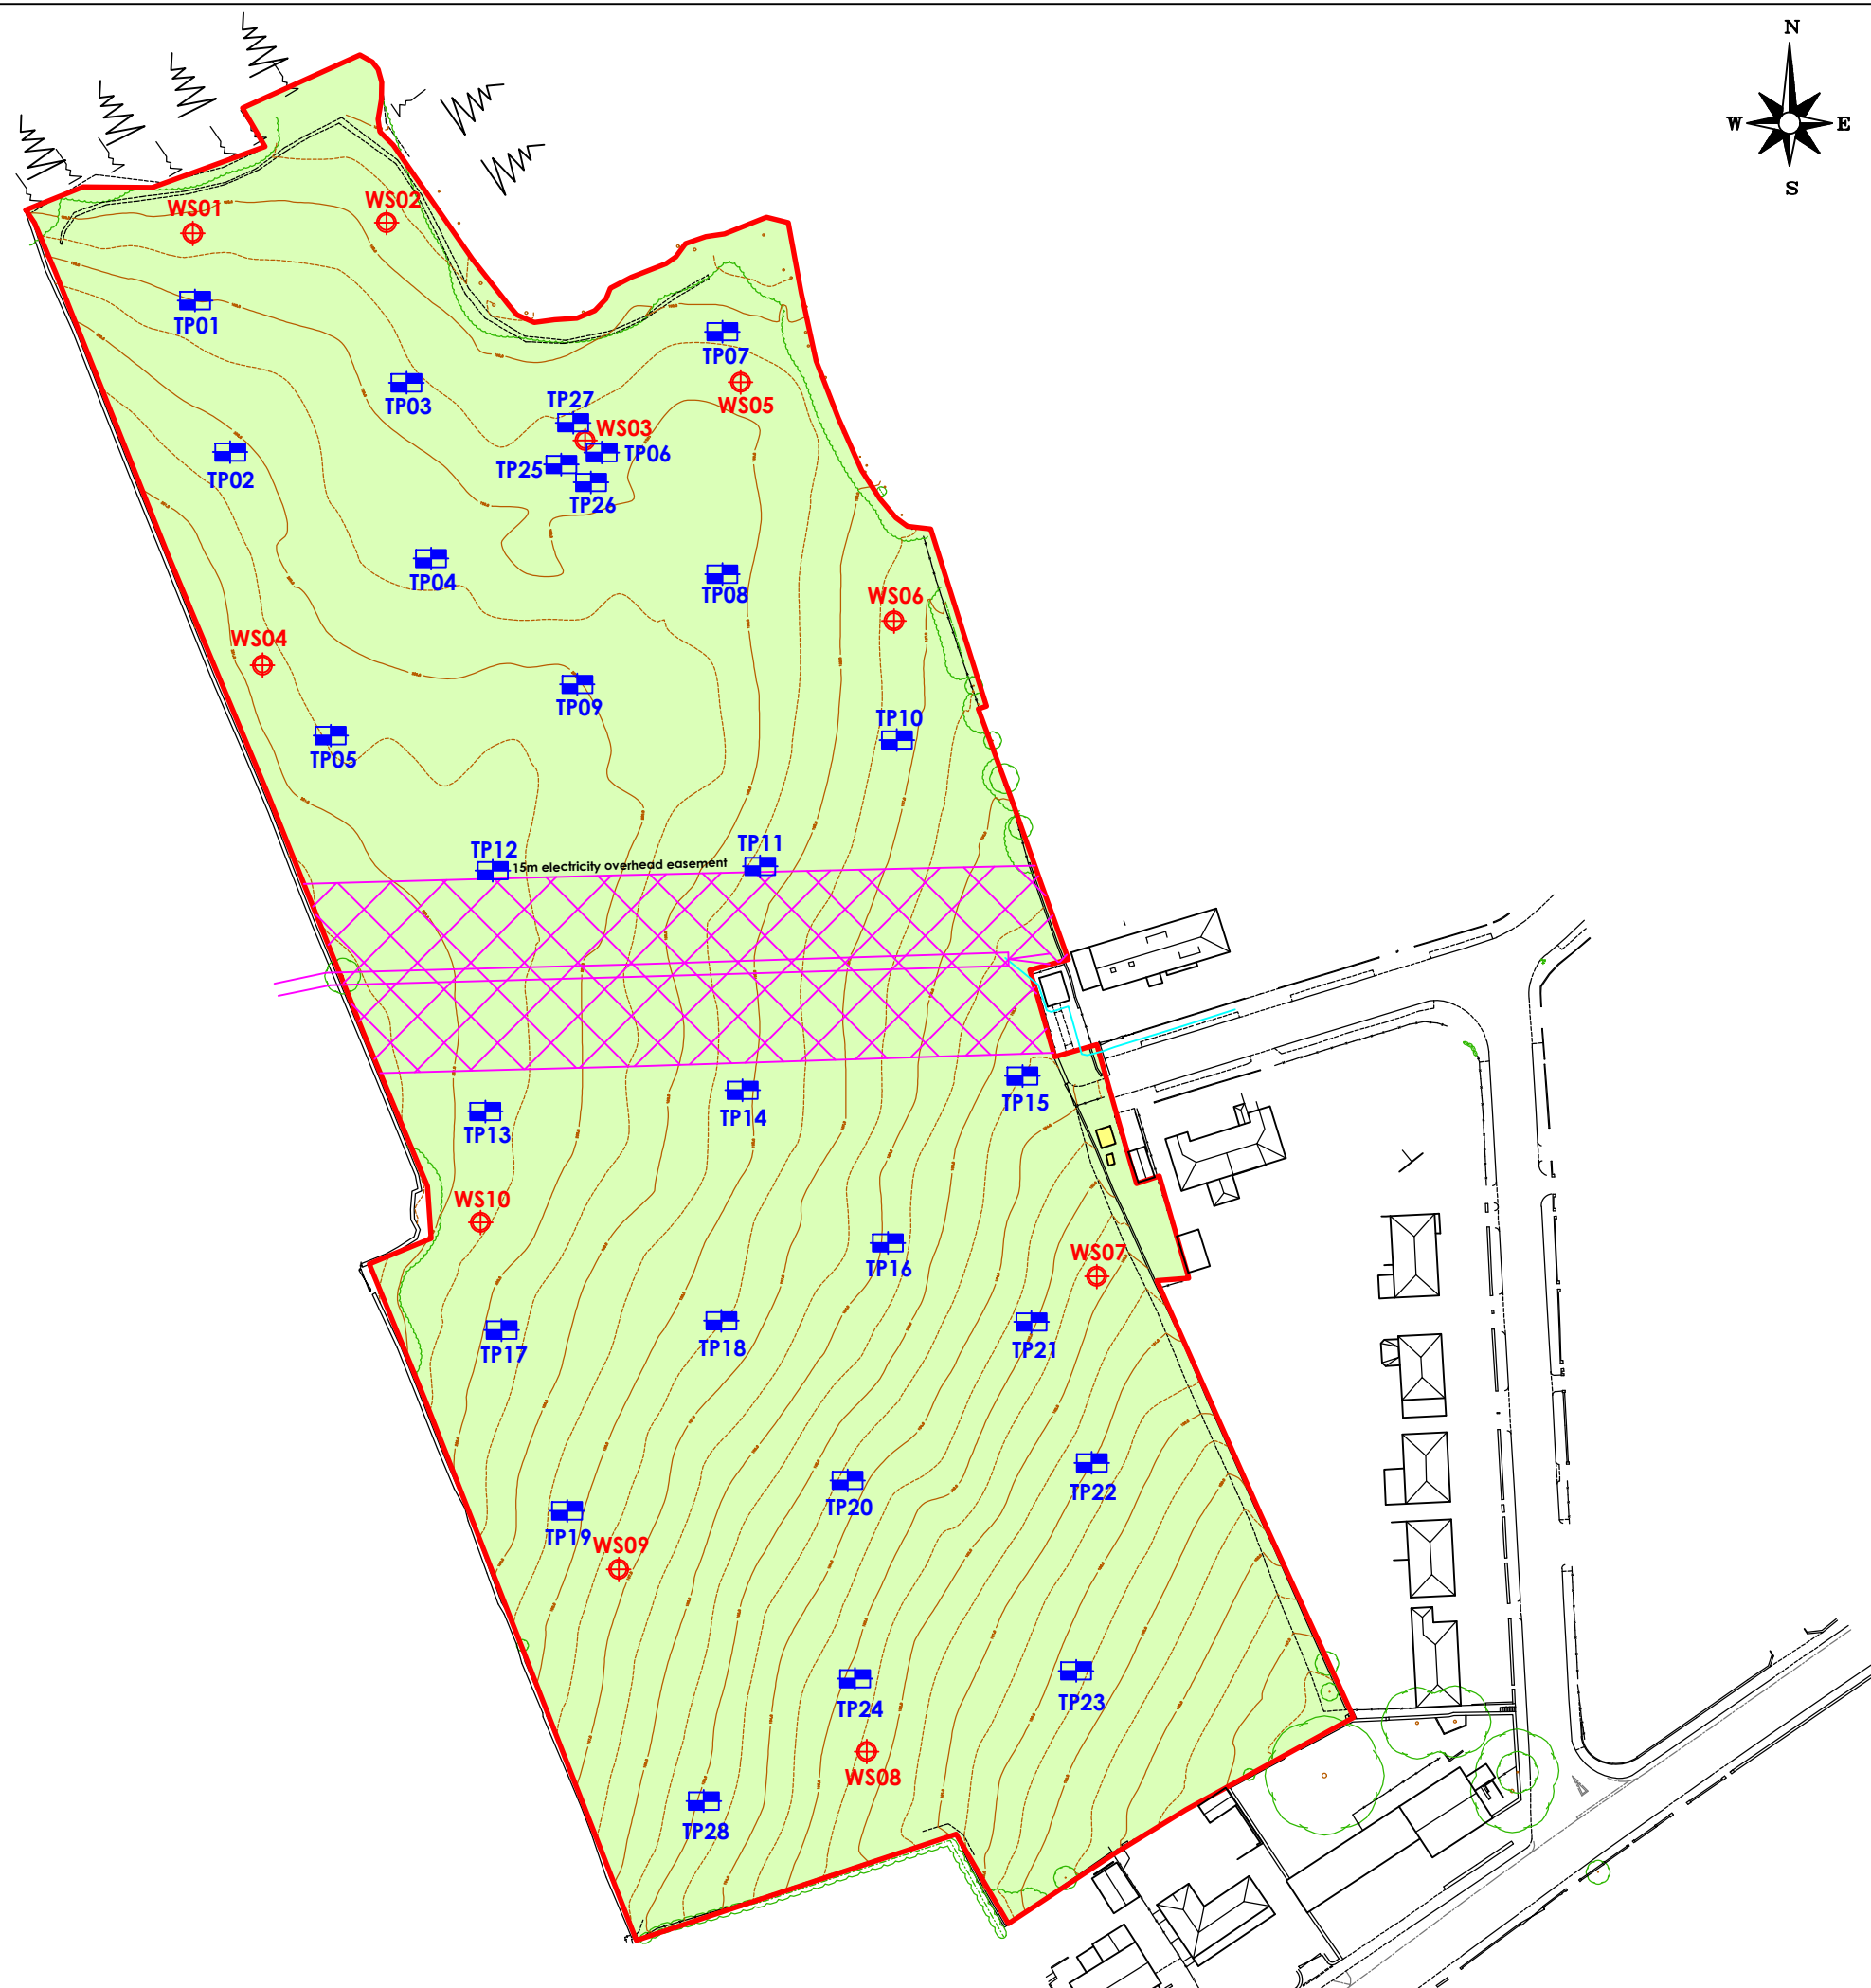
| SCALE | 1:1250 | SHEET | A3 | DRAWING NO. | 5080/6 |

- NOTES
- TRIAL PIT LOCATION
  - WINDOW SAMPLE LOCATION
  - APPROXIMATE SITE BOUNDARY
  - GRASS & OVERGROWN AREAS
  - BUILDING
  - LINE OF ELECTRICITY UTILITY (OVERHEAD)
  - LINE OF ELECTRICITY UTILITY (UNDERGROUND)
  - 15m EASEMENT AWAY FROM OVERHEADS

EXPLORATORY HOLE LOCATIONS BASED ON DATA FROM A HAND-HELD GPS (+/- 3M ACCURACY)

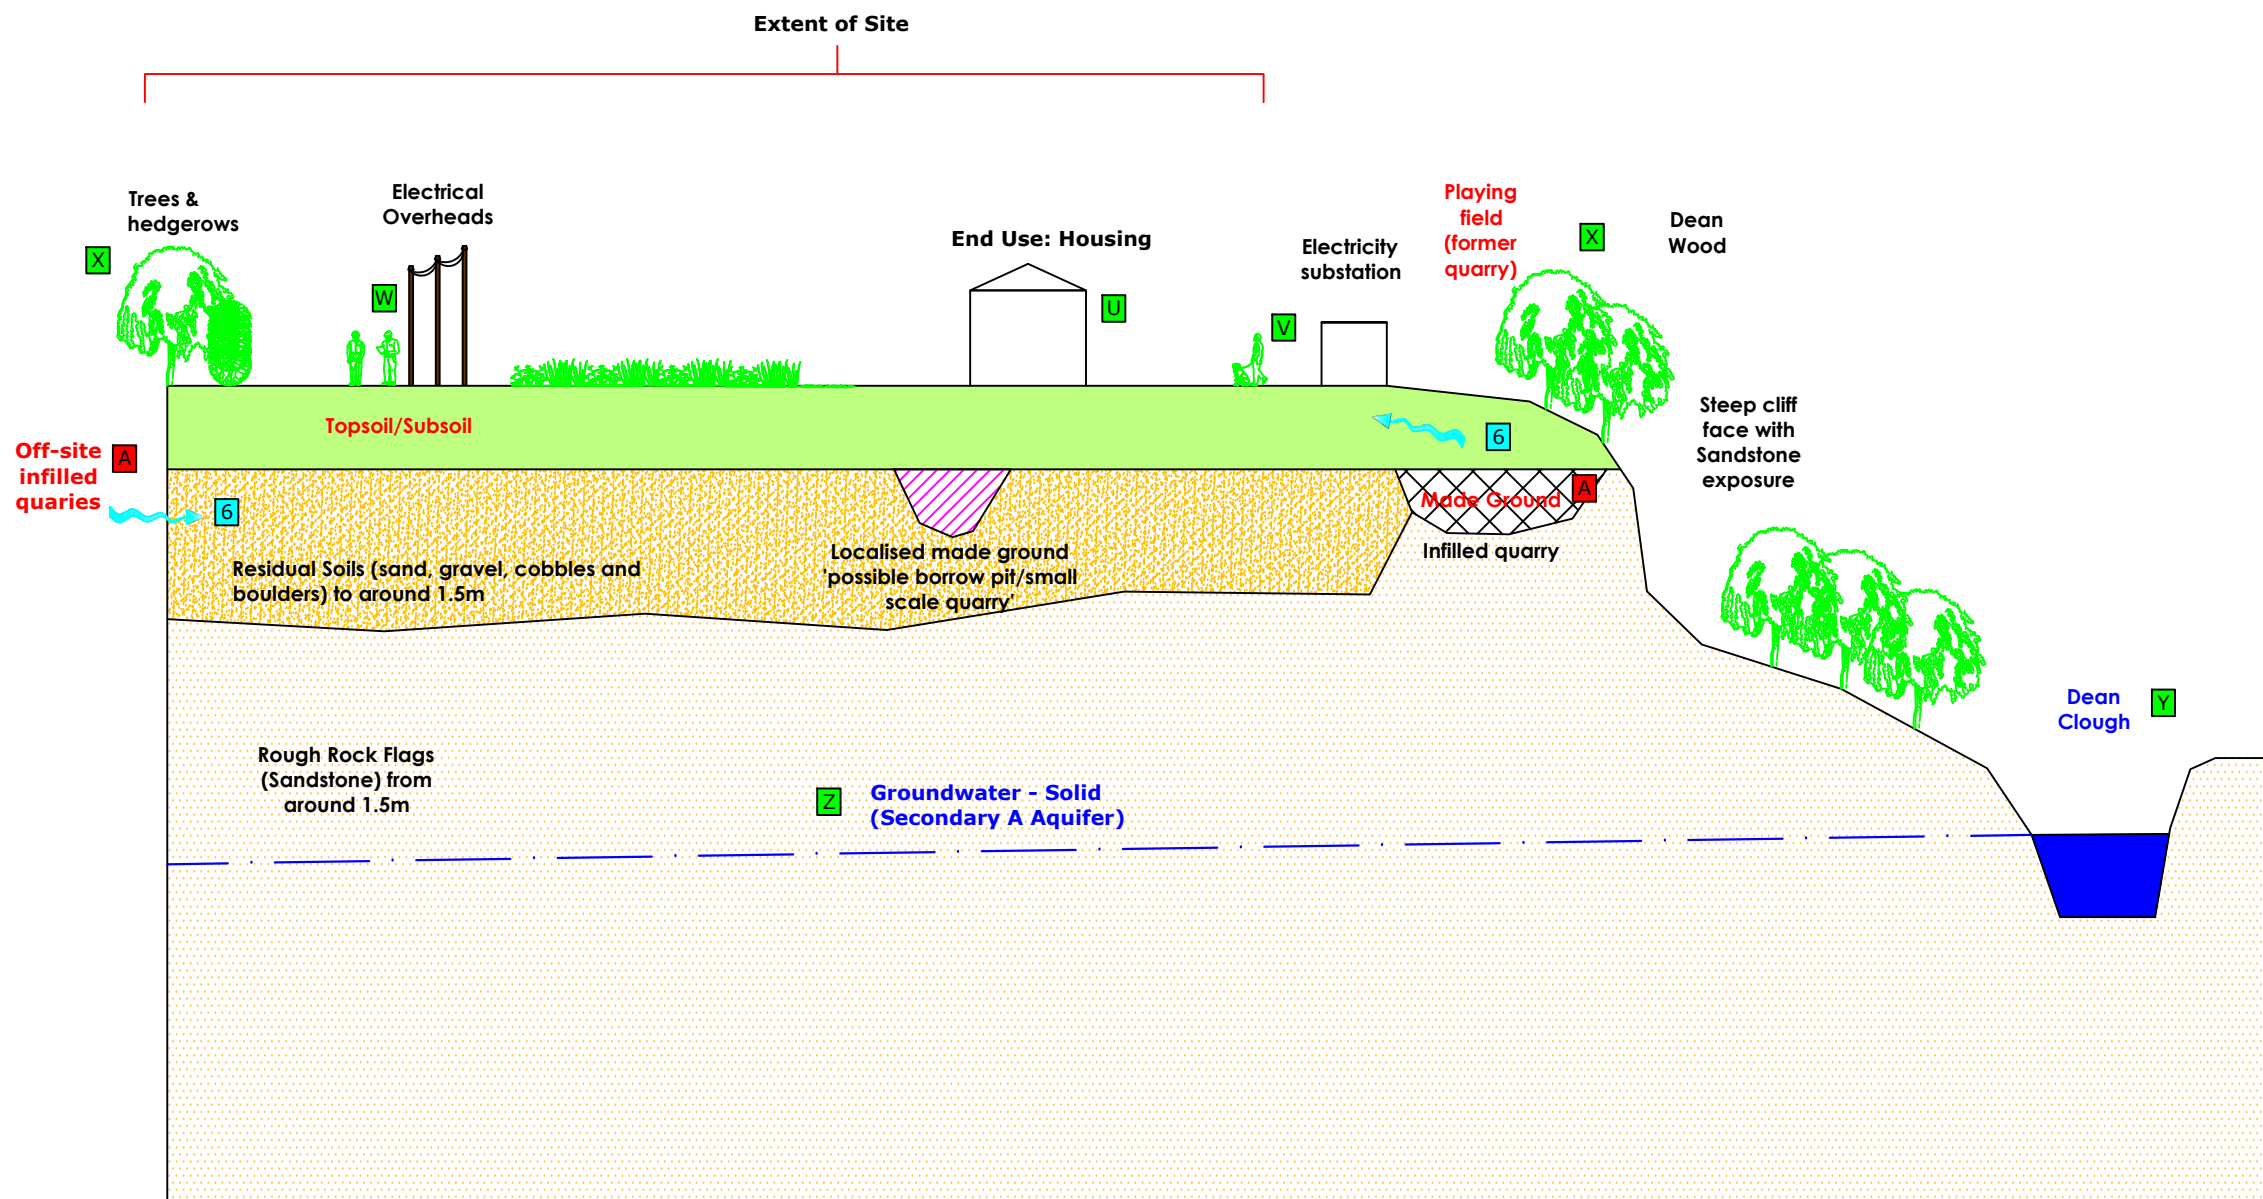
| SOURCES | |
| A | INFILLED QUARRIES (GAS) |

- 6.1 A preliminary conceptual site model, presented as Drawing 5080/5 in Appendix B, has been prepared after consideration of all the data presented in Sections 2 to 4 inclusive of this report.
- 6.2 Potential contaminant linkages are shown on the preliminary conceptual site model.
- 6.3 Infilled quarries to the north, west, south-west and east are a potential source of contaminants and hazardous ground gas.
- 6.4 The conceptual model will likely be subject to modification in light of data arising from the proposed intrusive ground investigation; see Section 11.2.
