## Rotary Borehole Site Investigation Report

| <b>LOCATION</b> | Kirklees College, Close Hill Lane,<br>Newsome, Huddersfield HD4 6LE |
| <b>OUR REF.</b> | G21331 |

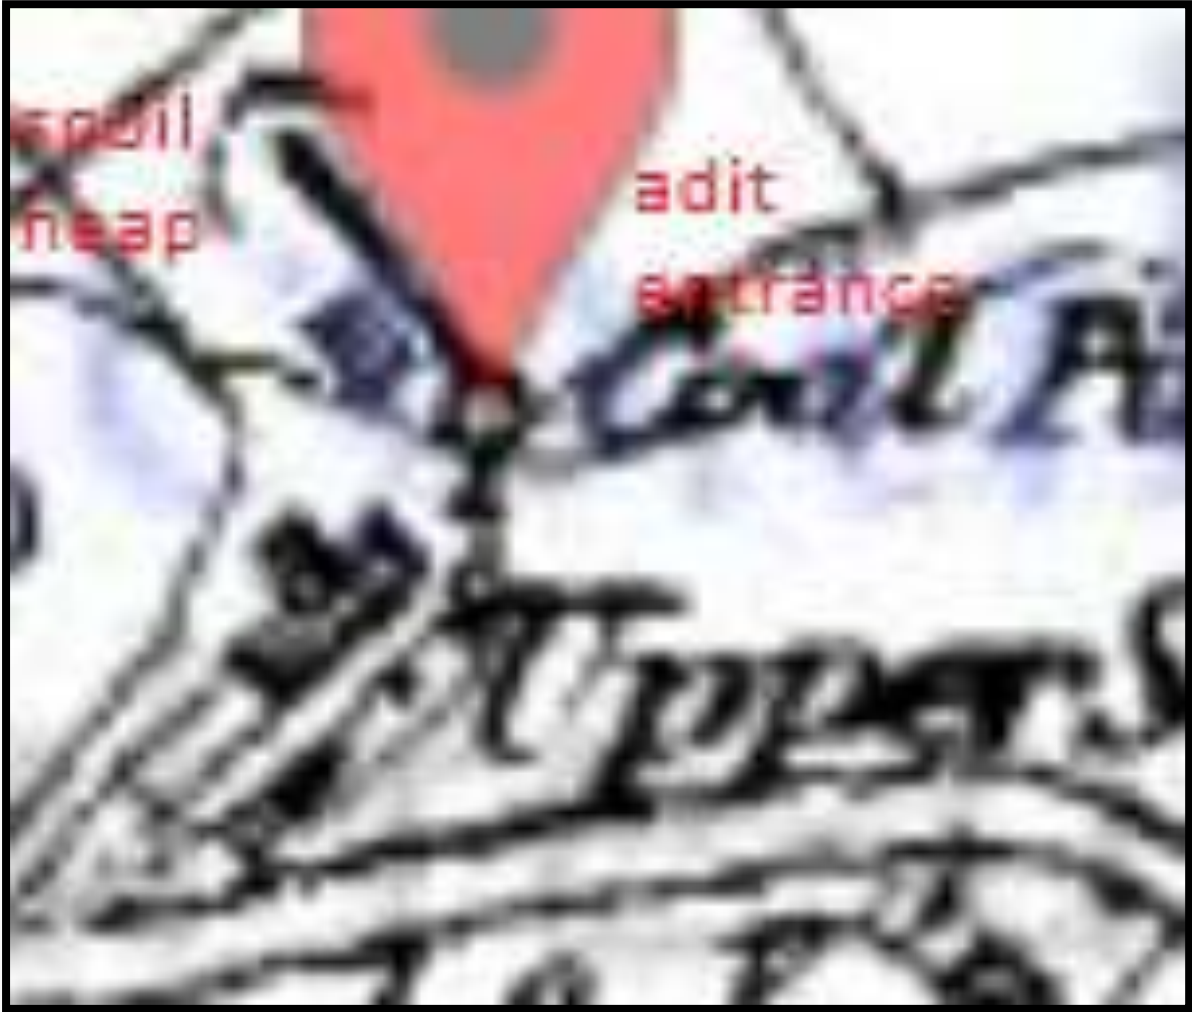
### HISTORICAL OS MAPS

In addition, Geoinvestigate's review of the OS map record suggests that the position of the adit entrance could perhaps be reasonably and accurately inferred from the location of two old walls shown on the map extract of 1887 provided in Appendix 2. In our opinion, these conspicuous/odd walls, which are aligned NW-SE and follow the line of a coal tramway into the adit, are possibly wing walls on either side of a cutting. The tramway is shown on an older faint map extract leading NW to a mine spoil heap. The walls are no longer present at the site.

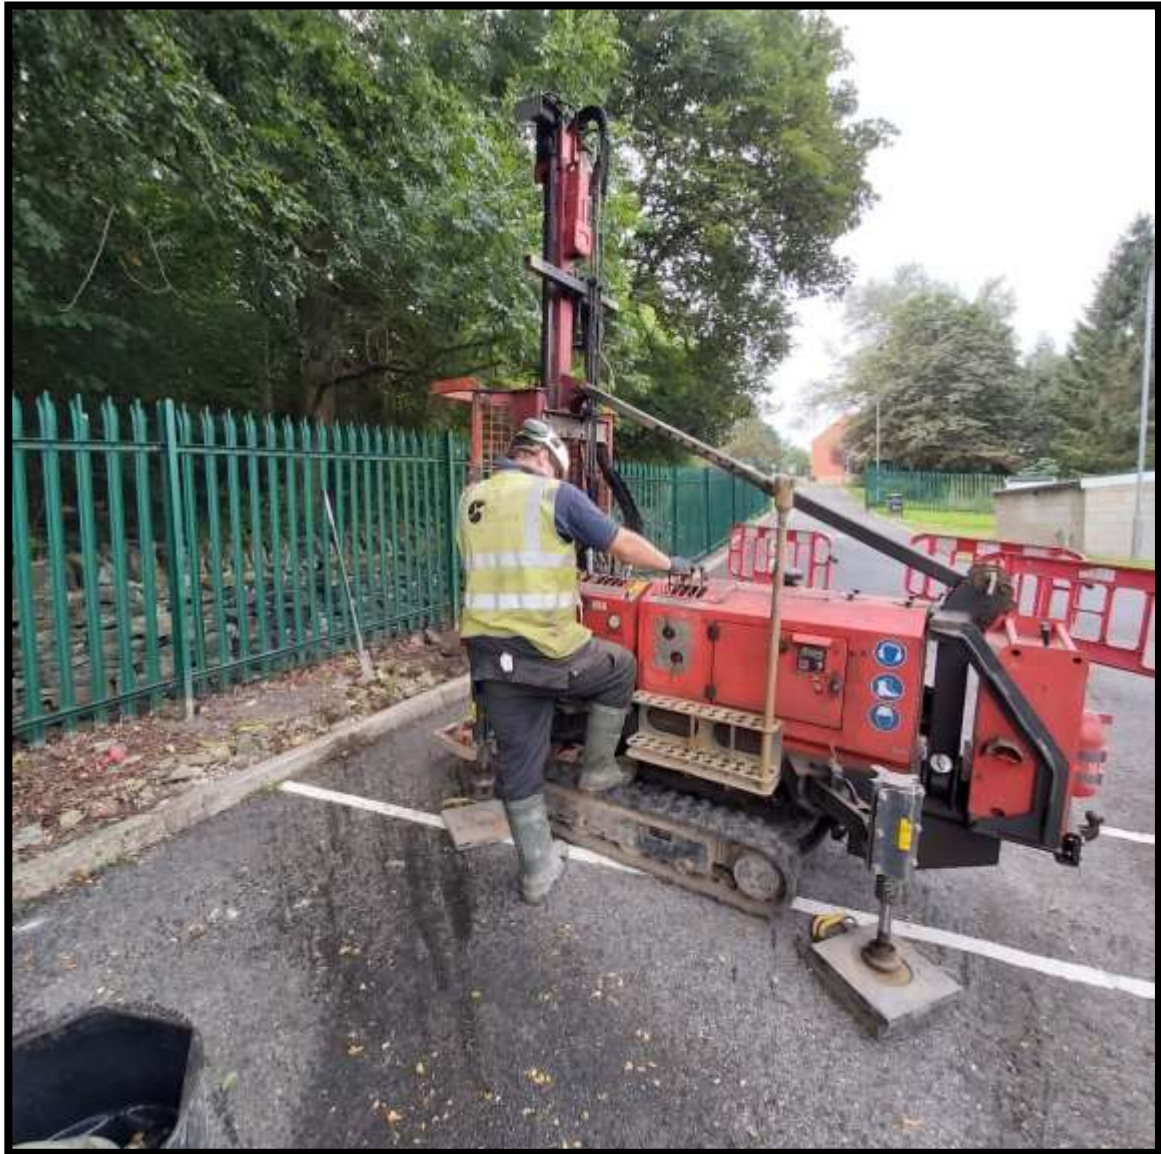
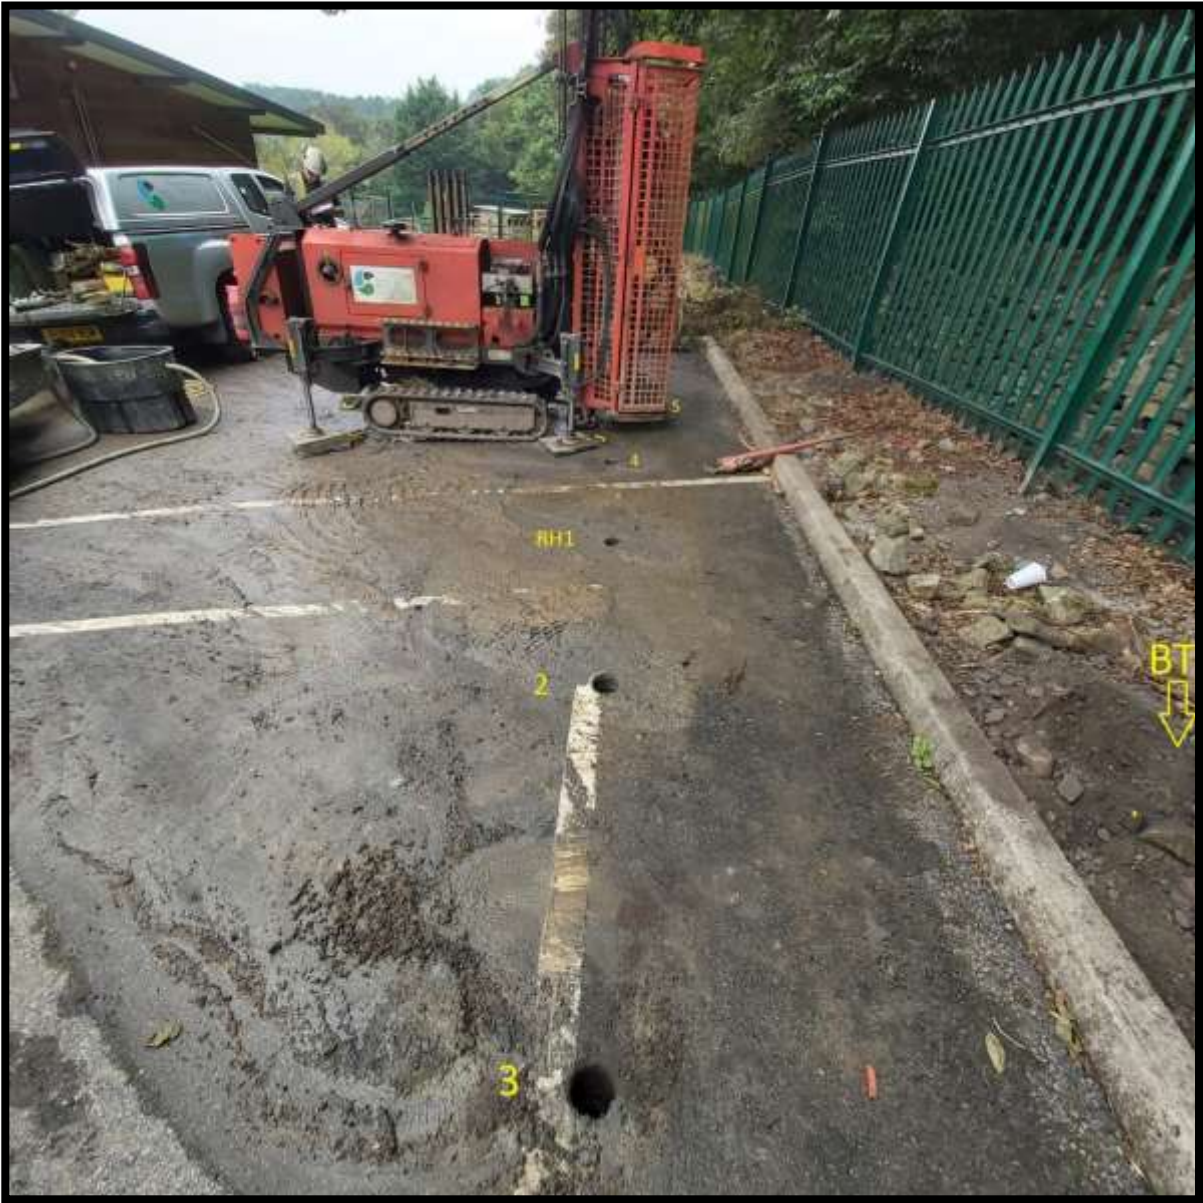
### Building layout, borehole positions & images

A borehole location plan and images of the drilling works are provided in Appendix 4.

As the CA online interactive map service provided an assumed adit width of 2m, the initial borehole spacing was 1m between RH1, 2 & 3 increasing to 1.3m between RH1, 4 - 10 approaching the building area and within it.

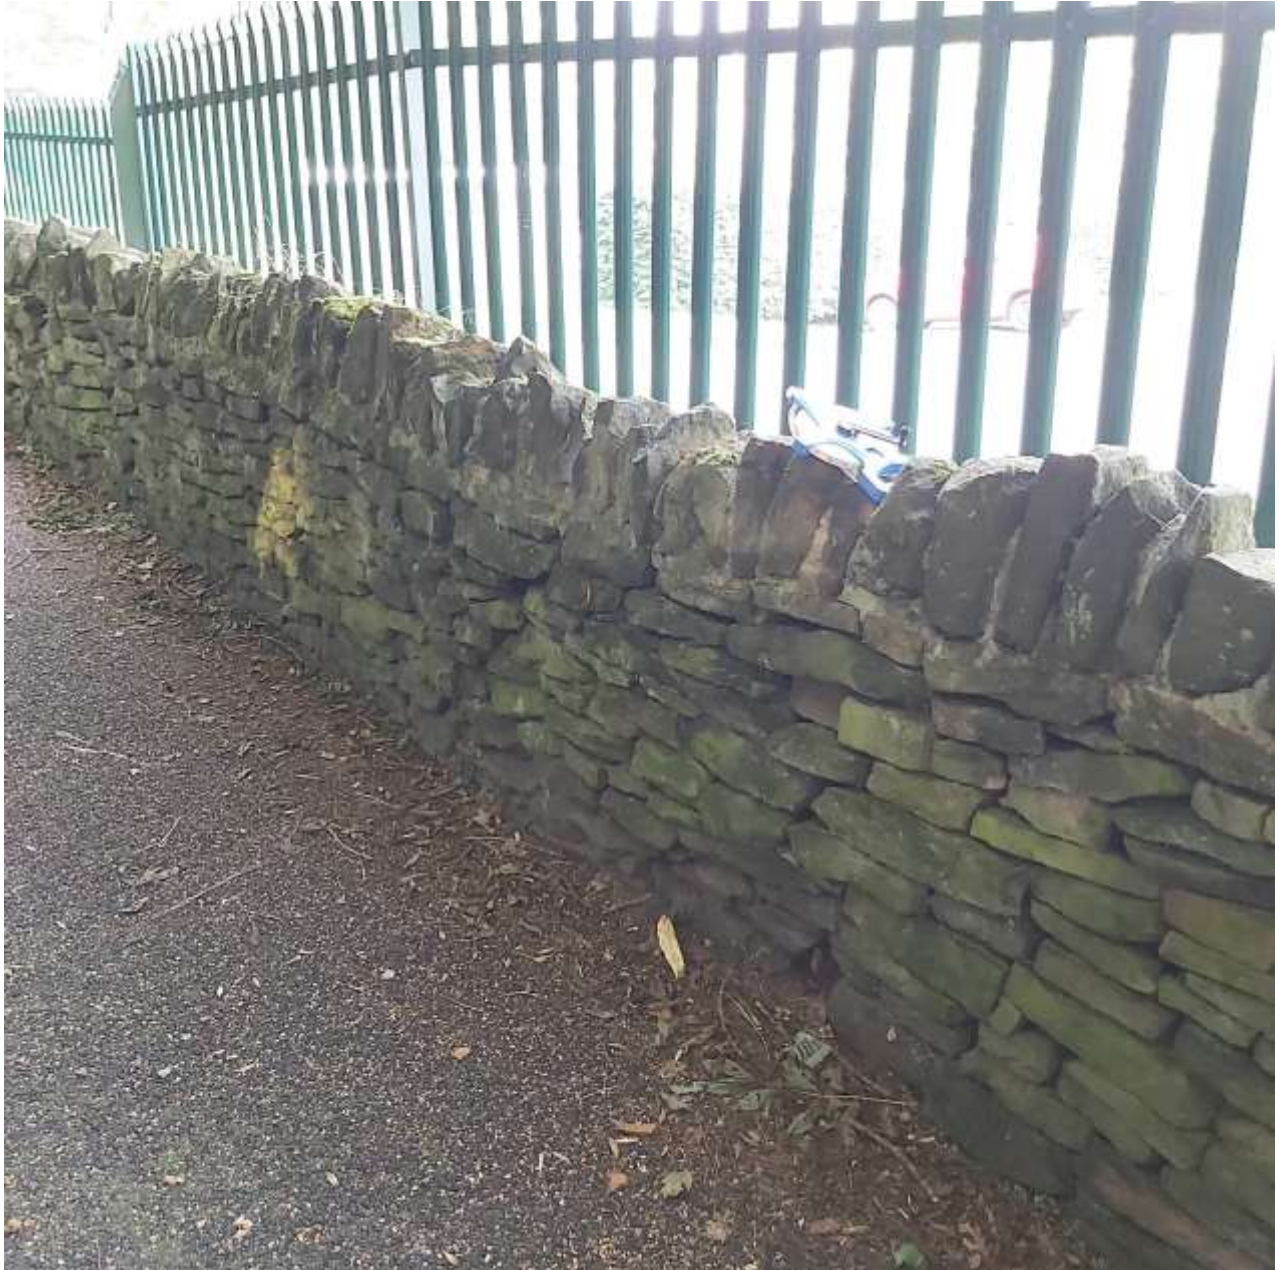
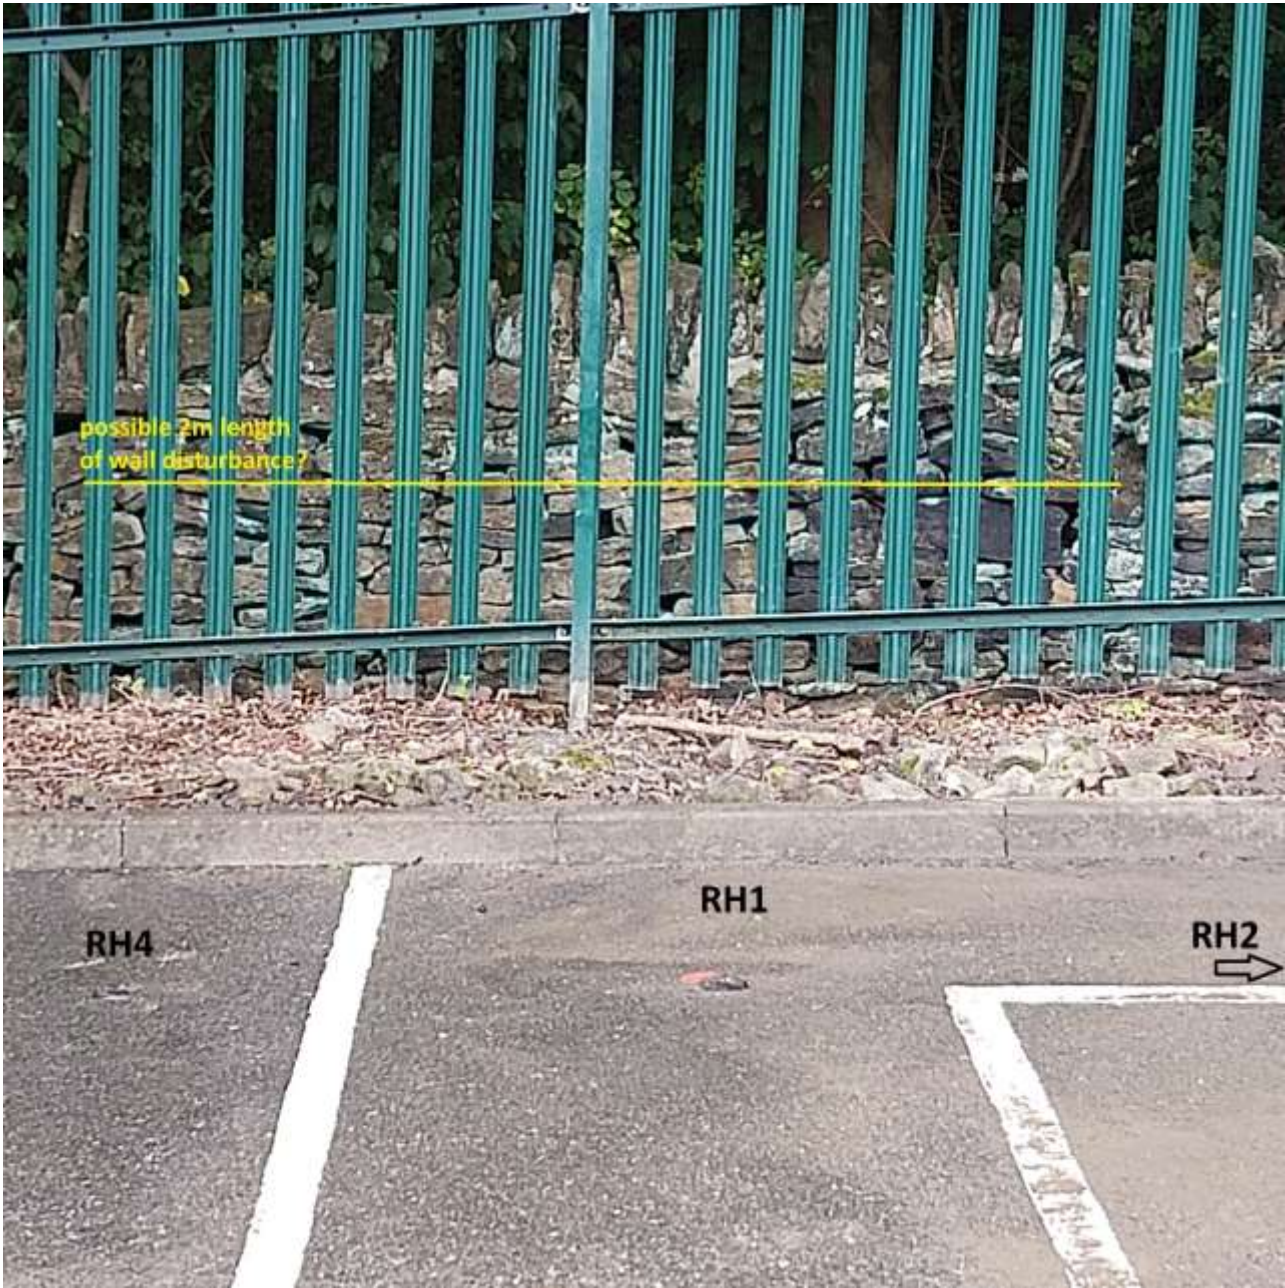
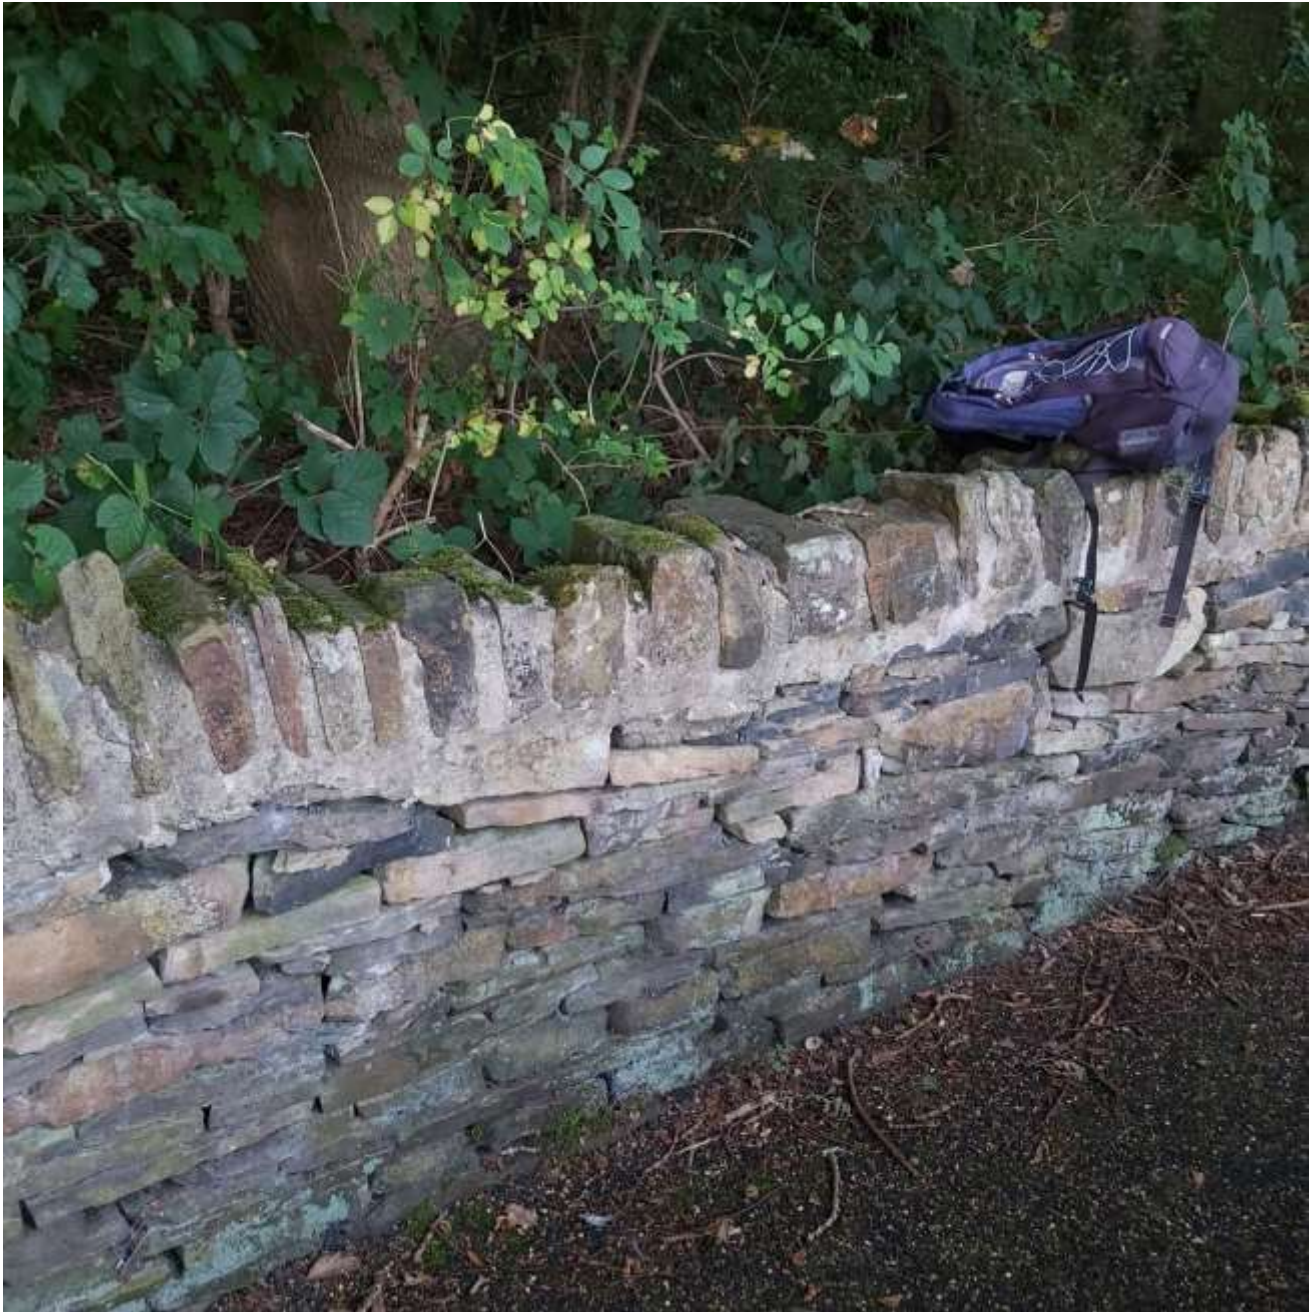
### IMAGES OF PUBLIC FOOTPATH

Images of the footpath wall opposite RH1 are included in Appendix 8 though not in good condition and both old drystone walls on either side of the public footpath perhaps show sag and subsidence over a 2m length opposite RH1. In our opinion, this may be due to the settlement of deeper cutting infill at the tunnel entrance at this point. However, this is speculation.

However, if so, the adit entrance lies either beneath the footpath or in our opinion more likely several metres to the east of the public footpath and outwith the site boundary. In our opinion, the footpath walls which are a later addition to the slope are unlikely to be located over the top of the adit, but it is possible. The other mining geology information on outcrop position and the underground working limit showing these occur to the east of the site boundary fits with this explanation.

In our opinion, the adit entrance lies several metres to the south of the nearest corner of the closest of the two new buildings, this corresponds with localised sagging and distortion of the existing footpath walls on the site boundary.

However, it may be prudent to locally extend foundations at the south corner of this building deeper into natural drift, perhaps approaching the invert/floor of the adit entrance or its approach cutting which borehole RH1 suggests may lie within sandstone at approx. 2.90m at this point.
