## **Heritage Statement – 2 Exchange, Honley**

### **INTERNAL ALTERATIONS, REPLACEMENT WINDOWS AND DOORS AND ROOF ALTERATIONS**

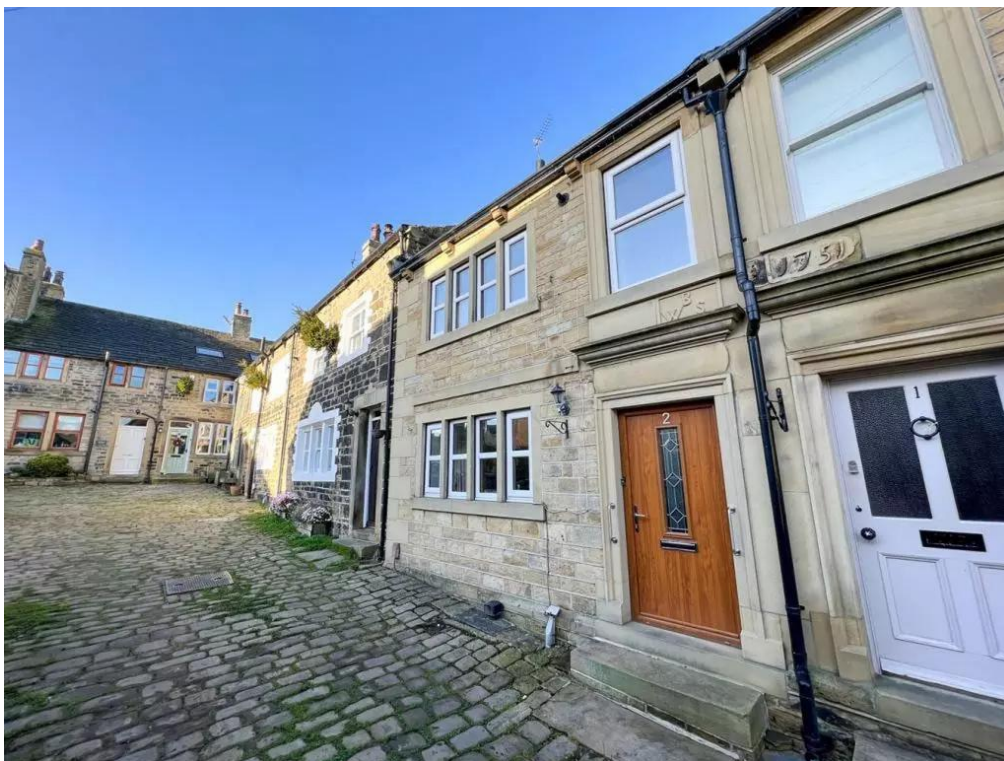
*Photograph of 2 Exchange, Honley*

*2 Exchange – photograph from 2016 showing timber door and windows – the photo on page 1 of this statement from approx. 2024 shows uPVC windows and door, reflecting that there has been a change*

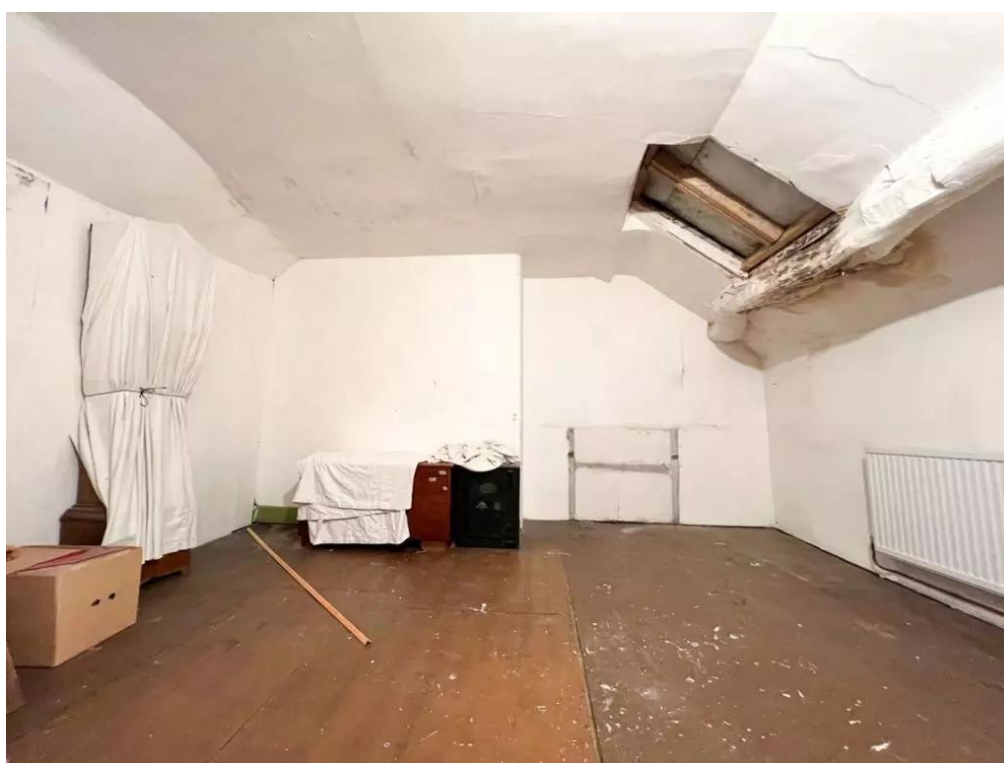
*Internal photo showing the current conditions of the existing roof*

The roof works are driven in part by the condition of the existing fabric. The project photograph shows evidence of water ingress and deterioration around the existing structure. The appropriate conservation approach is repair first: sound historic timber should be retained, local repairs or spliced repairs used where practical, and complete replacement limited to members that cannot reasonably be repaired. The current planning drawing notes that structural components are indicative and that structural engineer details are to be provided.
