## Design & Access Statement

**Project:** Barn at Wellhouse Fields, Radcliffe Road, Golcar, Huddersfield, HD7 4EY.

**Project No:** 305

**Date:** 29th September 2026.

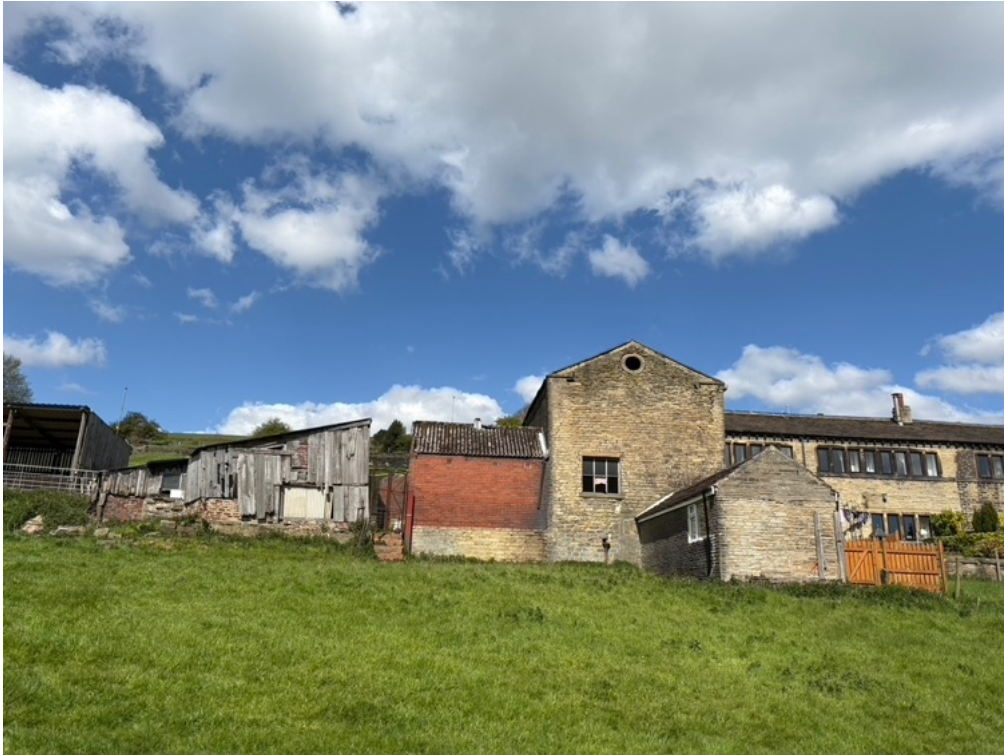
South east elevation / external building

The end gable (south east) is out of plumb and is showing signs of outward movement, there is also some evidence of movement within the building at the western corner.

New door openings are proposed to the south east end gable overlooking the valley. At ground floor, the door would provide access to a newly formed external terrace. At first floor a single door Juliet balcony is proposed.

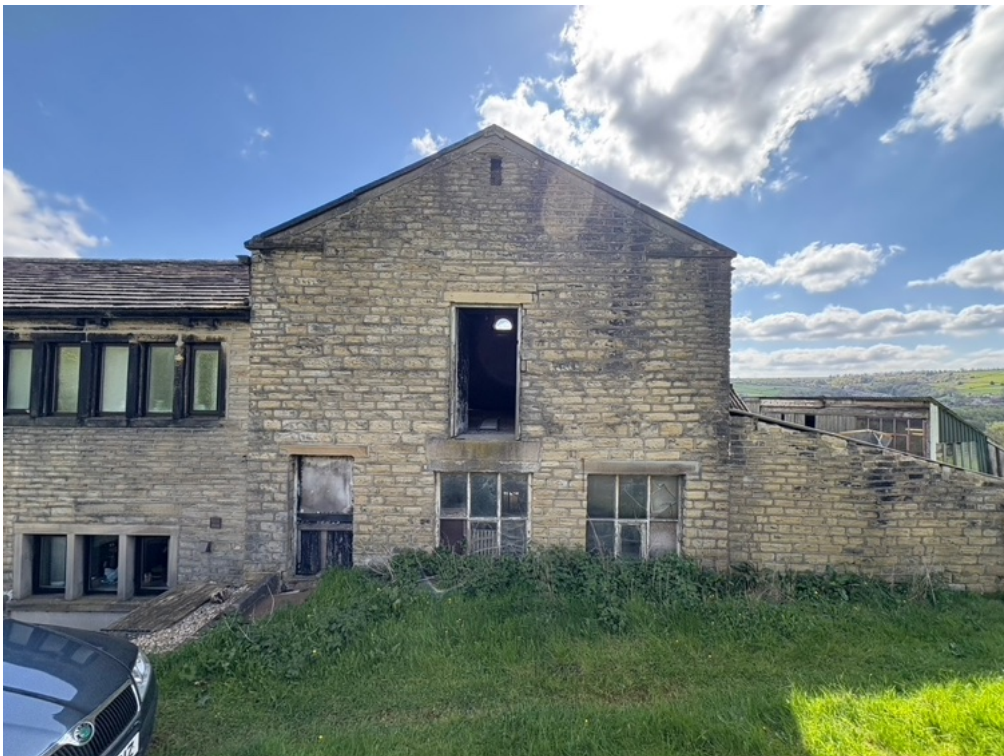
North east elevation

To the north west gable there are 2 windows and a door at ground floor level and a single door at first floor level. The south east gable contains one single window at ground floor, with a circular window at high level. The north east elevation contains one window at ground floor level and one at first floor level.

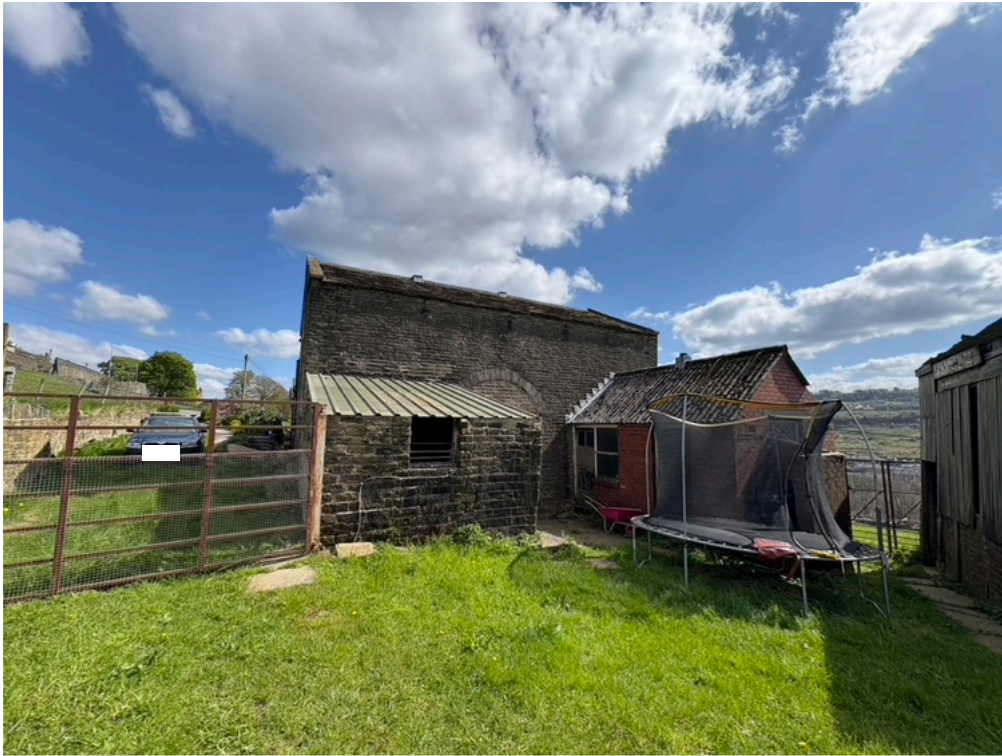
South west elevation

The Barn itself is a good example of the typical agricultural architecture typical to that found across Kirklees. The historic barn door is located to the south west where access. it has been partially infilled using stone with a single window and sliding door installed. The barn would've historically been part of a larger farm setting.

Attached to the principal elevation (south west) of the barn there are 2 single storey structures. One is constructed from natural stone with a metal clad roof, this structure is in fairly poor condition. The other is constructed from red brick with an asbestos roof and is used for storage. It is in good structural condition but does not sit well against the barn.

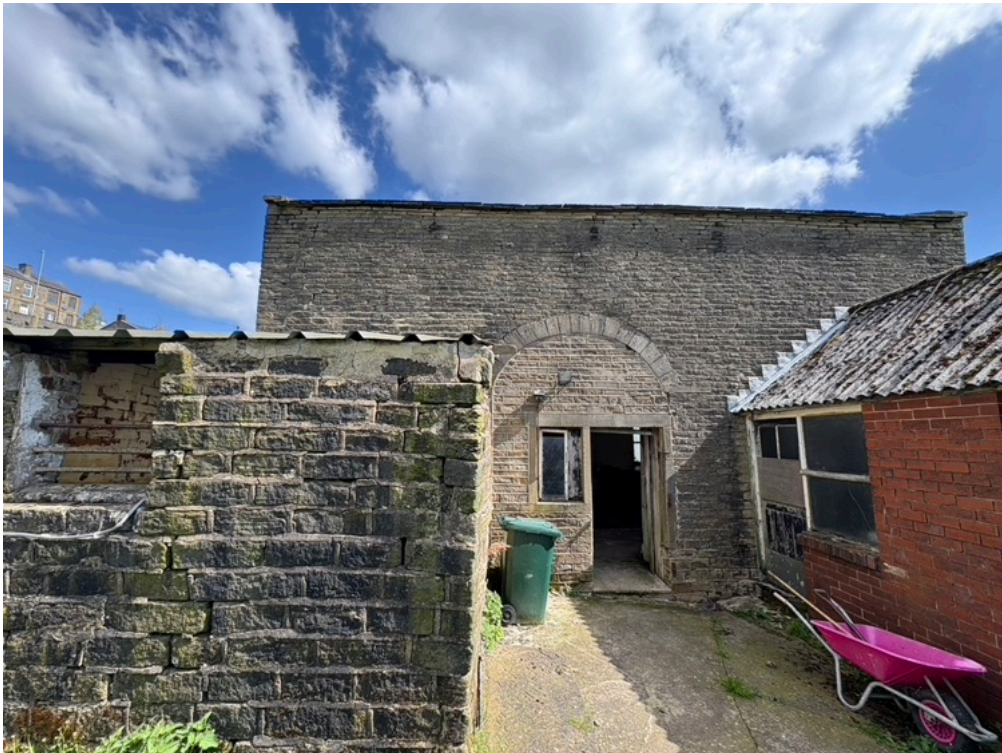
South west elevation

The smaller single storey section of building to the front of the barn is to be demolished with the other larger single storey section rebuilt using materials to match the main barn. This would allow for a new entrance area with glazed screens each side, a utility / cloaks & WC. A new structural opening would be required to link into the barn, this would be constructed as one single door opening.

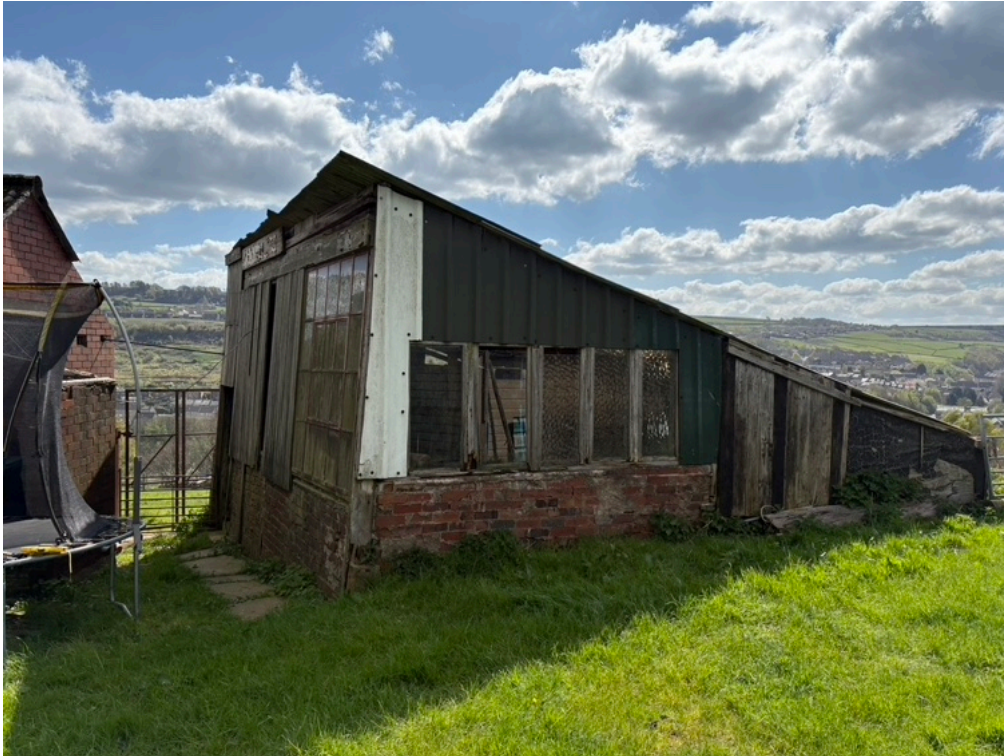
Outbuilding immediately in front of barn (to be demolished)

Immediately in front of the barn, there is a large outbuilding. This is constructed from red brick, timber cladding, asbestos and other assorted materials.

To improve the openness of the greenbelt, the existing outbuilding and garage towards to front of the barn would be demolished, making way for parking and a well sized garden.

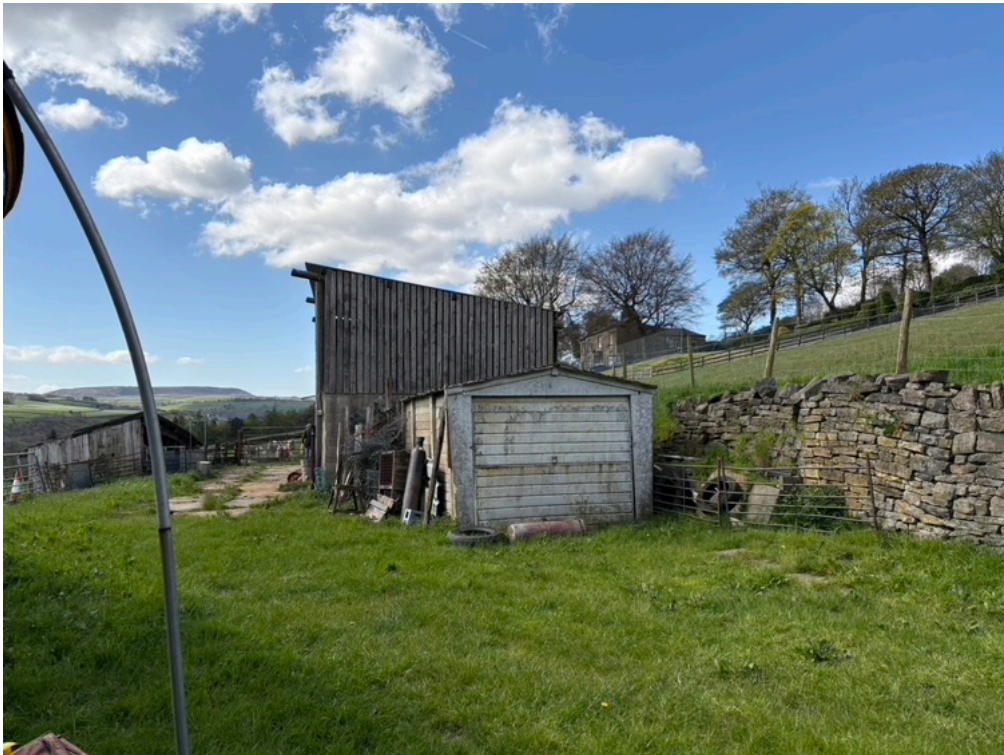
Garage in front of barn (to be demolished)

There is concrete and asbestos detached garage between the barn and other agricultural structures.

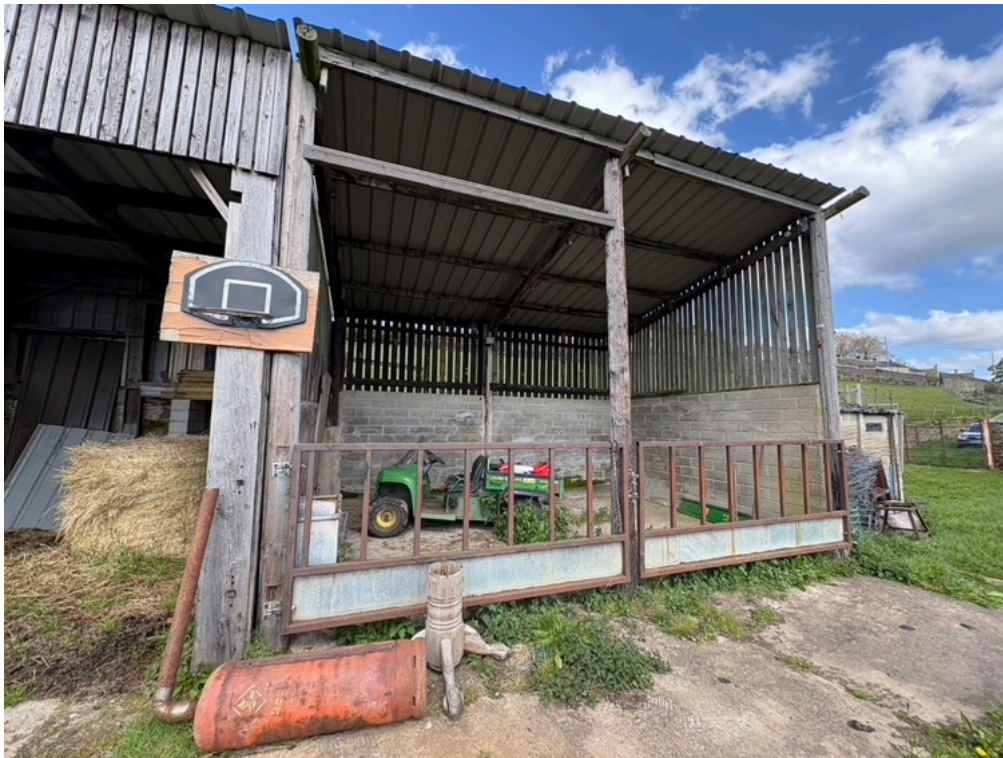
End bays of agricultural structures (to be demolished)

The end bays of the existing agricultural buildings would also be demolished, further assisting with the green belt. This would allow for access to be retained to these structures, ensuring the small scale farming could continue.

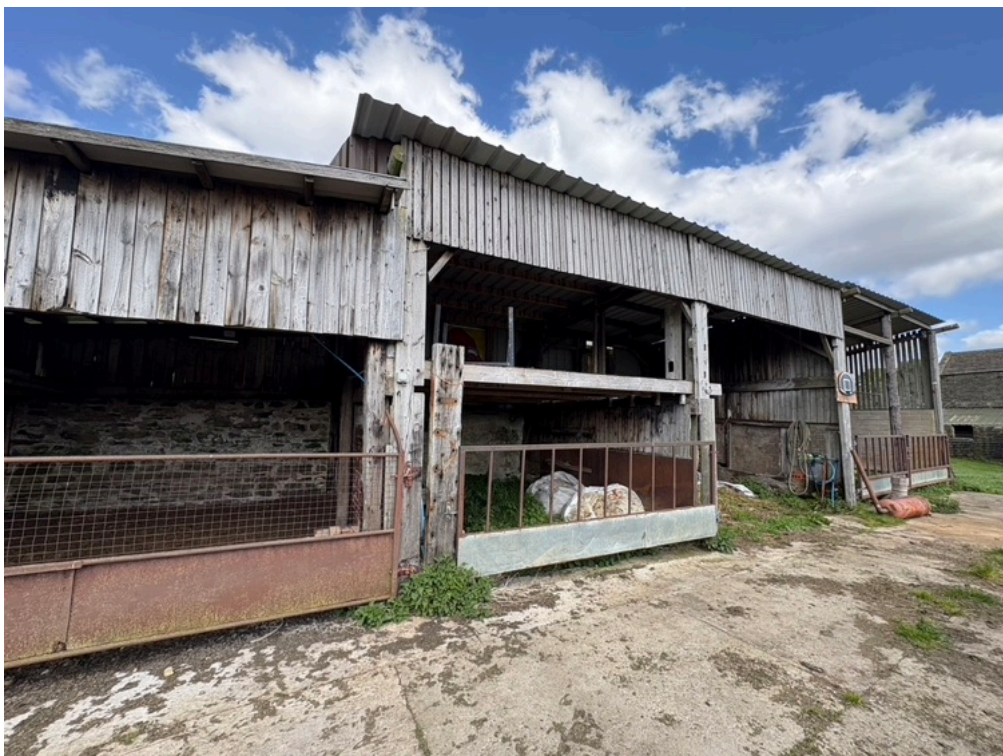
Agricultural structures retained (other than end bays noted above).

Beyond the suggested / application domestic curtilage are further structures. These are generally blockwork / stone and timber clad structures with metal clad roofs. They measure 4.6m high.

The retained structures beyond the proposed domestic curtilage would be retained for the hobby farming activities.

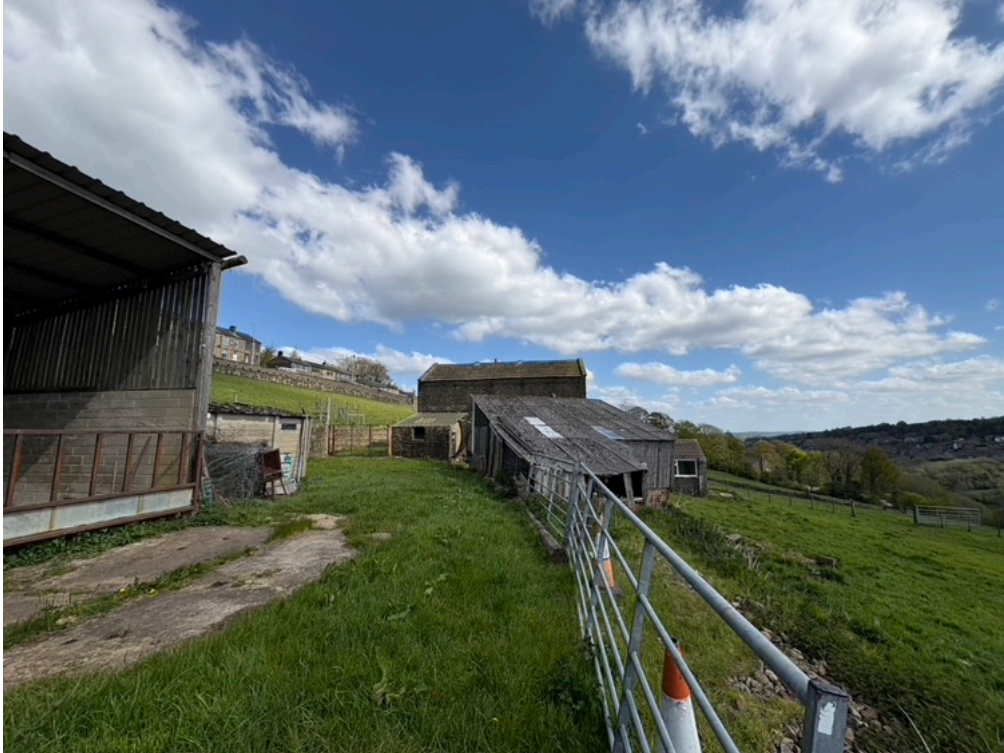
View of barn with existing outbuildings

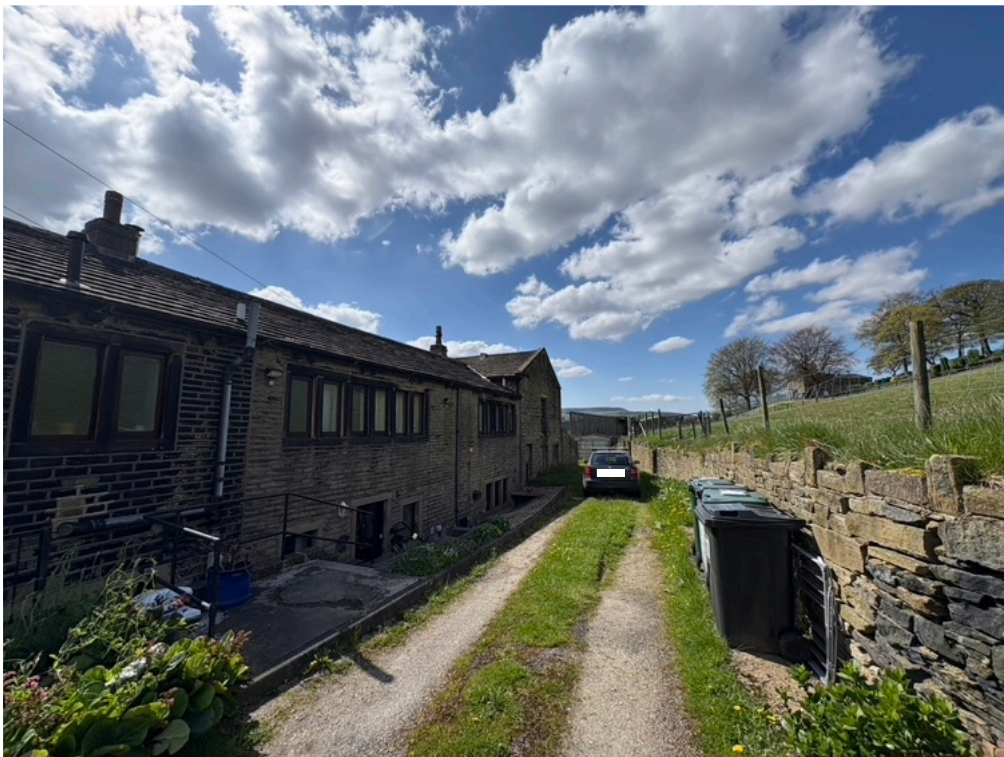
Barn in relation to listed buildings

- The site falls within the Wellhouse Conservation area, which was designated on 31<sup>st</sup> March 1981.
- The barn is located to the south west end of a row of terraced cottages (No.s 5-15). The cottages are grade II listed.

It was noted that due to the relationship between the barn and listed buildings, the barn would be assessed as curtilage listed, therefore a listed building consent application is required.

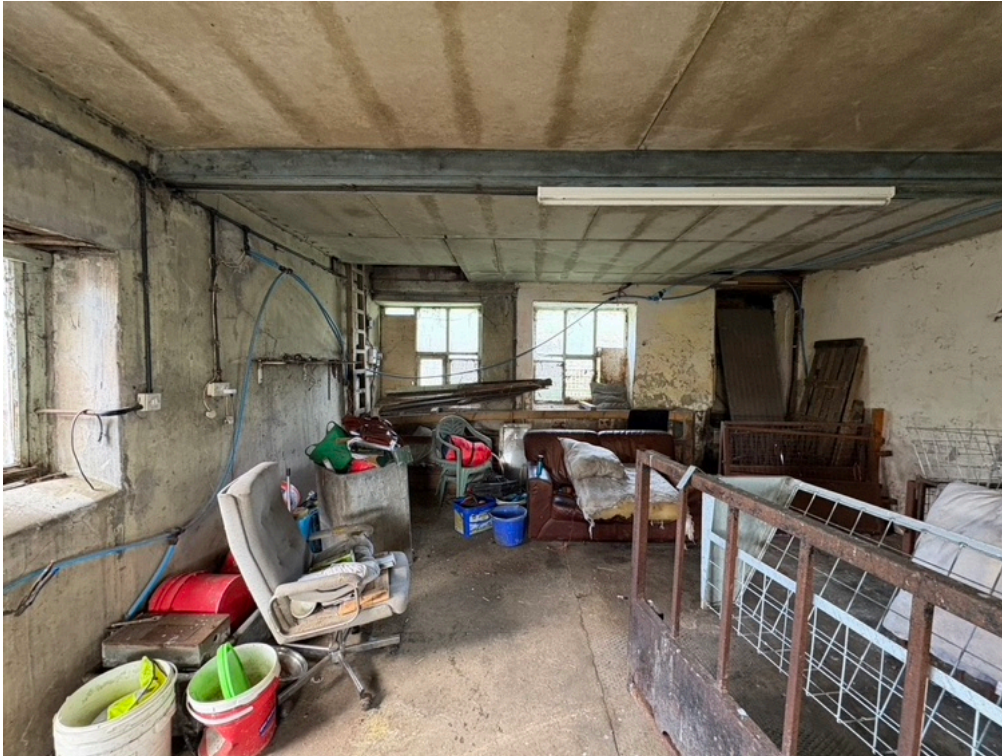
Internal photo at ground floor towards north west

The ground floor of the barn is concrete and is laid to a fall from the north west gable for the south east gable with some floor gullies set into the ground leading to an outlet into the field.

The ground floor structure, due to the existing fall, would not be suitable for retention / integration. A insulated ground floor is proposed to comply with current building regulations requirements.

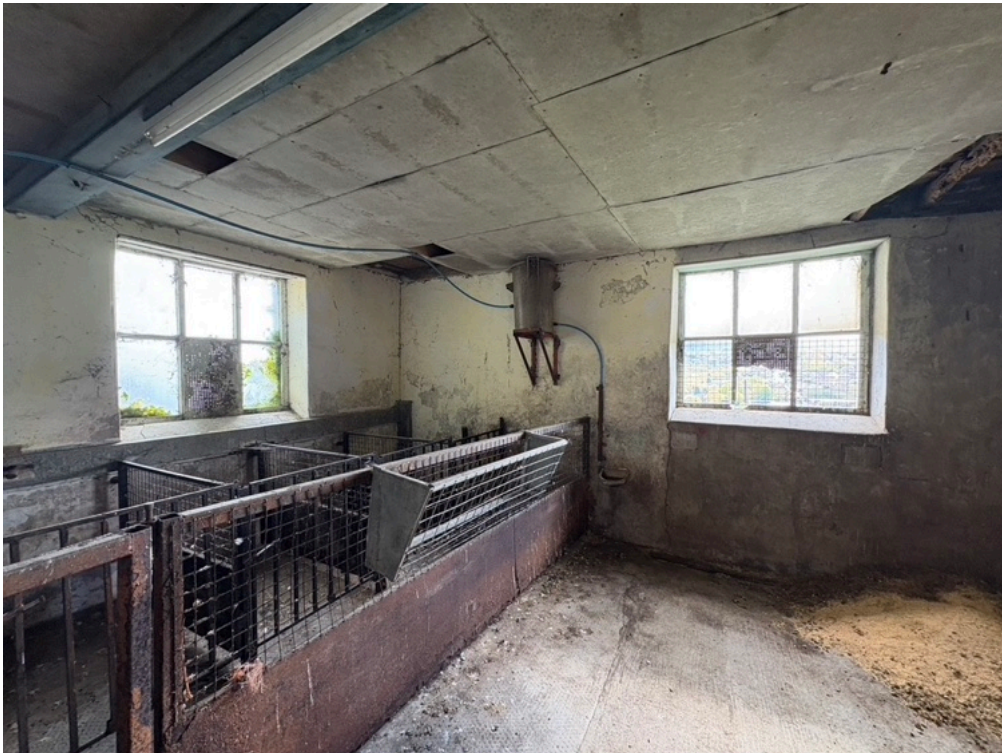
Internal photo at ground floor towards south east

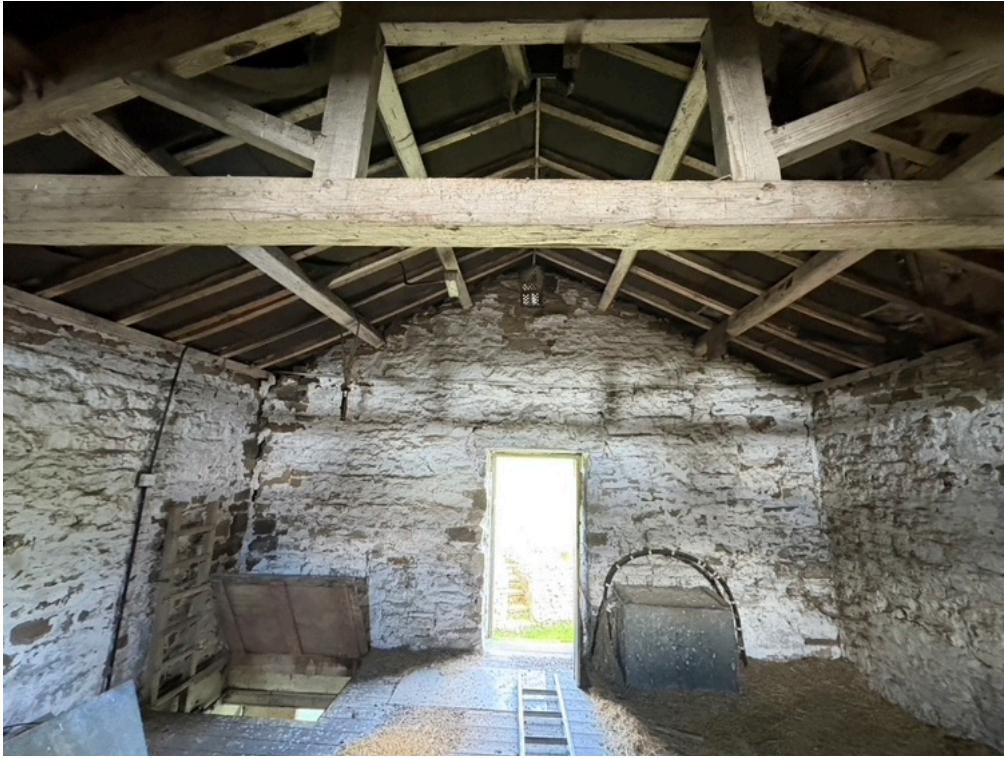
Internal photo at first floor towards north west

There is a first floor structure within the barn, this is constructed from timber comprising of 2 main beams spanning front to back and timber joists with tongue and groove floor boards, these are generally in good condition. It is assumed this is a later addition as one of the beams lands within the partially closed of barn door opening. Access to the first floor is via an internal hatch with ladder, or via the external door opening to the north west elevation.

The roof structure comprises of 2 queen post trusses, 6 purlins and rafters. The roof structure from no.15 is linked / extends over the barn.

The first floor structure appears to be in good, but would require further inspection. It is intended that this would be retained with minor alterations for the new staircase. Any defective timbers are to be repaired or replaced like for like.

The roof structure appears to be in good condition and would be retained. The roof would require reroofing and insulating. The existing materials would be used with any shortfall made up with materials to match. Insulation will be installed between / below rafters with the existing trusses and purlins kept visible.

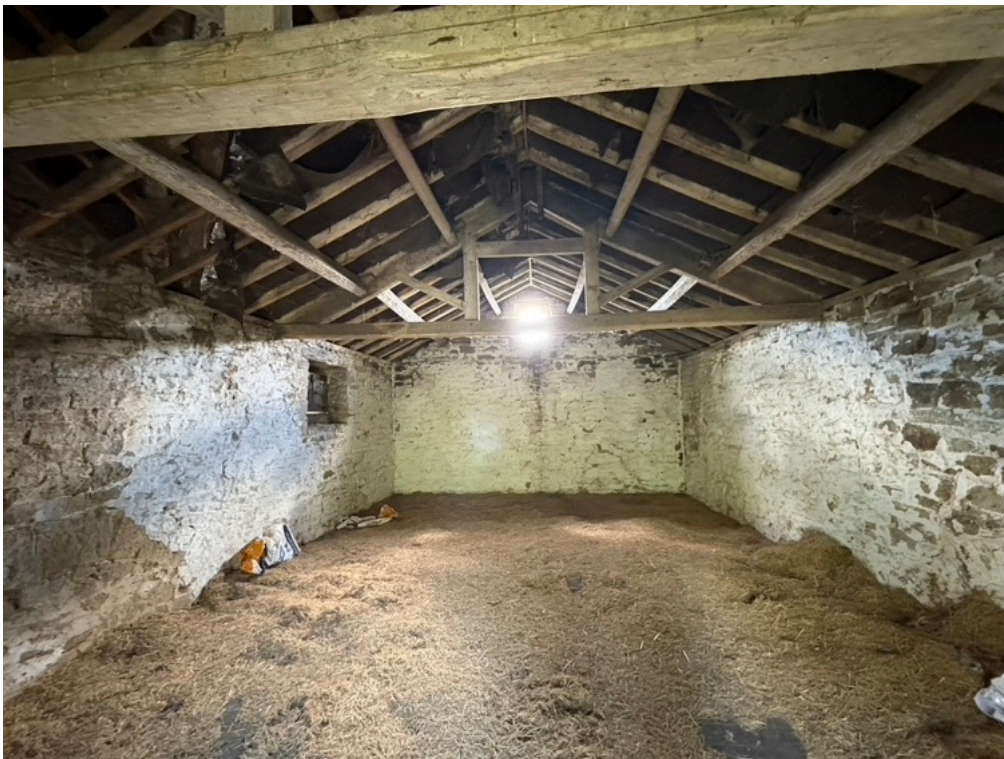
Internal photo at first floor towards south east
