# PHASE 2 GEO-ENVIRONMENTAL REPORT

| job number | C5127/26/E/9508 | date | 30.07.2026 |
| site address | Woodman Inn,<br>Thunder Bridge Lane,<br>Huddersfield,<br>West Yorkshire, HD8 0PX | | |

# Report on a Phase 2 Geo-environmental Investigation

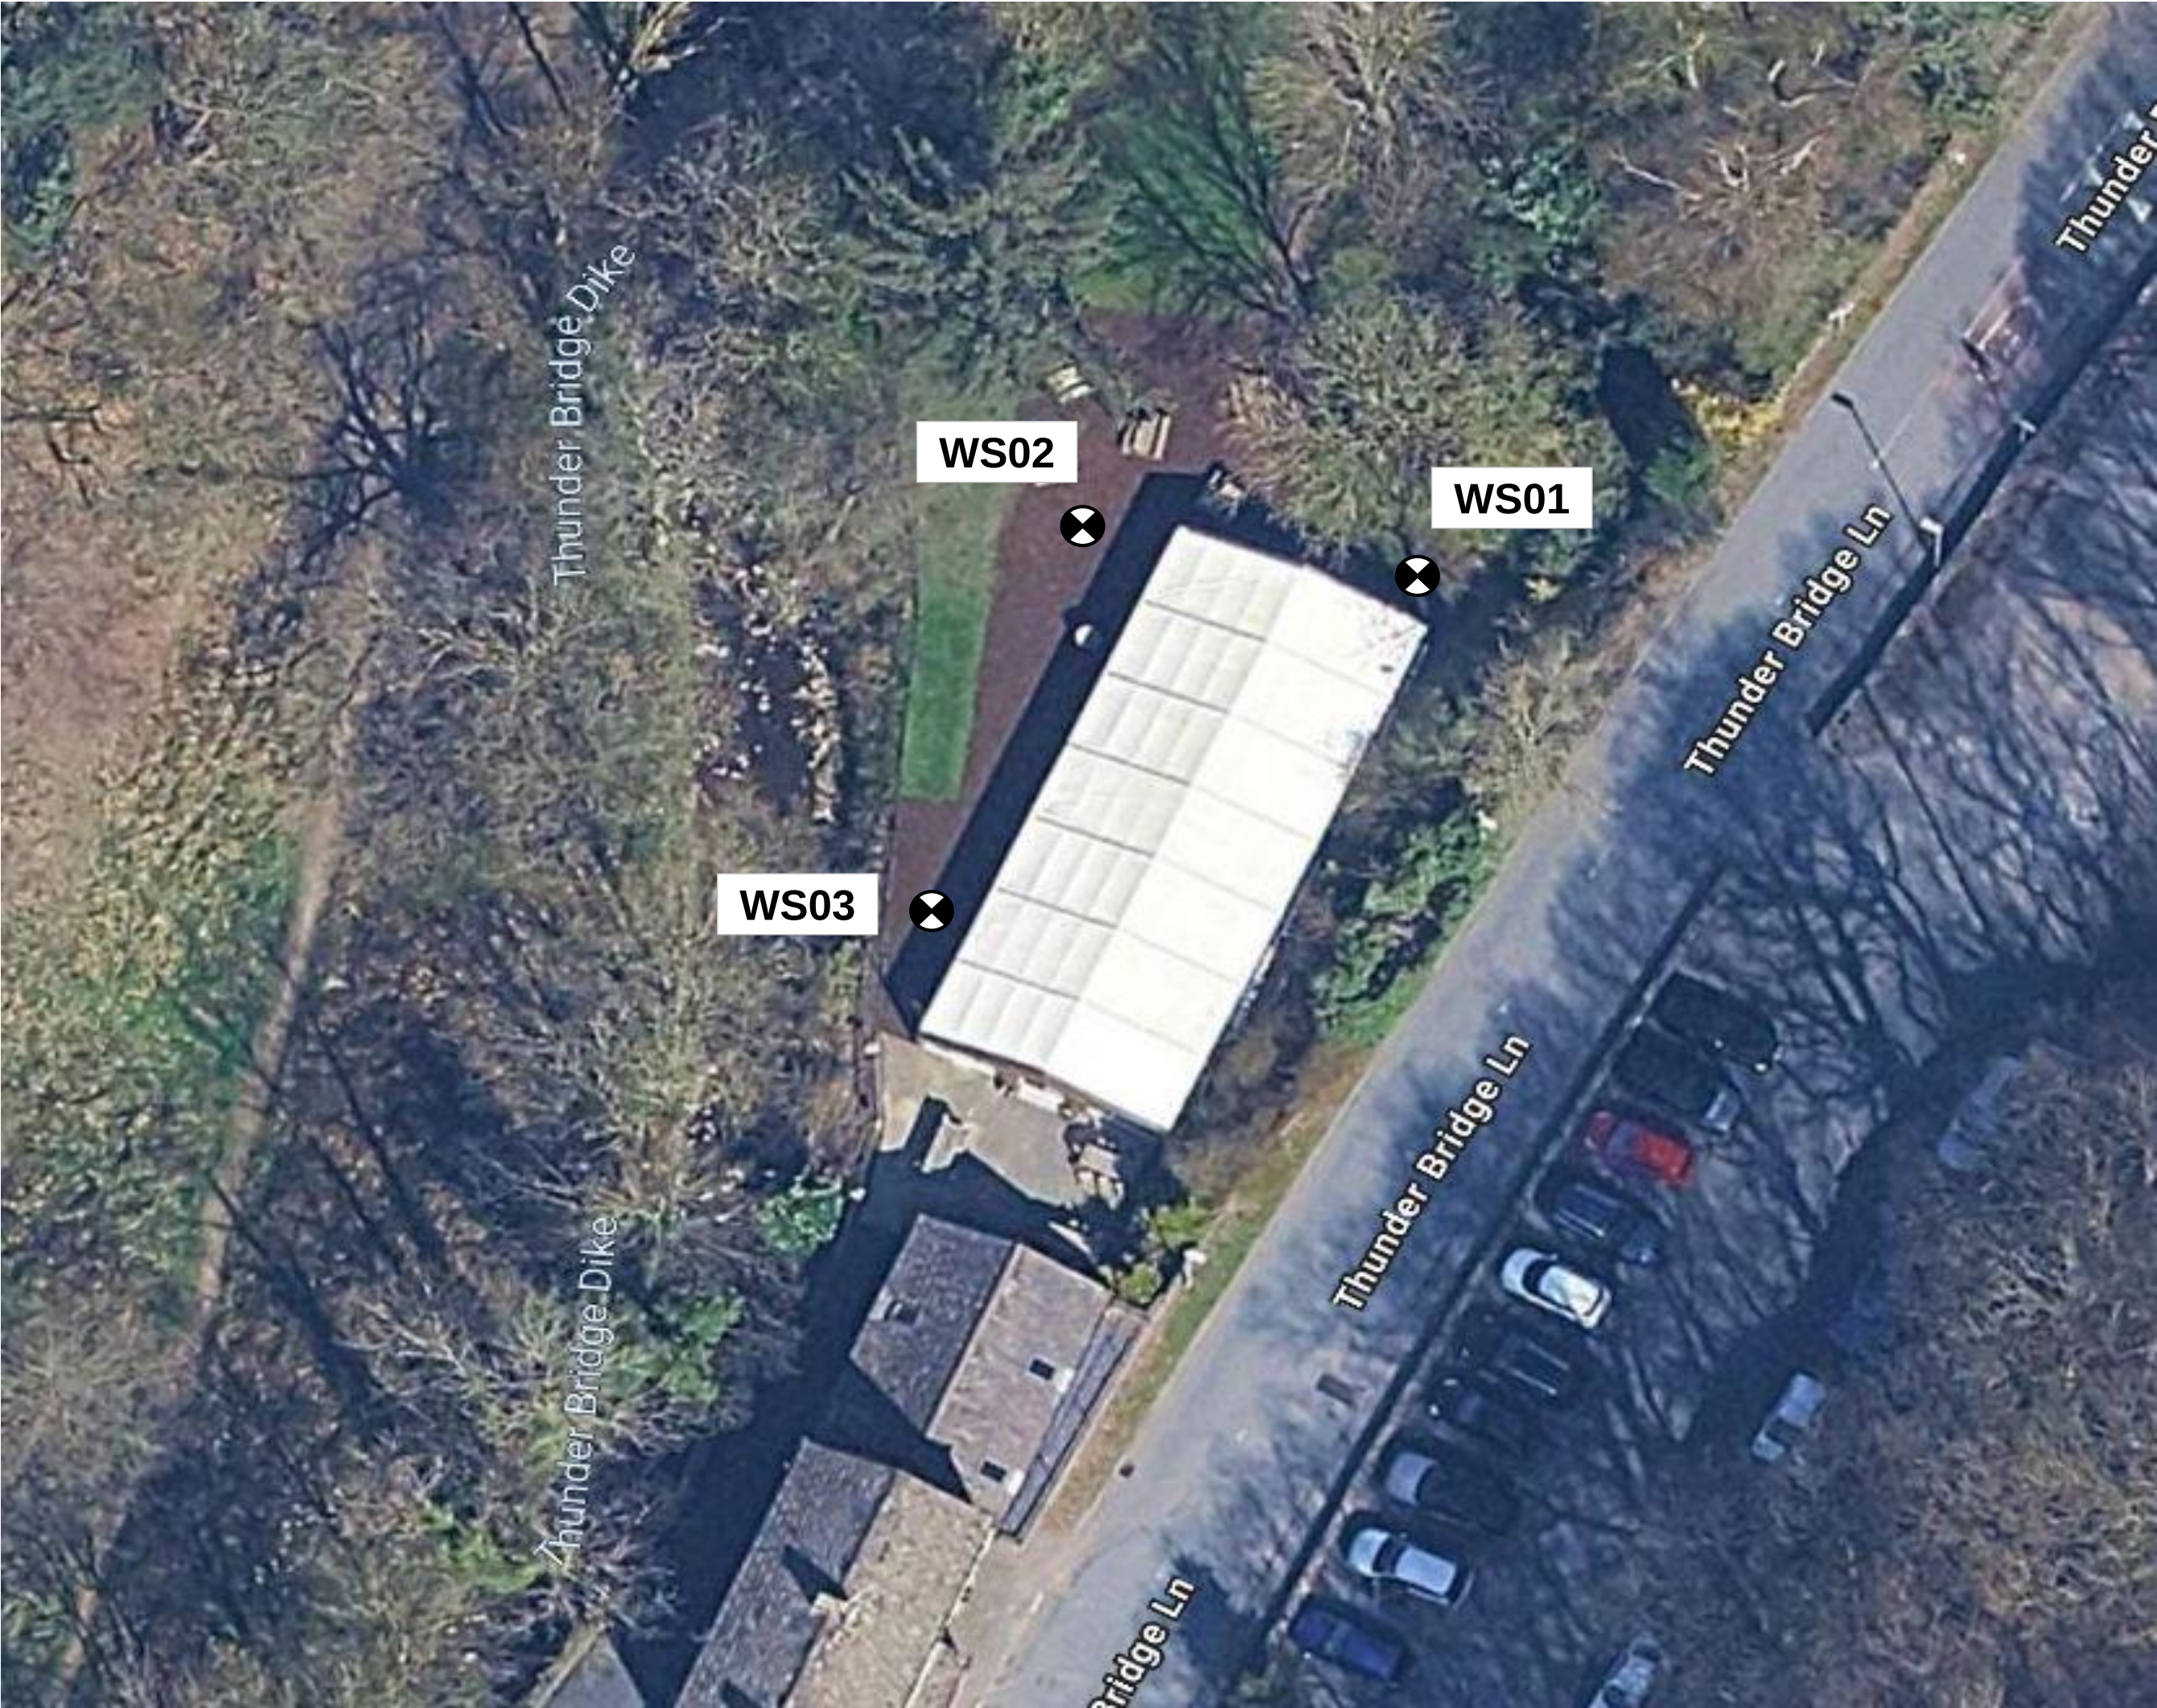
### Site Plan

**Notes:**  
Investigation positions approximated from site operative's notes.

The investigatory locations are shown on the site plan which is presented in Appendix 1 to this report.
