## Phase 2: Site Investigation

**Tesla SUC Leeds Birstall**

**NE-26-043**

**Solmek Ltd**

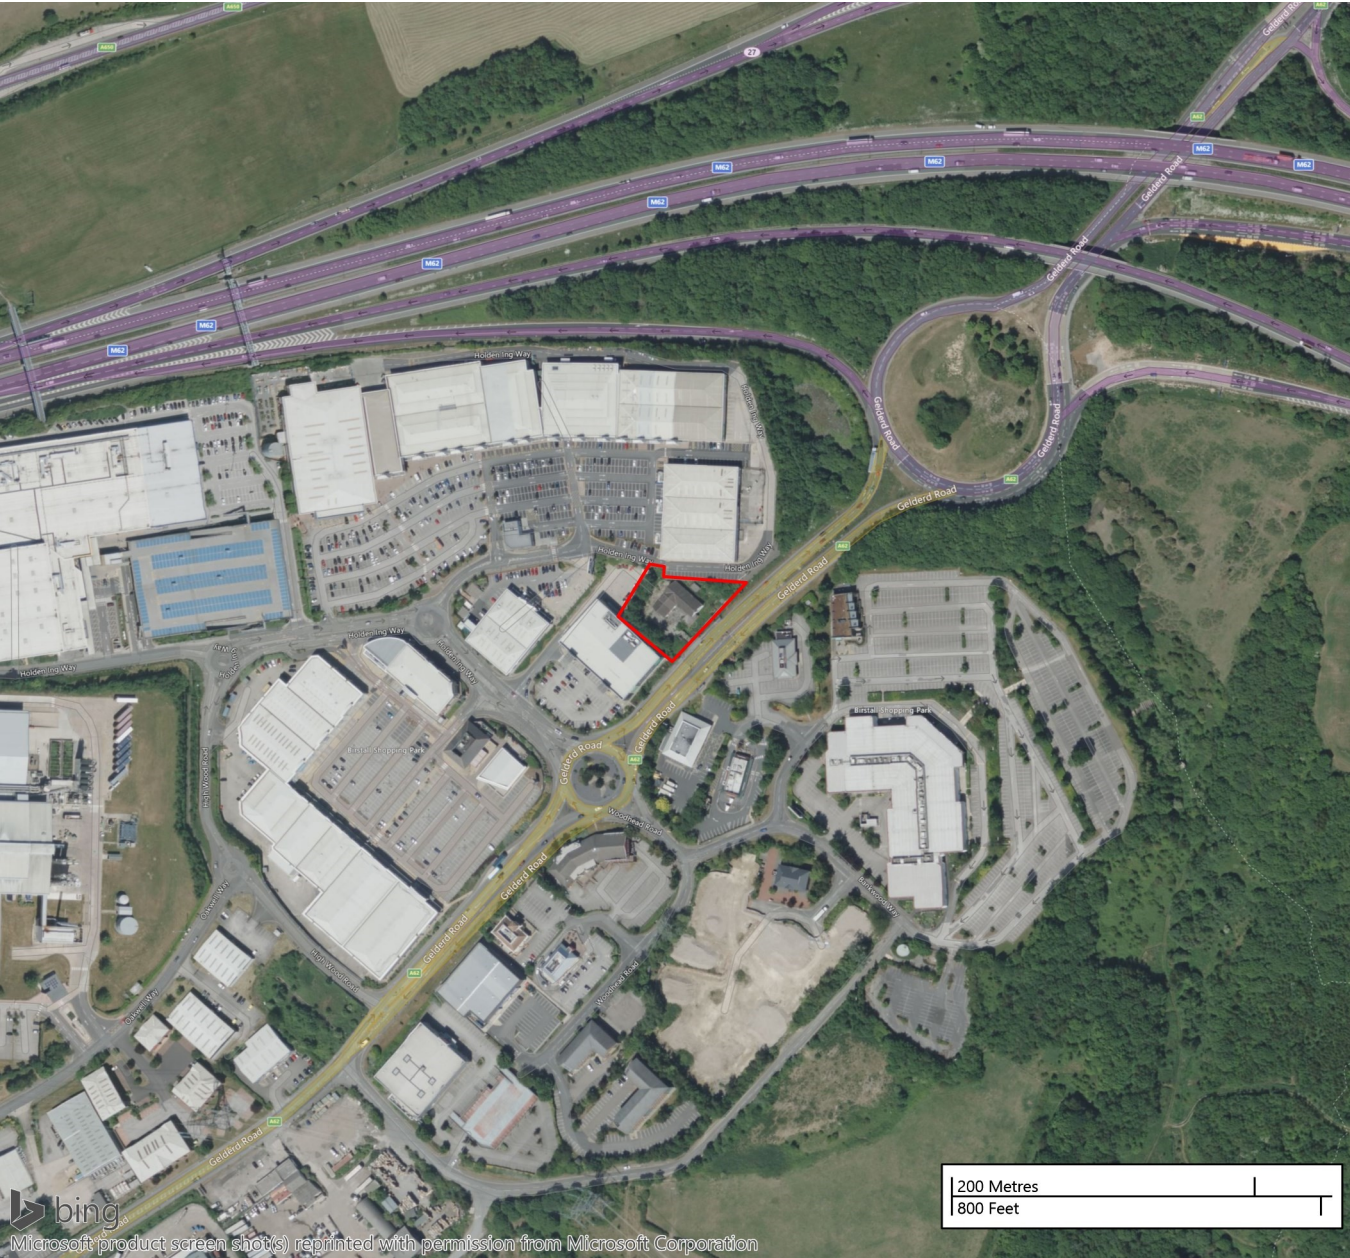
Figure Title

Descriptions of the strata encountered in the trial pits and boreholes together with details of sampling and groundwater are presented in Appendix B of this report. A plan showing the location of the trial pits and boreholes can be found in Appendix A (Figure 2).
