# Geoenvironmental Appraisal

## Land at Westgate, Cleckheaton For Strata Homes Ltd

Report no: 3043/2C

Date: May 2021

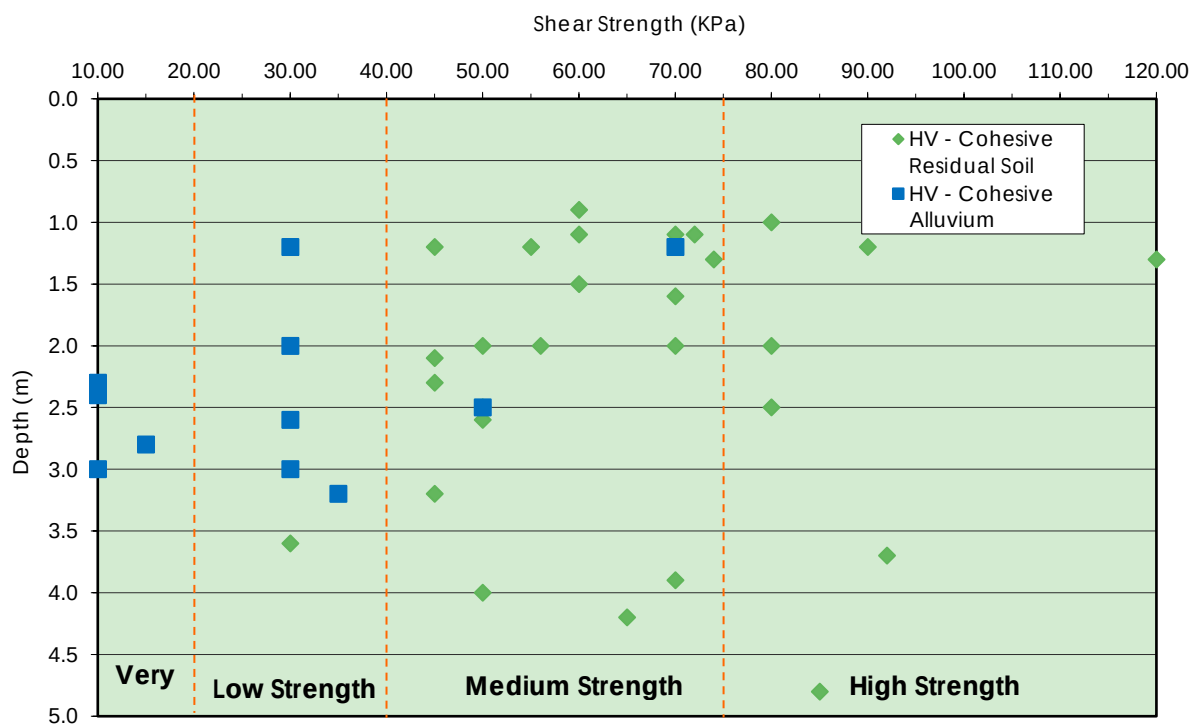
- 12.6.1 Hand shear vane testing was undertaken within trial pits in-situ to around 1.3m depth and from larger blocks of excavated clay below that depth.
- 12.6.2 The results are summarised within the plot below, within the Cohesive Alluvium deposits the results are generally very low strength to low strength.
- 12.6.3 For Cohesive Residual soils all the results are of at least medium strength except one which has fallen within the low strength category; this is likely because of a soft spot due to groundwater and/or higher sand content and is not thought to represent the true in-situ strength.
- 12.6.4 Below approximately 1.2m depth, undrained shear strength ( $S_u$ ) within Cohesive Residual soils is typically greater than 50kPa.
- 12.6.5 The plot below provides a summary of undrained shear strengths:

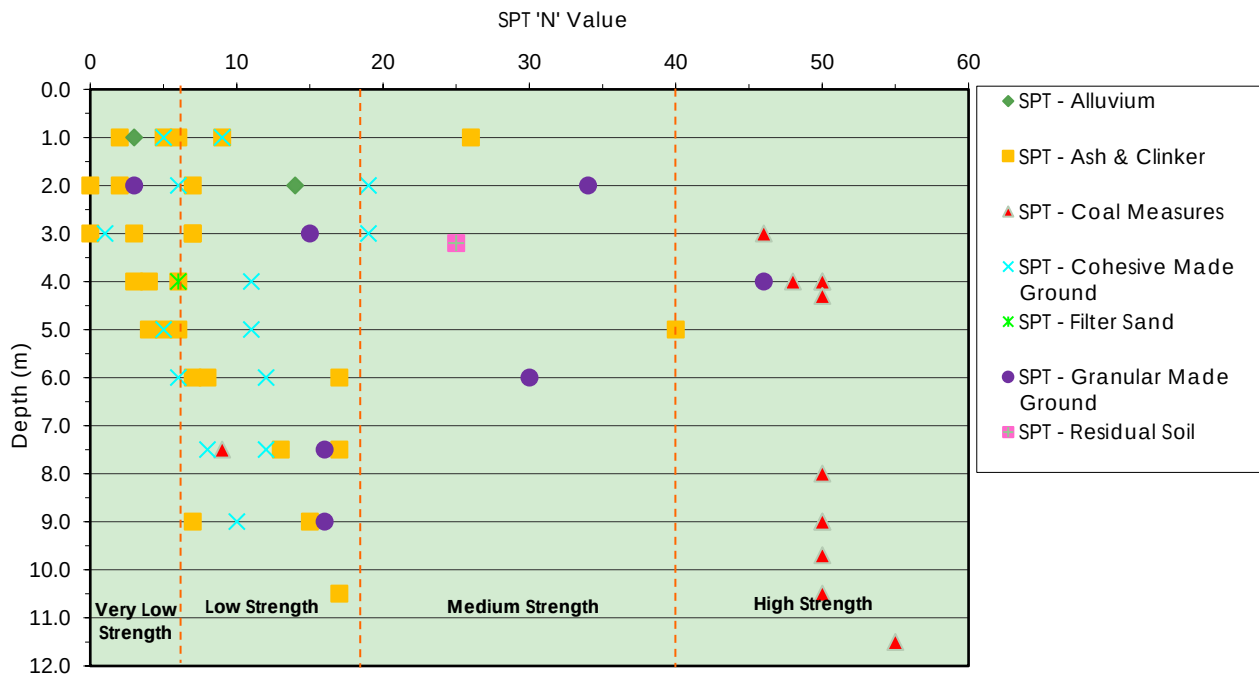
### Standard penetration test (SPT)

- 12.6.6 The in-situ relative strength of both natural and made ground was established by carrying out Standard Penetration Tests (SPTs) during the drilling of the cable percussion boreholes (BHs 501 to 509).
- 12.6.7 The SPT test results are displayed on the plot below:

- 12.6.8 SPT tests show that all of the made ground types tested are generally of poor and variable strength. The Alluvium (where present) is also of very low strength.
- 12.6.9 Residual soils are of medium strength and SPTs into bedrock (Coal Measures) typically refused after 50 blows. These readings support the descriptions given on the field logs.
- 12.6.10 High blow counts reported in the Granular Made Ground are likely the result of the test encountering coarse materials (cobbles, bricks etc) rather than the material actually being especially dense in-situ.

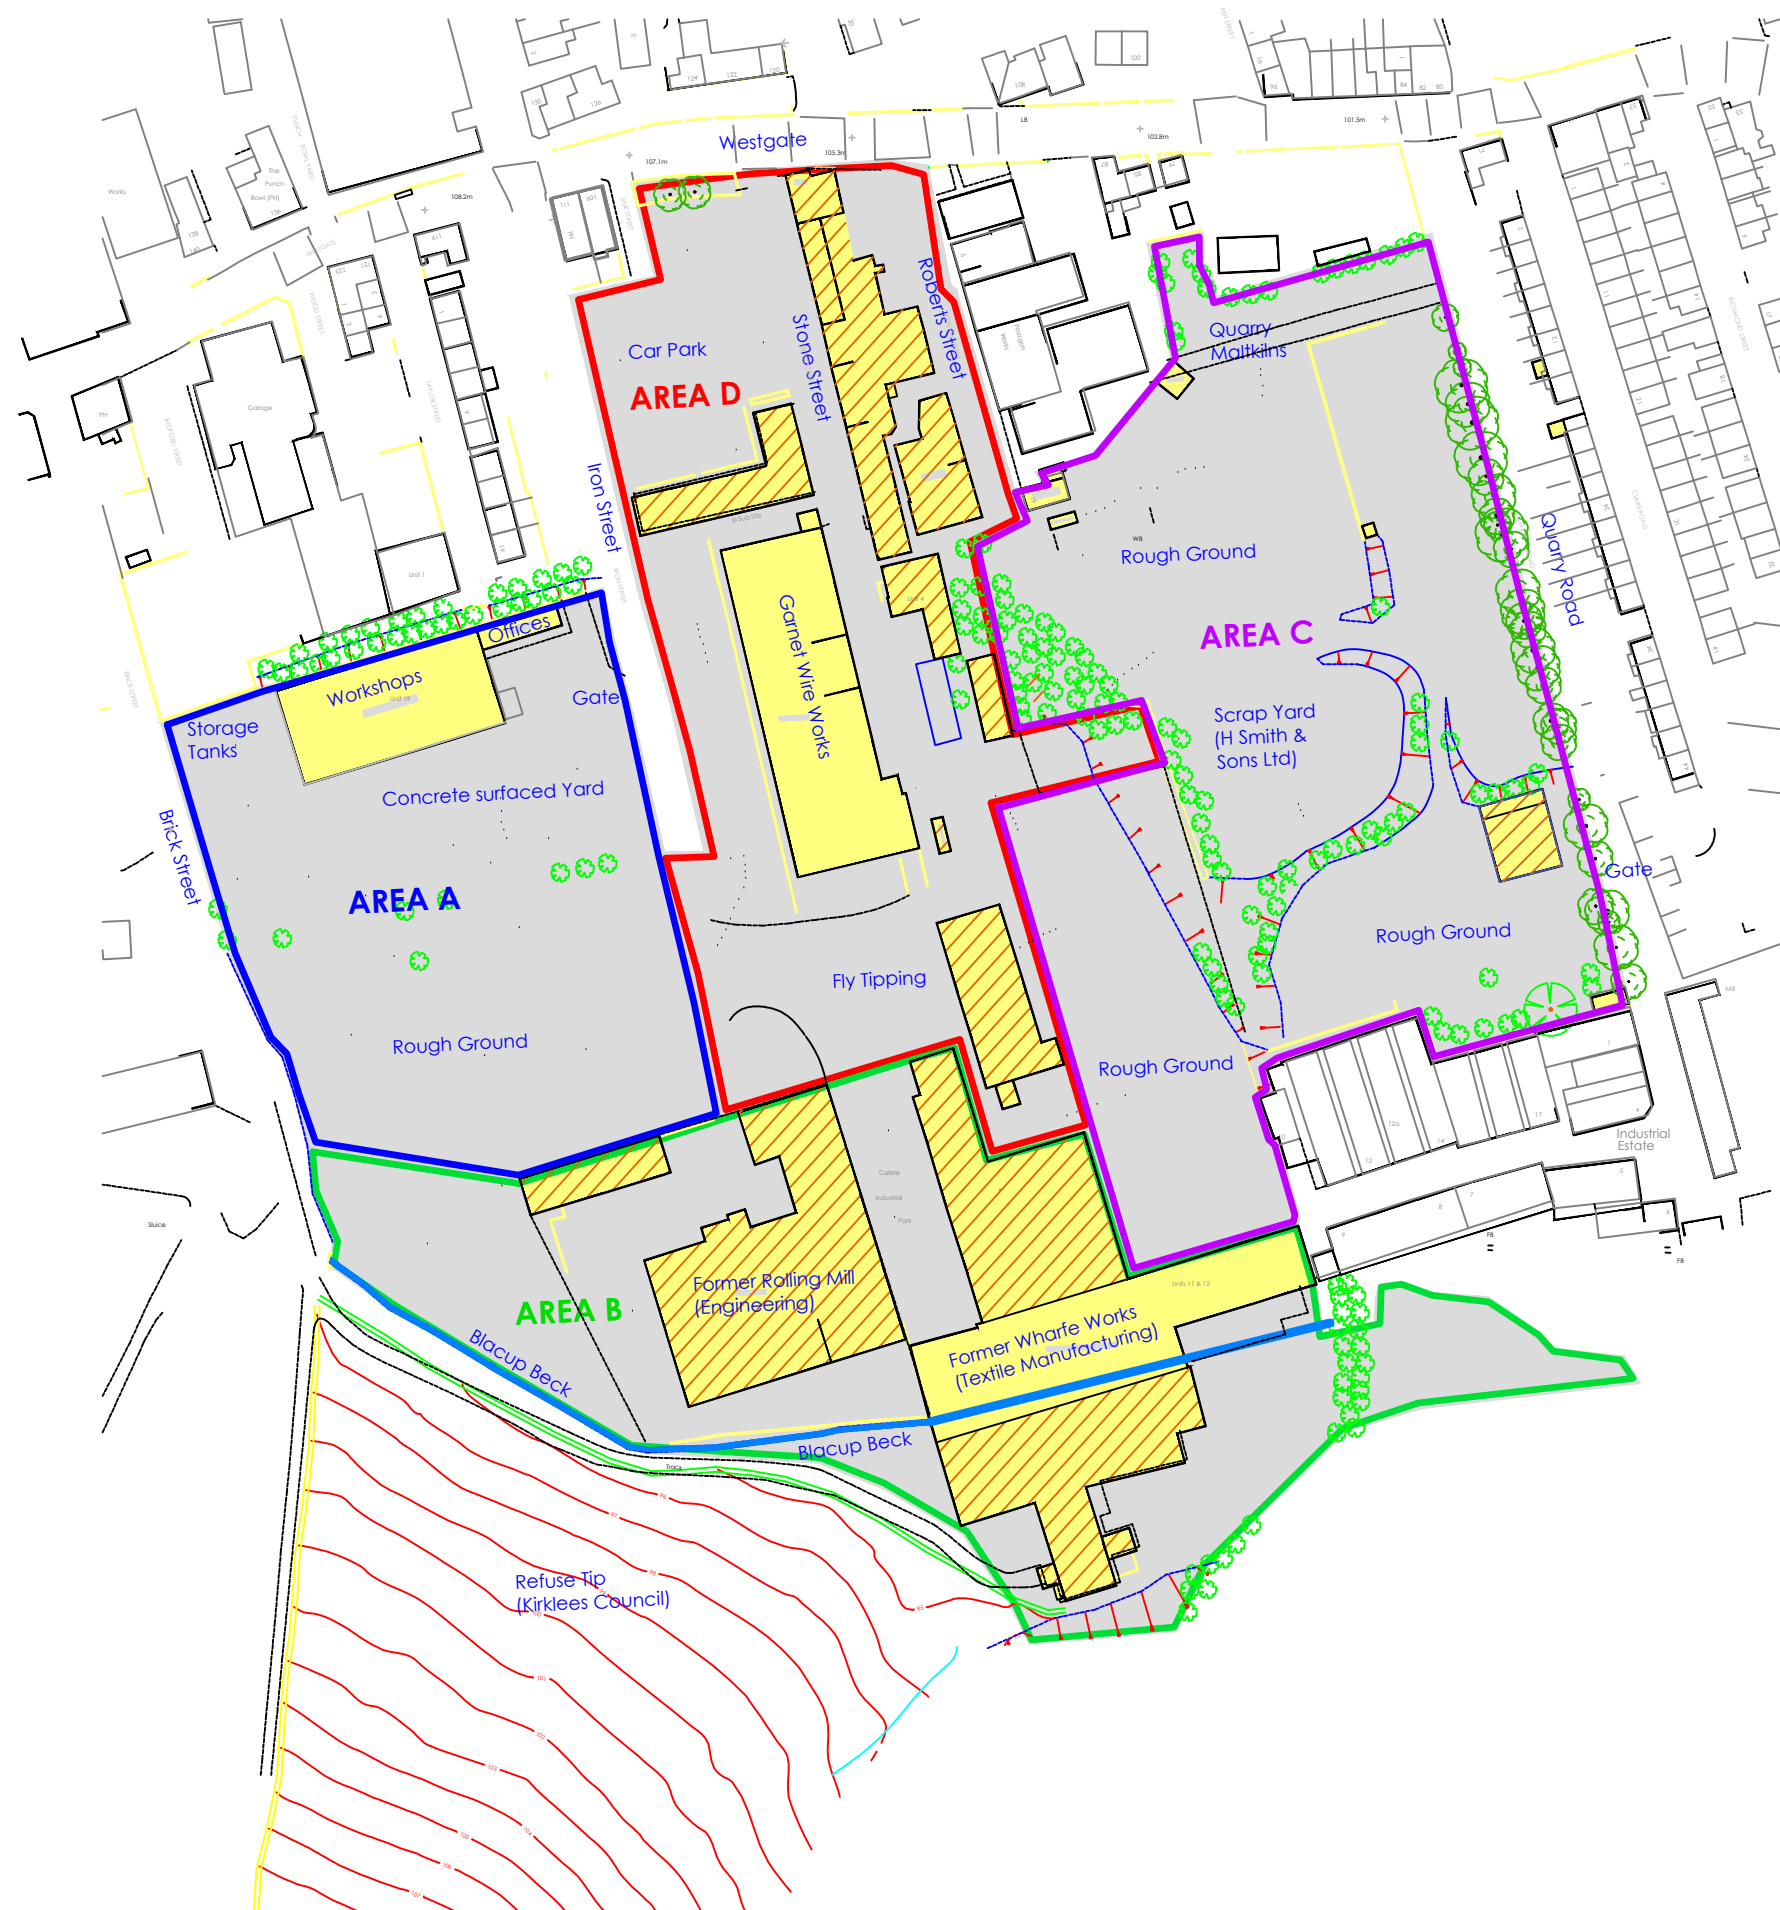
| SCALE | 1:1,250 | SHEET | A3 | DRAWING NO. | 3043/2 | REVISION | |

- NOTES
- EXISTING BUILDING
  - CONCRETE HARDSTAND (FORMER BUILDING FOOTPRINT)
  - EXTERNAL SURFACING (CONCRETE HARDSTAND/TARMAC/ROUGH GROUND)

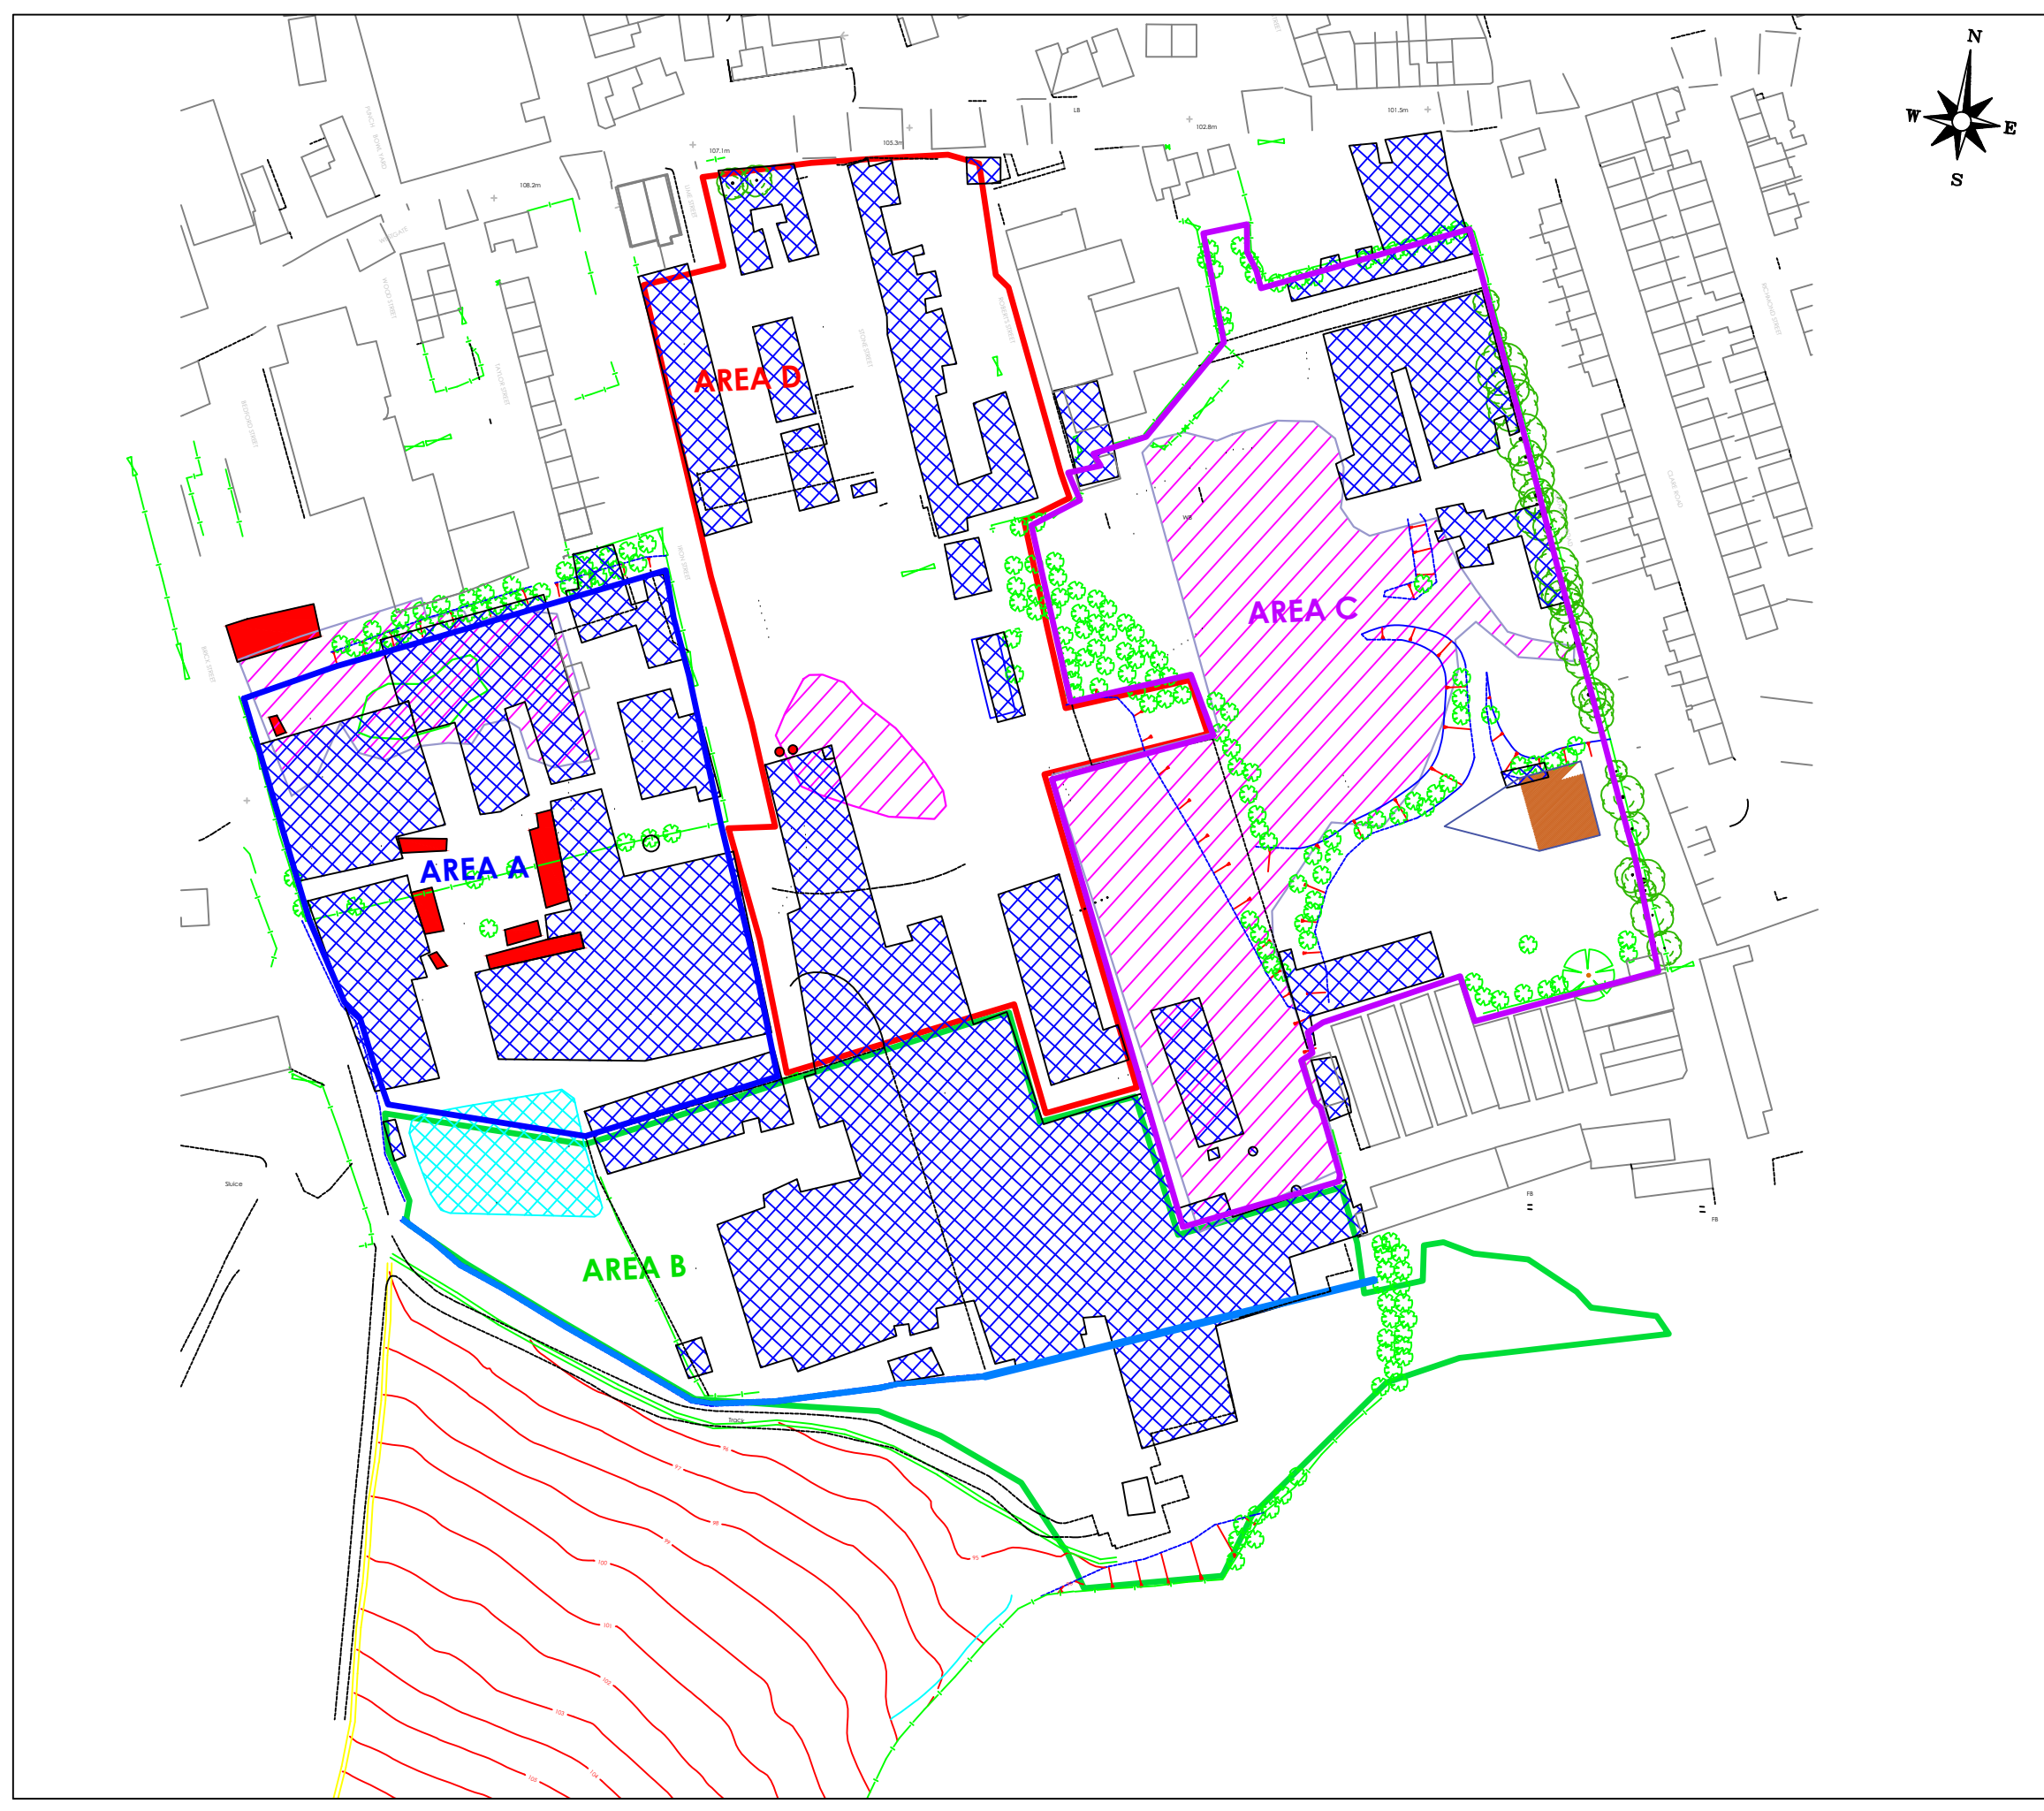
- FORMER QUARRY FOOTPRINT (1894 - 1938)
- FORMER BUILDING FOOTPRINT (1938)
- FORMER RESERVOIR FOOTPRINT (1938)
- APPROXIMATE LOCATION OF FORMER TANKS (1938)

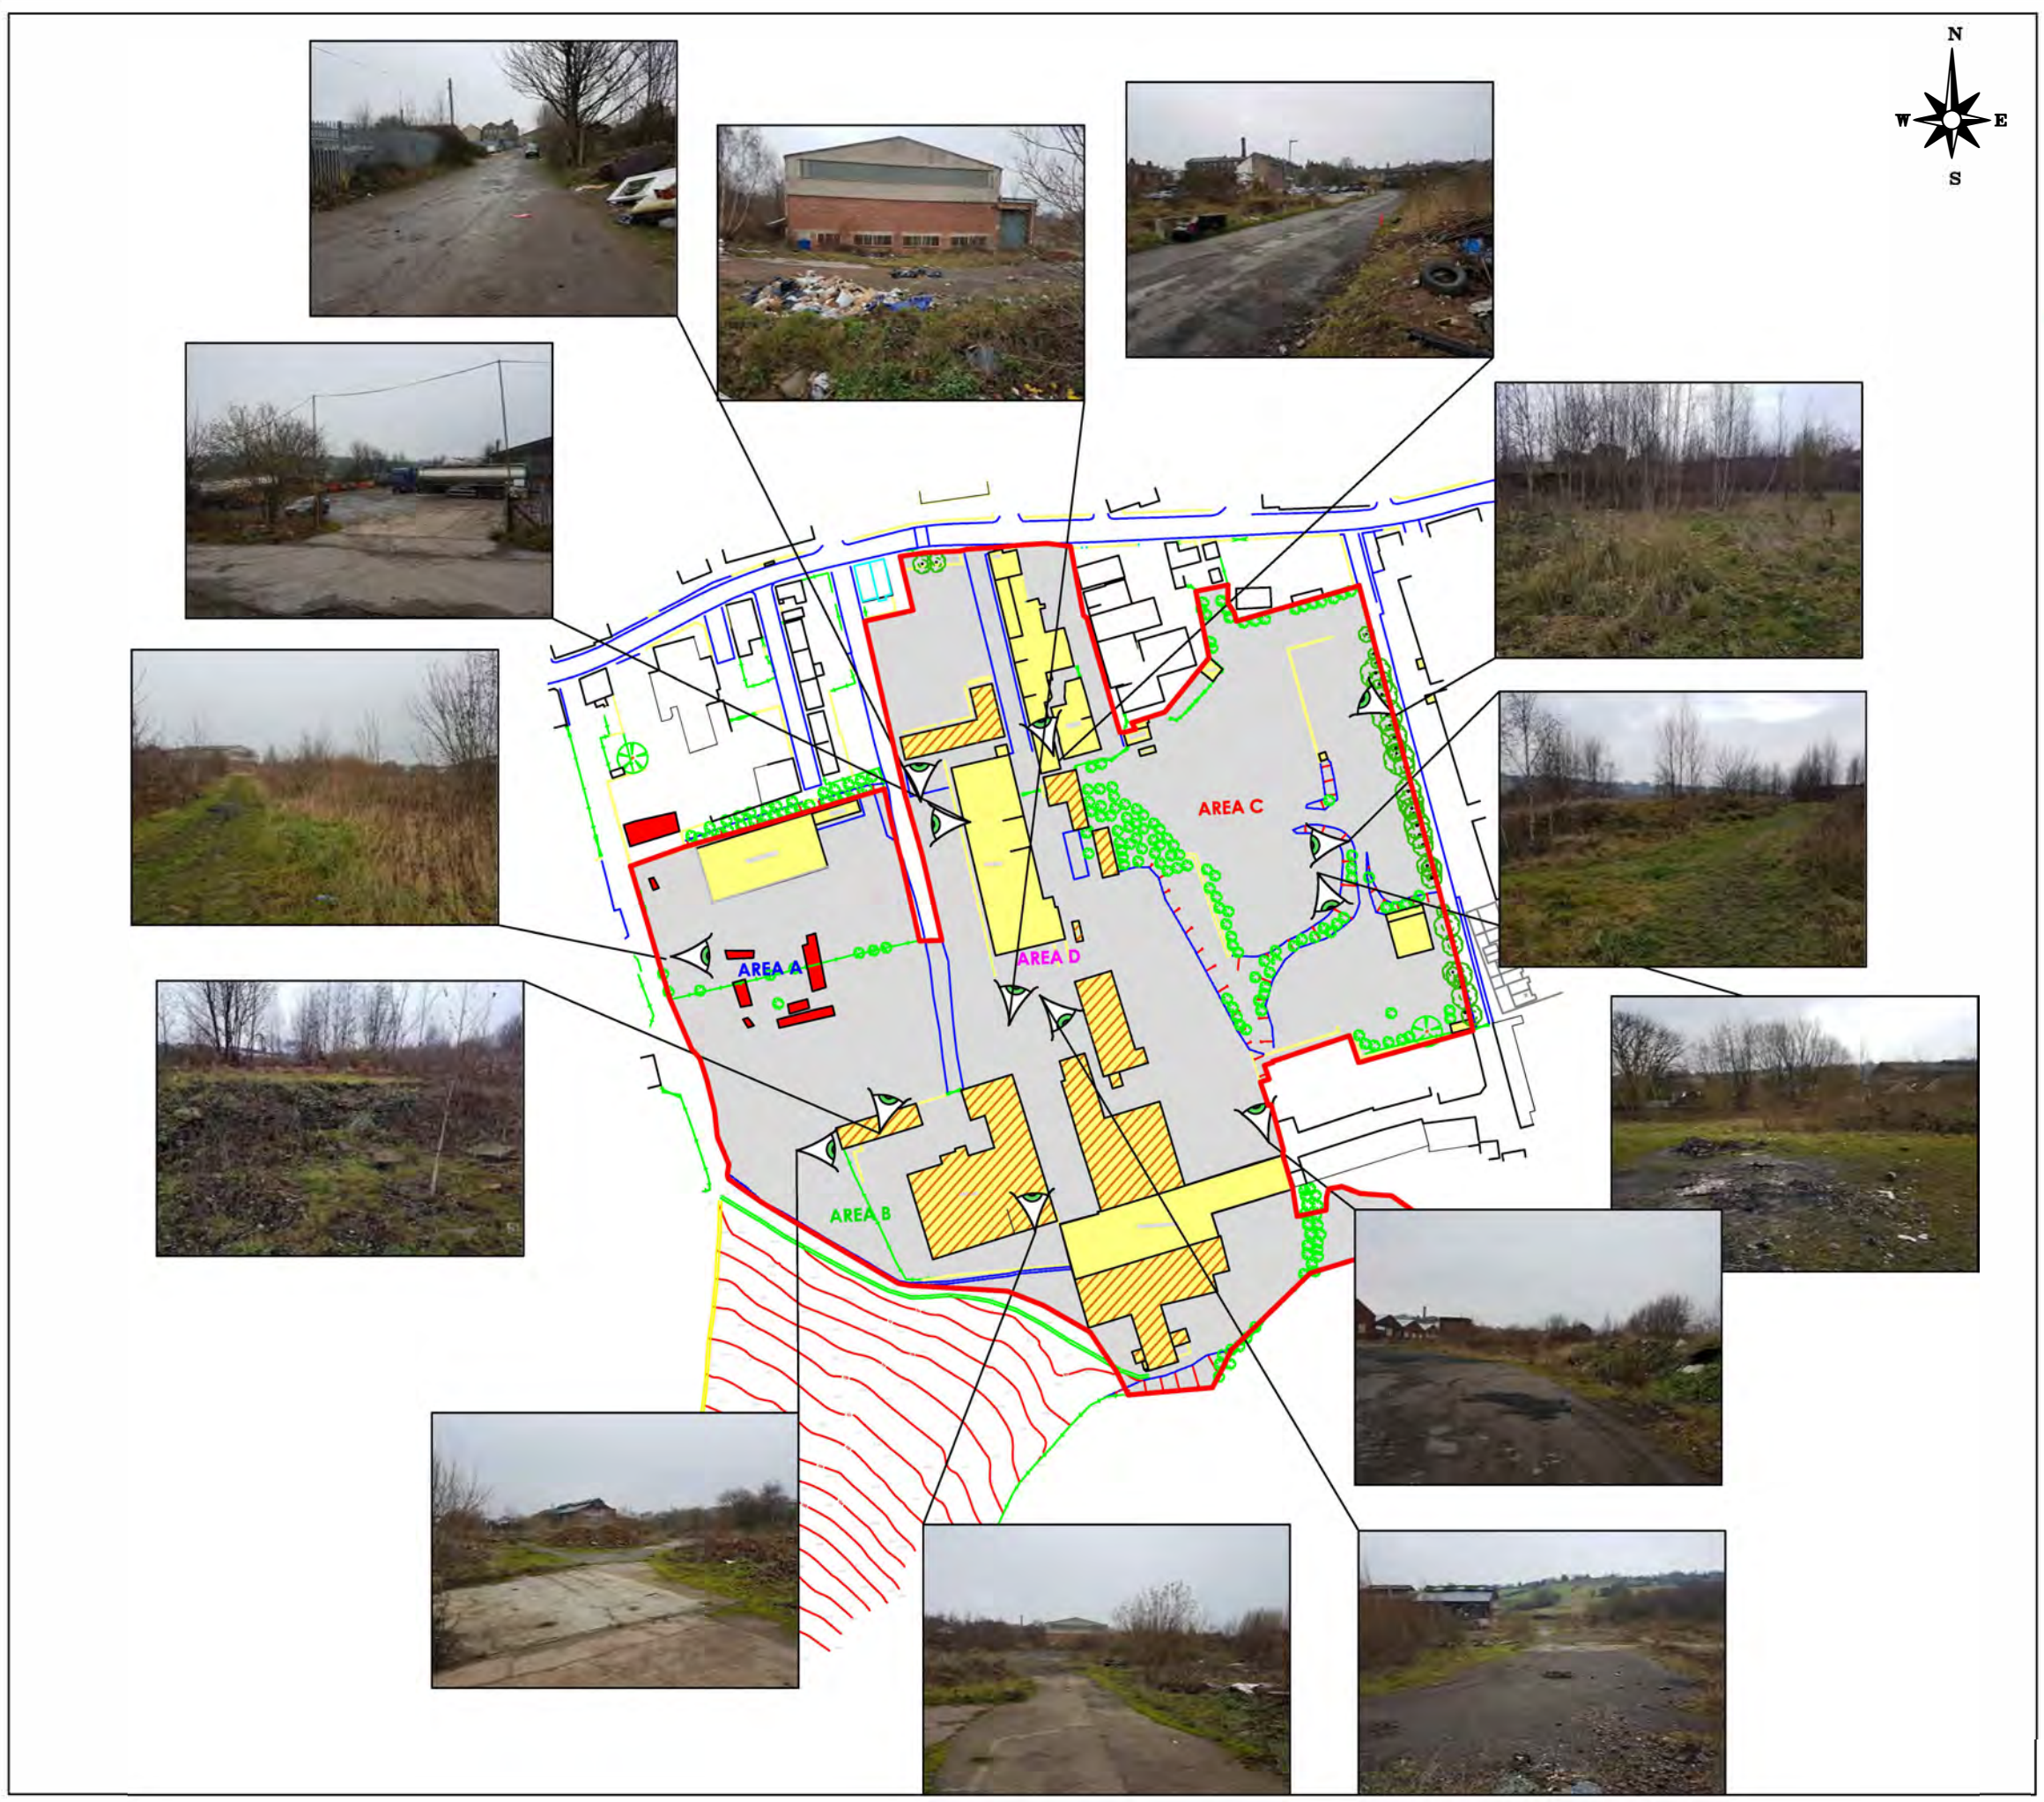
| SCALE | 1:1500 | SHEET | A3 | DRAWING NO. | 3043/3 | REVISION | |

- NOTES
- EXISTING BUILDING
  - CONCRETE HARDSTAND (FORMER BUILDING FOOTPRINT)
  - EXTERNAL SURFACING (CONCRETE HARDSTAND/TARMAC/ROUGH GROUND)
  - FUEL STORAGE TANKS
  - APPROXIMATE SITE BOUNDARY
  - LOCATION & ORIENTATION OF PHOTOGRAPH

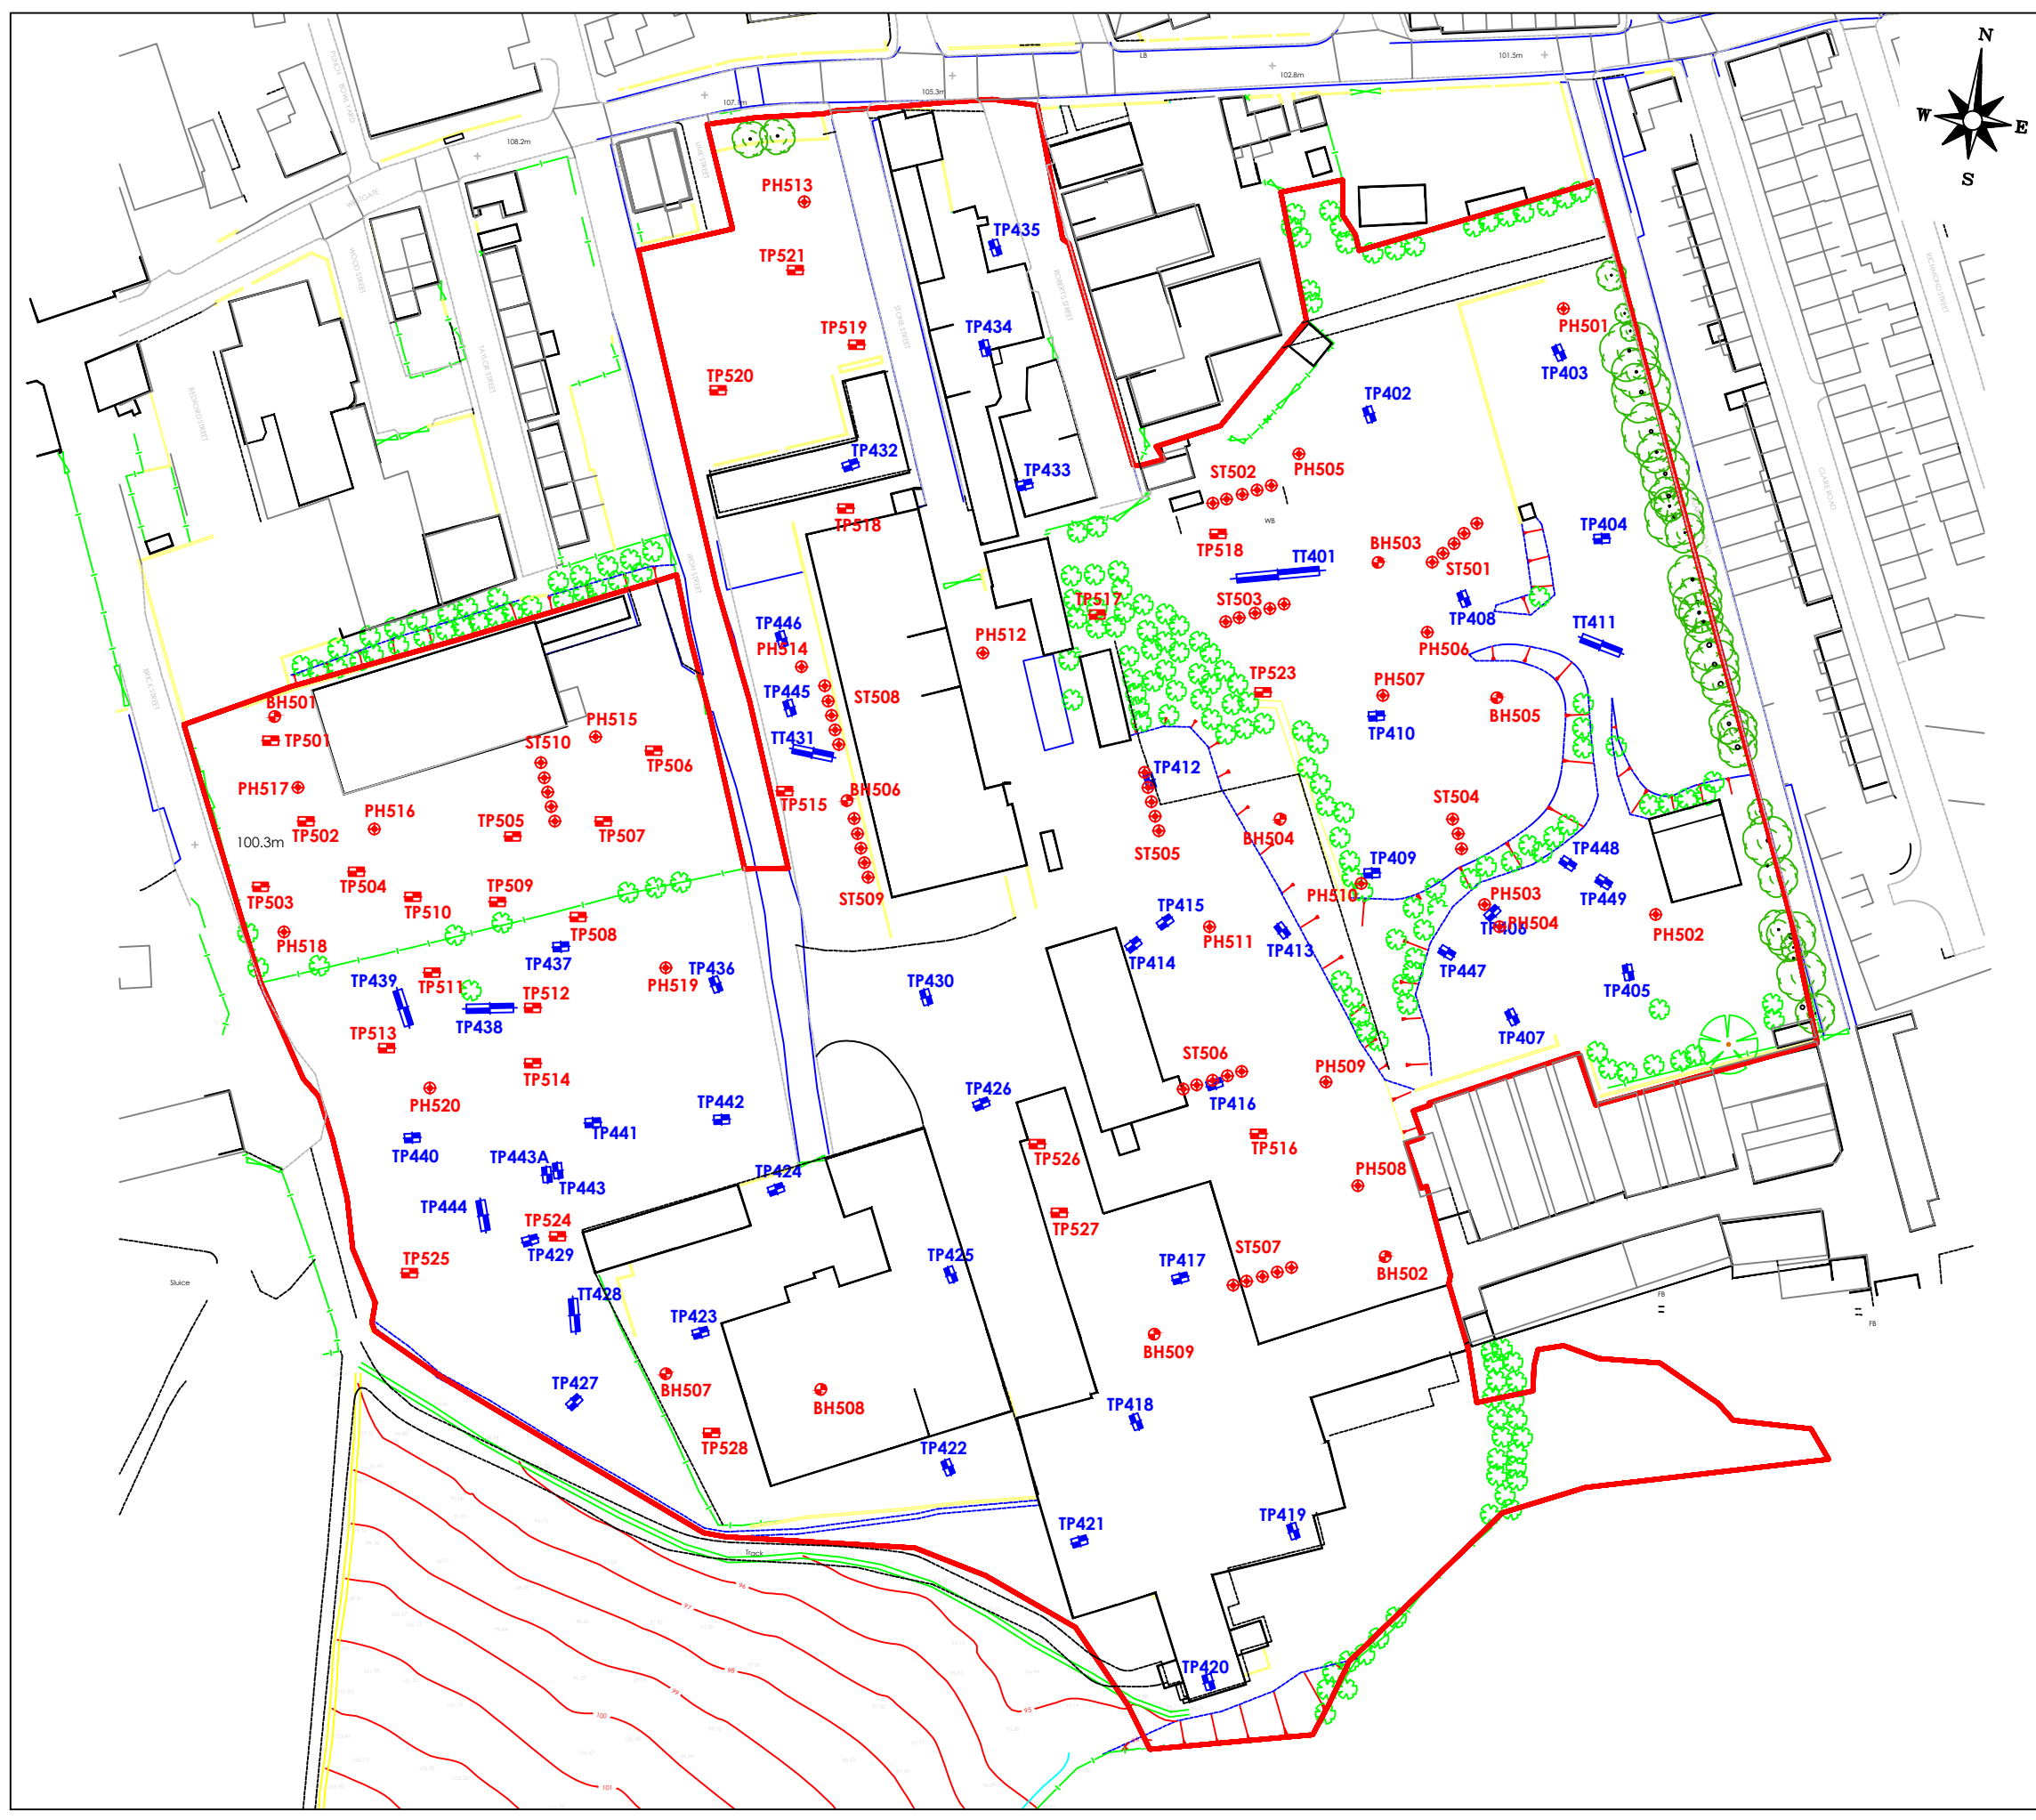
| SCALE | 1:1500 | SHEET | A3 | DRAWING NO. | 3043/7 | REVISION |

- TRIAL PIT LOCATION (LITHOS SEPTEMBER 2019)
- TRIAL PIT LOCATION (LITHOS SEPTEMBER 2020)
- CABLE PERCUSSION / ROTARY CORED BOREHOLE (LITHOS SEPTEMBER 2020)
- PROBEHOLE / STITCH PROBEHOLE LOCATION (LITHOS SEPTEMBER 2020)
- APPROXIMATE SITE BOUNDARY

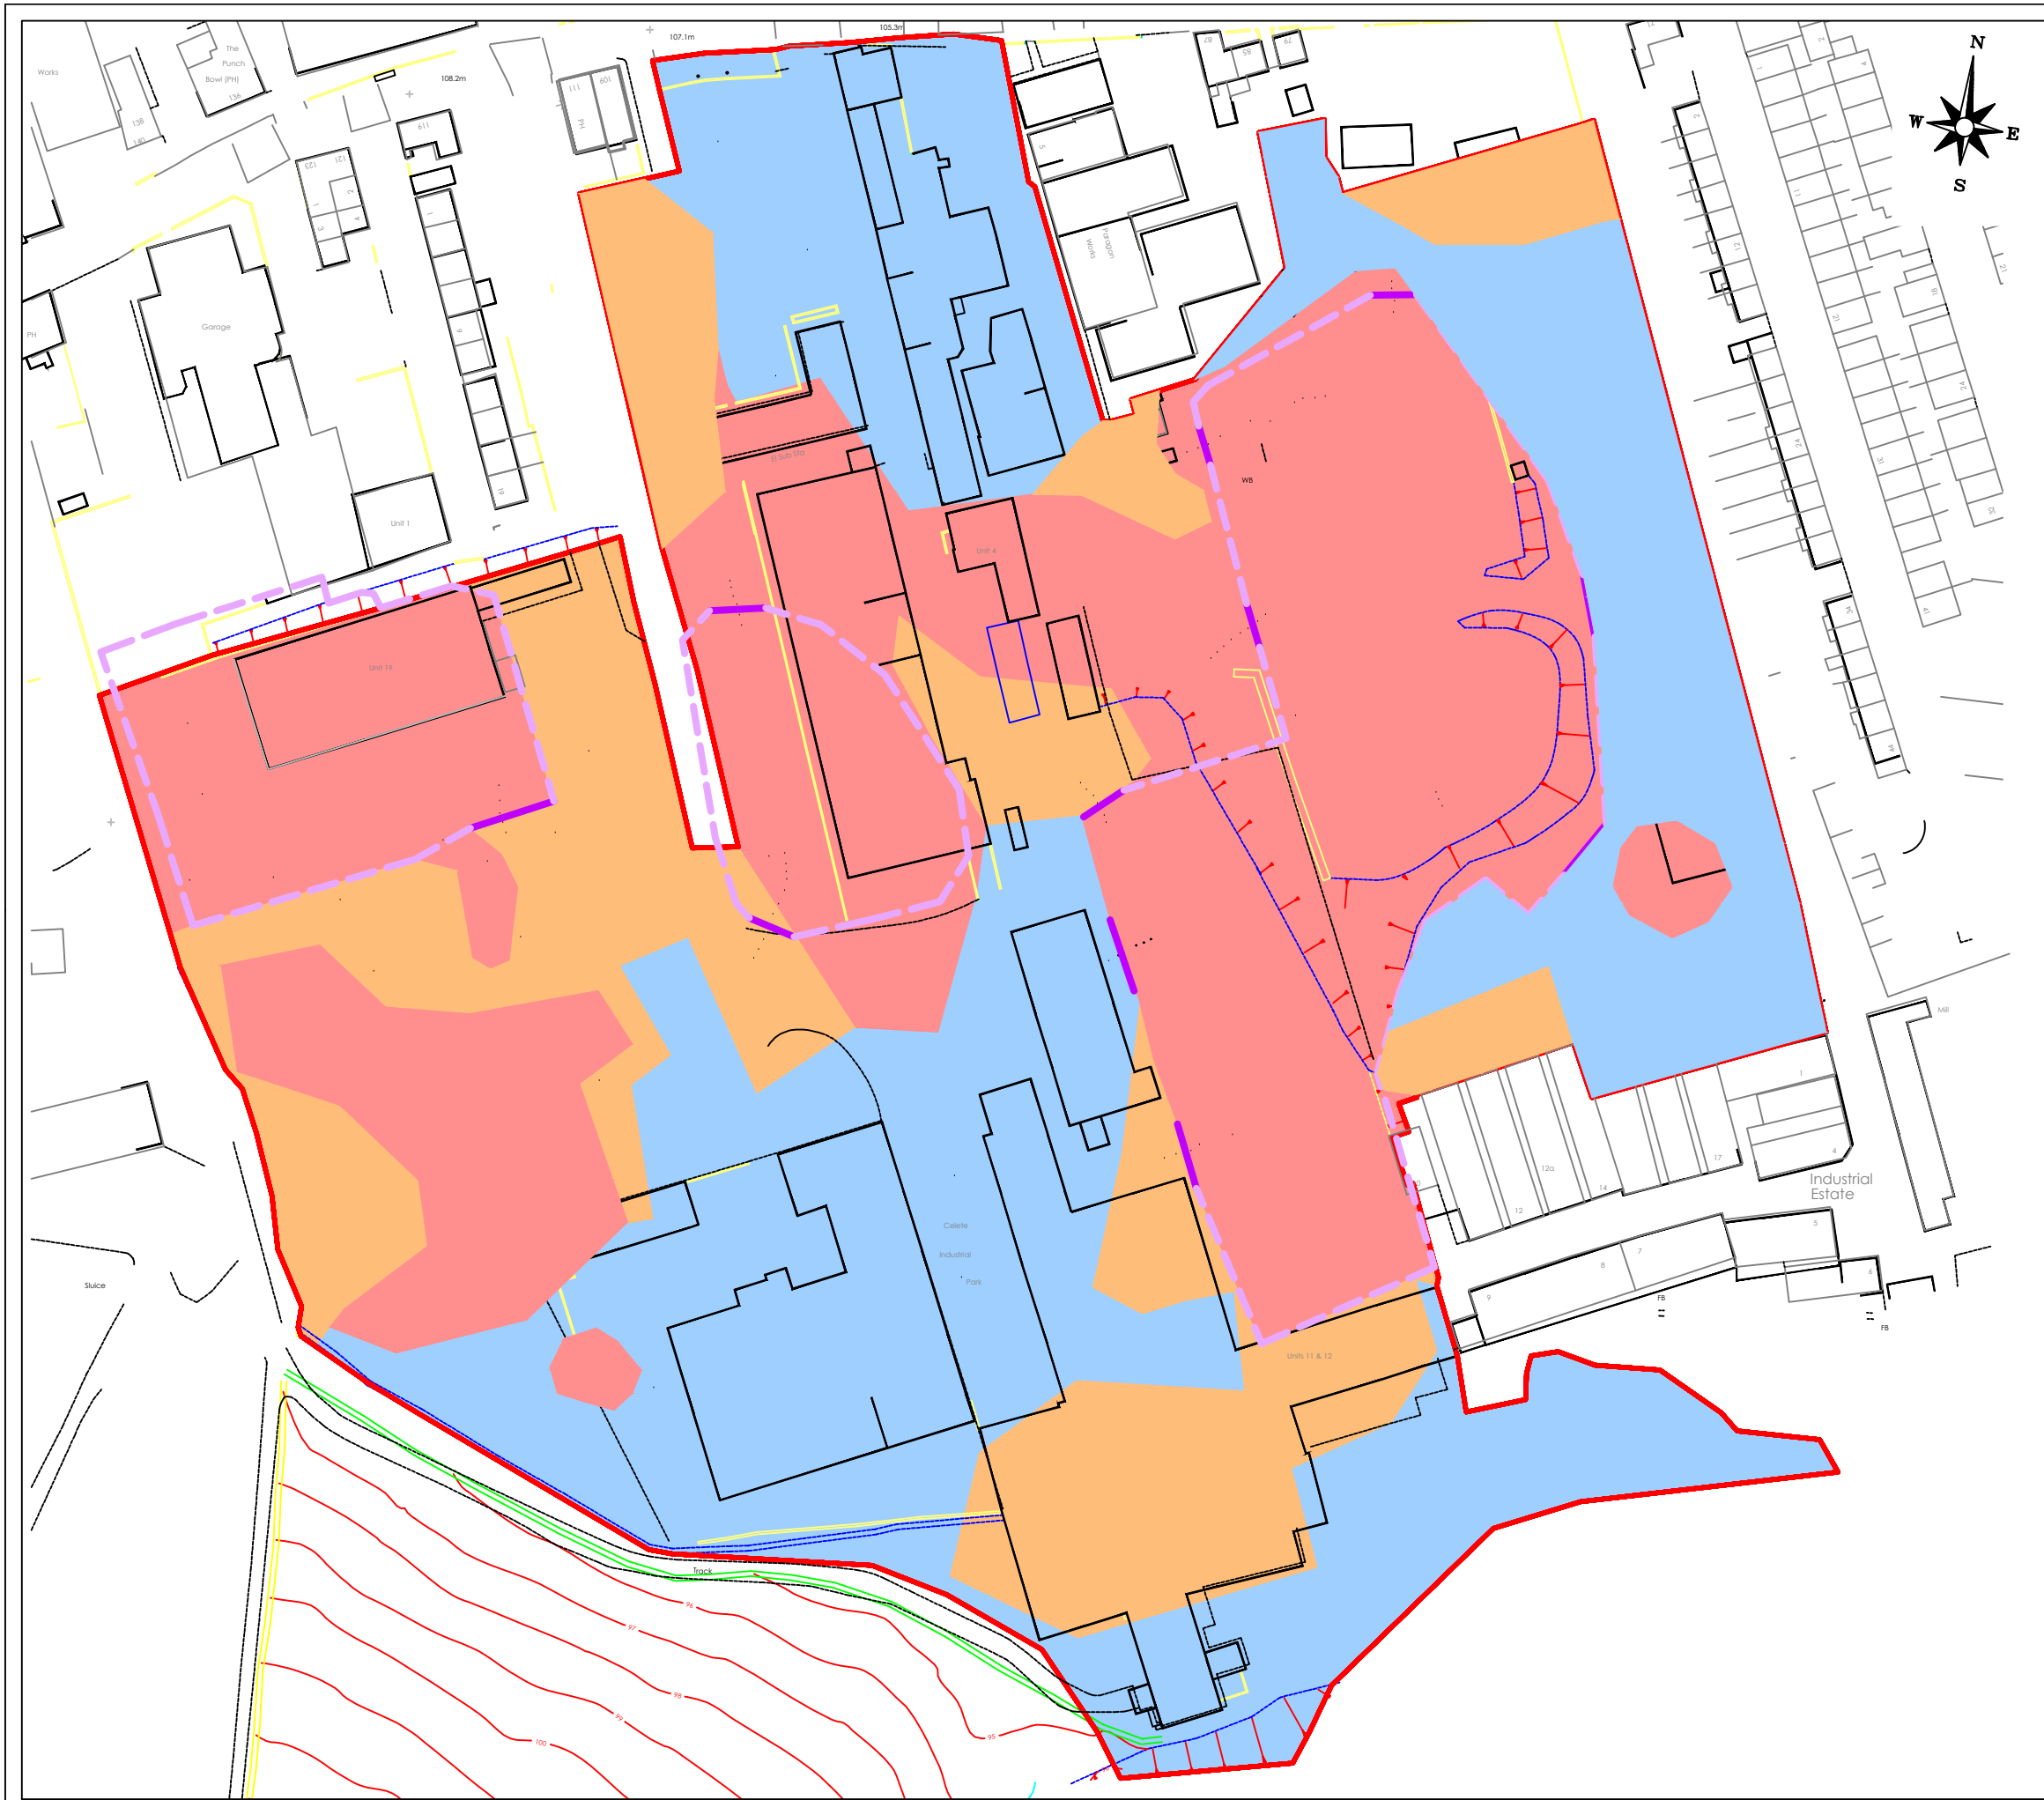
| SCALE | 1:1250 | SHEET | A3 | DRAWING NO. | 3043/8 | REVISION | A |

- MADE GROUND <1.5m DEPTH
- MADE GROUND >1.5m DEPTH
- MADE GROUND >2.5m DEPTH
- LINE OF HIGHWALLS (KNOWN)
- LINE OF HIGHWALLS (INTERPRETED)
- APPROXIMATE SITE BOUNDARY
