Demolition Asbestos Survey

In accordance with HSG264 - Asbestos: The Survey Guide

Floors 1 - 4, Bishops Court, Berry Brow, Huddersfield, HD4 7NH

Issue number:	1
Survey number:	7923.BC. Floors 1 - 4
Survey date:	Jan/Feb 2026
Client:	Metropolitan Demolition
Survey carried out by:	Phil Cox & Graham Brown
Survey compiled by:	Phil Cox & Graham Brown
Survey checked by:	Phil Cox & Graham Brown
Survey Issued	11/02/2026

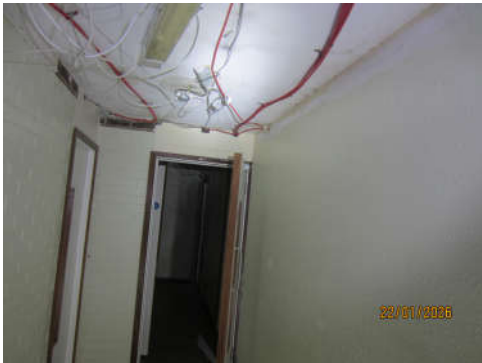
Level of ID:	Visually inspected	Ref:	As S01
	Building / Floor: BC / First Area: Communal areas Location: Ceiling Description: Artex on concrete Asbestos Type: Chrysotile Amount: 46m2

Remove artex in accordance with the Control of Asbestos Regulations 2012 and dispose of as hazardous waste.

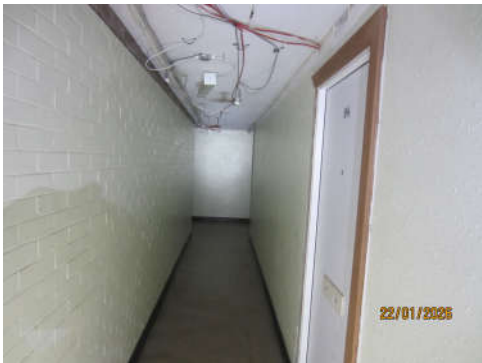
Level of ID:	Visually inspected	Ref:	As S02
	Building / Floor: BC / First Area: Communal areas Location: Wall Description: Artex on concrete Asbestos Type: Chrysotile Amount: 101m2

Remove artex in accordance with the Control of Asbestos Regulations 2012 and dispose of as hazardous waste.

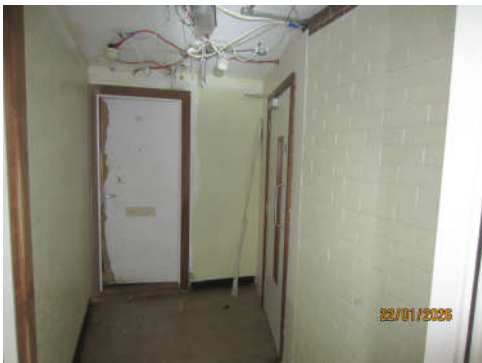
Level of ID:	Visually inspected	Ref:	As S04
	Building / Floor: BC / First Area: Communal areas Location: Floor Description: Bitumen on floor slab below floor covering Asbestos Type: Chrysotile Amount: 45m2

Remove bitumen in accordance with the Control of Asbestos Regulations 2012 and dispose of as hazardous waste.

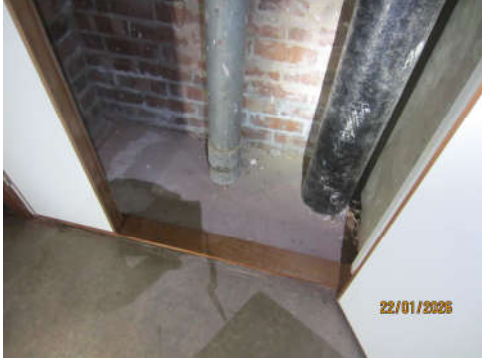
Level of ID:	Visually inspected	Ref:	P1
	<p>Building / Floor: BC / First Area: Communal, R10 Riser Location: Floor Description: Concrete, pitch fibre S&V pipe Asbestos Type: Chrysotile Amount: 2.5 lm</p>

Remove pitch fibre pipe in accordance with the Control of Asbestos Regulations 2012 and dispose of as hazardous waste.

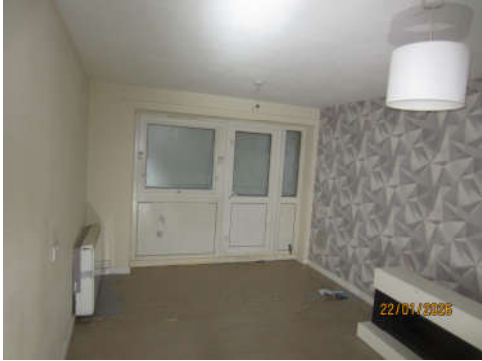
Level of ID:	Visually inspected	Ref:	As S01
	<p>Building / Floor: BC / First Area: Flats 91 to 96 Location: Ceiling Description: Artex on concrete Asbestos Type: Chrysotile Amount: 202m2</p>

Remove artex in accordance with the Control of Asbestos Regulations 2012 and dispose of as hazardous waste.

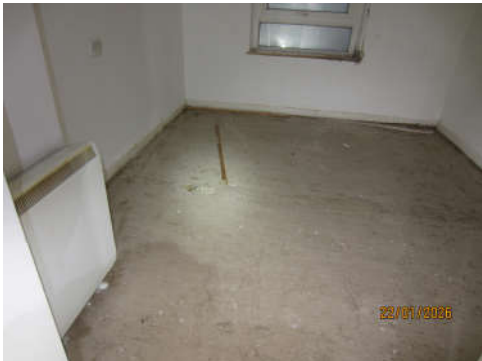
Level of ID:	Visually inspected	Ref:	As S04
	<p>Building / Floor: BC / First Area: Flats 91 to 96 Location: Floor Description: Bitumen on floor slab below floor covering Asbestos Type: Chrysotile Amount: 202m2</p>

Remove bitumen in accordance with the Control of Asbestos Regulations 2012 and dispose of as hazardous waste.

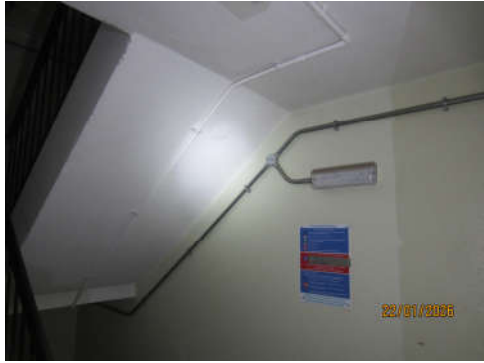
Level of ID:	Sampled	Ref:	S01
	<p>Building / Floor: BC / Second Area: Communal, R01 Stairs Location: Ceiling Description: Artex on concrete Asbestos Type: Chrysotile Amount: 10m2</p>			
Recommendations:				
Remove artex in accordance with the Control of Asbestos Regulations 2012 and dispose of as hazardous waste.

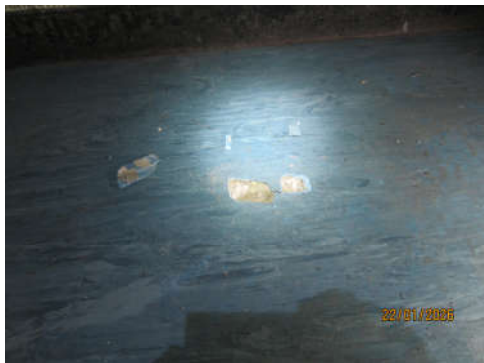
Level of ID:	Sampled	Ref:	S03
	<p>Building / Floor: BC / Second Area: Communal, R01 Stairs Location: Floor Description: Vinyl on concrete, metal balustrade Asbestos Type: No asbestos detected Amount:</p>			
Recommendations:				
No action required

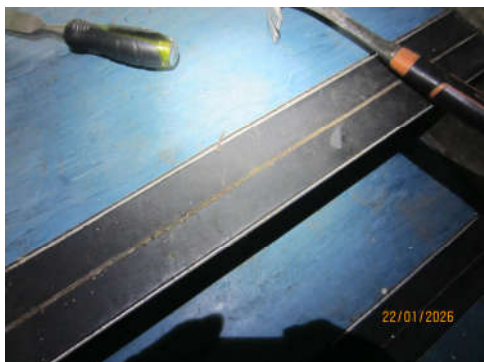
Level of ID:	Sampled	Ref:	S04
	<p>Building / Floor: BC / Second Area: Communal, R01 Stairs Location: Floor Description: Stair nosing Asbestos Type: No asbestos detected Amount:</p>			
Recommendations:				
No action required

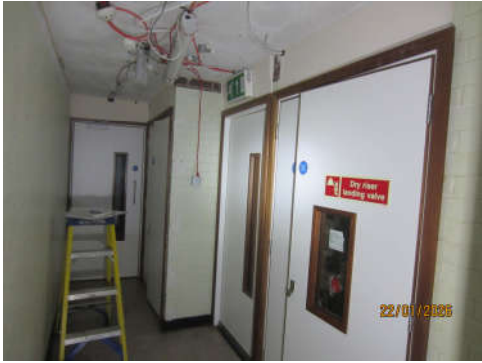
Level of ID:	Visually inspected	Ref:	As S01
	<p>Building / Floor: BC / Second</p> <p>Area: Communal, R02 Landing</p> <p>Location: Ceiling</p> <p>Description: Artex on concrete</p> <p>Asbestos Type: Chrysotile</p> <p>Amount: 4m2</p>

Remove artex in accordance with the Control of Asbestos Regulations 2012 and dispose of as hazardous waste.

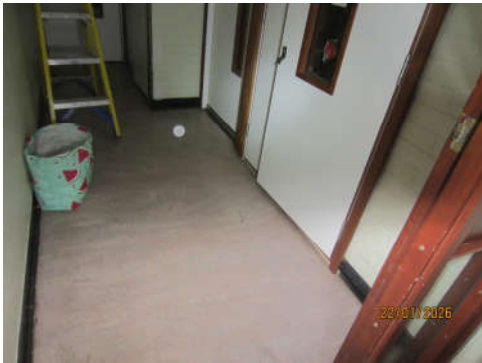
Level of ID:	Visually inspected	Ref:	As S06
	<p>Building / Floor: BC / Second</p> <p>Area: Communal, R02 Landing</p> <p>Location: Floor</p> <p>Description: Bitumen on floor slab below floor covering</p> <p>Asbestos Type: Chrysotile</p> <p>Amount: 4m2</p>

Remove bitumen in accordance with the Control of Asbestos Regulations 2012 and dispose of as hazardous waste.

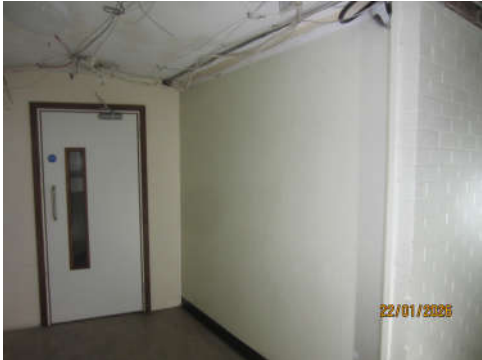
Level of ID:	Visually inspected	Ref:	As S02
	<p>Building / Floor: BC / Second</p> <p>Area: Communal, R04 Corridor</p> <p>Location: Wall</p> <p>Description: Artex on concrete, masonry, stud wall</p> <p>Asbestos Type: Chrysotile</p> <p>Amount: 12m2</p>

Remove artex in accordance with the Control of Asbestos Regulations 2012 and dispose of as hazardous waste.

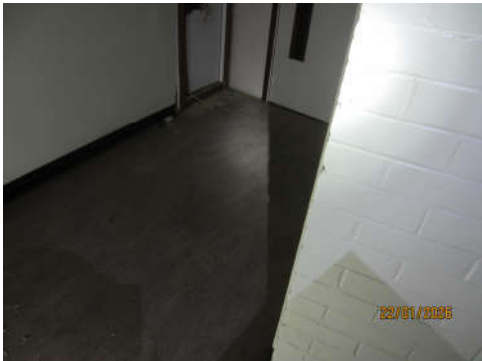
Level of ID:	Visually inspected	Ref:	As S06
	<p>Building / Floor: BC / Second</p> <p>Area: Communal, R04 Corridor</p> <p>Location: Floor</p> <p>Description: Bitumen on floor slab below floor covering</p> <p>Asbestos Type: Chrysotile</p> <p>Amount: 6m2</p>

Remove bitumen in accordance with the Control of Asbestos Regulations 2012 and dispose of as hazardous waste.

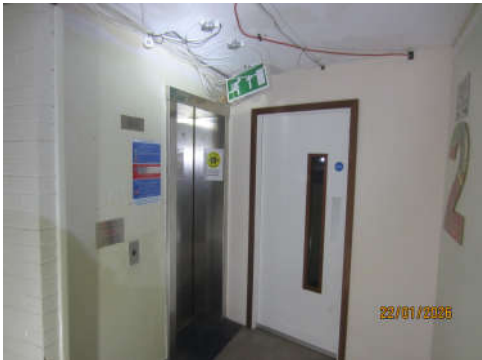
Level of ID:	Visually inspected	Ref:	As S02
	<p>Building / Floor: BC / Second</p> <p>Area: Communal, R05 Corridor</p> <p>Location: Wall</p> <p>Description: Artex on concrete, masonry, stud wall</p> <p>Asbestos Type: Chrysotile</p> <p>Amount: 15m2</p>

Remove artex in accordance with the Control of Asbestos Regulations 2012 and dispose of as hazardous waste.

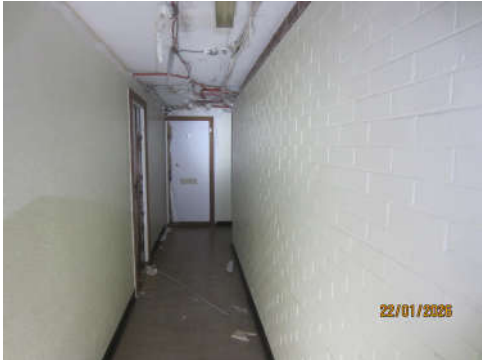
Level of ID:	Visually inspected	Ref:	As S02
	<p>Building / Floor: BC / Second</p> <p>Area: Communal, R06 Corridor</p> <p>Location: Wall</p> <p>Description: Artex on concrete, masonry</p> <p>Asbestos Type: Chrysotile</p> <p>Amount: 20m2</p>

Remove artex in accordance with the Control of Asbestos Regulations 2012 and dispose of as hazardous waste.

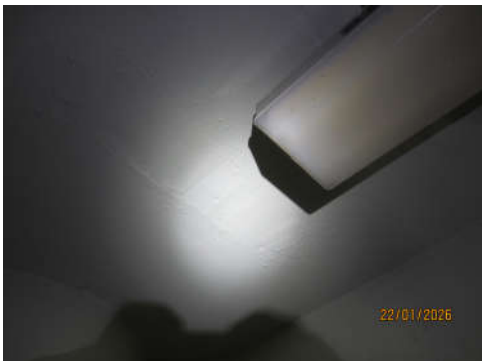
Level of ID:	Visually inspected	Ref:	As S01
	<p>Building / Floor: BC / Second</p> <p>Area: Communal, R08 Refuse chute room</p> <p>Location: Ceiling</p> <p>Description: Artex on concrete</p> <p>Asbestos Type: Chrysotile</p> <p>Amount: 2m2</p>

Remove artex in accordance with the Control of Asbestos Regulations 2012 and dispose of as hazardous waste.

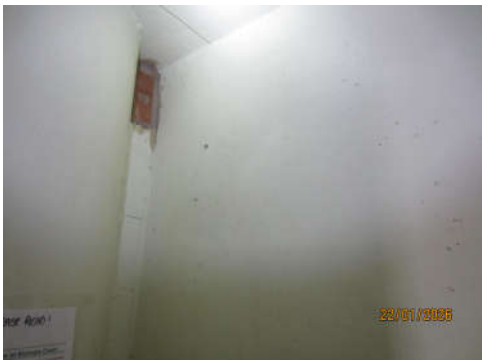
Level of ID:	Visually inspected	Ref:	As S02
	<p>Building / Floor: BC / Second</p> <p>Area: Communal, R08 Refuse chute room</p> <p>Location: Wall</p> <p>Description: Artex on concrete, masonry, stud wall</p> <p>Asbestos Type: Chrysotile</p> <p>Amount: 8m2</p>

Remove artex in accordance with the Control of Asbestos Regulations 2012 and dispose of as hazardous waste.

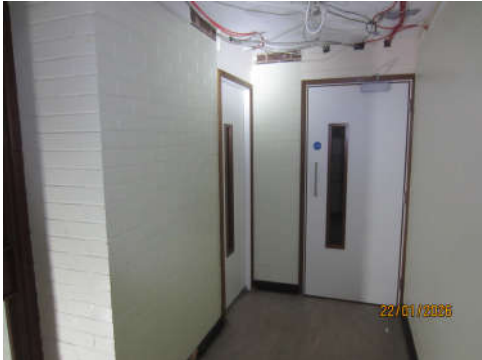
Level of ID:	Sampled	Ref:	S05
	<p>Building / Floor: BC / Second</p> <p>Area: Communal, R09 Corridor</p> <p>Location: Wall</p> <p>Description: Artex on concrete, masonry, stud wall</p> <p>Asbestos Type: Chrysotile</p> <p>Amount: 8m2</p>

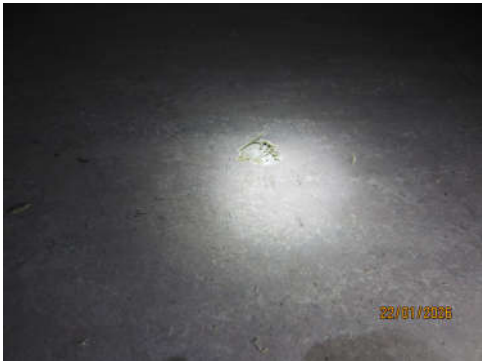
Level of ID:	Sampled	Ref:	S06
	<p>Building / Floor: BC / Second</p> <p>Area: Communal, R09 Corridor</p> <p>Location: Floor</p> <p>Description: Bitumen on floor slab below floor covering</p> <p>Asbestos Type: Chrysotile</p> <p>Amount: 5m2</p>

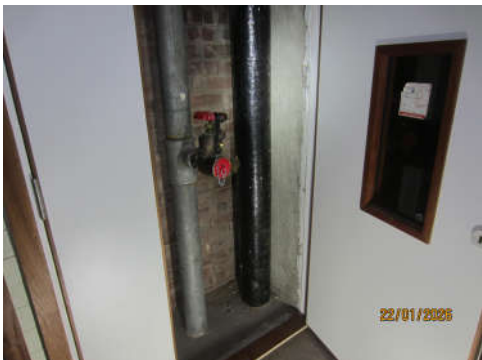
Level of ID:	Visually inspected	Ref:	P1
	<p>Building / Floor: BC / Second</p> <p>Area: Communal, R10 Riser</p> <p>Location: Pipework</p> <p>Description: Pitch fibre S&V pipe</p> <p>Asbestos Type: Chrysotile</p> <p>Amount: 2.5 Lm</p>

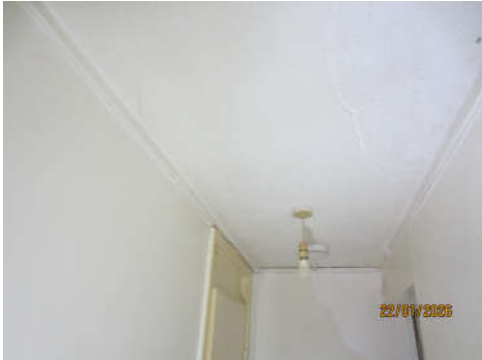
Level of ID:	Sampled	Ref:	S07
	Building / Floor: BC / Second Area: Flat 86 R01 Hallway Location: Ceiling Description: Artex on concrete Asbestos Type: Chrysotile Amount: 4m2

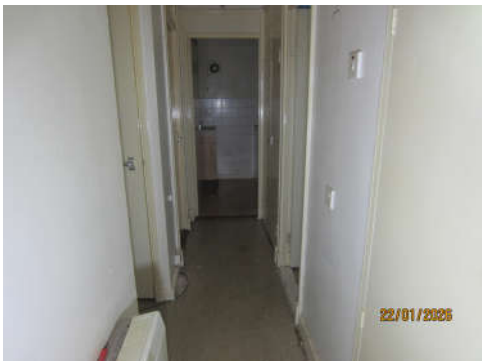
Level of ID:	Visually inspected	Ref:	As S06
	Building / Floor: BC / Second Area: Flat 86 R01 Hallway Location: Floor Description: Bitumen on floor slab below floor covering Asbestos Type: Chrysotile Amount: 4m2

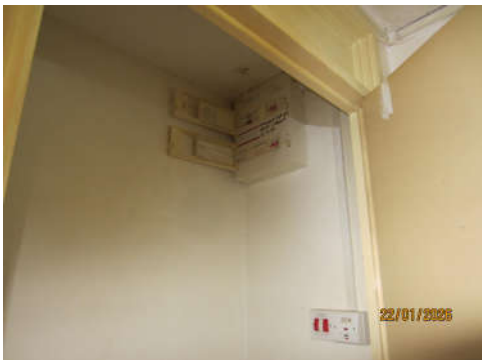
Level of ID:	Visually inspected	Ref:	As S07
	Building / Floor: BC / Second Area: Flat 86 R02 Store Location: Ceiling Description: Artex on concrete Asbestos Type: Chrysotile Amount: 3m2

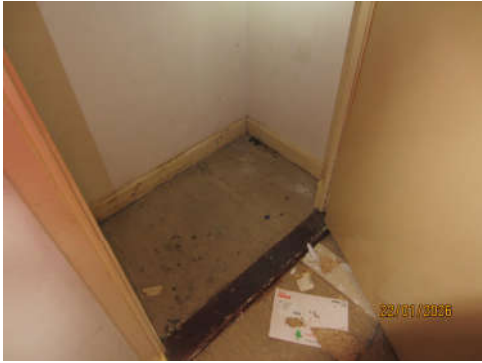
Level of ID:	Visually inspected	Ref:	As S06
	Building / Floor: BC / Second Area: Flat 86 R02 Store Location: Floor Description: Bitumen on floor slab below floor covering Asbestos Type: Chrysotile Amount: 3m2

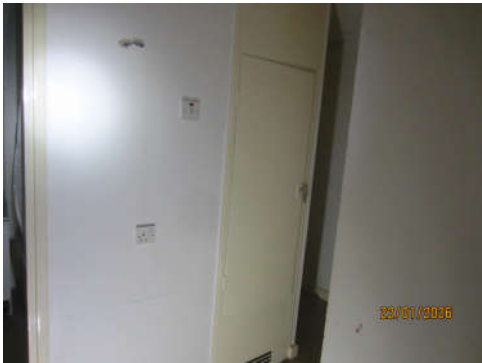
Level of ID:	Visually inspected	Ref:	
	Building / Floor: BC / Second Area: Flat 86 R03 Drying cupboard Location: Wall Description: Metal cabinet Asbestos Type: No suspect material Amount:

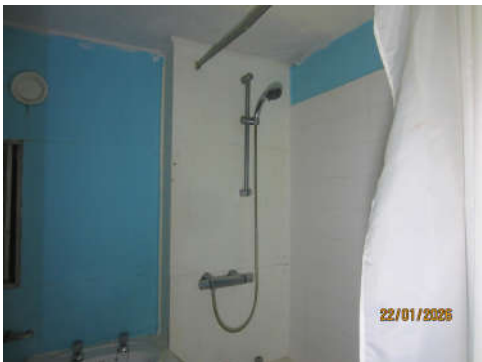
Level of ID:	Visually inspected	Ref:	As S07
	Building / Floor: BC / Second Area: Flat 86 R04 Bathroom Location: Ceiling Description: Artex on concrete Asbestos Type: Chrysotile Amount: 3m2

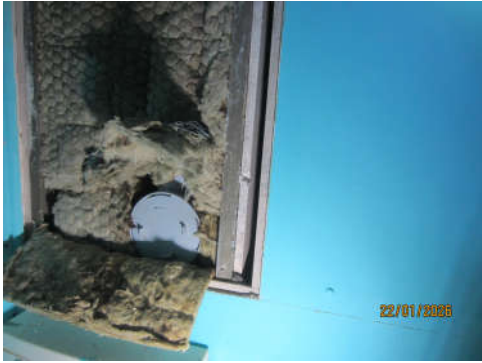
Level of ID:	Visually inspected	Ref:	
	Building / Floor: BC / Second Area: Flat 86 R04 Bathroom Location: Wall Description: Concrete, plasterboard lined, stud wall, supalux IPS & divider Asbestos Type: No suspect material Amount:			
Recommendations:				
No action required

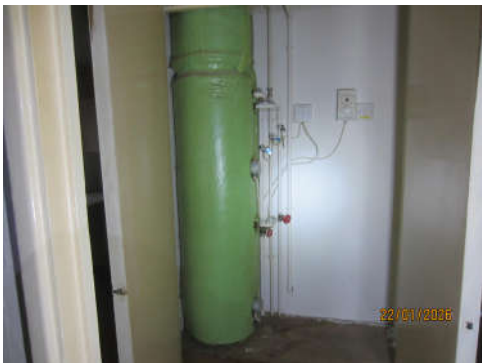
Level of ID:	Visually inspected	Ref:	
	Building / Floor: BC / Second Area: Flat 86 R05 Boiler cupboard Location: Wall Description: Stud wall, modern tank & insulation Asbestos Type: No suspect material Amount:			
Recommendations:				
No action required

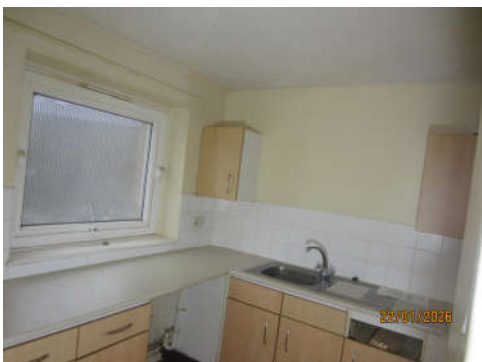
Level of ID:	Visually inspected	Ref:	As S07
	Building / Floor: BC / Second Area: Flat 86 R06 Kitchen Location: Ceiling Description: Artex on concrete Asbestos Type: Chrysotile Amount: 7.5m2			
Recommendations:				
Remove artex in accordance with the Control of Asbestos Regulations 2012 and dispose of as hazardous waste.

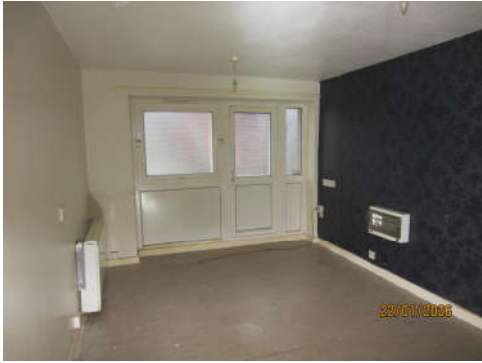
Level of ID:	Visually inspected	Ref:	As S07
	Building / Floor: BC / Second Area: Flat 86 R07 Lounge Location: Ceiling Description: Artex on concrete Asbestos Type: Chrysotile Amount: 14m2

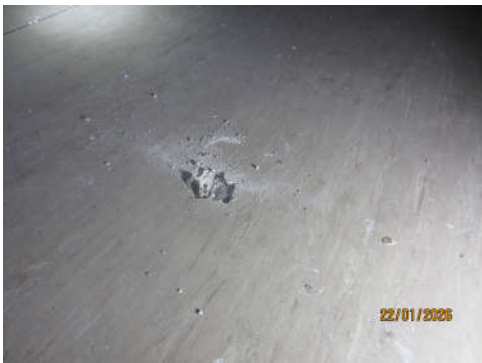
Level of ID:	Sampled	Ref:	S08
	Building / Floor: BC / Second Area: Flat 86 R07 Lounge Location: Floor Description: Bitumen on floor slab below floor covering Asbestos Type: Chrysotile Amount: 14m2

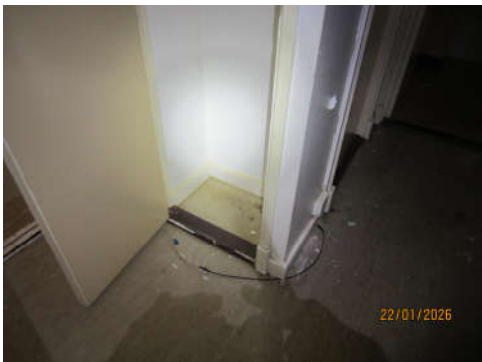
Level of ID:	Visually inspected	Ref:	As S08
	Building / Floor: BC / Second Area: Flat 86 R08 Cupboard Location: Floor Description: Bitumen on floor slab below floor covering Asbestos Type: Chrysotile Amount: .5m2

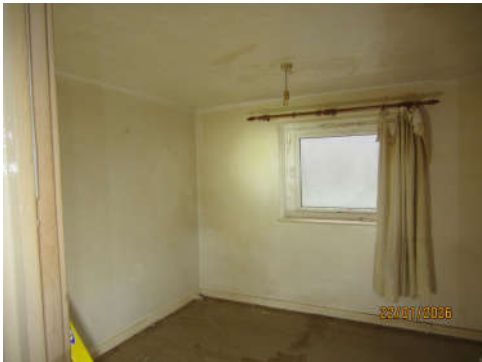
Level of ID:	Sampled	Ref:	S09
	Building / Floor: BC / Second Area: Flat 86 R09 Bedroom Location: Ceiling Description: Artex on concrete Asbestos Type: Chrysotile Amount: 10m2

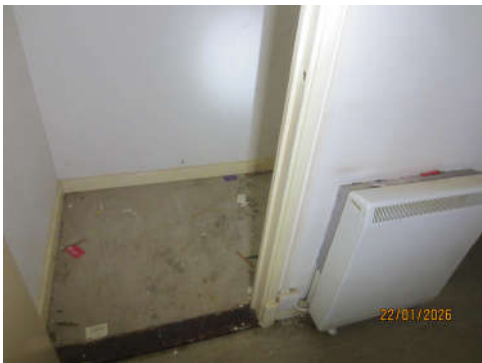
Level of ID:	Visually inspected	Ref:	As S08
	Building / Floor: BC / Second Area: Flat 86 R10 Cupboard Location: Floor Description: Bitumen on floor slab below floor covering Asbestos Type: Chrysotile Amount: 2m2

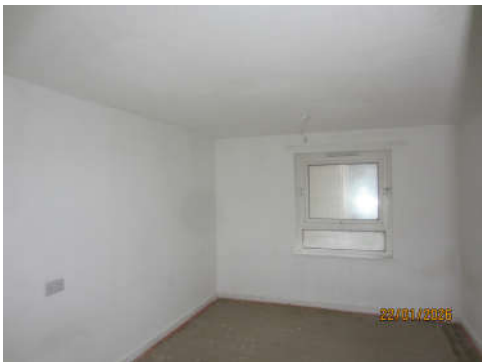
Level of ID:	Visually inspected	Ref:	As S09
	Building / Floor: BC / Second Area: Flats 85 & 87 to 90 Location: Ceiling Description: Artex on concrete Asbestos Type: Chrysotile Amount: 202m2

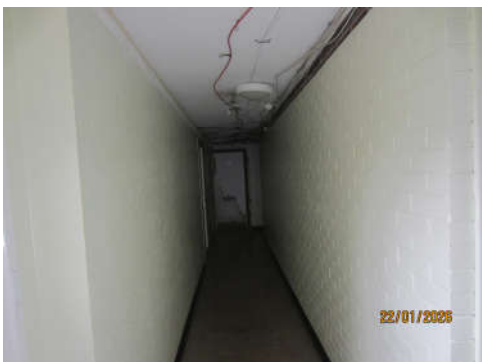
Level of ID:	Visually inspected	Ref:	As S05
	<p>Building / Floor: BC / Third</p> <p>Area: Communal areas</p> <p>Location: Wall</p> <p>Description: Artex on concrete</p> <p>Asbestos Type: Chrysotile</p> <p>Amount: 101m2</p>			
Recommendations:				
<p>Remove artex in accordance with the Control of Asbestos Regulations 2012 and dispose of as hazardous waste.</p>

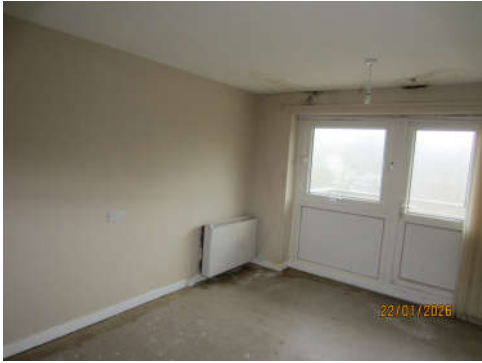
Level of ID:	Visually inspected	Ref:	As S08
	<p>Building / Floor: BC / Third</p> <p>Area: Communal areas</p> <p>Location: Floor</p> <p>Description: Bitumen on floor slab below floor covering</p> <p>Asbestos Type: Chrysotile</p> <p>Amount: 45m2</p>

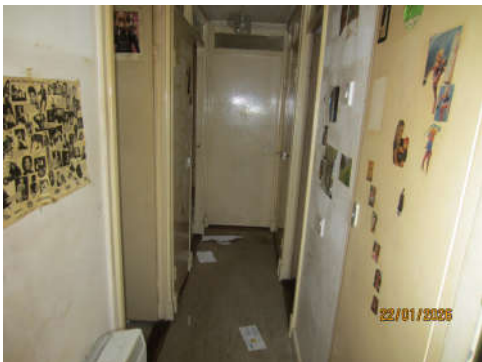
Level of ID:	Visually inspected	Ref:	As S08
	<p>Building / Floor: BC / Third</p> <p>Area: Flats 79 to 84</p> <p>Location: Floor</p> <p>Description: Bitumen on floor slab below floor covering</p> <p>Asbestos Type: Chrysotile</p> <p>Amount: 202m2</p>

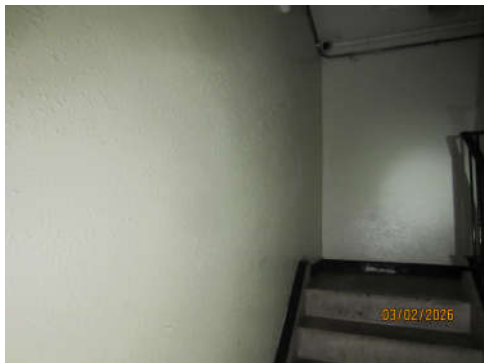
Level of ID:	Sampled	Ref:	S02
	Building / Floor: BC / Fourth Area: Communal, R01 Stairs Location: Wall Description: Artex on concrete Asbestos Type: Chrysotile Amount: 25m2			
Recommendations:				
Remove artex in accordance with the Control of Asbestos Regulations 2012 and dispose of as hazardous waste.

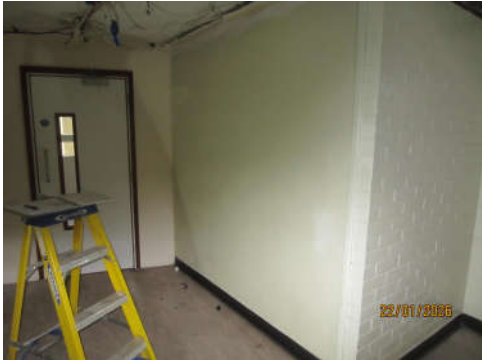
Level of ID:	Visually inspected	Ref:	As S02
	<p>Building / Floor: BC / Fourth</p> <p>Area: Communal, R04 Corridor</p> <p>Location: Wall</p> <p>Description: Artex on concrete, masonry, stud wall</p> <p>Asbestos Type: Chrysotile</p> <p>Amount: 12m2</p>

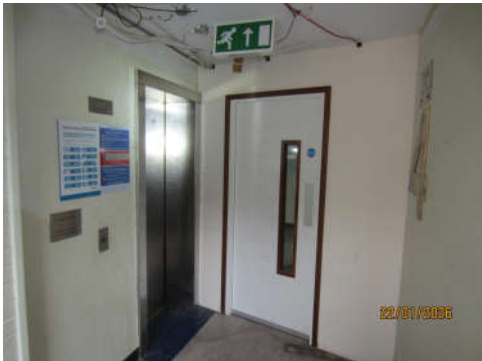
Level of ID:	Visually inspected	Ref:	As S03
	<p>Building / Floor: BC / Fourth</p> <p>Area: Communal, R05 Corridor</p> <p>Location: Floor</p> <p>Description: Bitumen on floor slab below floor covering</p> <p>Asbestos Type: Chrysotile</p> <p>Amount: 7m2</p>

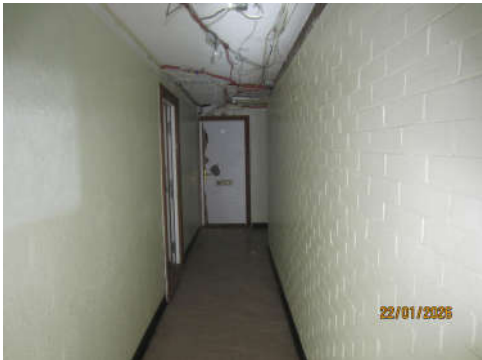
Level of ID:	Visually inspected	Ref:	As S01
	<p>Building / Floor: BC / Fourth</p> <p>Area: Communal, R06 Corridor</p> <p>Location: Ceiling</p> <p>Description: Artex on concrete</p> <p>Asbestos Type: Chrysotile</p> <p>Amount: 10m2</p>

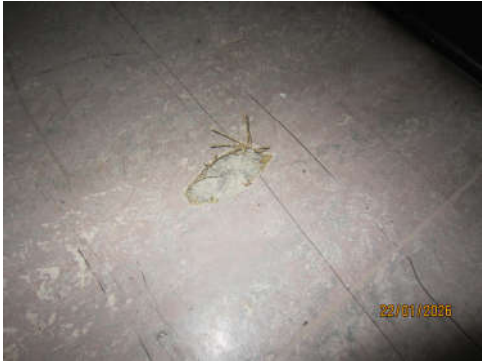
Level of ID:	Sampled	Ref:	S03
	Building / Floor: BC / Fourth Area: Communal, R06 Corridor Location: Floor Description: Bitumen on floor slab below floor covering Asbestos Type: Chrysotile Amount: 10m2

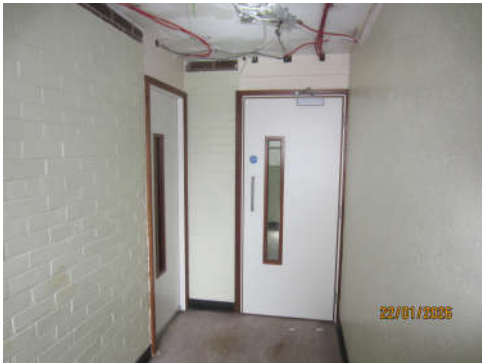
Level of ID:	Visually inspected	Ref:	As S05
	Building / Floor: BC / Fourth Area: Communal, R09 Corridor Location: Wall Description: Artex on concrete, masonry, stud wall Asbestos Type: Chrysotile Amount: 8m2

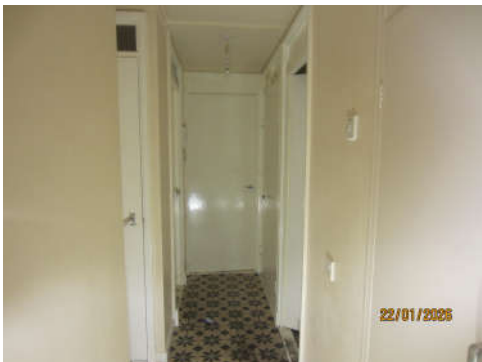
Level of ID:	Sampled	Ref:	S04
	Building / Floor: BC / Fourth Area: Flat 74 R01 Hallway Location: Ceiling Description: Artex on concrete Asbestos Type: Chrysotile Amount: 4m2

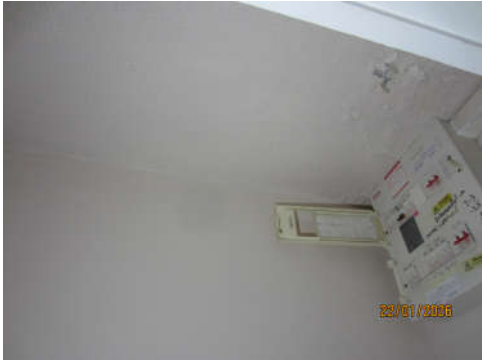
Level of ID:	Visually inspected	Ref:	
	<p>Building / Floor: BC / Fourth Area: Flat 74 R02 Store Location: Ceiling Description: Artex on concrete Asbestos Type: Chrysotile Amount: 3m2</p>

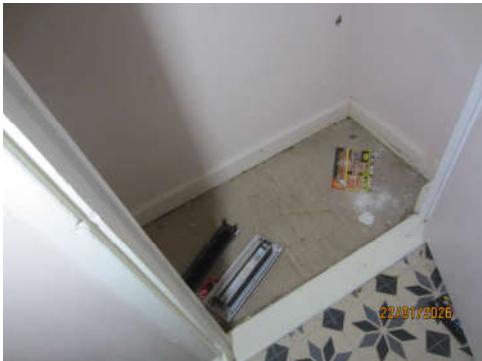
Level of ID:	Visually inspected	Ref:	As S03
	<p>Building / Floor: BC / Fourth Area: Flat 74 R02 Store Location: Floor Description: Bitumen on floor slab below floor covering Asbestos Type: Chrysotile Amount: 3m2</p>

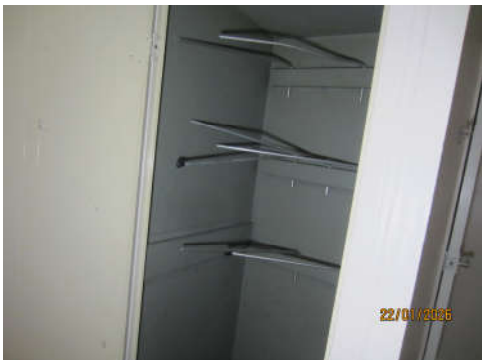
Level of ID:	Visually inspected	Ref:	
	<p>Building / Floor: BC / Fourth Area: Flat 74 R03 Drying cupboard Location: Wall Description: Metal cabinet Asbestos Type: No suspect material Amount:</p>

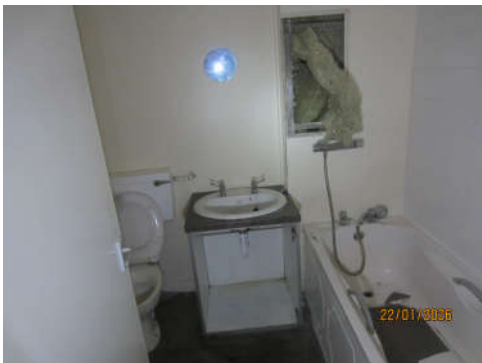
Level of ID:	Visually inspected	Ref:	
	<p>Building / Floor: BC / Fourth Area: Flat 74 R04 Bathroom Location: Wall Description: Concrete, plasterboard lined, stud wall, supalux IPS & divider Asbestos Type: No suspect material Amount:</p>			
Recommendations:				
No action required
