Demolition Asbestos Survey

Floors 13 – 17, Bishops Court, Berry Brow, Huddersfield, HD4 7NH

Issue number:	1
Survey number:	7923 BC floors 13 -17
Survey date:	January & February 2026
Client:	Metropolitan Demolition
Survey carried out by:	Phil Cox & Graham Brown
Survey compiled by:	Phil Cox & Graham Brown
Survey checked by:	Phil Cox & Graham Brown
Survey Issued	11/02/2026

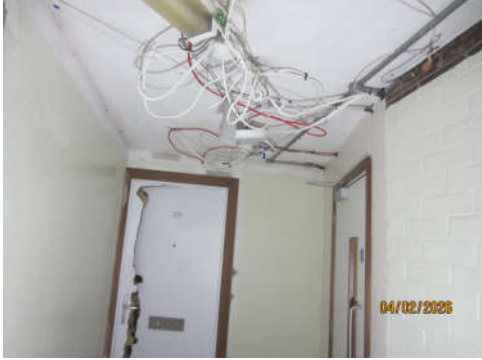
Level of ID:	Visually inspected	Ref:	As S02/14
	Building / Floor: BC / Thirteenth Area: Communal areas Location: Ceiling Description: Artex on concrete Asbestos Type: Chrysotile Amount: 46m2			
Recommendations:				
Remove artex in accordance with the Control of Asbestos Regulations 2012 and dispose of as hazardous waste.

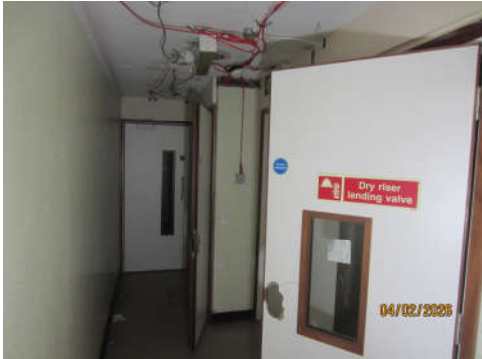
Level of ID:	Visually inspected	Ref:	As S06/10
	Building / Floor: BC / Thirteenth Area: Communal areas Location: Wall Description: Artex on concrete Asbestos Type: Chrysotile Amount: 101m2			
Recommendations:				
Remove artex in accordance with the Control of Asbestos Regulations 2012 and dispose of as hazardous waste.

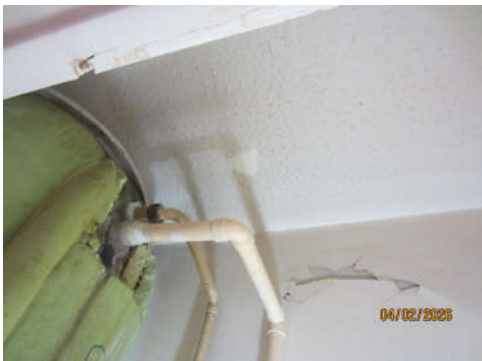
Level of ID:	Visually inspected	Ref:	As S02/14
	Building / Floor: BC / Thirteenth Area: Flats 19 to 24 Location: Ceiling Description: Artex on concrete Asbestos Type: Chrysotile Amount: 202m2			
Recommendations:				
Remove artex in accordance with the Control of Asbestos Regulations 2012 and dispose of as hazardous waste.

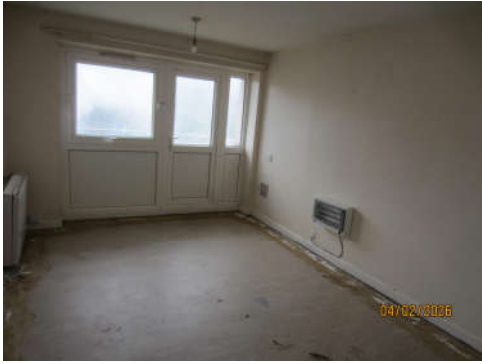
Level of ID:	Visually inspected	Ref:	As S03/14
	Building / Floor: BC / Thirteenth Area: Flats 19 to 24 Location: Floor Description: Bitumen on floor slab below floor covering Asbestos Type: Chrysotile Amount: 202m2

Remove bitumen in accordance with the Control of Asbestos Regulations 2012 and dispose of as hazardous waste.

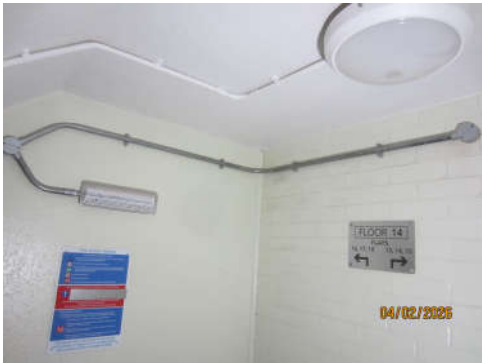
Level of ID:	Visually inspected	Ref:	As S02
	Building / Floor: BC / Fourteenth Area: Communal, R01 Stairs Location: Ceiling Description: Artex on concrete Asbestos Type: Chrysotile Amount: 10m2

Remove artex in accordance with the Control of Asbestos Regulations 2012 and dispose of as hazardous waste.

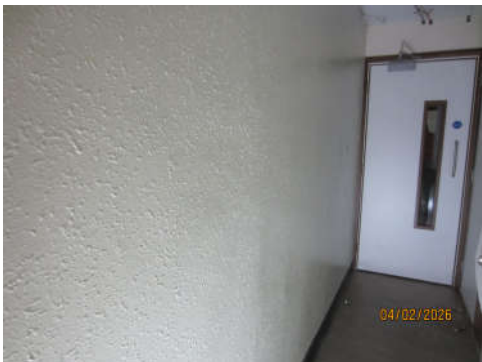
Level of ID:	Sampled	Ref:	As S06/10
	Building / Floor: BC / Fourteenth Area: Communal, R02 Landing Location: Wall Description: Artex on concrete, masonry Asbestos Type: Chrysotile Amount: 11m2

Remove artex in accordance with the Control of Asbestos Regulations 2012 and dispose of as hazardous waste.

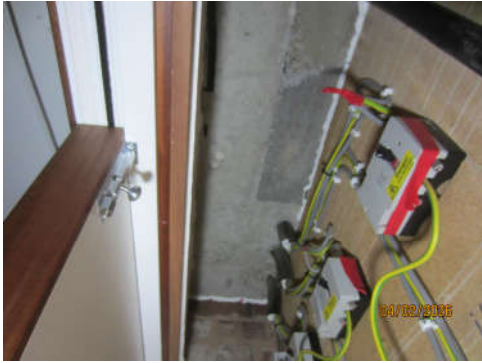
Level of ID:	Visually inspected	Ref:	
	Building / Floor: BC / Fourteenth Area: Communal R03 Electric cupboard Location: Wall Description: Concrete, masonry, timber back panel, modern electrics Asbestos Type: No suspect material Amount:			
Recommendations:				
No action required

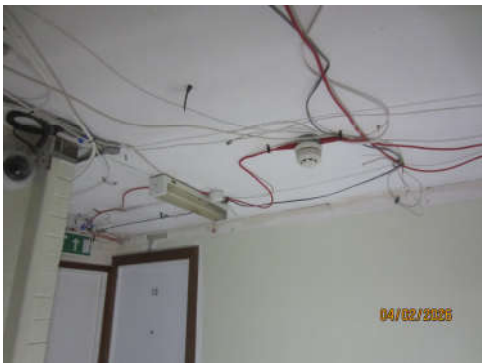
Level of ID:	Sampled	Ref:	S02
	Building / Floor: BC / Fourteenth Area: Communal, R04 Corridor Location: Ceiling Description: Artex on concrete Asbestos Type: Chrysotile Amount: 6m2			
Recommendations:				
Remove artex in accordance with the Control of Asbestos Regulations 2012 and dispose of as hazardous waste.

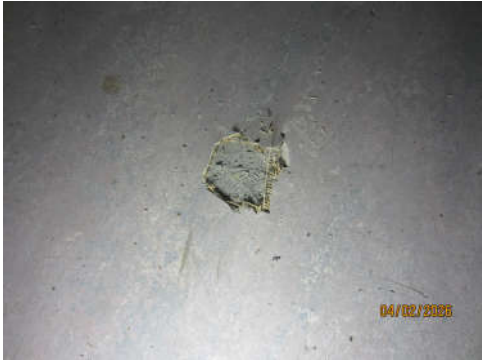
Level of ID:	Sampled	Ref:	S03
	<p>Building / Floor: BC / Fourteenth</p> <p>Area: Communal, R04 Corridor</p> <p>Location: Floor</p> <p>Description: Bitumen on floor slab below floor covering</p> <p>Asbestos Type: Chrysotile</p> <p>Amount: 6m2</p>

Remove bitumen in accordance with the Control of Asbestos Regulations 2012 and dispose of as hazardous waste.

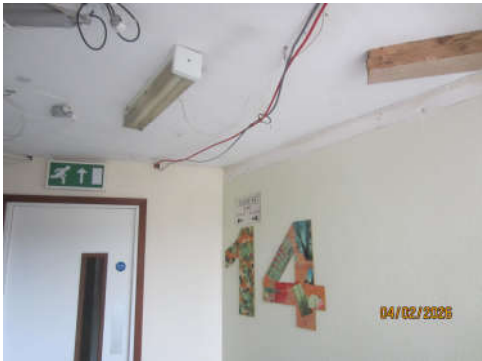
Level of ID:	Visually inspected	Ref:	As S06/10
	<p>Building / Floor: BC / Fourteenth</p> <p>Area: Communal, R05 Corridor</p> <p>Location: Wall</p> <p>Description: Artex on concrete, masonry, stud wall</p> <p>Asbestos Type: Chrysotile</p> <p>Amount: 15m2</p>

Remove artex in accordance with the Control of Asbestos Regulations 2012 and dispose of as hazardous waste.

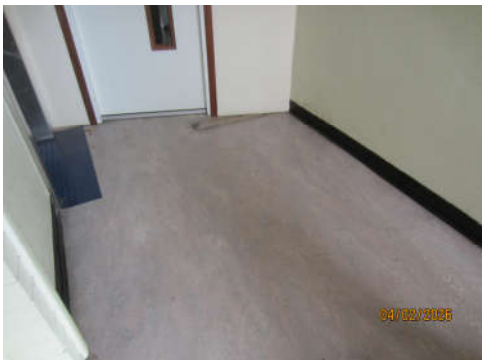
Level of ID:	Visually inspected	Ref:	As S03
	<p>Building / Floor: BC / Fourteenth</p> <p>Area: Communal, R05 Corridor</p> <p>Location: Floor</p> <p>Description: Bitumen on floor slab below floor covering</p> <p>Asbestos Type: Chrysotile</p> <p>Amount: 7m2</p>

Remove bitumen in accordance with the Control of Asbestos Regulations 2012 and dispose of as hazardous waste.

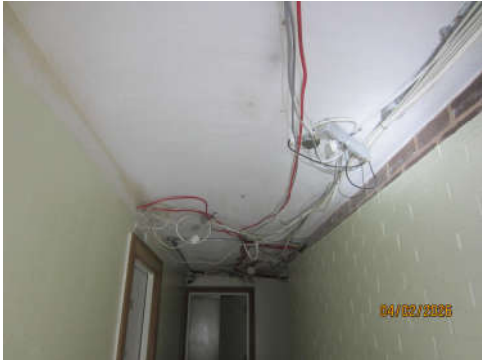
Level of ID:	Visually inspected	Ref:	As S02
	Building / Floor: BC / Fourteenth Area: Communal, R06 Corridor Location: Ceiling Description: Artex on concrete Asbestos Type: Chrysotile Amount: 10m2			
Recommendations:				
Remove artex in accordance with the Control of Asbestos Regulations 2012 and dispose of as hazardous waste.

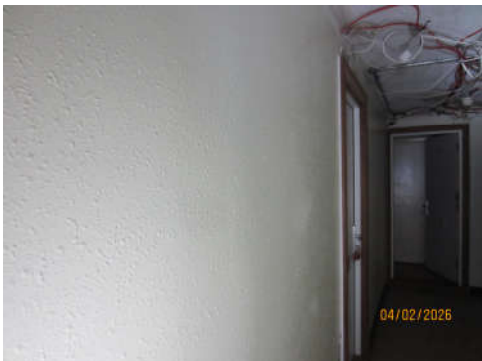
Level of ID:	Sampled	Ref:	As S06/10
	Building / Floor: BC / Fourteenth Area: Communal, R06 Corridor Location: Wall Description: Artex on concrete, masonry Asbestos Type: Chrysotile Amount: 20m2			
Recommendations:				
Remove artex in accordance with the Control of Asbestos Regulations 2012 and dispose of as hazardous waste.

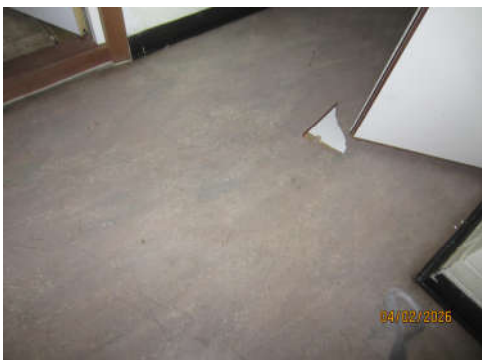
Level of ID:	Visually inspected	Ref:	As S03
	Building / Floor: BC / Fourteenth Area: Communal, R06 Corridor Location: Floor Description: Bitumen on floor slab below floor covering Asbestos Type: Chrysotile Amount: 10m2			
Recommendations:				
Remove bitumen in accordance with the Control of Asbestos Regulations 2012 and dispose of as hazardous waste.

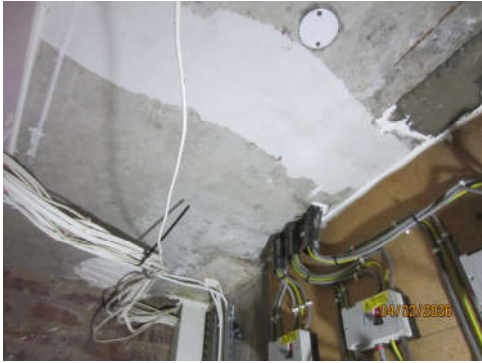
Level of ID:	Visually inspected	Ref:	
	Building / Floor: BC / Fourteenth Area: Communal, R07 Service riser Location: Ceiling Description: Concrete Asbestos Type: No suspect material Amount:			
Recommendations:				
No action required

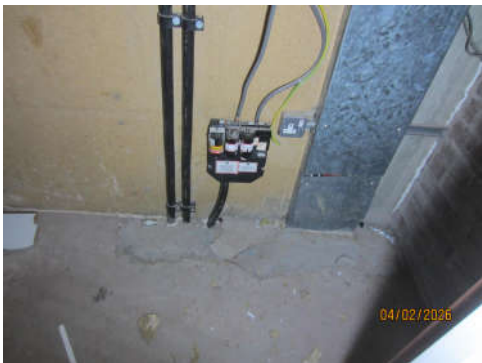
Level of ID:	Visually inspected	Ref:	
	Building / Floor: BC / Fourteenth Area: Communal, R07 Service riser Location: Floor Description: Concrete, modern electrical equipment Asbestos Type: No suspect material Amount:			
Recommendations:				
No action required

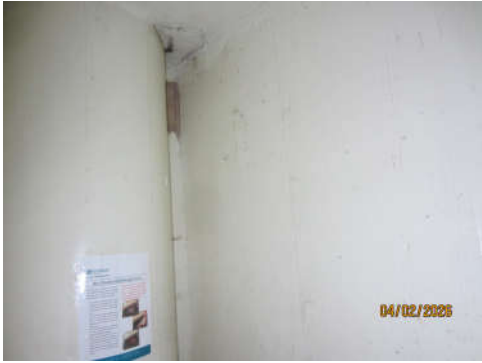
Level of ID:	Visually inspected	Ref:	As S06/10
	Building / Floor: BC / Fourteenth Area: Communal, R08 Refuse chute room Location: Wall Description: Artex on concrete, masonry, stud wall Asbestos Type: Chrysotile Amount: 8m2			
Recommendations:				
Remove artex in accordance with the Control of Asbestos Regulations 2012 and dispose of as hazardous waste.

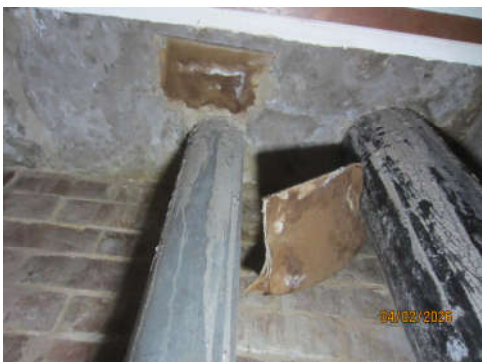
Level of ID:	Visually inspected	Ref:	P1
	Building / Floor: BC / Fourteenth Area: Communal, R10 Riser Location: Pipework Description: Pitch fibre S&V pipe Asbestos Type: Chrysotile Amount: 2.5 lin m			
Recommendations:				
Remove pitch fibre pipe in accordance with the Control of Asbestos Regulations 2012 and dispose of as hazardous waste.

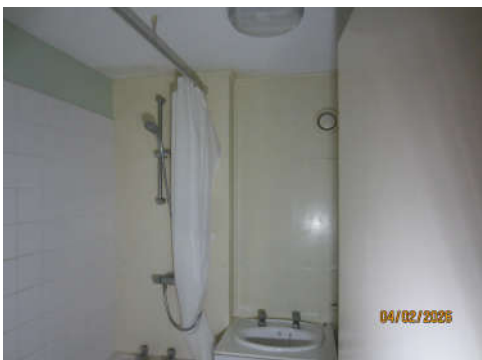
Level of ID:	Visually inspected	Ref:	As S05
	Building / Floor: BC / Fourteenth Area: Flat 15 R04 Bathroom Location: Ceiling Description: Artex on concrete Asbestos Type: Chrysotile Amount: 3m2			
Recommendations:				
Remove artex in accordance with the Control of Asbestos Regulations 2012 and dispose of as hazardous waste.

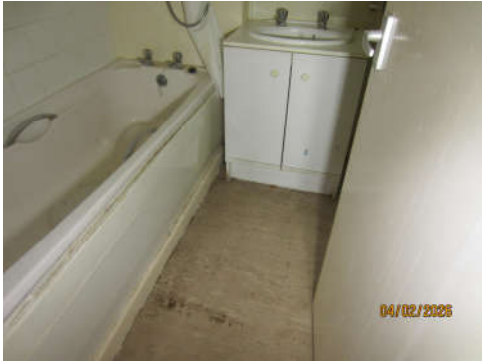
Level of ID:	Visually inspected	Ref:	As S06
	<p>Building / Floor: BC / Fourteenth</p> <p>Area: Flat 15 R04 Bathroom</p> <p>Location: Floor</p> <p>Description: Bitumen on floor slab below floor covering, modern sanitaryware & fittings</p> <p>Asbestos Type: Chrysotile</p> <p>Amount: 3m2</p>

Remove bitumen in accordance with the Control of Asbestos Regulations 2012 and dispose of as hazardous waste.

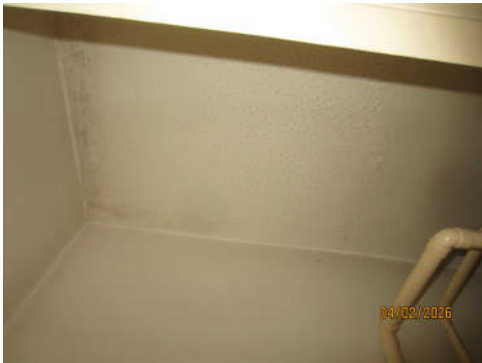
Level of ID:	Visually inspected	Ref:	As S05
	<p>Building / Floor: BC / Fourteenth</p> <p>Area: Flat 15 R05 Boiler cupboard</p> <p>Location: Ceiling</p> <p>Description: Artex on concrete</p> <p>Asbestos Type: Chrysotile</p> <p>Amount: 1m2</p>

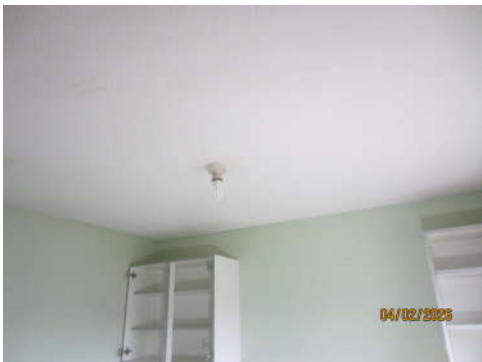
Level of ID:	Sampled	Ref:	S05
	<p>Building / Floor: BC / Fourteenth</p> <p>Area: Flat 15 R06 Kitchen</p> <p>Location: Ceiling</p> <p>Description: Artex on concrete</p> <p>Asbestos Type: Chrysotile</p> <p>Amount: 7.5m2</p>

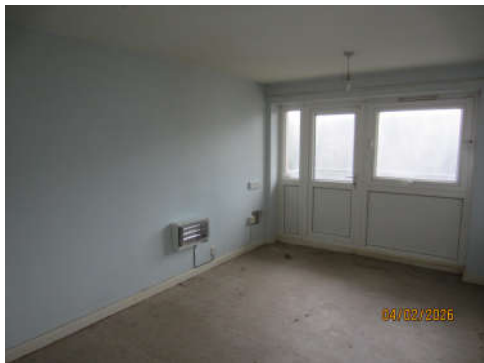
Level of ID:	Visually inspected	Ref:	As S05
	Building / Floor: BC / Fourteenth Area: Flat 15 R07 Lounge Location: Ceiling Description: Artex on concrete Asbestos Type: Chrysotile Amount: 14m2			
Recommendations:				
Remove artex in accordance with the Control of Asbestos Regulations 2012 and dispose of as hazardous waste.

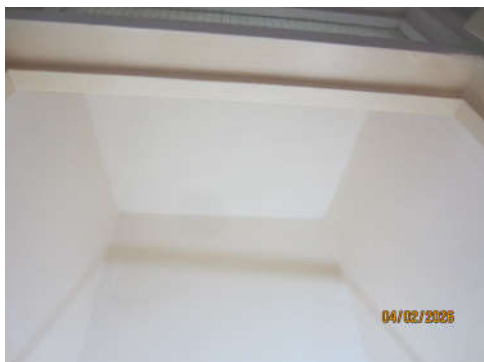
Level of ID:	Visually inspected	Ref:	As S05
	Building / Floor: BC / Fourteenth Area: Flat 15 R08 Cupboard Location: Ceiling Description: Artex on concrete Asbestos Type: Chrysotile Amount: .5m2			
Recommendations:				
Remove artex in accordance with the Control of Asbestos Regulations 2012 and dispose of as hazardous waste.

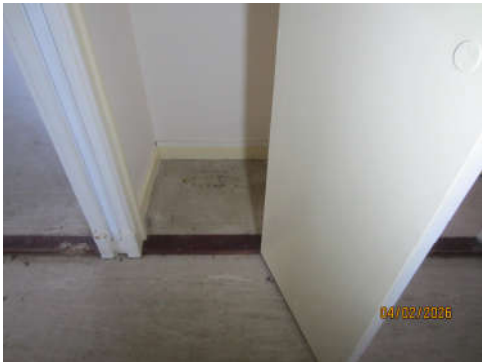
Level of ID:	Visually inspected	Ref:	As S06
	Building / Floor: BC / Fourteenth Area: Flat 15 R08 Cupboard Location: Floor Description: Bitumen on floor slab below floor covering Asbestos Type: Chrysotile Amount: .5m2

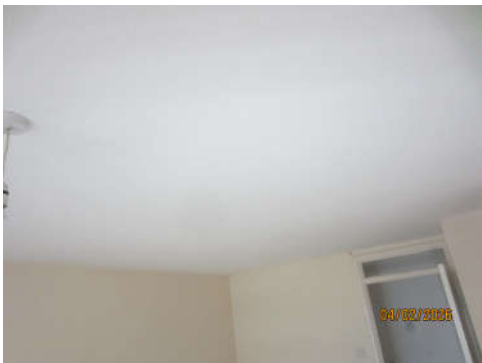
Level of ID:	Visually inspected	Ref:	As S05
	Building / Floor: BC / Fourteenth Area: Flat 15 R09 Bedroom Location: Ceiling Description: Artex on concrete Asbestos Type: Chrysotile Amount: 10m2

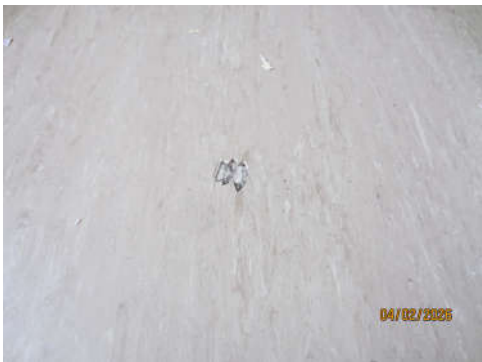
Level of ID:	Sampled	Ref:	S06
	Building / Floor: BC / Fourteenth Area: Flat 15 R09 Bedroom Location: Floor Description: Bitumen on floor slab below floor covering Asbestos Type: Chrysotile Amount: 10m2

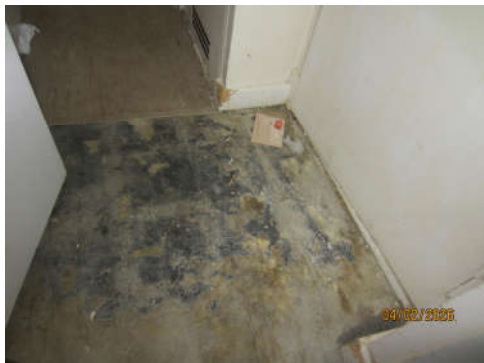
Level of ID:	Visually inspected	Ref:	As S06
	<p>Building / Floor: BC / Fourteenth</p> <p>Area: Flats 13 & 14 & 16 to 18</p> <p>Location: Floor</p> <p>Description: Bitumen on floor slab below floor covering</p> <p>Asbestos Type: Chrysotile</p> <p>Amount: 202m2</p>			
Recommendations:				
<p>Remove bitumen in accordance with the Control of Asbestos Regulations 2012 and dispose of as hazardous waste.</p>

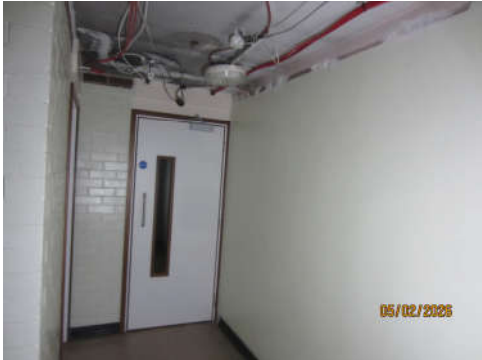
Level of ID:	Visually inspected	Ref:	As S06/10
	Building / Floor: BC / Fifteenth Area: Communal areas Location: Wall Description: Artex on concrete Asbestos Type: Chrysotile Amount: 101m2

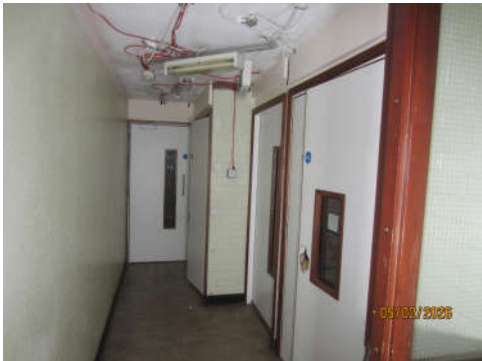
Level of ID:	Visually inspected	Ref:	As S03/16
	Building / Floor: BC / Fifteenth Area: Communal areas Location: Floor Description: Bitumen on floor slab below floor covering Asbestos Type: Chrysotile Amount: 45m2

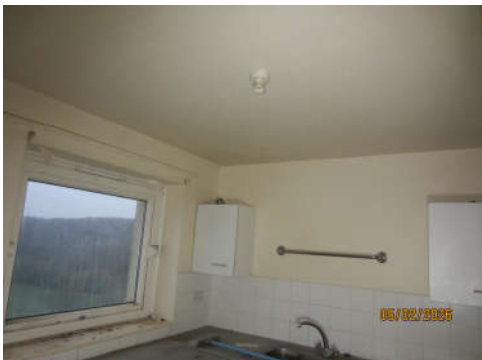
Level of ID:	Visually inspected	Ref:	
	Building / Floor: BC / Fifteenth Area: Flats 7 to 12 Location: Ceiling Description: Artex on concrete Asbestos Type: Chrysotile Amount: 202m2

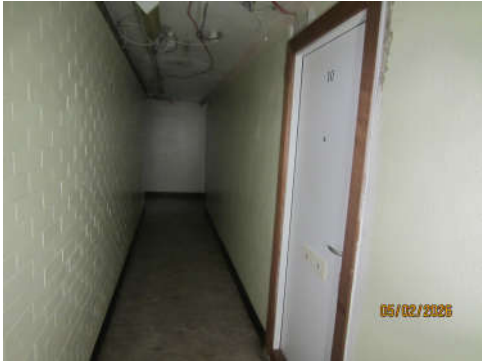
Level of ID:	Visually inspected	Ref:	
	<p>Building / Floor: BC / Fifteenth</p> <p>Area: Flats 7 to 12</p> <p>Location: Floor</p> <p>Description: Bitumen on floor slab below floor covering</p> <p>Asbestos Type: Chrysotile</p> <p>Amount: 202m2</p>

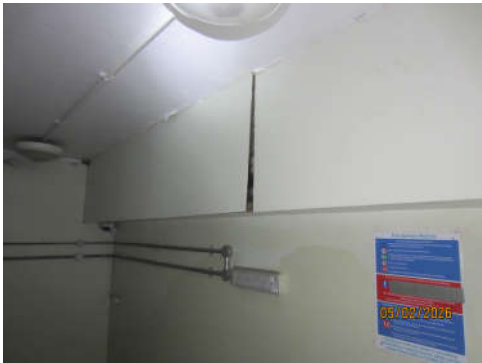
Level of ID:	Visually inspected	Ref:	As S02
	<p>Building / Floor: BC / Sixteenth</p> <p>Area: Communal, R01 Stairs</p> <p>Location: Ceiling</p> <p>Description: Artex on concrete, timber boxing-in to cast pipe</p> <p>Asbestos Type: Chrysotile</p> <p>Amount: 10m2</p>

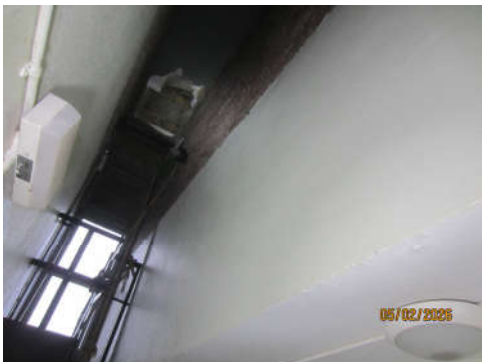
Level of ID:	Sampled	Ref:	As S06/10
	<p>Building / Floor: BC / Sixteenth</p> <p>Area: Communal, R01 Stairs</p> <p>Location: Wall</p> <p>Description: Artex on concrete</p> <p>Asbestos Type: Chrysotile</p> <p>Amount: 25m2</p>

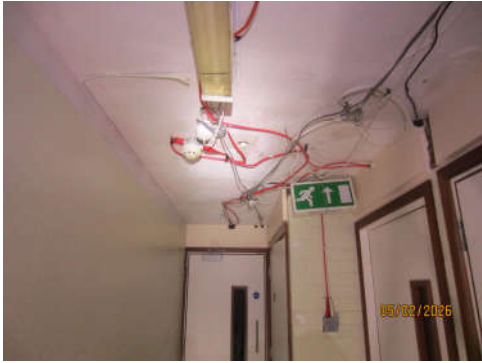
Level of ID:	Sampled	Ref:	S02
	Building / Floor: BC / Sixteenth Area: Communal, R02 Landing Location: Ceiling Description: Artex on concrete Asbestos Type: Chrysotile Amount: 4m2

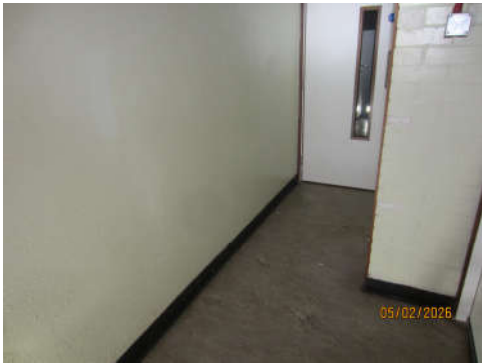
Level of ID:	Visually inspected	Ref:	As S03
	Building / Floor: BC / Sixteenth Area: Communal, R02 Landing Location: Floor Description: Bitumen on floor slab below floor covering Asbestos Type: Chrysotile Amount: 4m2

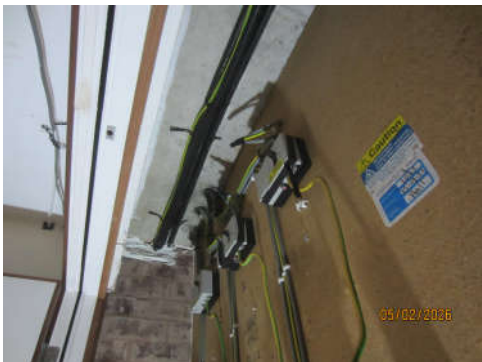
Level of ID:	Visually inspected	Ref:	As S02
	Building / Floor: BC / Sixteenth Area: Communal R03 Electric cupboard Location: Ceiling Description: Concrete Asbestos Type: No suspect material Amount:

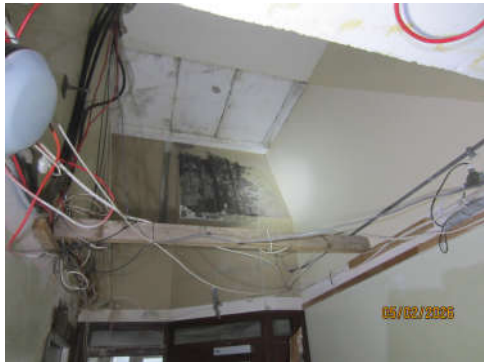
Level of ID:	Visually inspected	Ref:	As S02
	Building / Floor: BC / Sixteenth Area: Communal, R04 Corridor Location: Ceiling Description: Artex on concrete Asbestos Type: Chrysotile Amount: 6m2			
Recommendations:				
Remove artex in accordance with the Control of Asbestos Regulations 2012 and dispose of as hazardous waste.

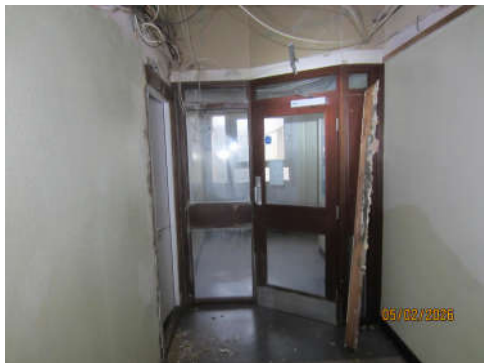
Level of ID:	Sampled	Ref:	As S06/10
	Building / Floor: BC / Sixteenth Area: Communal, R04 Corridor Location: Wall Description: Artex on concrete, masonry, stud wall Asbestos Type: Chrysotile Amount: 12m2			
Recommendations:				
Remove artex in accordance with the Control of Asbestos Regulations 2012 and dispose of as hazardous waste.

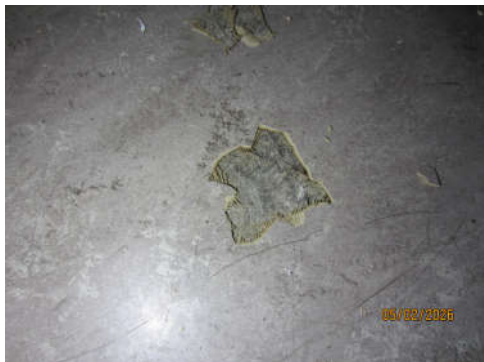
Level of ID:	Sampled	Ref:	S03
	Building / Floor: BC / Sixteenth Area: Communal, R04 Corridor Location: Floor Description: Bitumen on floor slab below floor covering Asbestos Type: Chrysotile Amount: 6m2			
Recommendations:				
Remove bitumen in accordance with the Control of Asbestos Regulations 2012 and dispose of as hazardous waste.

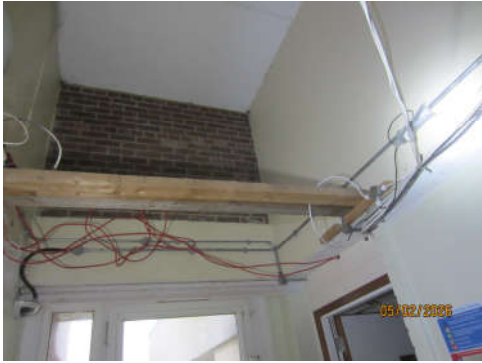
Level of ID:	Sampled	Ref:	As S02
	Building / Floor: BC / Sixteenth Area: Communal, R05 Corridor Location: Ceiling Description: Artex on concrete Asbestos Type: Chrysotile Amount: 7m2			
Recommendations:				
Remove artex in accordance with the Control of Asbestos Regulations 2012 and dispose of as hazardous waste.

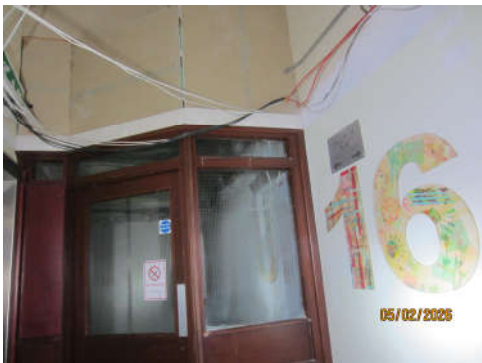
Level of ID:	Visually inspected	Ref:	As S06/10
	Building / Floor: BC / Sixteenth Area: Communal, R05 Corridor Location: Wall Description: Artex on concrete, masonry, stud wall Asbestos Type: Chrysotile Amount: 15m2			
Recommendations:				
Remove artex in accordance with the Control of Asbestos Regulations 2012 and dispose of as hazardous waste.

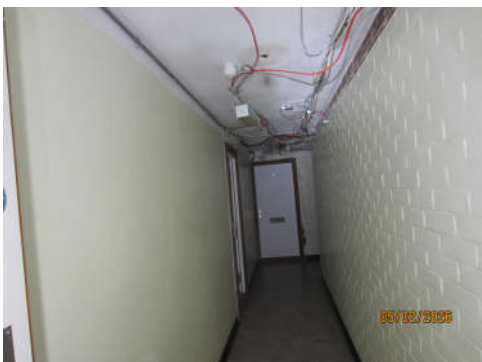
Level of ID:	Visually inspected	Ref:	As S02
	Building / Floor: BC / Sixteenth Area: Communal, R06 Corridor Location: Ceiling Description: Artex on concrete Asbestos Type: Chrysotile Amount: 10m2			
Recommendations:				
Remove artex in accordance with the Control of Asbestos Regulations 2012 and dispose of as hazardous waste.

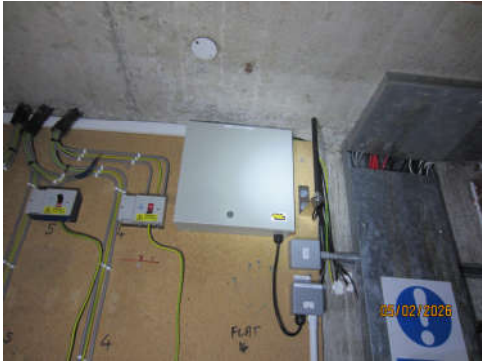
Level of ID:	Visually inspected	Ref:	
	Building / Floor: BC / Sixteenth Area: Communal, R07 Service riser Location: Ceiling Description: Concrete Asbestos Type: No suspect material Amount:			
Recommendations:				
No action required

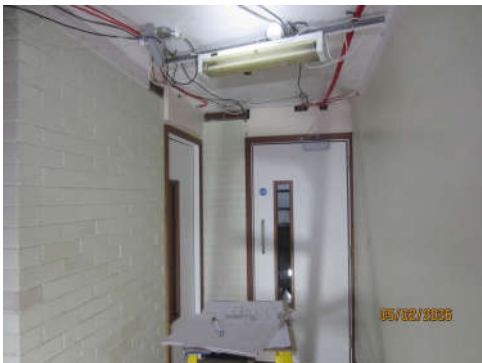
Level of ID:	Visually inspected	Ref:	
	Building / Floor: BC / Sixteenth Area: Communal, R09 Corridor Location: Wall Description: Artex on concrete, masonry, stud wall Asbestos Type: Chrysotile Amount: 8m2			
Recommendations:				
Remove artex in accordance with the Control of Asbestos Regulations 2012 and dispose of as hazardous waste.

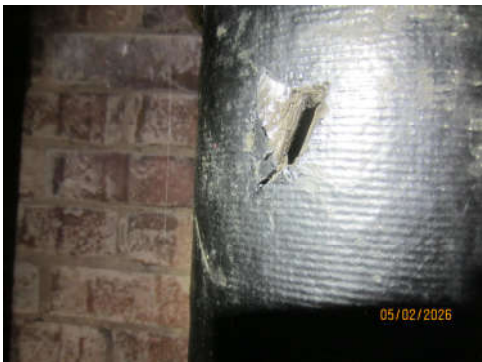
Level of ID:	Visually inspected	Ref:	P1
	Building / Floor: BC / Sixteenth Area: Communal, R10 Riser Location: Pipework Description: Pitch fibre S&V pipe Asbestos Type: Chrysotile Amount: 2.5 lin m			
Recommendations:				
Remove pitch fibre pipe in accordance with the Control of Asbestos Regulations 2012 and dispose of as hazardous waste.

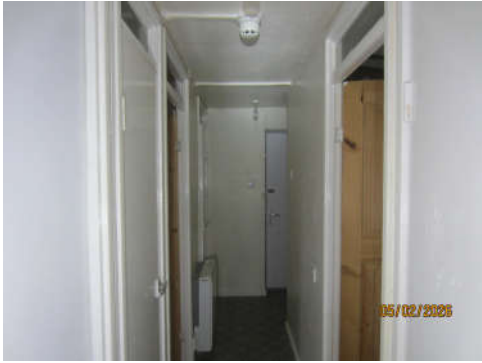
Level of ID:	Visually inspected	Ref:	As S02
	Building / Floor: BC / Sixteenth Area: Flat 6 R01 Hallway Location: Ceiling Description: Artex on concrete Asbestos Type: Chrysotile Amount: 4m2			
Recommendations:				
Remove artex in accordance with the Control of Asbestos Regulations 2012 and dispose of as hazardous waste.

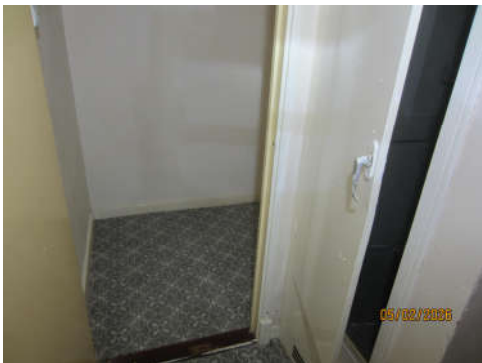
Level of ID:	Visually inspected	Ref:	As S07
	Building / Floor: BC / Sixteenth Area: Flat 6 R02 Store Location: Floor Description: Bitumen on floor slab below floor covering Asbestos Type: Chrysotile Amount: 3m2			
Recommendations:				
Remove bitumen in accordance with the Control of Asbestos Regulations 2012 and dispose of as hazardous waste.

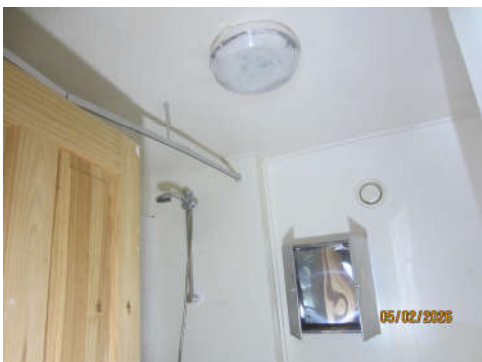
Level of ID:	Visually inspected	Ref:	As S02
	Building / Floor: BC / Sixteenth Area: Flat 6 R04 Bathroom Location: Ceiling Description: Artex on concrete Asbestos Type: Chrysotile Amount: 3m2			
Recommendations:				
Remove artex in accordance with the Control of Asbestos Regulations 2012 and dispose of as hazardous waste.

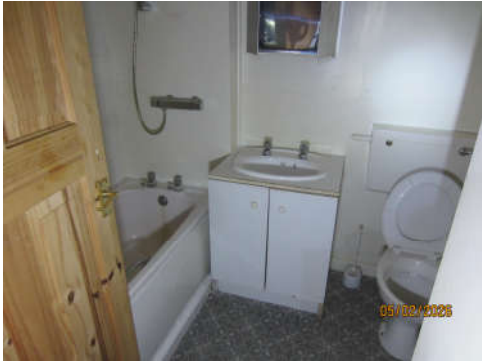
Level of ID:	Visually inspected	Ref:	As S07
	<p>Building / Floor: BC / Sixteenth</p> <p>Area: Flat 6 R04 Bathroom</p> <p>Location: Floor</p> <p>Description: Bitumen on floor slab below floor covering, modern sanitaryware & fittings</p> <p>Asbestos Type: Chrysotile</p> <p>Amount: 3m2</p>			
Recommendations:				
<p>Remove bitumen in accordance with the Control of Asbestos Regulations 2012 and dispose of as hazardous waste.</p>

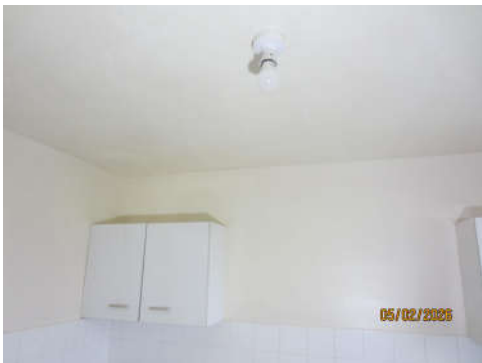
Level of ID:	Visually inspected	Ref:	As S02
	<p>Building / Floor: BC / Sixteenth</p> <p>Area: Flat 6 R06 Kitchen</p> <p>Location: Ceiling</p> <p>Description: Artex on concrete</p> <p>Asbestos Type: Chrysotile</p> <p>Amount: 7.5m2</p>			
Recommendations:				
<p>Remove artex in accordance with the Control of Asbestos Regulations 2012 and dispose of as hazardous waste.</p>

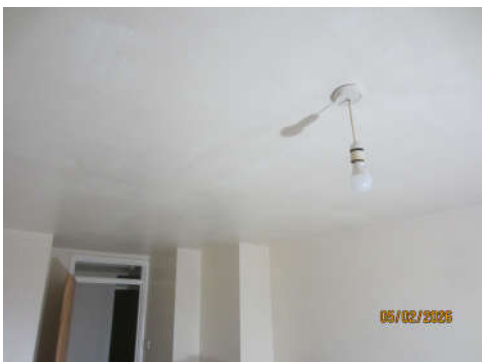
Level of ID:	Sampled	Ref:	S08
	Building / Floor: BC / Sixteenth Area: Flat 6 R09 Bedroom Location: Ceiling Description: Artex on concrete Asbestos Type: Chrysotile Amount: 10m2			
Recommendations:				
Remove artex in accordance with the Control of Asbestos Regulations 2012 and dispose of as hazardous waste.

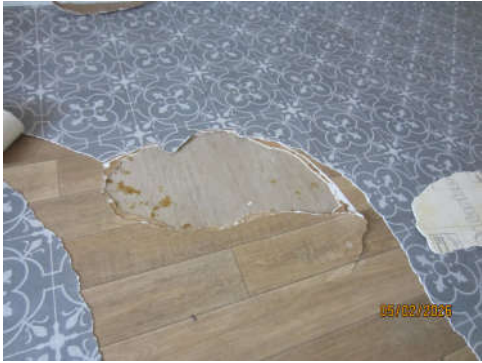
Level of ID:	Visually inspected	Ref:	As S07
	<p>Building / Floor: BC / Sixteenth Area: Flat 6 R09 Bedroom Location: Floor Description: Bitumen on floor slab below floor covering Asbestos Type: Chrysotile Amount: 10m2</p>			
Recommendations:				
<p>Remove bitumen in accordance with the Control of Asbestos Regulations 2012 and dispose of as hazardous waste.</p>

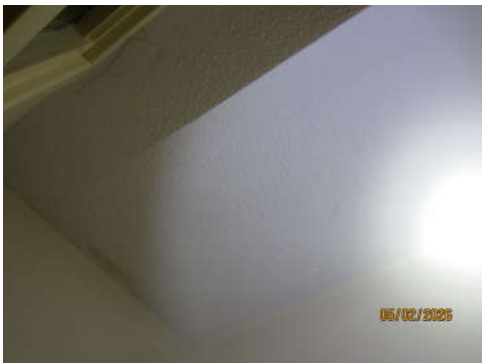
Level of ID:	Visually inspected	Ref:	As S08
	<p>Building / Floor: BC / Sixteenth Area: Flat 6 R10 Cupboard Location: Ceiling Description: Artex on concrete Asbestos Type: Chrysotile Amount: 2m2</p>			
Recommendations:				
<p>Remove artex in accordance with the Control of Asbestos Regulations 2012 and dispose of as hazardous waste.</p>

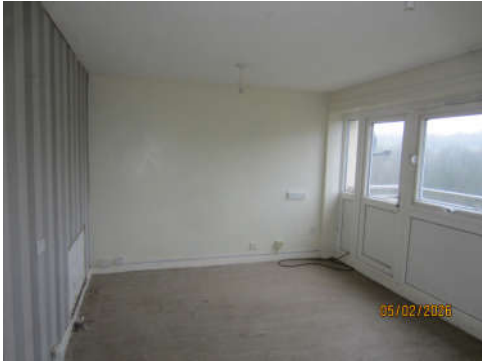
Level of ID:	Visually inspected	Ref:	As S07
	<p>Building / Floor: BC / Sixteenth</p> <p>Area: Flats 1 to 5</p> <p>Location: Floor</p> <p>Description: Bitumen on floor slab below floor covering</p> <p>Asbestos Type: Chrysotile</p> <p>Amount: 202m2</p>

Remove bitumen in accordance with the Control of Asbestos Regulations 2012 and dispose of as hazardous waste.

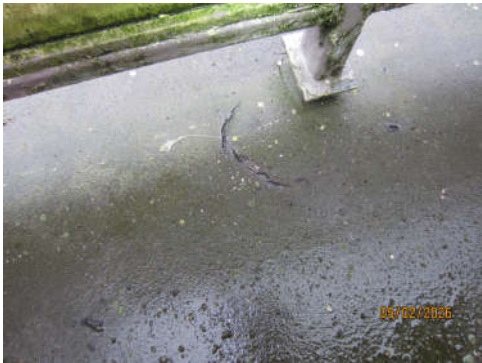
Level of ID:	Sampled	Ref:	S09
	<p>Building / Floor: BC / Sixteenth</p> <p>Area: Flat 4 Lounge balcony</p> <p>Location: External</p> <p>Description: Asphalt</p> <p>Asbestos Type: No asbestos detected</p> <p>Amount:</p>

No action required

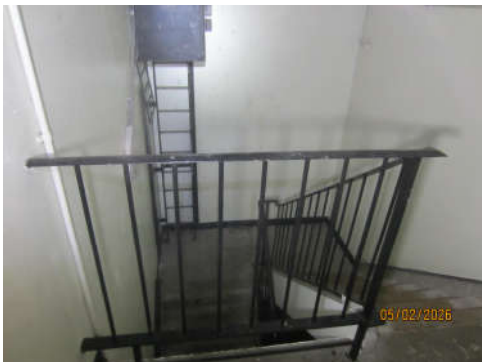
Level of ID:	Visually inspected	Ref:	
	<p>Building / Floor: BC / Seventeenth</p> <p>Area: Lift motor room</p> <p>Location: Access</p> <p>Description: Metal cat ladder from 16th floor mid landing</p> <p>Asbestos Type: No suspect material</p> <p>Amount:</p>

No action required

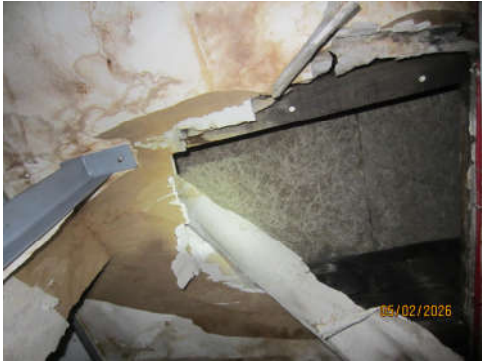
Level of ID:	Visually inspected	Ref:	
	<p>Building / Floor: BC / Seventeenth</p> <p>Area: Lift motor room</p> <p>Location: Roof</p> <p>Description: Felt on stramit board, plasterboard lined</p> <p>Asbestos Type: No suspect material</p> <p>Amount:</p>			
Recommendations:				
No action required

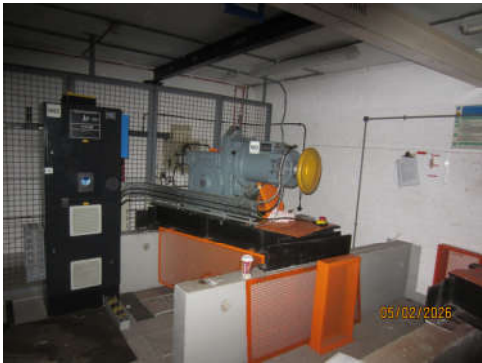
Level of ID:	Visually inspected	Ref:	
	<p>Building / Floor: BC / Seventeenth</p> <p>Area: Lift motor room</p> <p>Location: Wall</p> <p>Description: Concrete & masonry, metal cage</p> <p>Asbestos Type: No suspect material</p> <p>Amount:</p>			
Recommendations:				
No action required

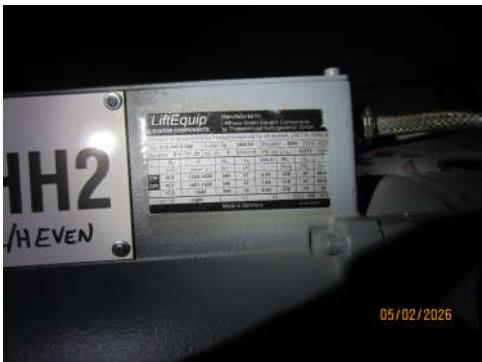
Level of ID:	Visually inspected	Ref:	
	<p>Building / Floor: BC / Seventeenth</p> <p>Area: Lift motor room</p> <p>Location: Floor</p> <p>Description: Concrete, , modern machinery, manufactured 2009</p> <p>Asbestos Type: No suspect material</p> <p>Amount:</p>			
Recommendations:				
No action required
