| Site Air Test Certificate Ref: | ST/26/7/1/MH2 | Date of Issue: | 01/07/2026 | Page 1 of 5 |

| | <b>Area Assessed:</b> | Eleventh Floor of Block of Flats |
| | <b>Description of reason for test (including the nature and extent of ACMs removed):</b> | Reassurance Air Test following removal of Bitumen Adhesive to Floor and Textured Coating to Concrete Ceilings and Walls |

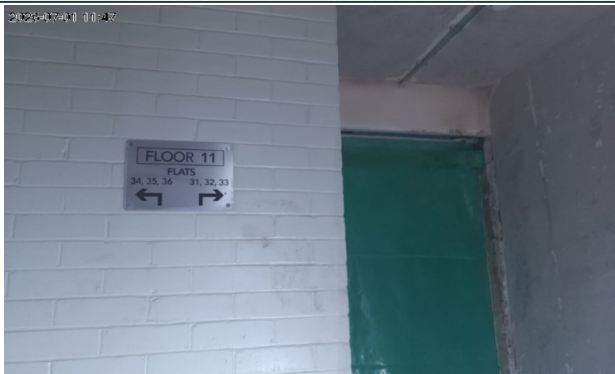
#### Entrance To Floor

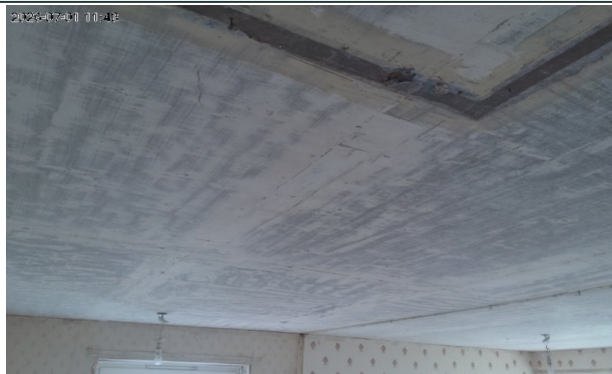
#### Ceiling

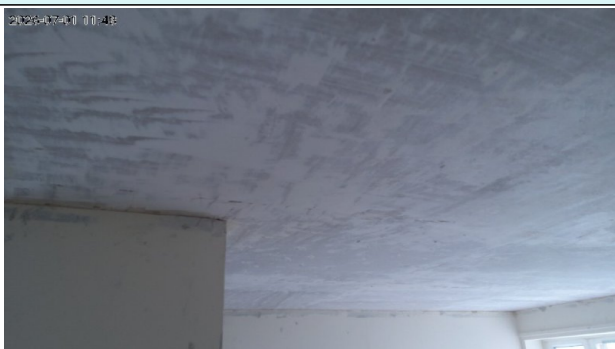
#### Ceiling

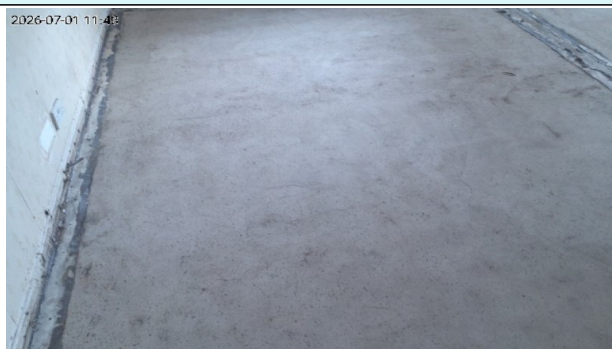
#### Floor

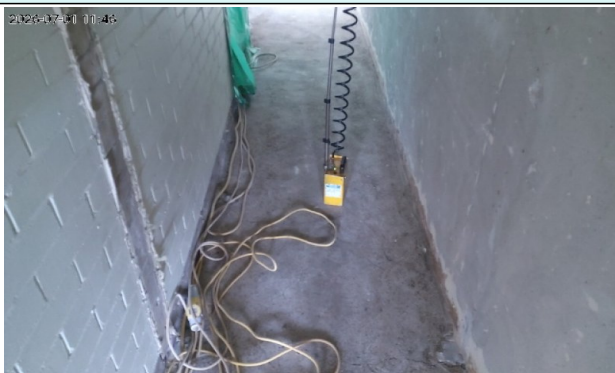
#### Sampling pump (sample ref: 26/7/A/1/MH8)

| 26/7/A/1/MH8 | HFNE 10 | 6A | N/A | N/A | 8.5 | 11:40 | - | --:-- | 8.5 | 12:41 |

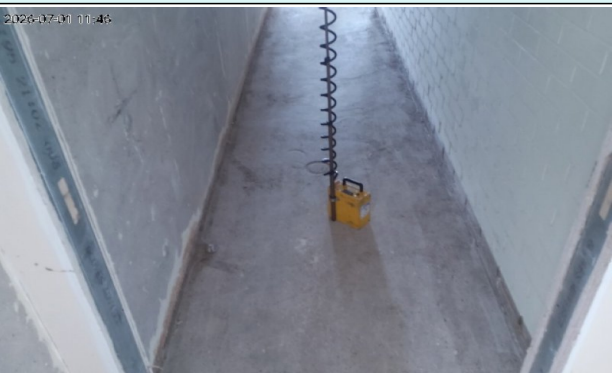
#### Sampling pump (sample ref: 26/7/A/1/MH9)

| 26/7/A/1/MH9 | HFNE 21 | 6B | N/A | N/A | 8.5 | 11:41 | - | --:-- | 8.5 | 12:42 |

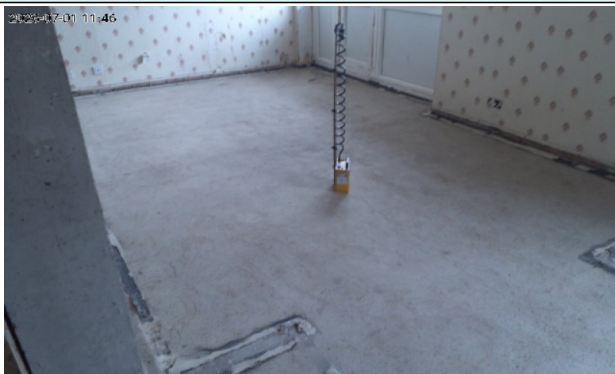
#### Sampling pump (sample ref: 26/7/A/1/MH10)

| 26/7/A/1/MH10 | HFNE 22 | 6C | N/A | N/A | 8.5 | 11:42 | - | --:-- | 8.5 | 12:43 |

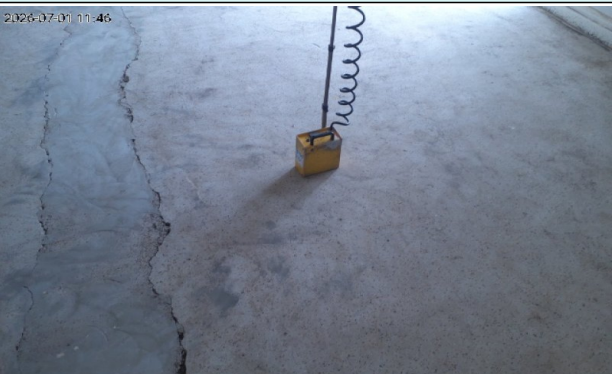
#### Sampling pump (sample ref: 26/7/A/1/MH11)

| 26/7/A/1/MH11 | HFNE 23 | 6D | N/A | N/A | 8.5 | 11:43 | - | --:-- | 8.5 | 12:44 |

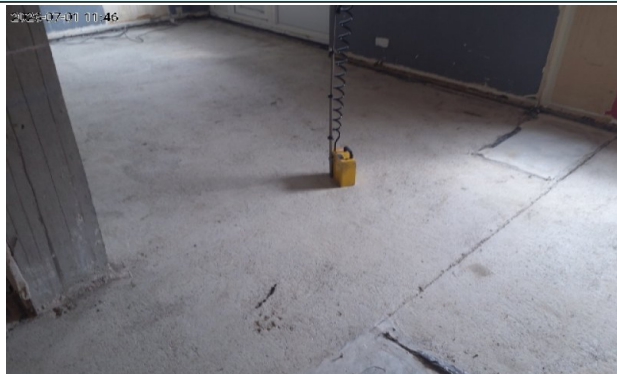
Sampling pump (sample ref: 26/7/A/1/MH12)

| 26/7/A/1/MH12 | HFNE 25 | 6E | N/A | N/A | 8.5 | 11:44 | - | --:-- | 8.5 | 12:45 |

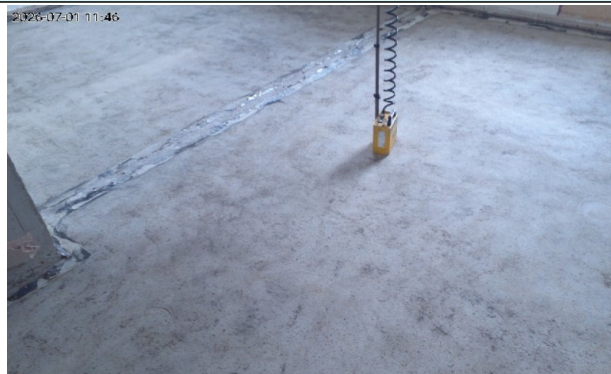
Sampling pump (sample ref: 26/7/A/1/MH13)

| 26/7/A/1/MH13 | HFNE 26 | 6F | N/A | N/A | 8.5 | 11:45 | - | --:-- | 8.5 | 12:46 |
