| Site Air Test Certificate Ref: | ST/26/8/19/MH1 | Date of Issue: | 19/08/2026 | Page 1 of 5 |

| | <b>Area Assessed:</b> | Ground Floor of Block of Flats | | | |
| | <b>Description of reason for test (including the nature and extent of ACMs removed):</b> | Reassurance Air Test following removal of Bitumen Adhesive to Floor and Textured Coating from Ceilings (Concrete) and Textured Coating to Concrete Walls and Ceiling to Corridors | | | |

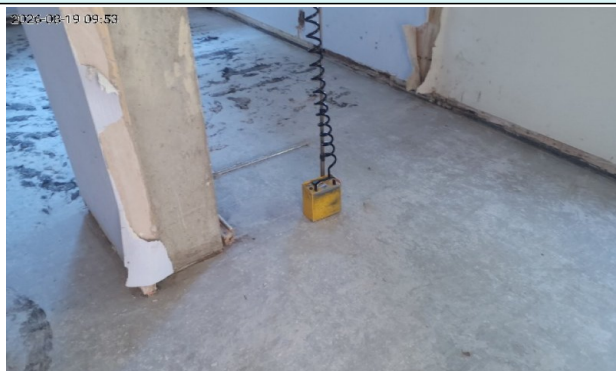
#### Sampling pump (sample ref: 26/8/A/19/MH1)

| 26/8/A/19/MH1 | HFNE 17 | 6A | N/A | N/A | 8.5 | 09:45 | - | --:-- | 8.5 | 10:46 |

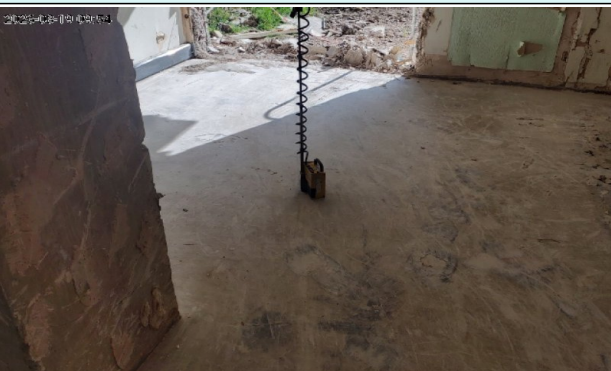
#### Sampling pump (sample ref: 26/8/A/19/MH2)

| 26/8/A/19/MH2 | HFNE 18 | 6B | N/A | N/A | 8.5 | 09:46 | - | --:-- | 8.5 | 10:47 |

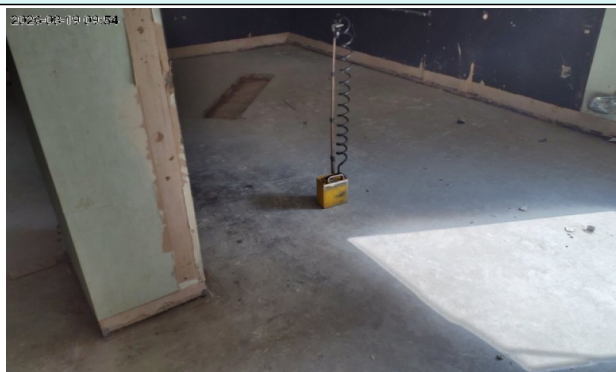
#### Sampling pump (sample ref: 26/8/A/19/MH3)

| 26/8/A/19/MH3 | HFNE 20 | 6C | N/A | N/A | 8.5 | 09:47 | - | --:-- | 8.5 | 10:48 |

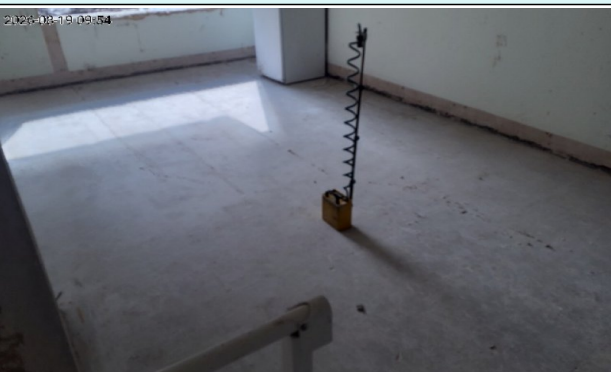
#### Sampling pump (sample ref: 26/8/A/19/MH4)

| 26/8/A/19/MH4 | HFNE 11 | 6D | N/A | N/A | 8.5 | 09:48 | - | --:-- | 8.5 | 10:49 |

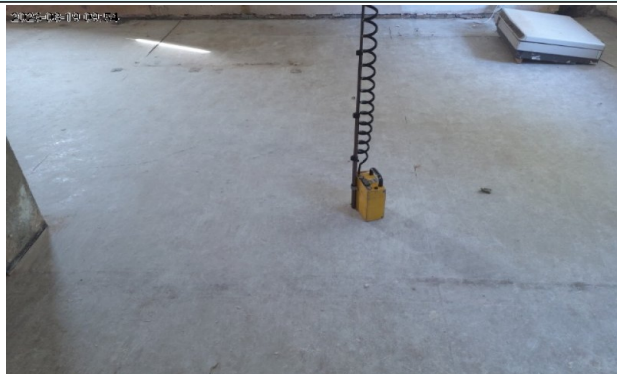
Sampling pump (sample ref: 26/8/A/19/MH5)

| 26/8/A/19/MH5 | HFNE 33 | 6E | N/A | N/A | 8.5 | 09:49 | - | --:-- | 8.5 | 10:50 |

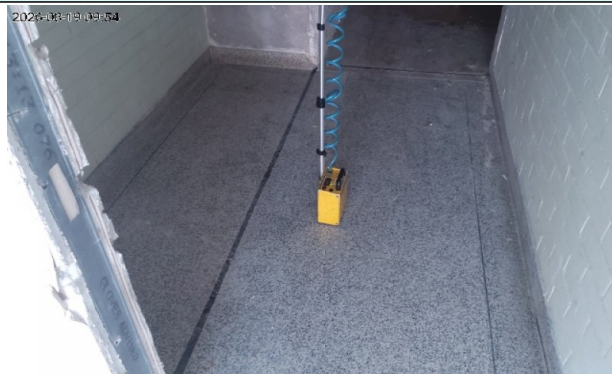
Sampling pump (sample ref: 26/8/A/19/MH6)

| 26/8/A/19/MH6 | HFNE JD03926 | 6F | N/A | N/A | 8.5 | 09:50 | - | --:-- | 8.5 | 10:51 |
