| Site Air Test Certificate Ref: | ST/26/8/17/MH1 | Date of Issue: | 17/08/2026 | Page 1 of 5 |

| | <b>Area Assessed:</b> | Third Floor of Block of Flats |
| | <b>Description of reason for test (including the nature and extent of ACMs removed):</b> | Reassurance Air Test following removal of Bitumen Adhesive to Floor and Textured Coating from Ceilings (Concrete) and Textured Coating to Concrete Walls and Ceiling to Corridors |

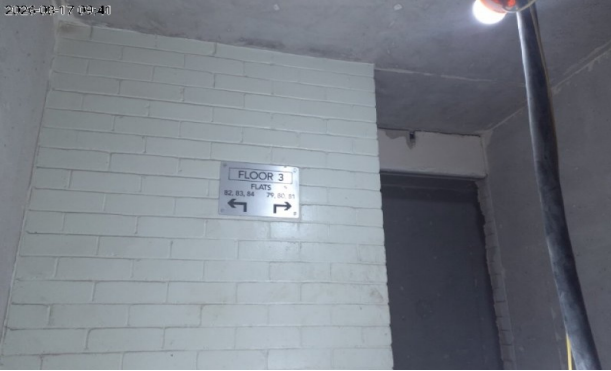
| <b>Floor Entrance</b> | <b>Ceiling</b> |

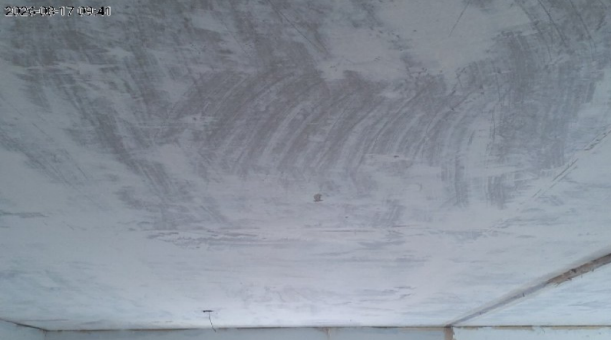
| <b>Ceiling</b> | <b>Floor</b> |

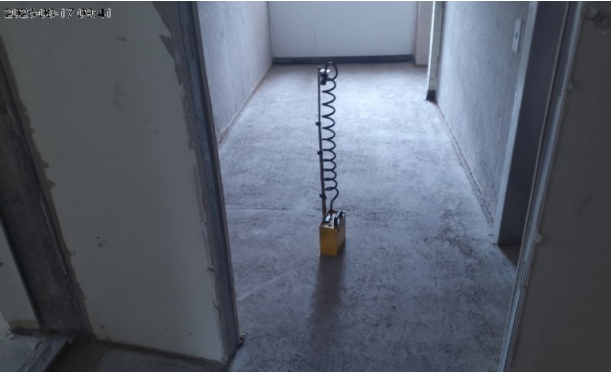
| <b>Sampling pump (sample ref: 26/8/A/17/MH1)</b> | <b>Sampling pump (sample ref: 26/8/A/17/MH2)</b> |

| Sample Number | Pump No. | Head No. | Temp | Pressure | Start Flow | Start Time | Interim Flow | Interim Time | End Flow | End Time |
|---|---|---|---|---|---|---|---|---|---|---|
| 26/8/A/17/MH1 | HFNE 17 | 6A | N/A | N/A | 8.5 | 09:29 | - | --:-- | 8.5 | 10:31 |

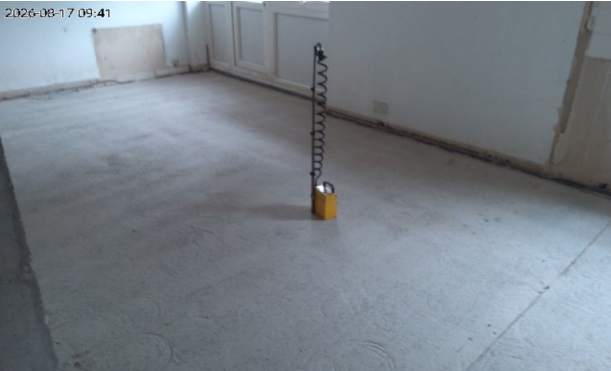
| <b>Sampling pump (sample ref: 26/8/A/17/MH3)</b> | <b>Sampling pump (sample ref: 26/8/A/17/MH4)</b> |

| Sample Number | Pump No. | Head No. | Temp | Pressure | Start Flow | Start Time | Interim Flow | Interim Time | End Flow | End Time |
|---|---|---|---|---|---|---|---|---|---|---|
| 26/8/A/17/MH3 | HFNE 20 | 6C | N/A | N/A | 8.5 | 09:31 | - | --:-- | 8.5 | 10:33 |

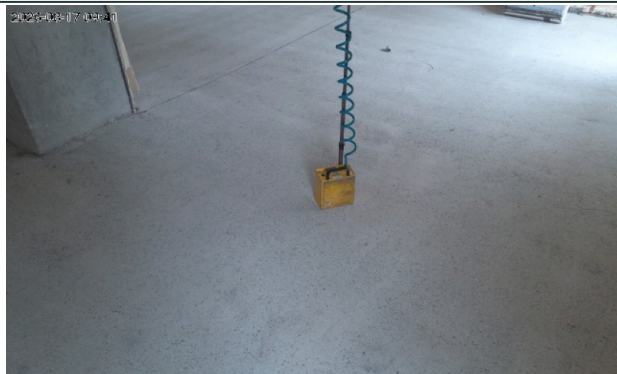
Sampling pump (sample ref: 26/8/A/17/MH5)

| Sample Number | Pump No. | Head No. | Temp | Pressure | Start Flow | Start Time | Interim Flow | Interim Time | End Flow | End Time |
|---|---|---|---|---|---|---|---|---|---|---|
| 26/8/A/17/MH5 | HFNE 23 | 6E | N/A | N/A | 8.5 | 09:33 | - | --:-- | 8.5 | 10:35 |

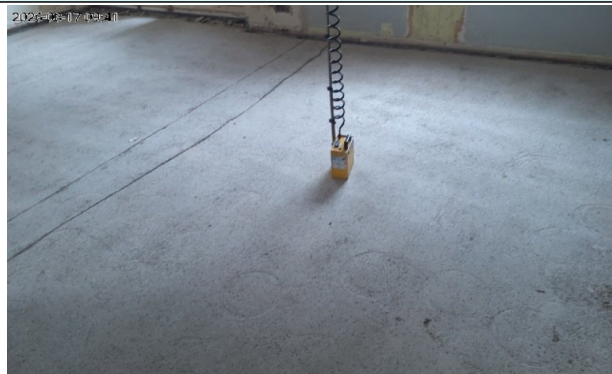
Sampling pump (sample ref: 26/8/A/17/MH6)

| 26/8/A/17/MH6 | HFNE 25 | 6F | N/A | N/A | 8.5 | 09:34 | - | --:-- | 8.5 | 10:36 |
