Demolition Asbestos Survey

Floors 1 to 4, Holme Park Court, Berry Brow, Huddersfield, HD4 7NH

Issue number:	1
Survey number:	7923.HP. Floors 1 - 4
Survey date:	December 2025 & January 2026
Client:	Metropolitan Demolition
Survey carried out by:	Phil Cox & Graham Brown
Survey compiled by:	Phil Cox & Graham Brown
Survey checked by:	Phil Cox & Graham Brown
Survey Issued	02/02/26

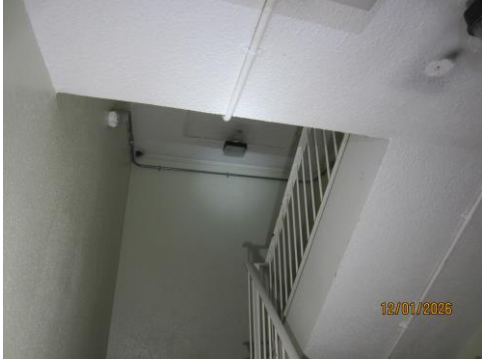
Level of ID:	Sampled	Ref:	S01
	Building / Floor: HPC / First Area: Communal, R01 Stairs Location: Ceiling Description: Artex on concrete Asbestos Type: Chrysotile Amount: 10m2			
Recommendations:				
Remove in accordance with the Control of Asbestos Regulations 2012 and dispose of as hazardous waste.

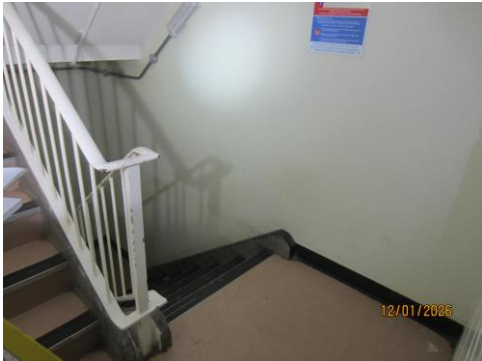
Level of ID:	Sampled	Ref:	S02
	Building / Floor: HPC / First Area: Communal, R01 Stairs Location: Wall Description: Artex on concrete Asbestos Type: Chrysotile Amount: 25m2			
Recommendations:				
Remove in accordance with the Control of Asbestos Regulations 2012 and dispose of as hazardous waste.

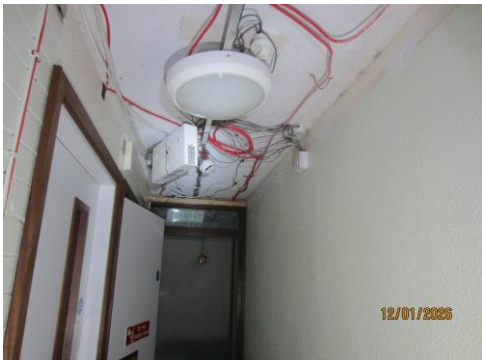
Level of ID:	Visually inspected	Ref:	As S01
	Building / Floor: HPC / First Area: Communal, R02 Landing Location: Ceiling Description: Artex on concrete Asbestos Type: Chrysotile Amount: 4m2			
Recommendations:				
Remove artex in accordance with the Control of Asbestos Regulations 2012 and dispose of as hazardous waste.

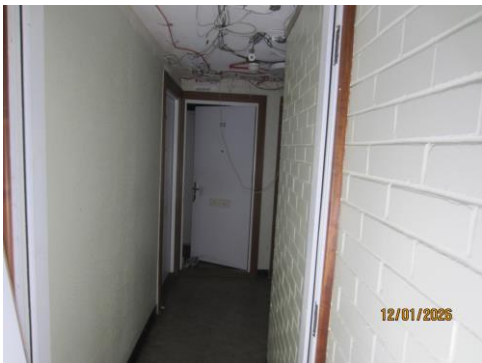
Level of ID:	Visually inspected	Ref:	As S02
	<p>Building / Floor: HPC / First Area: Communal, R03 Corridor Location: Wall Description: Artex on concrete, masonry, stud wall Asbestos Type: Chrysotile Amount: 12m2</p>

Remove artex in accordance with the Control of Asbestos Regulations 2012 and dispose of as hazardous waste.

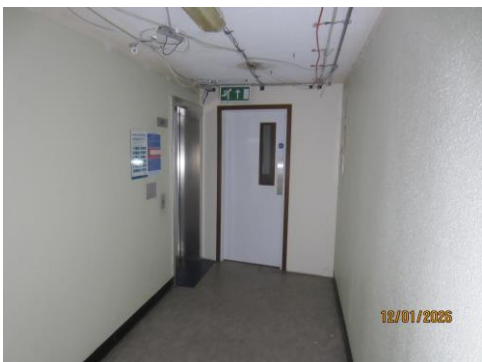
Level of ID:	Visually inspected	Ref:	As S02
	<p>Building / Floor: HPC / First Area: Communal, R04 Corridor Location: Wall Description: Artex on concrete, masonry, stud wall Asbestos Type: Chrysotile Amount: 15m2</p>

Remove artex in accordance with the Control of Asbestos Regulations 2012 and dispose of as hazardous waste.

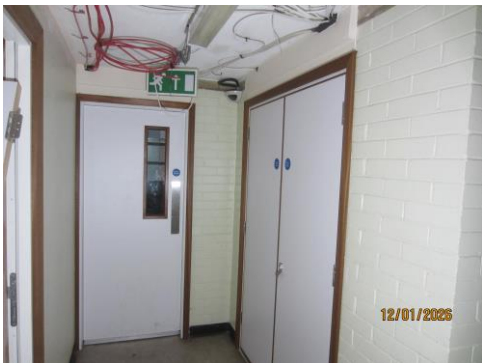
Level of ID:	Visually inspected	Ref:	S05
	Building / Floor: HPC / First Area: Communal, R05 Corridor Location: Wall Description: Artex on concrete, masonry Asbestos Type: Chrysotile Amount: 20m2			
Recommendations:				
Remove artex in accordance with the Control of Asbestos Regulations 2012 and dispose of as hazardous waste.

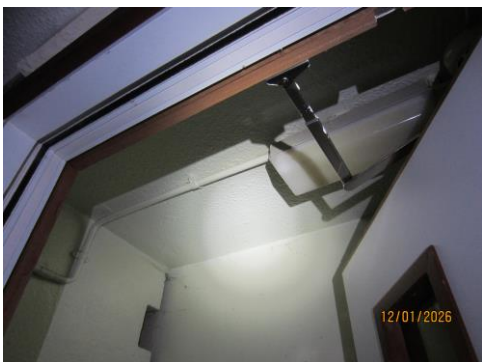
Level of ID:	Visually inspected	Ref:	As S04
	Building / Floor: HPC / First Area: Communal, R07 Refuse chute room Location: Ceiling Description: Artex on concrete Asbestos Type: Chrysotile Amount: 2m2			
Recommendations:				
Remove artex in accordance with the Control of Asbestos Regulations 2012 and dispose of as hazardous waste.

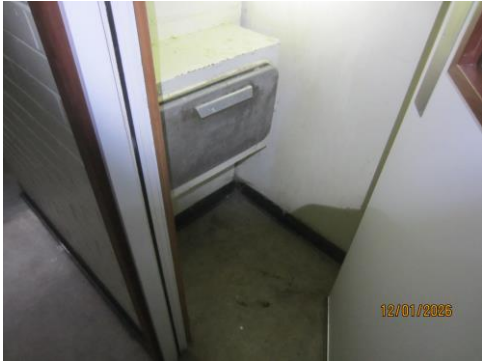
Level of ID:	Visually inspected	Ref:	As S05
	Building / Floor: HPC / First Area: Communal, R07 Refuse chute room Location: Wall Description: Artex on concrete, masonry, stud wall Asbestos Type: Chrysotile Amount: 10m2

Remove artex in accordance with the Control of Asbestos Regulations 2012 and dispose of as hazardous waste.

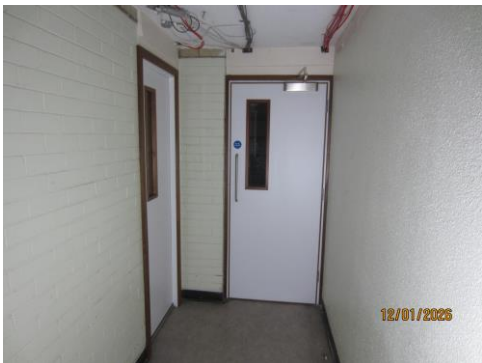
Level of ID:	Visually inspected	Ref:	As S05
	Building / Floor: HPC / First Area: Communal, R08 Corridor Location: Wall Description: Artex on concrete, masonry, stud wall Asbestos Type: Chrysotile Amount: 8m2

Remove artex in accordance with the Control of Asbestos Regulations 2012 and dispose of as hazardous waste.

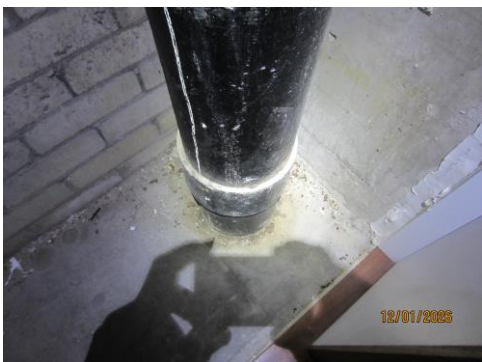
Level of ID:	Visually inspected	Ref:	
	Building / Floor: HPC / First Area: Communal, R09 Riser Location: Wall Description: Concrete, masonry Asbestos Type: No suspect material Amount:

No action required

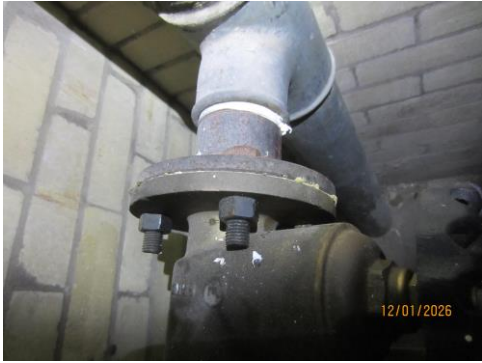
Level of ID:	Sampled	Ref:	S06
	Building / Floor: HPC / First Area: Communal, R09 Riser Location: Pipework Description: Flange gasket to pipework Asbestos Type: No asbestos detected Amount:			
Recommendations:				
No action required

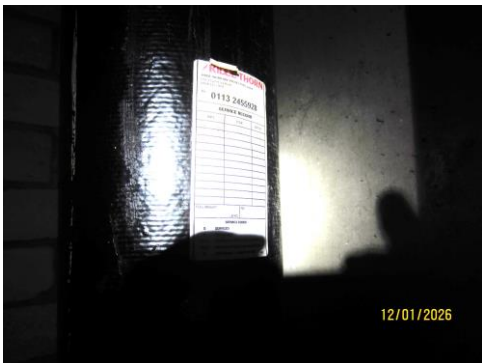
Level of ID:	Visually inspected	Ref:	
	Building / Floor: HPC / First Area: Communal, R09 Riser Location: Floor Description: Concrete, fire protection wrap to downpipe Asbestos Type: No suspect material Amount:			
Recommendations:				
No action required

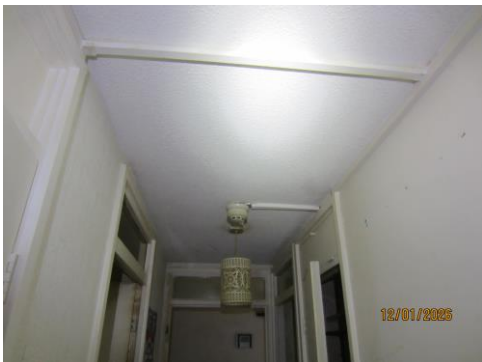
Level of ID:	Sampled	Ref:	S07
	Building / Floor: HPC / First Area: Flat 92, R01 Hallway Location: Ceiling Description: Artex on concrete Asbestos Type: Chrysotile Amount: 4m2			
Recommendations:				
Remove artex in accordance with the Control of Asbestos Regulations 2012 and dispose of as hazardous waste.

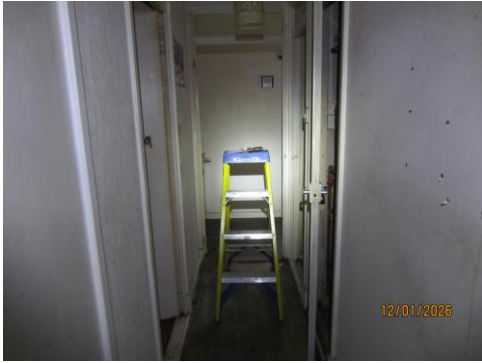
Level of ID:	Visually inspected	Ref:	
	<p>Building / Floor: HPC / First</p> <p>Area: Flat 92, R01 Hallway</p> <p>Location: Wall</p> <p>Description: Concrete, plasterboard lined, stud walls, metal cabinet, header panels above doors are a mixture of glass, timber, supalux & fire board</p> <p>Asbestos Type: No suspect material</p> <p>Amount:</p>			
Recommendations:				
No action required

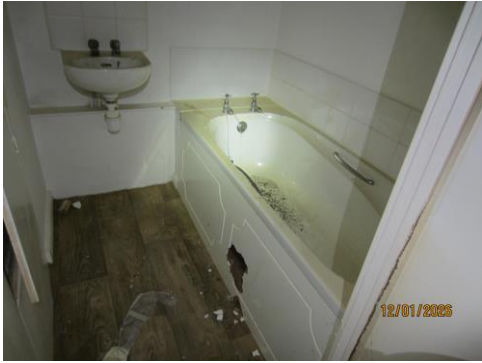
Level of ID:	Visually inspected	Ref:	As S08
	<p>Building / Floor: HPC / First</p> <p>Area: Flat 92, R02 Bathroom</p> <p>Location: Floor</p> <p>Description: Bitumen on floor slab below floor covering, modern sanitaryware & fittings</p> <p>Asbestos Type: Chrysotile</p> <p>Amount: 1m2</p>

Remove bitumen in accordance with the Control of Asbestos Regulations 2012 and dispose of as hazardous waste.

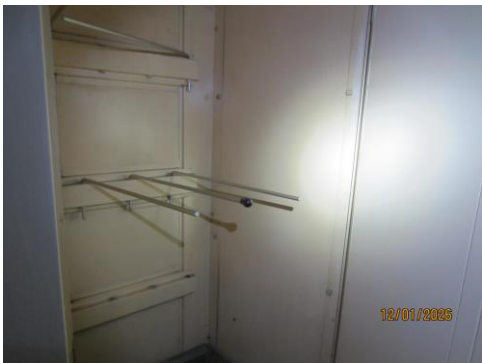
Level of ID:	Visually inspected	Ref:	
	<p>Building / Floor: HPC / First</p> <p>Area: Flat 92, R03 Drying cabinet</p> <p>Location: Wall</p> <p>Description: Metal</p> <p>Asbestos Type: No suspect material</p> <p>Amount:</p>

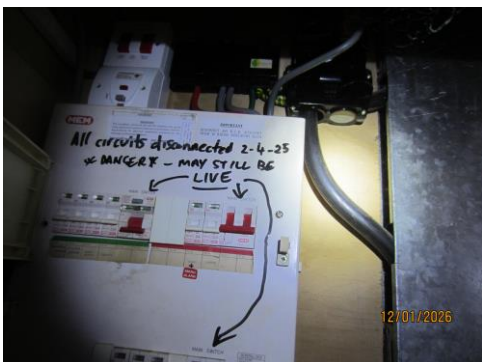
Level of ID:	Visually inspected	Ref:	
	<p>Building / Floor: HPC / First</p> <p>Area: Flat 92, R04 Electric cupboard</p> <p>Location: Wall</p> <p>Description: Stud wall, timber backing panel, modern electrics</p> <p>Asbestos Type: No suspect material</p> <p>Amount:</p>

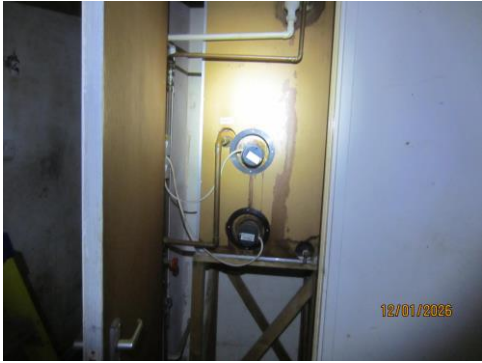
Level of ID:	Visually inspected	Ref:	
	Building / Floor: HPC / First Area: Flat 92, R05 Tank cupboard Location: Wall Description: Stud wall, modern tank & insulation Asbestos Type: No suspect material Amount:			
Recommendations:				
No action required

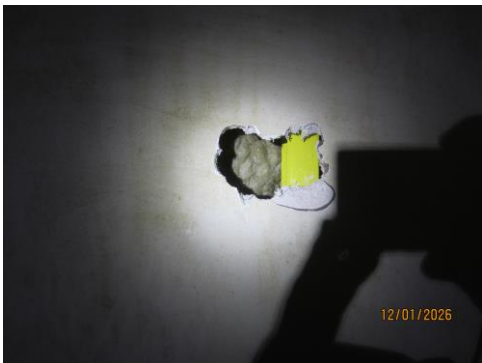
Level of ID:	Visually inspected	Ref:	
	Building / Floor: HPC / First Area: Flat 92 R06 Toilet Location: Wall Description: Stud wall, Supalux IPS and divider panel Asbestos Type: No suspect material Amount:			
Recommendations:				
No action required

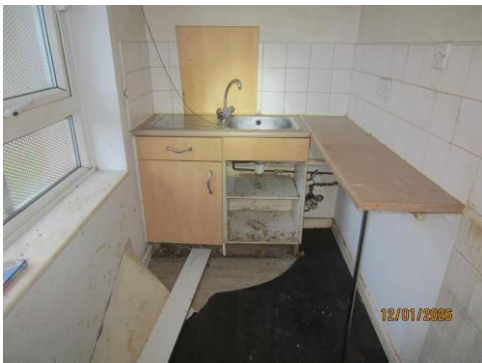
Level of ID:	Visually inspected	Ref:	As S08
	Building / Floor: HPC / First Area: Flat 92 R07 Kitchen Location: Floor Description: Bitumen on floor slab below floor covering, modern units & fittings Asbestos Type: Chrysotile Amount: 3.5m2			
Recommendations:				
Remove bitumen in accordance with the Control of Asbestos Regulations 2012 and dispose of as hazardous waste.

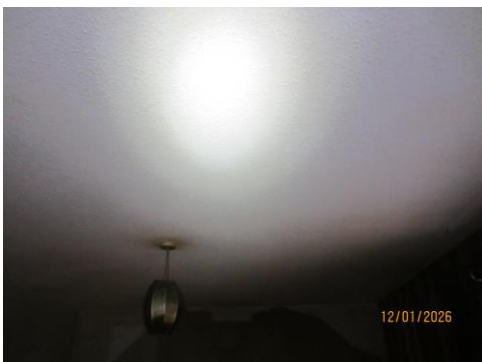
Level of ID:	Sampled	Ref:	S09
	Building / Floor: HPC / First Area: Flat 92 R08 Lounge Location: Ceiling Description: Artex on concrete Asbestos Type: Chrysotile Amount: 16m2			
Recommendations:				
Remove artex in accordance with the Control of Asbestos Regulations 2012 and dispose of as hazardous waste.

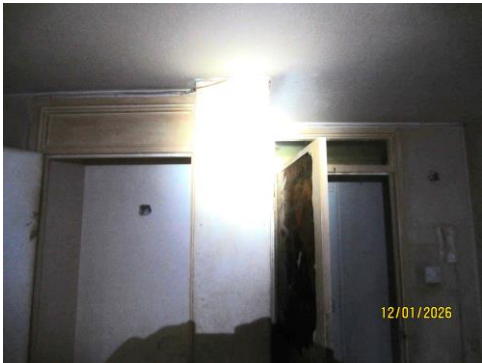
Level of ID:	Visually inspected	Ref:	As S09
	Building / Floor: HPC / First Area: Flat 92 R09 Cupboard Location: Ceiling Description: Artex on concrete Asbestos Type: Chrysotile Amount: 0.5m2			
Recommendations:				
Remove artex in accordance with the Control of Asbestos Regulations 2012 and dispose of as hazardous waste.

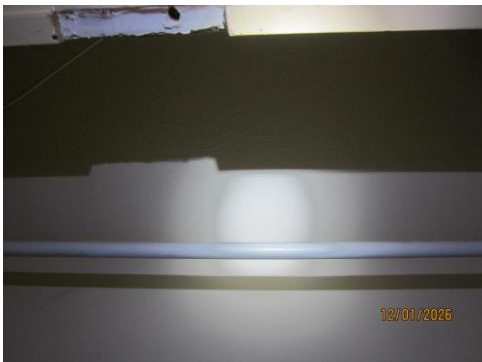
Level of ID:	Visually inspected	Ref:	As S09
	Building / Floor: HPC / First Area: Flat 92 R10 Cupboard Location: Ceiling Description: Artex on concrete Asbestos Type: Chrysotile Amount: 1m2			
Recommendations:				
Remove artex in accordance with the Control of Asbestos Regulations 2012 and dispose of as hazardous waste.

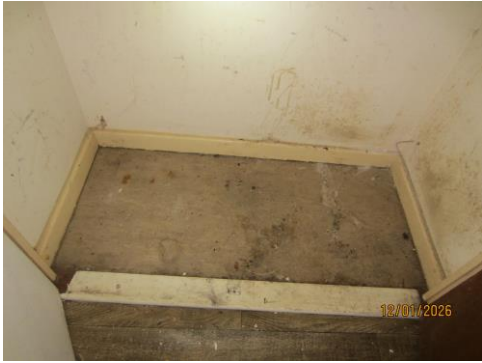
Level of ID:	Visually inspected	Ref:	As S08
	Building / Floor: HPC / First Area: Flat 92 R10 Cupboard Location: Floor Description: Bitumen on floor slab below floor covering Asbestos Type: Chrysotile Amount: 1m2

Remove bitumen in accordance with the Control of Asbestos Regulations 2012 and dispose of as hazardous waste.

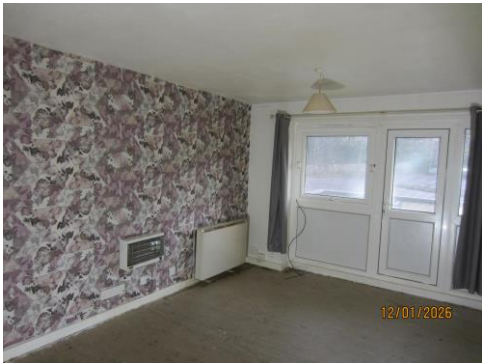
Level of ID:	Visually inspected	Ref:	As S09
	Building / Floor: HPC / First Area: Flat 91 & flats 93 to 96 Location: Ceiling Description: Artex on concrete Asbestos Type: Chrysotile Amount: 175m2

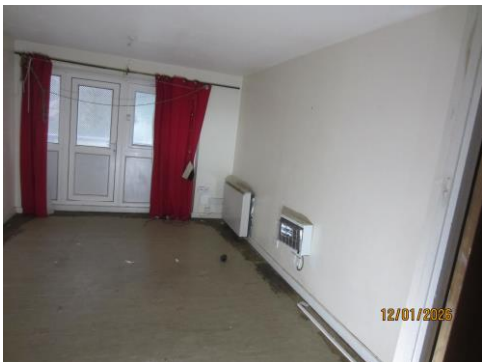
Level of ID:	Visually inspected	Ref:	As S08
	Building / Floor: HPC / First Area: Flat 91 & flats 93 to 96 Location: Floor Description: Bitumen on floor slab below floor covering Asbestos Type: Chrysotile Amount: 175m2

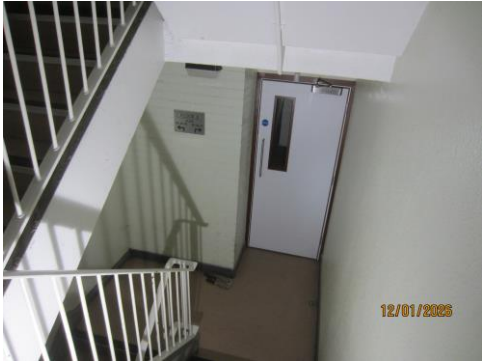
Level of ID:	Visually inspected	Ref:	As S09
	Building / Floor: HPC / Second Area: Communal areas Location: Wall Description: Artex on concrete Asbestos Type: Chrysotile Amount: 101m2

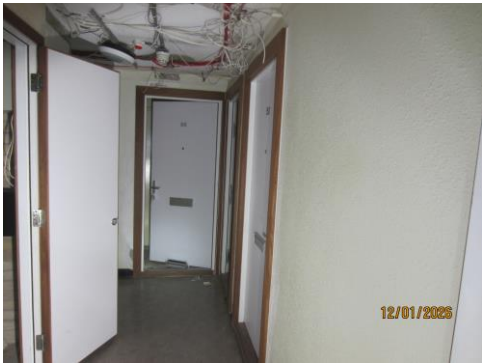
Level of ID:	Visually inspected	Ref:	As S08
	Building / Floor: HPC / Second Area: Communal areas Location: Floor Description: Bitumen on floor slab below floor covering Asbestos Type: Chrysotile Amount: 45m2

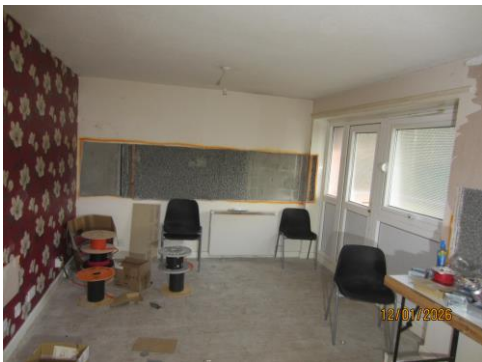
Level of ID:	Visually inspected	Ref:	As S09
	Building / Floor: HPC / Second Area: Flats 85 to 90 Location: Ceiling Description: Artex on concrete Asbestos Type: Chrysotile Amount: 202m2

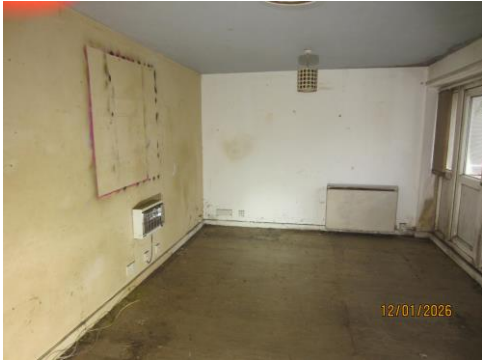
Level of ID:	Visually inspected	Ref:	As S08
	Building / Floor: HPC / Second Area: Flats 85 to 90 Location: Floor Description: Bitumen on floor slab below floor covering Asbestos Type: Chrysotile Amount: 202m2

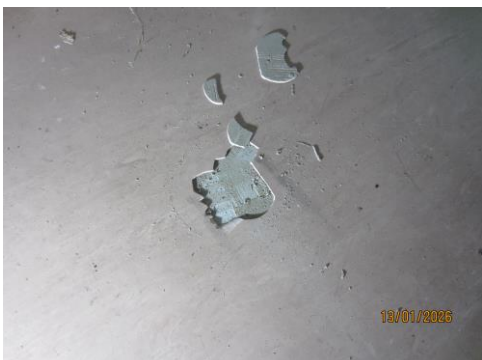
Level of ID:	Sampled	Ref:	S05
	Building / Floor: HPC / Third Area: Communal, R01 Stairs Location: Floor Description: Vinyl on concrete, stair nosing, metal balustrade Asbestos Type: No asbestos detected Amount:

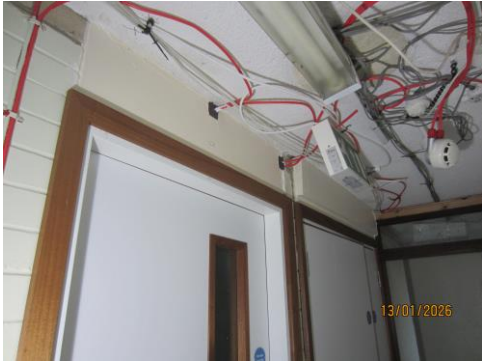
Level of ID:	Visually inspected	Ref:	As S04
	<p>Building / Floor: HPC / Third</p> <p>Area: Communal, R02 Landing</p> <p>Location: Ceiling</p> <p>Description: Artex on concrete</p> <p>Asbestos Type: Chrysotile</p> <p>Amount: 4m2</p>

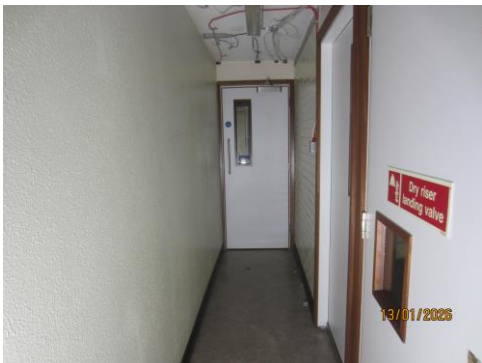
Level of ID:	Visually inspected	Ref:	As S02
	<p>Building / Floor: HPC / Third</p> <p>Area: Communal, R02 Landing</p> <p>Location: Wall</p> <p>Description: Artex on concrete, masonry</p> <p>Asbestos Type: Chrysotile</p> <p>Amount: 11m2</p>

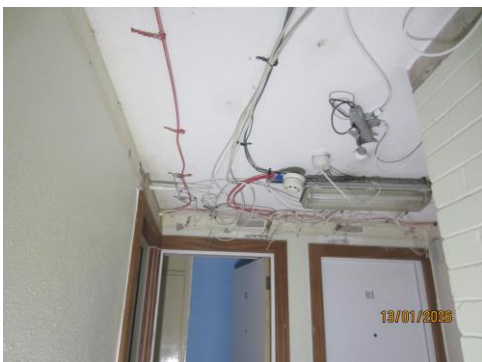
Level of ID:	Visually inspected	Ref:	As S04
	<p>Building / Floor: HPC / Third</p> <p>Area: Communal, R03 Corridor</p> <p>Location: Ceiling</p> <p>Description: Artex on concrete</p> <p>Asbestos Type: Chrysotile</p> <p>Amount: 6m2</p>

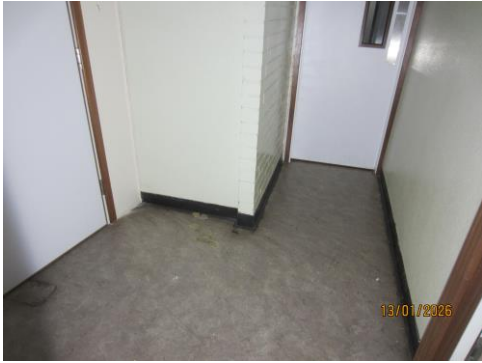
Level of ID:	Visually inspected	Ref:	As S03
	Building / Floor: HPC / Third Area: Communal, R03 Corridor Location: Floor Description: Bitumen on floor slab below floor covering Asbestos Type: Chrysotile Amount: 6m2

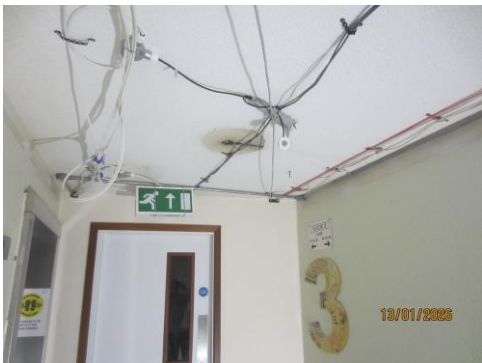
Level of ID:	Sampled	Ref:	S04
	Building / Floor: HPC / Third Area: Communal, R04 Corridor Location: Ceiling Description: Artex on concrete Asbestos Type: Chrysotile Amount: 7m2

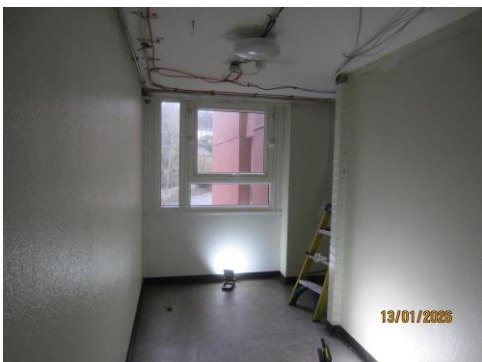
Level of ID:	Visually inspected	Ref:	As S02
	Building / Floor: HPC / Third Area: Communal, R04 Corridor Location: Wall Description: Artex on concrete, masonry, stud wall Asbestos Type: Chrysotile Amount: 15m2

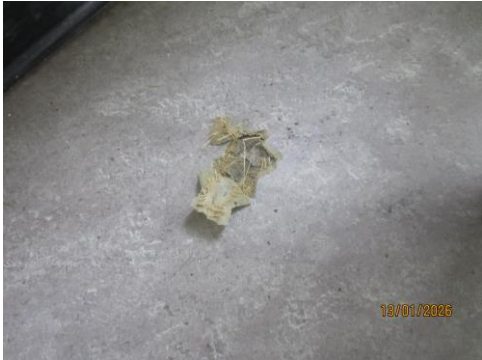
Level of ID:	Sampled	Ref:	S03
	Building / Floor: HPC / Third Area: Communal, R04 Corridor Location: Floor Description: Bitumen on floor slab below floor covering Asbestos Type: Chrysotile Amount: 7m2

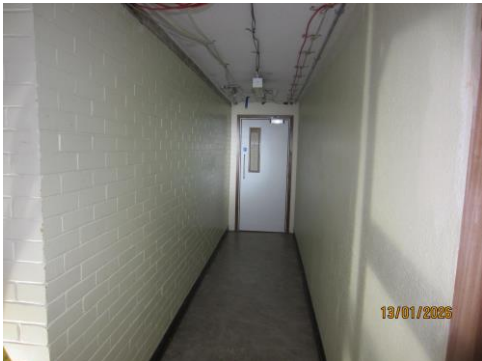
Level of ID:	Visually inspected	Ref:	As S04
	Building / Floor: HPC / Third Area: Communal, R05 Corridor Location: Ceiling Description: Artex on concrete Asbestos Type: Chrysotile Amount: 10m2

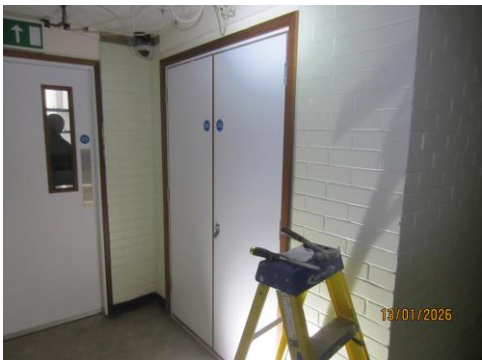
Level of ID:	Visually inspected	Ref:	As S03
	Building / Floor: HPC / Third Area: Communal, R05 Corridor Location: Floor Description: Bitumen on floor slab below floor covering Asbestos Type: Chrysotile Amount: 10m2

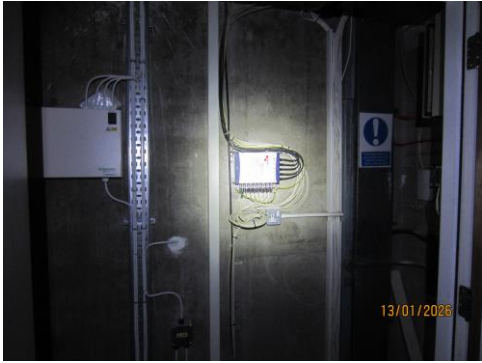
Level of ID:	Visually inspected	Ref:	
	Building / Floor: HPC / Third Area: Communal, R06 Service riser Location: Wall Description: Concrete, masonry Asbestos Type: No suspect material Amount:			
Recommendations:				
No action required

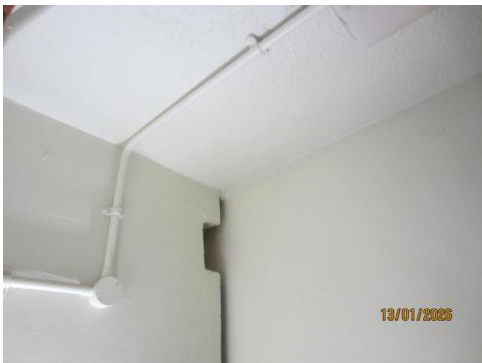
Level of ID:	Visually inspected	Ref:	As S02
	Building / Floor: HPC / Third Area: Communal, R07 Refuse chute room Location: Wall Description: Artex on concrete, masonry, stud wall Asbestos Type: Chrysotile Amount: 10m2			
Recommendations:				
Remove artex in accordance with the Control of Asbestos Regulations 2012 and dispose of as hazardous waste.

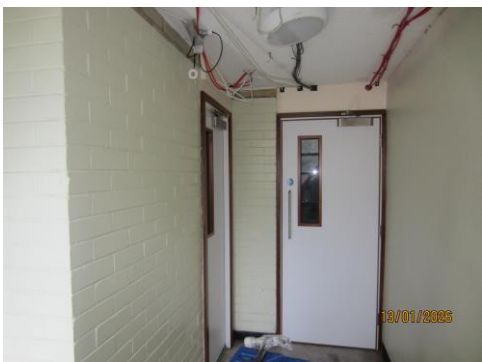
Level of ID:	Visually inspected	Ref:	As S04
	Building / Floor: HPC / Third Area: Communal, R08 Corridor Location: Ceiling Description: Artex on concrete Asbestos Type: Chrysotile Amount: 5m2			
Recommendations:				
Remove artex in accordance with the Control of Asbestos Regulations 2012 and dispose of as hazardous waste.

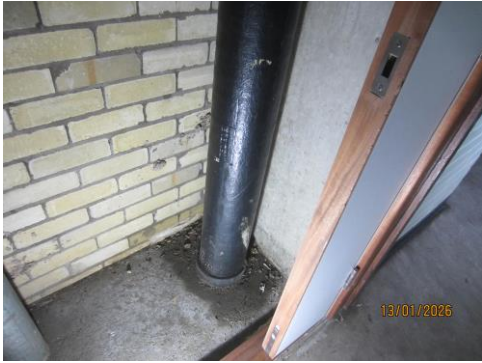
Level of ID:	Sampled	Ref:	S01
	Building / Floor: HPC / Third Area: Communal, R09 Riser Location: Pipework Description: Fire wrap to down pipe Asbestos Type: No asbestos detected Amount:			
Recommendations:				
No action required

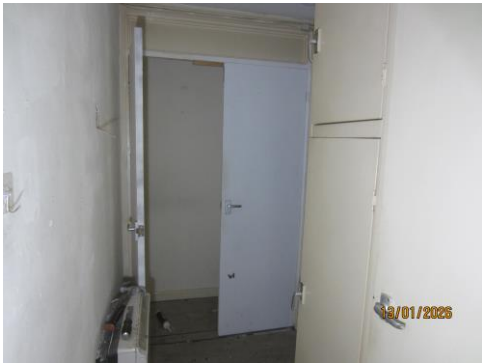
Level of ID:	Visually inspected	Ref:	As S07
	Building / Floor: HPC / Third Area: Flat 79, R01 Hallway Location: Ceiling Description: Artex on concrete Asbestos Type: Chrysotile Amount: 4m2			
Recommendations:				
Remove artex in accordance with the Control of Asbestos Regulations 2012 and dispose of as hazardous waste.

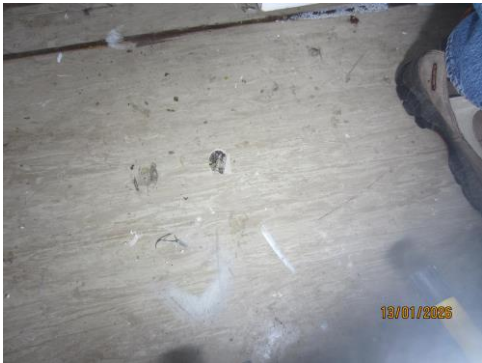
Level of ID:	Sampled	Ref:	S06
	Building / Floor: HPC / Third Area: Flat 79, R01 Hallway Location: Floor Description: Bitumen on floor slab below floor covering Asbestos Type: Chrysotile Amount: 4m2			
Recommendations:				
Remove bitumen in accordance with the Control of Asbestos Regulations 2012 and dispose of as hazardous waste.

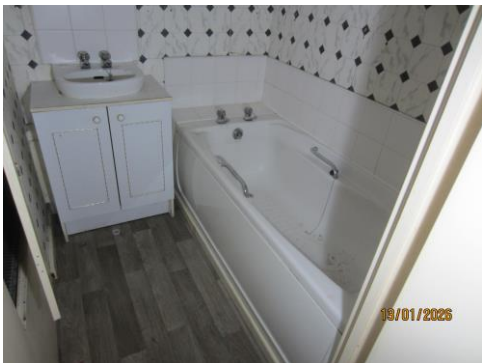
Level of ID:	Visually inspected	Ref:	As S06
	Building / Floor: HPC / Third Area: Flat 79, R02 Bathroom Location: Floor Description: Bitumen on floor slab below floor covering, modern sanitaryware & fittings Asbestos Type: Chrysotile Amount: 1m2

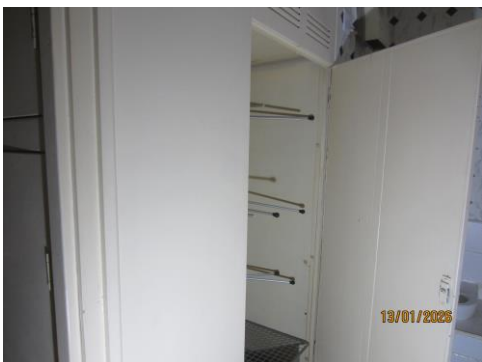
Level of ID:	Visually inspected	Ref:	
	Building / Floor: HPC / Third Area: Flat 79, R03 Drying cabinet Location: Wall Description: Metal Asbestos Type: No suspect material Amount:

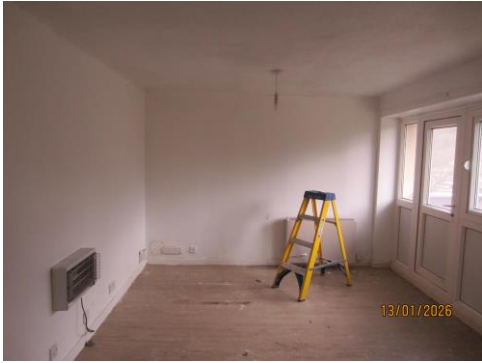
Level of ID:	Sampled	Ref:	S07
	Building / Floor: HPC / Third Area: Flat 79 R08 Lounge Location: Ceiling Description: Artex on concrete Asbestos Type: Chrysotile Amount: 16m2
