Demolition Asbestos Survey

Floors 9 - 12, Holme Park Court, Berry Brow, Huddersfield, HD4 7NH

Issue number:	1
Survey number:	7923 HPC Floors 9 - 12
Survey date:	January 2026
Client:	Metropolitan Demolition
Survey carried out by:	Phil Cox & Graham Brown
Survey compiled by:	Phil Cox & Graham Brown
Survey checked by:	Phil Cox & Graham Brown
Survey Issued	06/02/2026

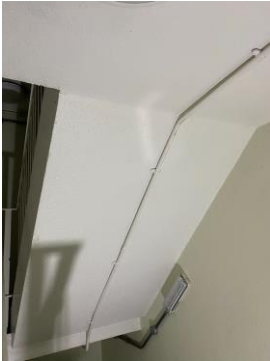
Level of ID:	Visually inspected	Ref:	As S05
	Building / Floor: HPC / Ninth Area: Communal, R01 Stairs Location: Ceiling Description: Artex on concrete Asbestos Type: Chrysotile Amount: 10 m2

Remove artex in accordance with the Control of Asbestos Regulations 2012 and dispose of as hazardous waste.

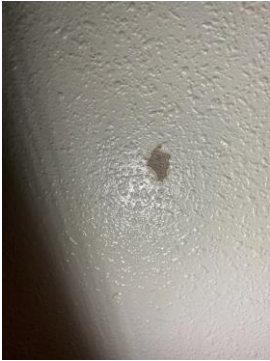
Level of ID:	Sampled	Ref:	S01
	Building / Floor: HPC / Ninth Area: Communal, R01 Stairs Location: Wall Description: Artex on concrete Asbestos Type: Chrysotile Amount: 25 m2

Remove artex in accordance with the Control of Asbestos Regulations 2012 and dispose of as hazardous waste.

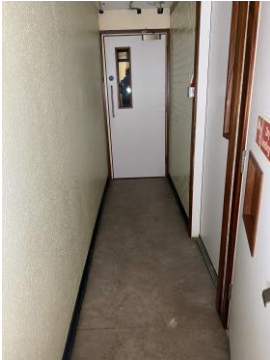
Level of ID:	Visually inspected	Ref:	As S05
	Building / Floor: HPC / Ninth Area: Communal, R02 Landing Location: Ceiling Description: Artex on concrete Asbestos Type: Chrysotile Amount: 4 m2

Remove artex in accordance with the Control of Asbestos Regulations 2012 and dispose of as hazardous waste.

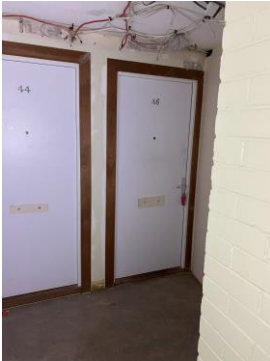
Level of ID:	Visually inspected	Ref:	As S02
	<p>Building / Floor: HPC / Ninth</p> <p>Area: Communal, R03 Corridor</p> <p>Location: Floor</p> <p>Description: Bitumen on floor slab below floor covering</p> <p>Asbestos Type: Chrysotile</p> <p>Amount: 6 m2</p>

Remove bitumen in accordance with the Control of Asbestos Regulations 2012 and dispose of as hazardous waste.

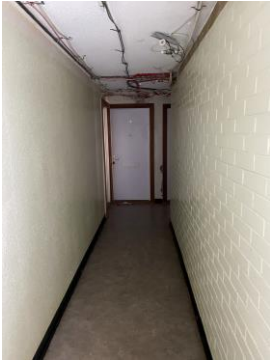
Level of ID:	Visually inspected	Ref:	As S01
	<p>Building / Floor: HPC / Ninth</p> <p>Area: Communal, R05 Corridor</p> <p>Location: Wall</p> <p>Description: Artex on concrete, masonry</p> <p>Asbestos Type: Chrysotile</p> <p>Amount: 20 m2</p>

Remove artex in accordance with the Control of Asbestos Regulations 2012 and dispose of as hazardous waste.

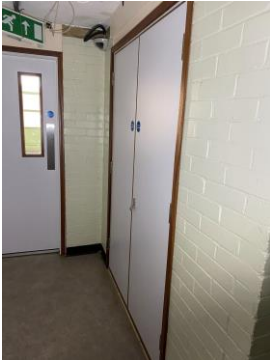
Level of ID:	Sampled	Ref:	S02
	<p>Building / Floor: HPC / Ninth</p> <p>Area: Communal, R05 Corridor</p> <p>Location: Floor</p> <p>Description: Bitumen on floor slab below floor covering</p> <p>Asbestos Type: Chrysotile</p> <p>Amount: 10 m2</p>

Remove bitumen in accordance with the Control of Asbestos Regulations 2012 and dispose of as hazardous waste.

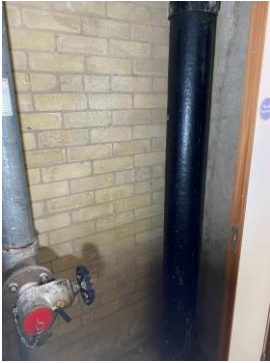
Level of ID:	Visually inspected	Ref:	As S01/6
	Building / Floor: HPC / Ninth Area: Communal, R09 Riser Location: Pipework Description: Pitch Fibre S&V pipe Asbestos Type: Chrysotile Amount: 2.5 lin m

Remove Pitch fibre pipe in accordance with the Control of Asbestos Regulations 2012 and dispose of as hazardous waste.

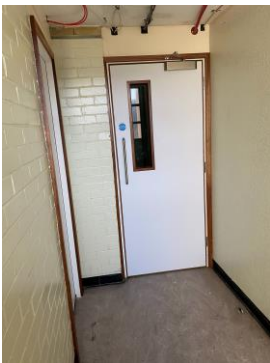
Level of ID:	Visually inspected	Ref:	As S01
	Building / Floor: HPC / Ninth Area: Communal, R08 Corridor Location: Wall Description: Artex on concrete, masonry, stud wall Asbestos Type: Chrysotile Amount: 8 m2

Remove artex in accordance with the Control of Asbestos Regulations 2012 and dispose of as hazardous waste.

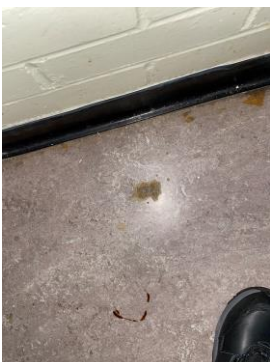
Level of ID:	Visually inspected	Ref:	As S02
	Building / Floor: HPC / Ninth Area: Communal, R08 Corridor Location: Floor Description: Bitumen on floor slab below floor covering Asbestos Type: Chrysotile Amount: 5 m2

Remove bitumen in accordance with the Control of Asbestos Regulations 2012 and dispose of as hazardous waste.

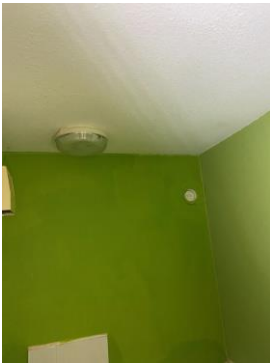
Level of ID:	Visually inspected	Ref:	As S05
	Building / Floor: HPC / Ninth Area: Flat 46, R02 Bathroom Location: Ceiling Description: Artex on concrete Asbestos Type: Chrysotile Amount: 2 m2			
Recommendations:				
Remove artex in accordance with the Control of Asbestos Regulations 2012 and dispose of as hazardous waste.

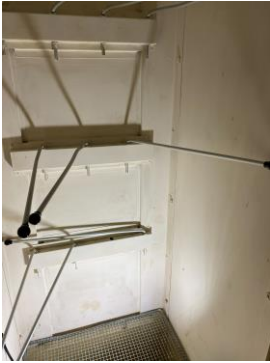
Level of ID:	Visually inspected	Ref:	
	<p>Building / Floor: HPC / Ninth</p> <p>Area: Flat 46, R03 Drying cabinet</p> <p>Location: Wall</p> <p>Description: Metal</p> <p>Asbestos Type: No suspect material</p> <p>Amount: m2</p>			
Recommendations:				
No action required

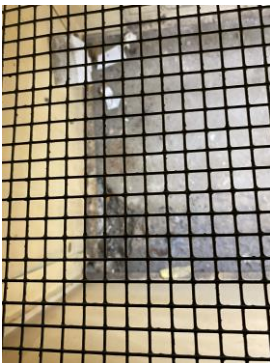
Level of ID:	Visually inspected	Ref:	
	<p>Building / Floor: HPC / Ninth</p> <p>Area: Flat 46, R03 Drying cabinet</p> <p>Location: Floor</p> <p>Description: Concrete</p> <p>Asbestos Type: No suspect material</p> <p>Amount: m2</p>			
Recommendations:				
No action required

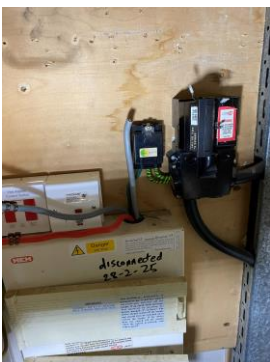
Level of ID:	Visually inspected	Ref:	
	<p>Building / Floor: HPC / Ninth</p> <p>Area: Flat 46, R04 Electric cupboard</p> <p>Location: Wall</p> <p>Description: Stud wall, timber backing panel, modern electrics</p> <p>Asbestos Type: No suspect material</p> <p>Amount: m2</p>			
Recommendations:				
No action required

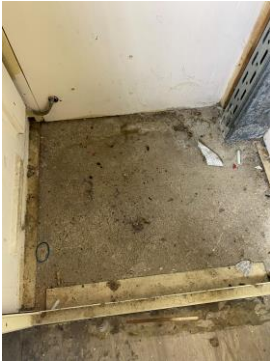
Level of ID:	Visually inspected	Ref:	
	Building / Floor: HPC / Ninth Area: Flat 46, R04 Electric cupboard Location: Floor Description: Concrete Asbestos Type: No suspect material Amount: m2			
Recommendations:				
No action required

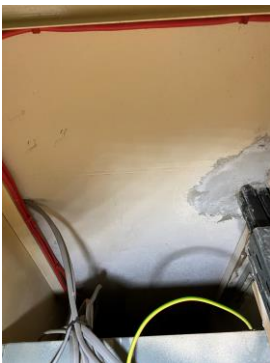
Level of ID:	Visually inspected	Ref:	
	Building / Floor: HPC / Ninth Area: Flat 46, R05 Tank cupboard Location: Ceiling Description: Concrete Asbestos Type: No suspect material Amount: m2			
Recommendations:				
No action required

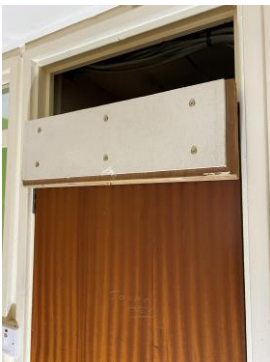
Level of ID:	Sampled	Ref:	S04
	Building / Floor: HPC / Ninth Area: Flat 46, R05 Tank cupboard Location: Wall Description: Header panel to door sampled. Stud wall, modern tank & insulation Asbestos Type: No asbestos detected Amount: m2			
Recommendations:				
No action required

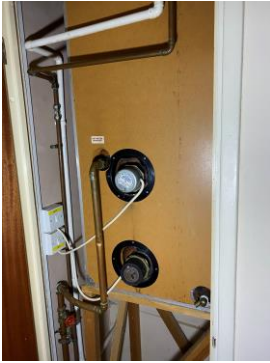
Level of ID:	Sampled	Ref:	S03
	Building / Floor: HPC / Ninth Area: Flat 46, R05 Tank cupboard Location: Floor Description: Vinyl on concrete Asbestos Type: No asbestos detected Amount: m2			
Recommendations:				
No action required

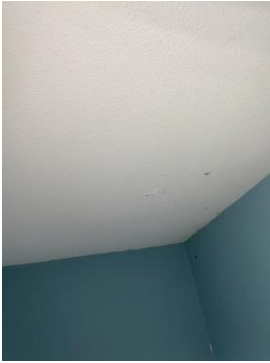
Level of ID:	Visually inspected	Ref:	As S05
	Building / Floor: HPC / Ninth Area: Flat 46 R07 Kitchen Location: Ceiling Description: Artex on concrete Asbestos Type: Chrysotile Amount: 3.5 m2

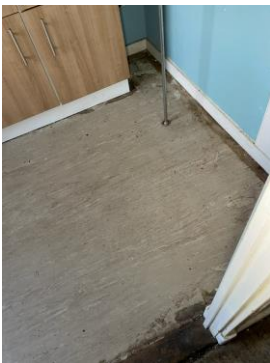
Level of ID:	Visually inspected	Ref:	As S02
	Building / Floor: HPC / Ninth Area: Flat 46 R07 Kitchen Location: Floor Description: Bitumen on floor slab below floor covering, modern units & fittings Asbestos Type: Chrysotile Amount: 3.5 m2

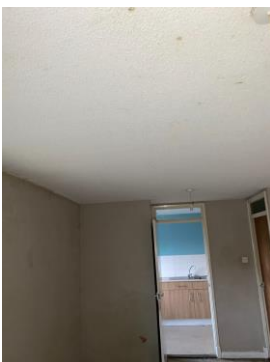
Level of ID:	Visually inspected	Ref:	As S05
	Building / Floor: HPC / Ninth Area: Flat 46 R08 Lounge Location: Ceiling Description: Artex on concrete Asbestos Type: Chrysotile Amount: 14 m2

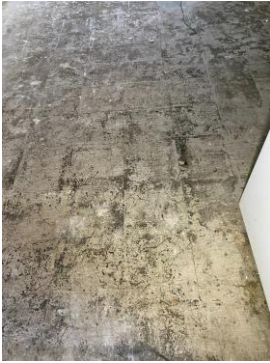
Level of ID:	Visually inspected	Ref:	As S02
	Building / Floor: HPC / Ninth Area: Flat 46 R08 Lounge Location: Floor Description: Bitumen on the floor slab below floor covering Asbestos Type: Chrysotile Amount: 14 m2

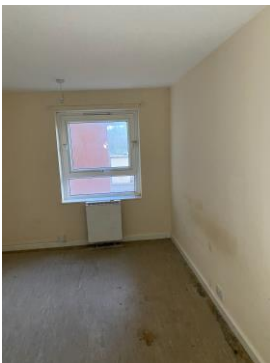
Level of ID:	Visually inspected	Ref:	As S05
	Building / Floor: HPC / Ninth Area: Flat 46 R09 Bedroom Location: Ceiling Description: Artex on concrete Asbestos Type: Chrysotile Amount: 11 m2

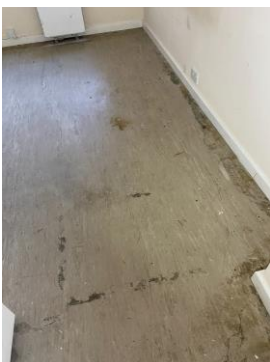
Level of ID:	Visually inspected	Ref:	As S02
	Building / Floor: HPC / Ninth Area: Flat 46 R09 Bedroom Location: Floor Description: Bitumen on floor slab below floor covering Asbestos Type: Chrysotile Amount: 11 m2

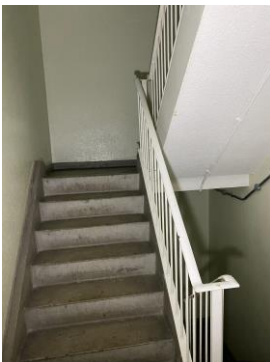
Level of ID:	Visually inspected	Ref:	As S05
	Building / Floor: HPC / Tenth Area: Communal areas Location: Ceiling Description: Artex on concrete Asbestos Type: Chrysotile Amount: 44 m2			
Recommendations:				
Remove artex in accordance with the Control of Asbestos Regulations 2012 and dispose of as hazardous waste.

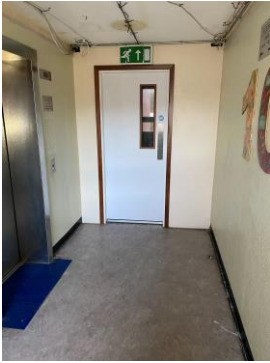
Level of ID:	Visually inspected	Ref:	As S02
	Building / Floor: HPC / Tenth Area: Communal areas Location: Floor Description: Bitumen on floor slab below floor covering Asbestos Type: Chrysotile Amount: 34 m2

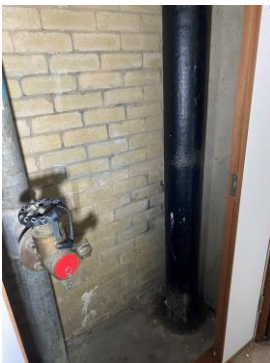
Level of ID:	Visually inspected	Ref:	As S01/6
	Building / Floor: HPC / Tenth Area: Communal, R09 Riser Location: Pipework Description: Pitch Fibre S&V pipe Asbestos Type: Chrysotile Amount: 2.5 lin m

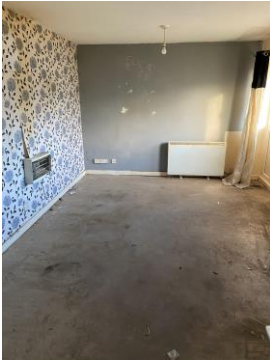
Level of ID:	Visually inspected	Ref:	As S05
	Building / Floor: HPC / Tenth Area: Flats 37 to 42 Location: Ceiling Description: Artex on concrete Asbestos Type: Chrysotile Amount: 205 m2

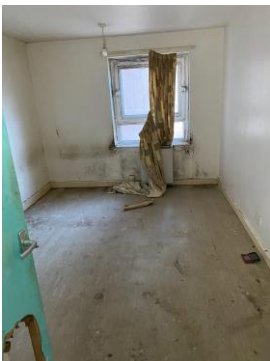
Level of ID:	Visually inspected	Ref:	As S02
	Building / Floor: HPC / Tenth Area: Flats 37 to 42 Location: Floor Description: Bitumen on floor slab below floor covering Asbestos Type: Chrysotile Amount: 199 m2

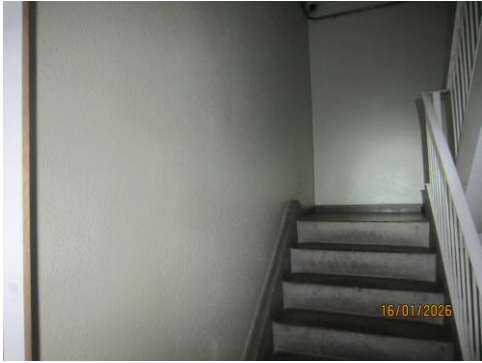
Level of ID:	Sampled	Ref:	S02
	Building / Floor: HPC / Eleventh Area: Communal, R01 Stairs Location: Wall Description: Artex on concrete Asbestos Type: Chrysotile Amount: 25 m2

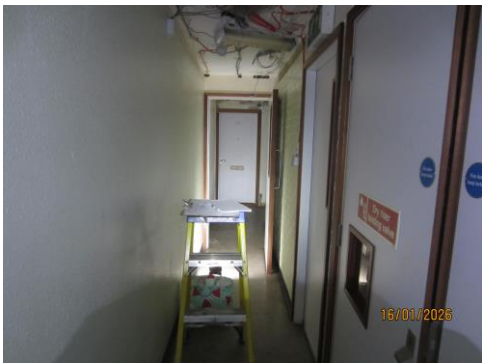
Level of ID:	Visually inspected	Ref:	As S01
	Building / Floor: HPC / Eleventh Area: Communal, R02 Landing Location: Ceiling Description: Artex on concrete Asbestos Type: Chrysotile Amount: 4 m2

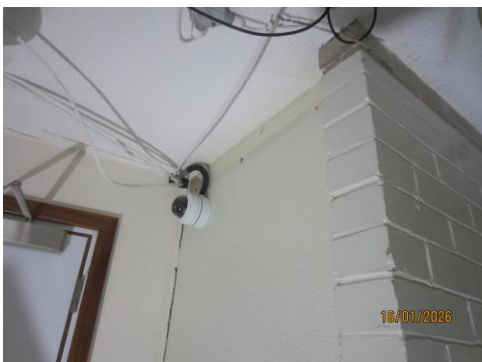
Level of ID:	Visually inspected	Ref:	As S02
	Building / Floor: HPC / Eleventh Area: Communal, R03 Corridor Location: Wall Description: Artex on concrete, masonry, stud wall Asbestos Type: Chrysotile Amount: 12 m2

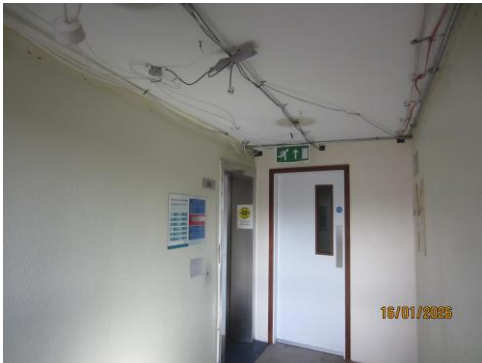
Level of ID:	Sampled	Ref:	S04
	Building / Floor: HPC / Eleventh Area: Communal, R04 Corridor Location: Ceiling Description: Artex on concrete Asbestos Type: Chrysotile Amount: 7 m2			
Recommendations:				
Remove artex in accordance with the Control of Asbestos Regulations 2012 and dispose of as hazardous waste.

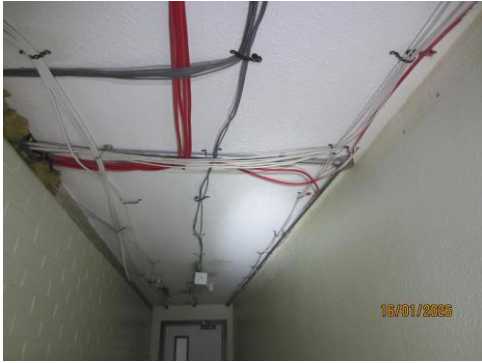
Level of ID:	Visually inspected	Ref:	As S01
	Building / Floor: HPC / Eleventh Area: Communal, R05 Corridor Location: Ceiling Description: Artex on concrete Asbestos Type: Chrysotile Amount: 10 m2

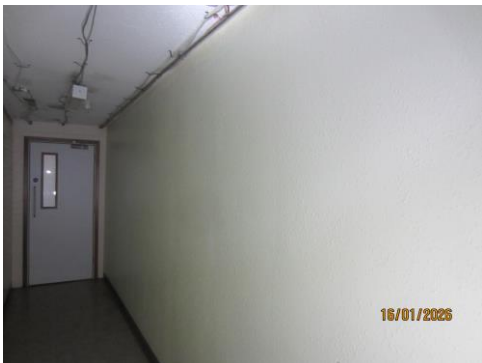
Level of ID:	Sampled	Ref:	S06
	Building / Floor: HPC / Eleventh Area: Communal, R05 Corridor Location: Wall Description: Artex on concrete, masonry Asbestos Type: Chrysotile Amount: 20 m2

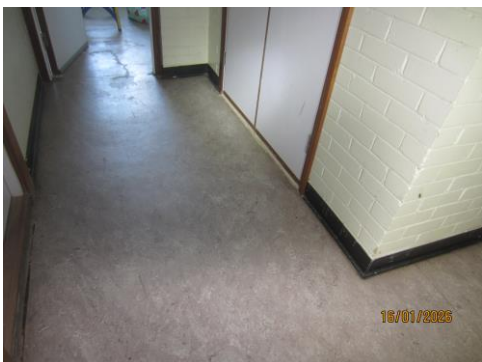
Level of ID:	Visually inspected	Ref:	As S03
	Building / Floor: HPC / Eleventh Area: Communal, R05 Corridor Location: Floor Description: Bitumen on floor slab below floor covering Asbestos Type: Chrysotile Amount: 10 m2

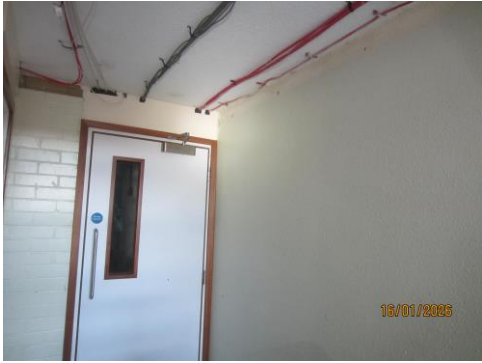
Level of ID:	Visually inspected	Ref:	As S04
	Building / Floor: HPC / Eleventh Area: Communal, R08 Corridor Location: Ceiling Description: Artex on concrete Asbestos Type: Chrysotile Amount: 5 m2			
Recommendations:				
Remove artex in accordance with the Control of Asbestos Regulations 2012 and dispose of as hazardous waste.

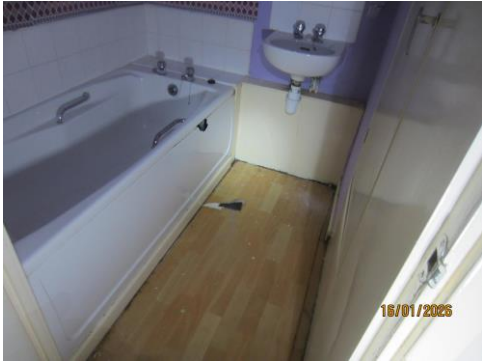
Level of ID:	Visually inspected	Ref:	As S09
	<p>Building / Floor: HPC / Eleventh</p> <p>Area: Flat 36, R02 Bathroom</p> <p>Location: Floor</p> <p>Description: Bitumen on floor slab below floor covering, modern sanitaryware & fittings</p> <p>Asbestos Type: Chrysotile</p> <p>Amount: 1 m2</p>

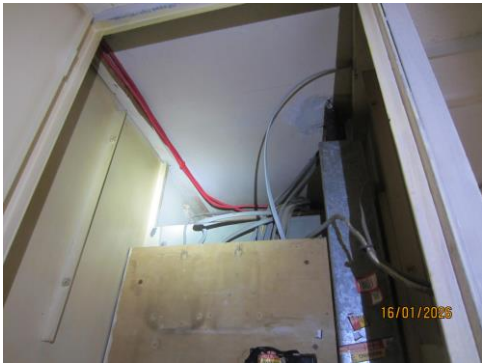
Level of ID:	Visually inspected	Ref:	
	<p>Building / Floor: HPC / Eleventh</p> <p>Area: Flat 36, R04 Electric cupboard</p> <p>Location: Ceiling</p> <p>Description: Concrete</p> <p>Asbestos Type: No suspect material</p> <p>Amount: m2</p>

No action required

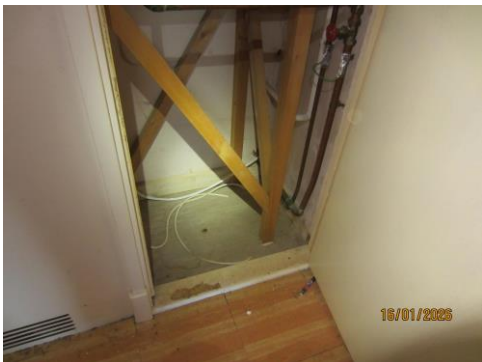
Level of ID:	Visually inspected	Ref:	
	<p>Building / Floor: HPC / Eleventh</p> <p>Area: Flat 36, R05 Tank cupboard</p> <p>Location: Floor</p> <p>Description: Vinyl on concrete</p> <p>Asbestos Type: No suspect material</p> <p>Amount: m2</p>

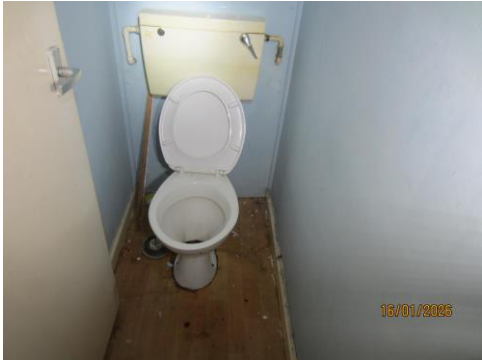
Level of ID:	Visually inspected	Ref:	As S09
	<p>Building / Floor: HPC / Eleventh</p> <p>Area: Flat 36 R06 Toilet</p> <p>Location: Floor</p> <p>Description: Bitumen on floor slab below floor covering</p> <p>Asbestos Type: Chrysotile</p> <p>Amount: 1.5 m2</p>

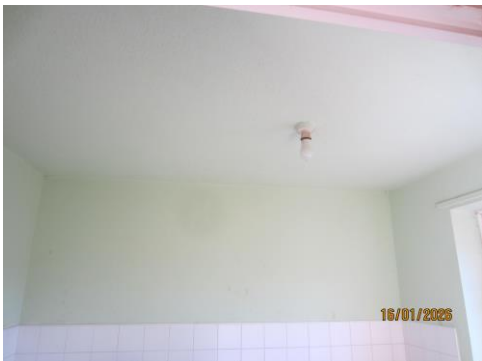
Level of ID:	Visually inspected	Ref:	As S07
	<p>Building / Floor: HPC / Eleventh</p> <p>Area: Flat 36 R07 Kitchen</p> <p>Location: Ceiling</p> <p>Description: Artex on concrete</p> <p>Asbestos Type: Chrysotile</p> <p>Amount: 3.5 m2</p>

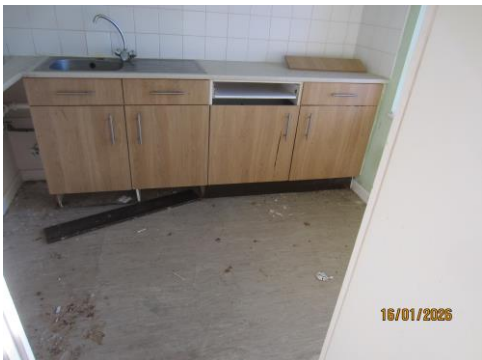
Level of ID:	Visually inspected	Ref:	As S09
	<p>Building / Floor: HPC / Eleventh</p> <p>Area: Flat 36 R07 Kitchen</p> <p>Location: Floor</p> <p>Description: Bitumen on floor slab below floor covering, modern units & fittings</p> <p>Asbestos Type: Chrysotile</p> <p>Amount: 3.5 m2</p>

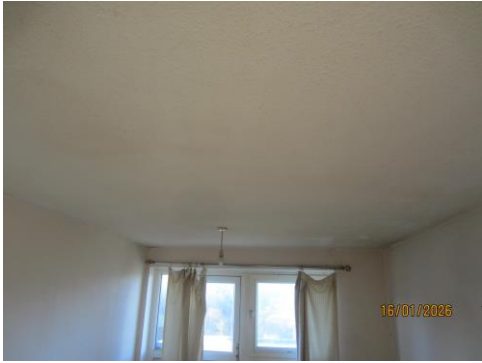
Level of ID:	Sampled	Ref:	S07
	Building / Floor: HPC / Eleventh Area: Flat 36 R08 Lounge Location: Ceiling Description: Artex on concrete Asbestos Type: Chrysotile Amount: 14 m2

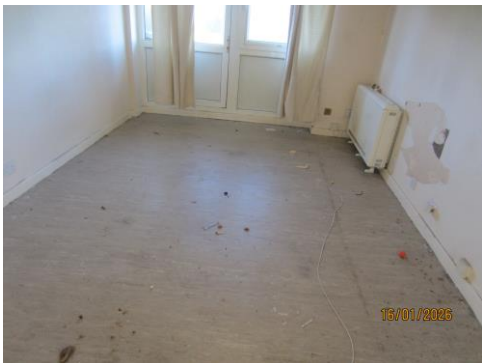
Level of ID:	Visually inspected	Ref:	As S09
	Building / Floor: HPC / Eleventh Area: Flat 36 R08 Lounge Location: Floor Description: Bitumen on the floor slab below floor covering Asbestos Type: Chrysotile Amount: 14 m2

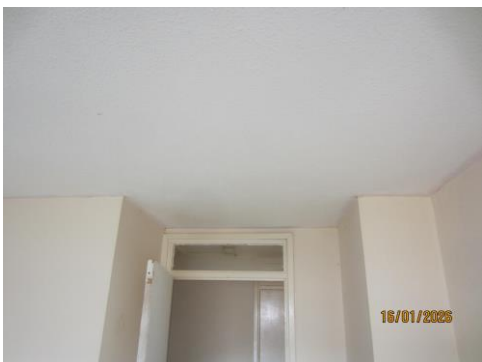
Level of ID:	Visually inspected	Ref:	S08
	Building / Floor: HPC / Eleventh Area: Flat 36 R09 Bedroom Location: Ceiling Description: Artex on concrete Asbestos Type: Chrysotile Amount: 11 m2

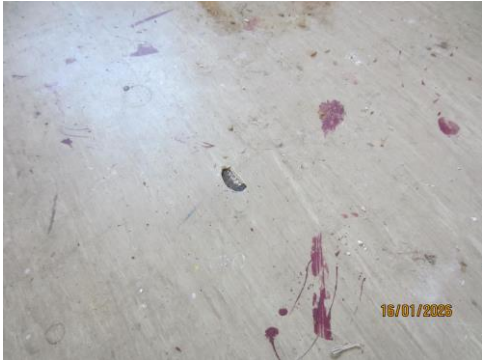
Level of ID:	Sampled	Ref:	S09
	Building / Floor: HPC / Eleventh Area: Flat 36 R09 Bedroom Location: Floor Description: Bitumen on floor slab below floor covering Asbestos Type: Chrysotile Amount: 11 m2

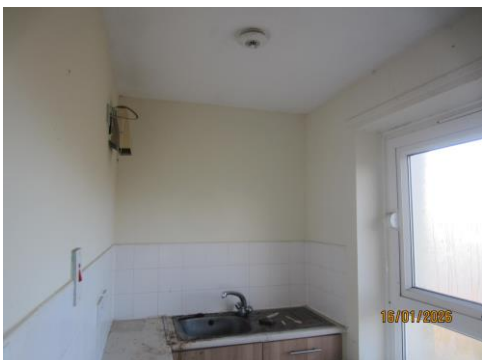
Level of ID:	Visually inspected	Ref:	As S08
	Building / Floor: HPC / Eleventh Area: Flat 31 to 35 Location: Ceiling Description: Artex on concrete Asbestos Type: Chrysotile Amount: 168 m2

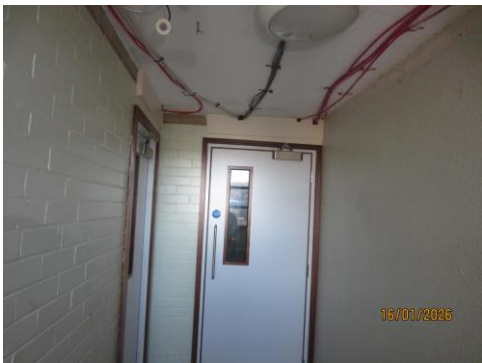
Level of ID:	Visually inspected	Ref:	As S08
	Building / Floor: HPC / Twelfth Area: Communal areas Location: Ceiling Description: Artex on concrete Asbestos Type: Chrysotile Amount: 44 m2			
Recommendations:				
Remove artex in accordance with the Control of Asbestos Regulations 2012 and dispose of as hazardous waste.

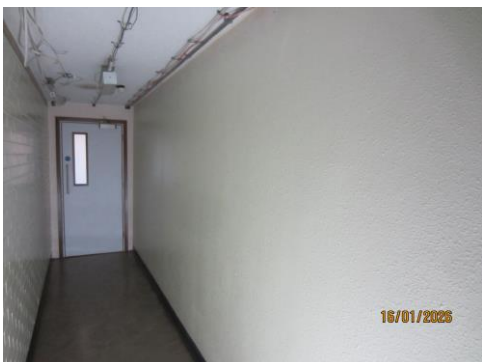
Level of ID:	Visually inspected	Ref:	As S05
	Building / Floor: HPC / Twelfth Area: Communal areas Location: Wall Description: Artex on concrete Asbestos Type: Chrysotile Amount: 101 m2			
Recommendations:				
Remove artex in accordance with the Control of Asbestos Regulations 2012 and dispose of as hazardous waste.

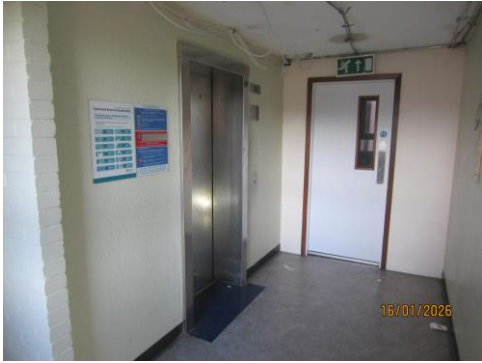
Level of ID:	Visually inspected	Ref:	As S09
	Building / Floor: HPC / Twelfth Area: Communal areas Location: Floor Description: Bitumen on floor slab below floor covering Asbestos Type: Chrysotile Amount: 34 m2

Remove bitumen in accordance with the Control of Asbestos Regulations 2012 and dispose of as hazardous waste.

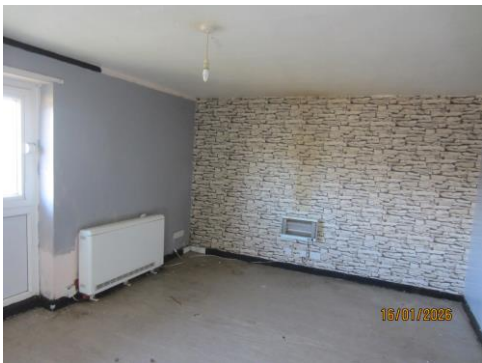
Level of ID:	Visually inspected	Ref:	As S08
	Building / Floor: HPC / Twelfth Area: Flats 25 to 30 Location: Ceiling Description: Artex on concrete Asbestos Type: Chrysotile Amount: 205 m2

Remove artex in accordance with the Control of Asbestos Regulations 2012 and dispose of as hazardous waste.

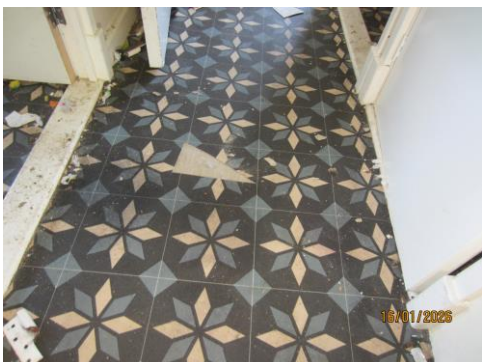
Level of ID:	Visually inspected	Ref:	As S09
	Building / Floor: HPC / Twelfth Area: Flats 25 to 30 Location: Floor Description: Bitumen on floor slab below floor covering Asbestos Type: Chrysotile Amount: 199 m2
